**An Archaeological Watching Brief  
at  
2, Roebuck Street, Hastings,  
East Sussex**

**HS/CA/10/00037 & 38**

**Project Number CBAS0171**

June 2011

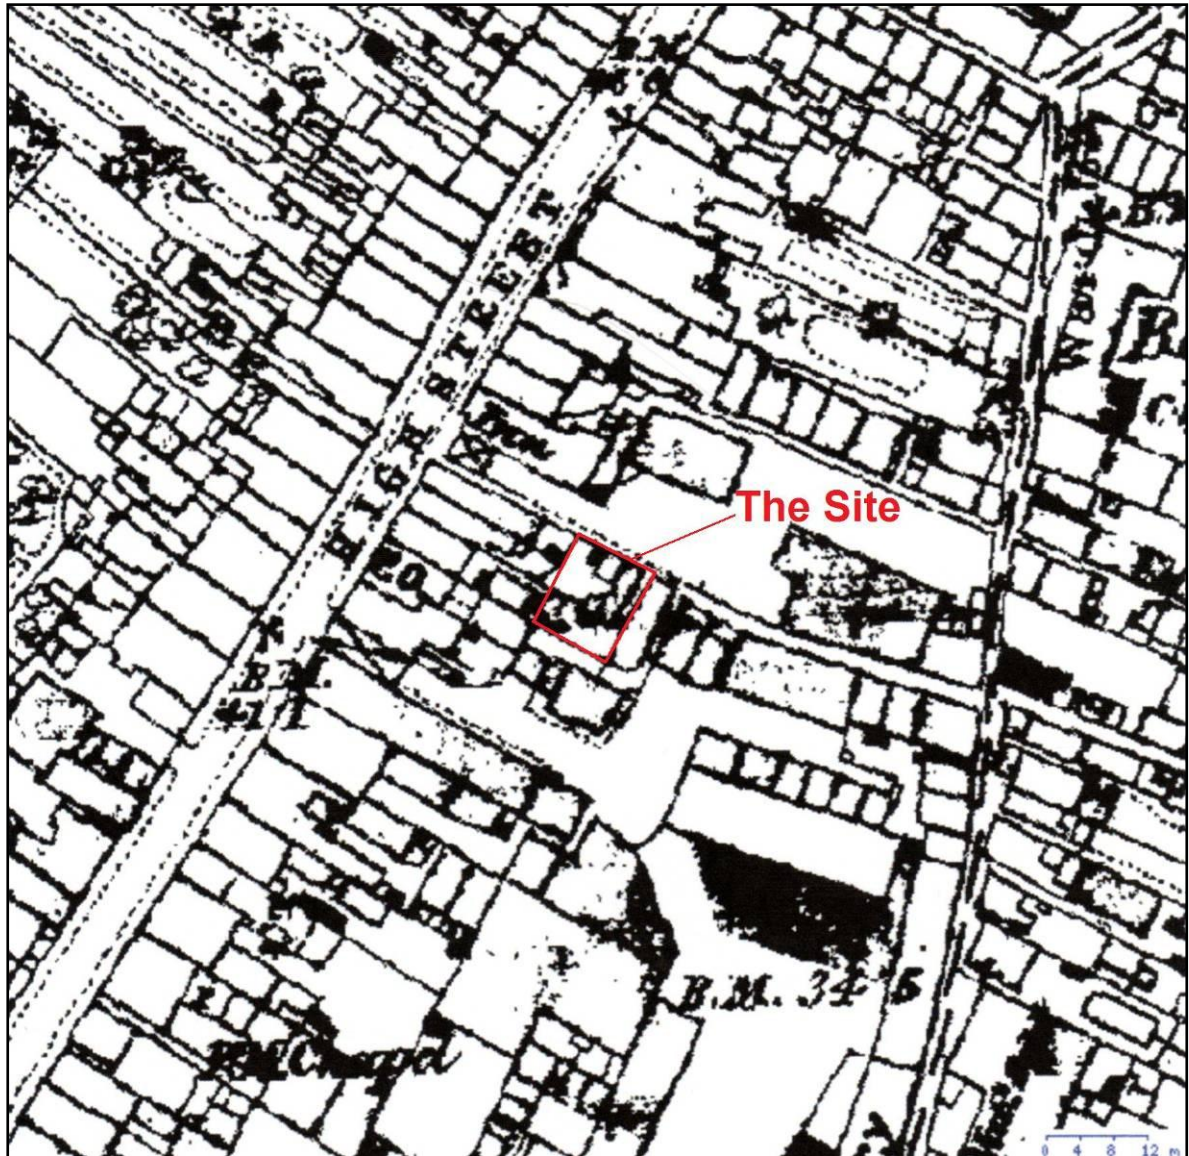
Fig. 3: 2 Roebuck Street, Hastings: 1<sup>st</sup> Edition OS Map (1873-5)

- 2.16** The 1st Edition OS map (1873-5) shows the site to be occupied by one or two small buildings, with buildings fronting onto the High Street on its west side, and other buildings to the south and east. Roebuck Street is little more than a narrow passageway at this date (Fig. 3). By the 3<sup>rd</sup> Edition OS map (1909-10) these buildings have gone and have been replaced by a small building fronting onto Roebuck Street with some smaller buildings on its south side (Fig. 4). A large industrial building is situated on the east side of the site.

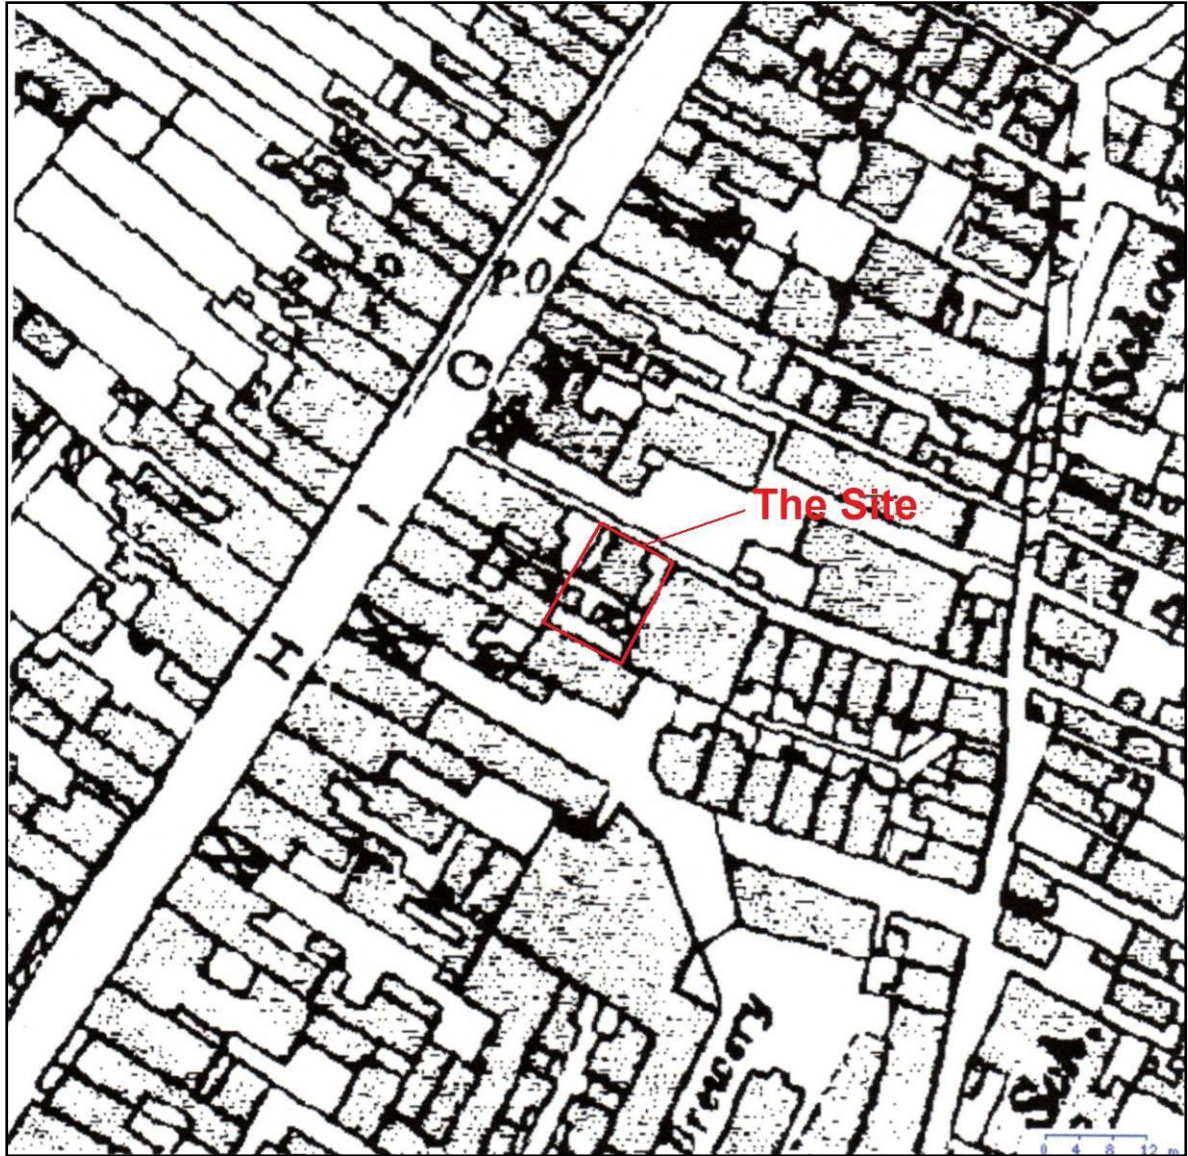
Fig. 4: 2 Roebuck Street, Hastings: 3rd Edition OS Map (1909-10)

- 6.2** The brick sample taken from the wall (Context 1) suggests a date for these wall from the later 18<sup>th</sup> century to the 19<sup>th</sup> century, which would suggest that these foundations belong to the buildings shown on Samuel Cants map of Hastings (1746-8) which shows some buildings on the south side of Roebuck Street that could extend on to the site, and also the map of 1769 which also shows a building there. Buildings are also shown on the 1<sup>st</sup> Edition OS map (1873-5) and then different and more substantial buildings on the 3<sup>rd</sup> Edition OS of 1909-10.

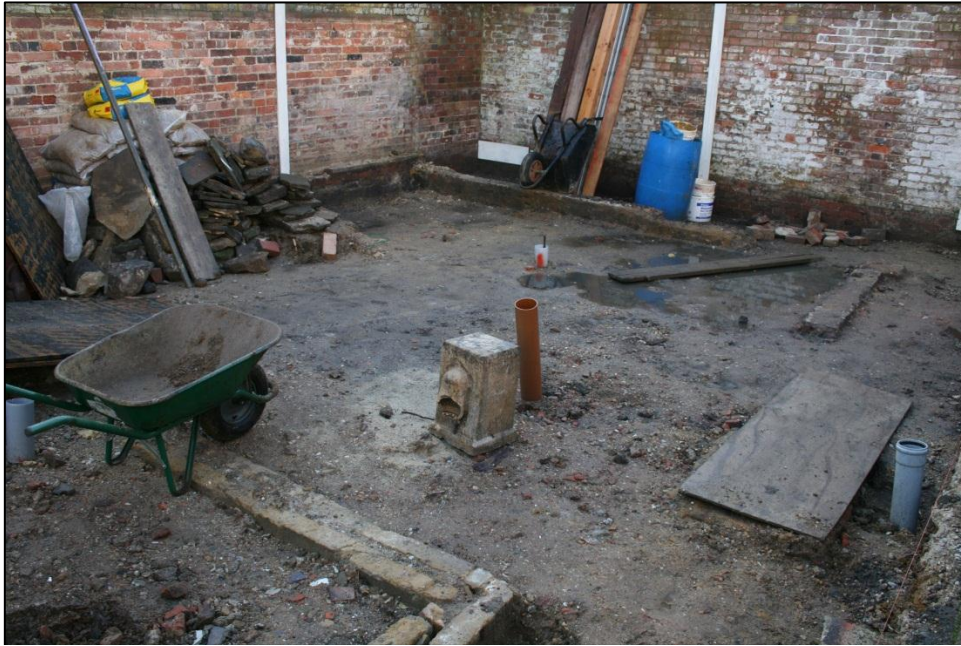
Fig. 7: 2 Roebuck Street, Hastings: South end of site with concrete foundation of garage in foreground and brick wall (1) at rear

- 4.3 Context 3 was located to the north of Context 1, and was the concrete foundation to the recently demolished garage. The foundation was constructed from concrete blocks, each measuring 450mm in length with a width of 240mm and a thickness of 100mm, and were bonded with mid-grey cement.

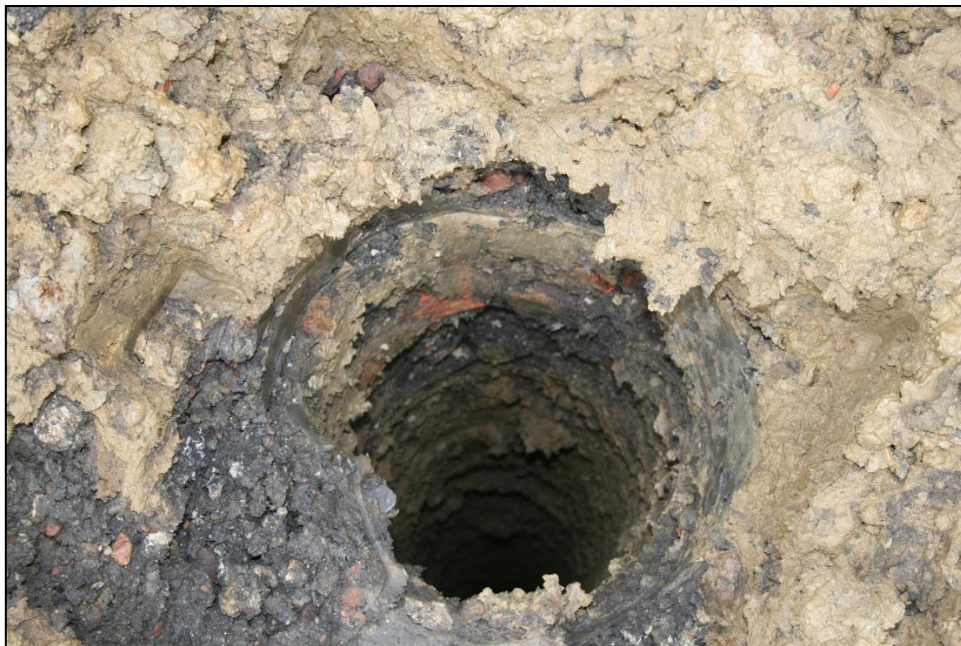
Fig. 8: 2 Roebuck Street, Hastings: Example borehole

- 3.2** A watching brief was maintained on the 1<sup>st</sup> and 4<sup>th</sup> February 2011 during the boring of the holes for the pilings for the foundations of the new house. The holes were bored using a tracked boring rig with an air compressor. The boring rig used 1m lengths of drill with a diameter of 350mm (Fig. 8).
