**An Archaeological Evaluation and  
Watching Brief at Pococksgate Farm,  
Frant, East Sussex.**

TQ 5843 3344

by  
Keith Butler PIfA

August 2012

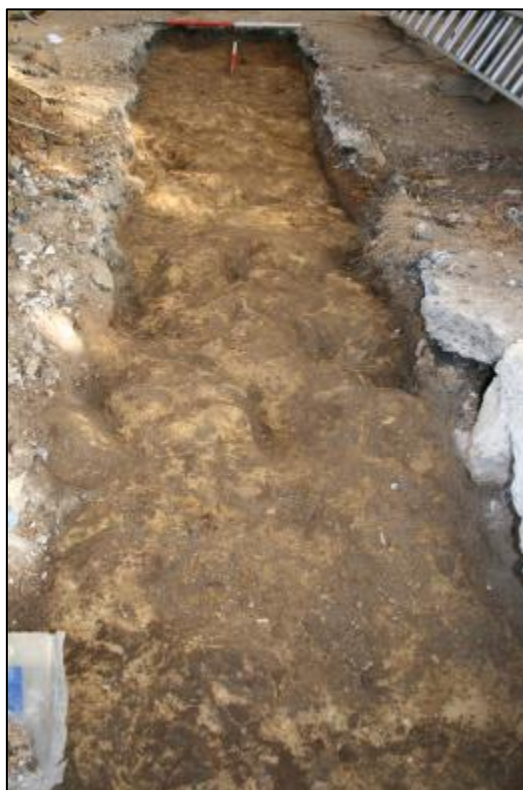
Plate 2: Trench A

- 4.1 Trench A was very shallow before the natural sandstone was reached, being excavated to a depth of 170mm at its eastern end, and a depth of 370mm at the western end (Fig. 5 and Plate 2). Context 1 was a layer of concrete flooring having a thickness of 80mm. The concrete was a mid grey in colour and having inclusions of small pebbles (10%).

- 4.2 Below Context 1 was Context 2, a layer of very dark greyish-brown clinker with a thickness of up to 100mm. The only inclusions in this layer were the fragments of two bricks, these were retained (see Section 5 below).

- 4.3 Below Context 2 was Context 3, which was a layer of orange-brown clayey silt with a loose consistence. This was up to 70mm thick and was apparent in the four metres from the eastern end of the trench. Inclusions in this layer comprised straw and small pieces of wood shavings (5%), pieces of sandstone up to 30mm (<1%) and ceramic building material (CBM) (<1%). Artefacts recovered from this layer comprised CBM and metal.

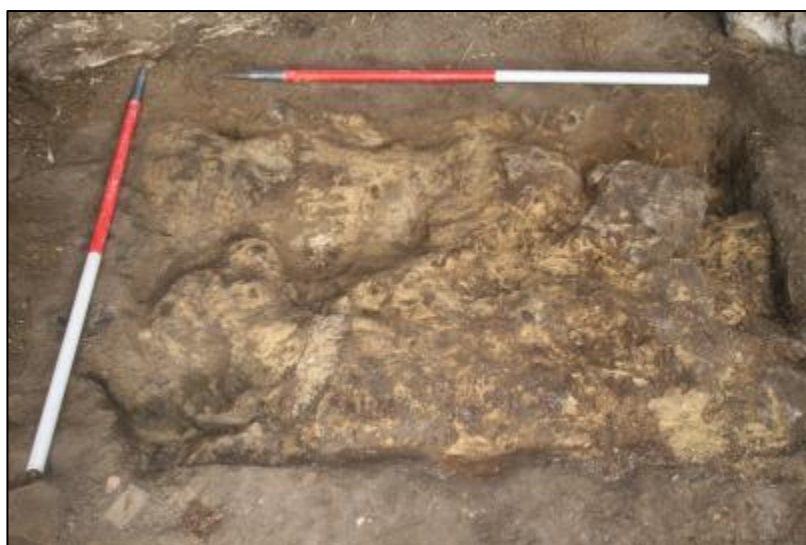
**Plate 3: Trench B**

- 4.8** In Trench **B** only two layers were apparent. Context **7** was a layer of dark brown silty clay loam with a loose consistence. This layer was only 150mm at its deepest but was much shallower in most of the trench, with the natural sandstone breaking through the surface of Context **7** in places. The inclusions were of sandstone pieces up to 30mm (<1%) and straw and wood shavings (2%). The artefacts were of CBM and metal.

- 4.9** Below Context 7 was Context 8, which was the same orangey-buff sandstone with a firm consistence as Context 5 in Trench A (Fig. 4), but without the pockets of sandy clay. This context had a very uneven interface with the layer above. No artefacts were recovered from this layer.
- 4.10** Context 9 was within Context 8, and was the remains of a small wooden stake located in the south west corner of the trench. The remains of the stake measured 150mm by 70mm. The stake appeared to have been driven into the natural, although there was no associated cut. From its state of preservation the stake appears to be of a recent date.
- 4.11** There were no archaeological features noted in Trench B, apart from the remnant of the wooden stake.
