**An Archaeological Watching Brief
at
Ore Place Farmhouse, The Ridge,
Hastings, East Sussex.**

HS/FA/10/00371

Project Number CBAS 0191

November 2011

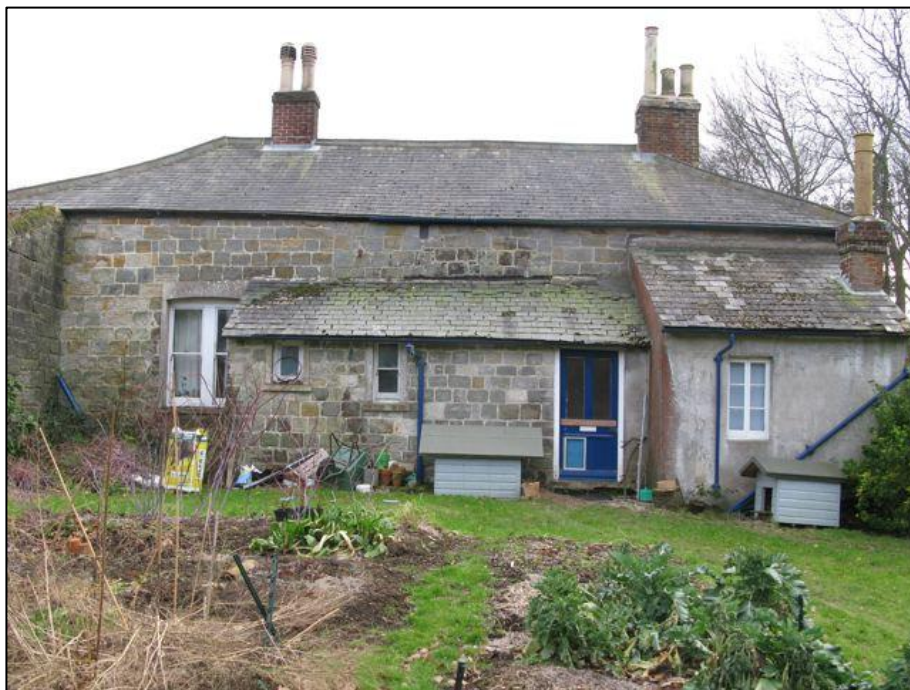
- 4.6 Whilst on site a brief visual survey of the exterior of the Farmhouse was undertaken. The roof of the Farmhouse was covered with slate tiles, and was hipped at both ends (Fig. 5). The ridge and the hips had a row of black ceramic tiles with a triangular profile. There are two chimney stacks, with the largest being located at the western end of the building at the junction of the hips and the ridge of the roof. The second chimney stack is located slightly in from eastern end of the ridge. Both of the chimney stacks have courses of oversailed bricks. The north, east and western walls were constructed of evenly coursed faced sandstone blocks with a bonding material of mid grey mortar. The southern elevation was coated in a cement render.

Fig. 5: Ore Place Farmhouse: Original extensions, now demolished
(Source: Julia Hilton)

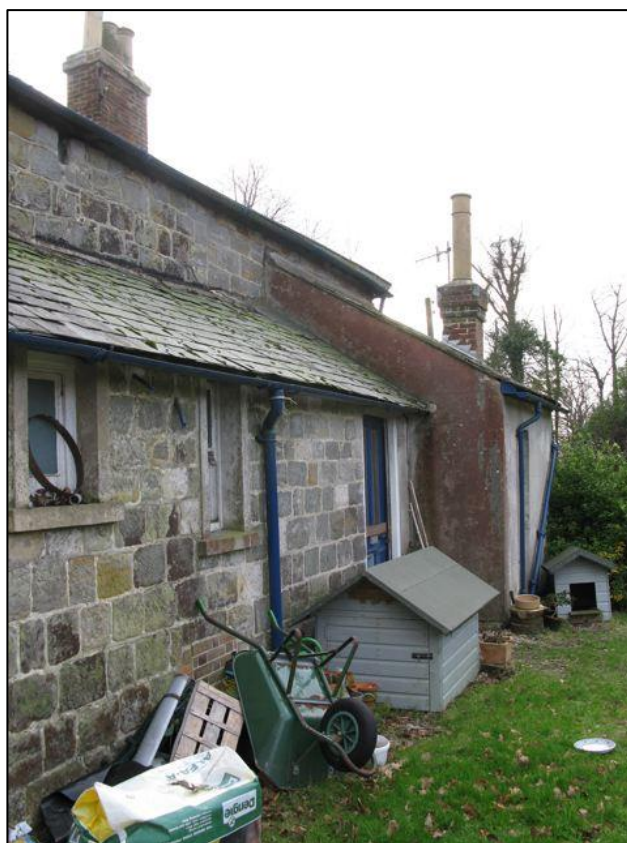
Fig. 6: Ore Place Farmhouse: Original extensions, now demolished
(Source: Julia Hilton)

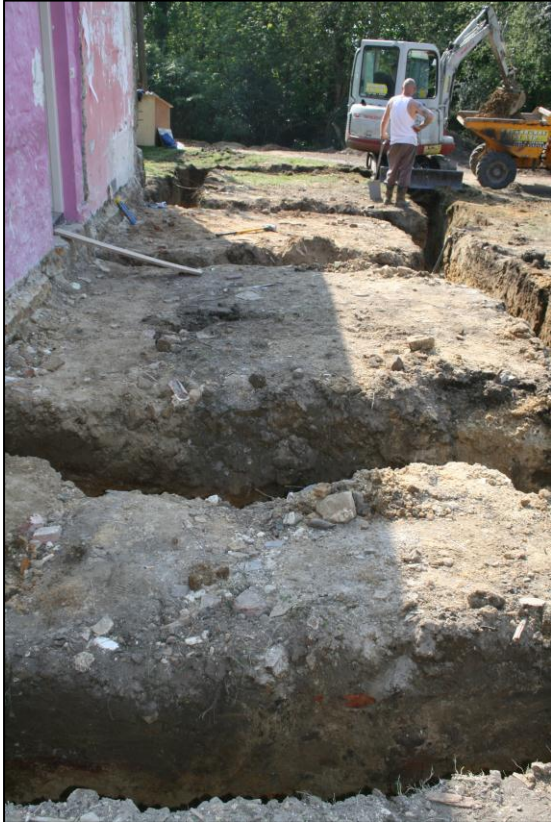
- 4.1 During the excavation of the foundation trenches (Fig. 7) four deposits were apparent; Context 1 was a thin layer of topsoil up to 100mm thick. This was dark brown in colour, and comprised a silty clay loam with a loose consistence. The inclusions in this deposit were of mortar (<1%), ceramic building material (CBM) (1%) and pieces of slate, all of these were associated with the demolition of the lean-to buildings. This deposit produced the only artefacts recovered from the site, which were two pieces of late 19th to early 20th century pottery.

- 4.2 Below Context 1 was Context 2, which was a deposit of mid brown silty clay with a loose consistence, and had a thickness of up to 400mm. The only inclusions in this layer were of pieces of sandstone up to 40mm in size (<1%). Both this deposit and Context 1 were very disturbed due to the previous demolition and removal of a manhole and associated drains.

- 4.3 Context 3 was below Context 2, and was an orangey-buff silty clay deposit with a firm consistence. The deposit was up to 400mm thick, with inclusions of sandstone pieces up to 60mm in size (40%). The inclusions of sandstone were found in pockets within the clay. No artefacts were recovered from this deposit.

- 4.4 Context 4 was below Context 3, and was the natural. This deposit was of grey sandstone (Ashdown Beds) with no inclusions, and a firm to compact consistence.

Fig. 7: Ore Place Farmhouse:
Excavated foundations for new

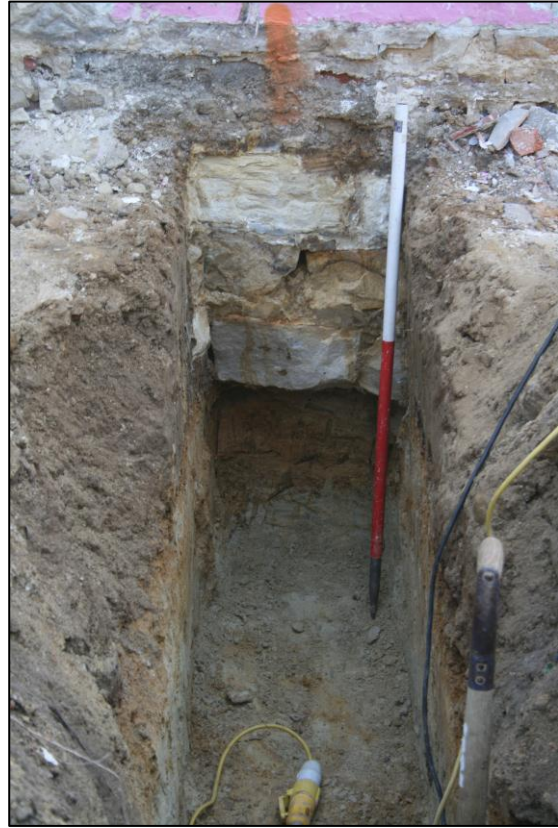
- 4.5 The foundations of the north wall of Ore Place Farmhouse were seen where they were exposed by the new foundation trenches (Fig. 8). The foundations (Context 5) were constructed of the same type of faced sandstone blocks as the upstanding above-ground northern wall of the farmhouse. The dimensions of the sandstone blocks in the foundation were approximately 400mm by 200mm. The foundations were 600mm deep and consisted of three evenly laid courses. The bonding material was a mid grey coloured lime mortar.

Fig. 8: Ore Place Farmhouse:
Foundations of Farmhouse

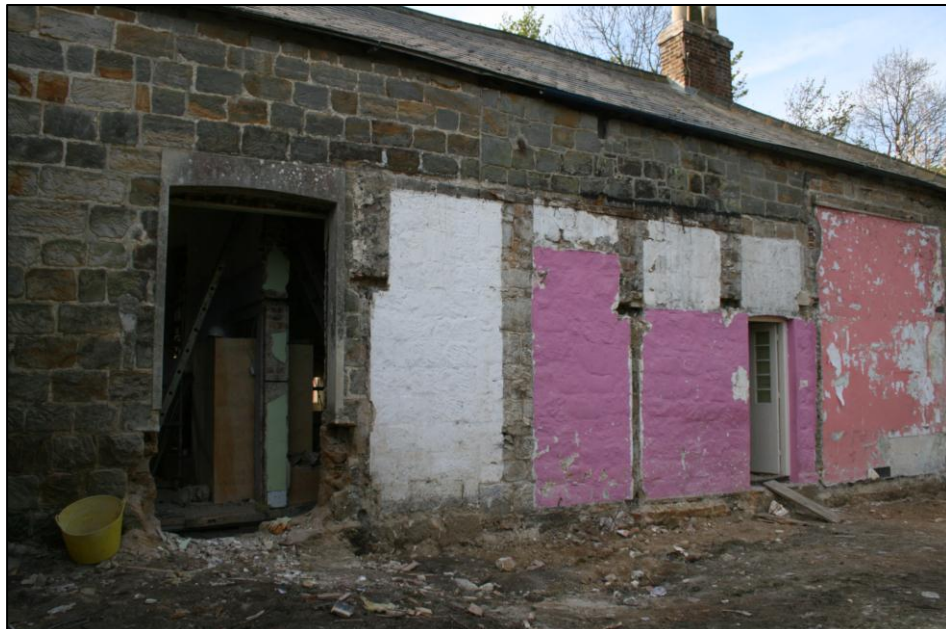
- 4.7** The removal of the existing extensions against the northern elevation of the farmhouse shows evidence of the original use of the building as a coach house. There is a change of the stone work located in the centre of this elevation between the two current doors. This appears to be an in-filled large entrance to a coach house (Fig. 9). The two current doorways are at ground level, with the eastern opening being both higher and wider, having been built into the earlier larger entrance. There are no windows in the northern elevation.

Fig. 8: Ore Place Farmhouse: North wall of Farmhouse showing
original entrance noted by the change in the stonework to the right of
the large doorway to the far side of the small doorway
