**An Archaeological Watching Brief
at
The Yews, Ringmer, East Sussex.**

(LW/10/1328)

Project No. CBAS0196

November 2011

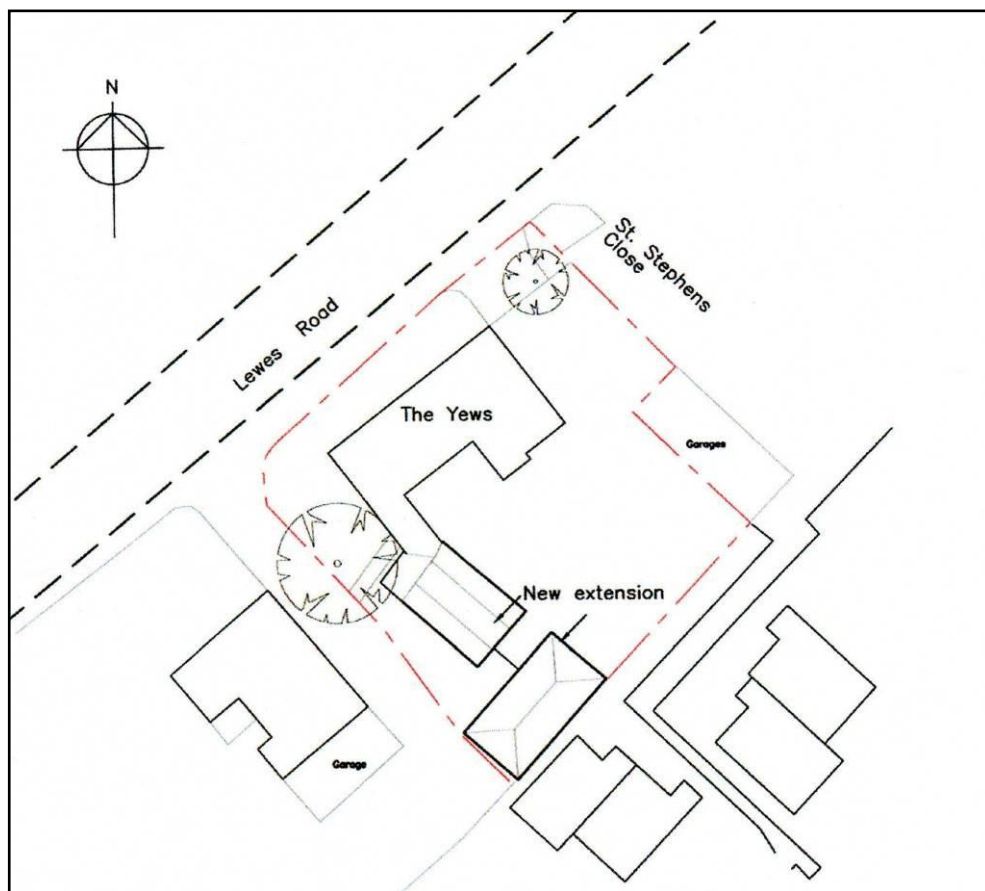
Fig. 4: The Yews, Lewes Road, Ringmer: Site development Plan
(Adapted from architects drawing)

- 3.1** A watching brief was maintained on the 1st June 2011 during the excavations of the footings for a new extension at The Yews, Ringmer (Fig. 4). Upon arrival at the site the former extension that occupied the site had been demolished, with amounts of rubble piled up on the area of the footings. This was first removed then the footings were marked out. The footings measured 8m by 6m, with a width of 600mm, and a depth of 1m.

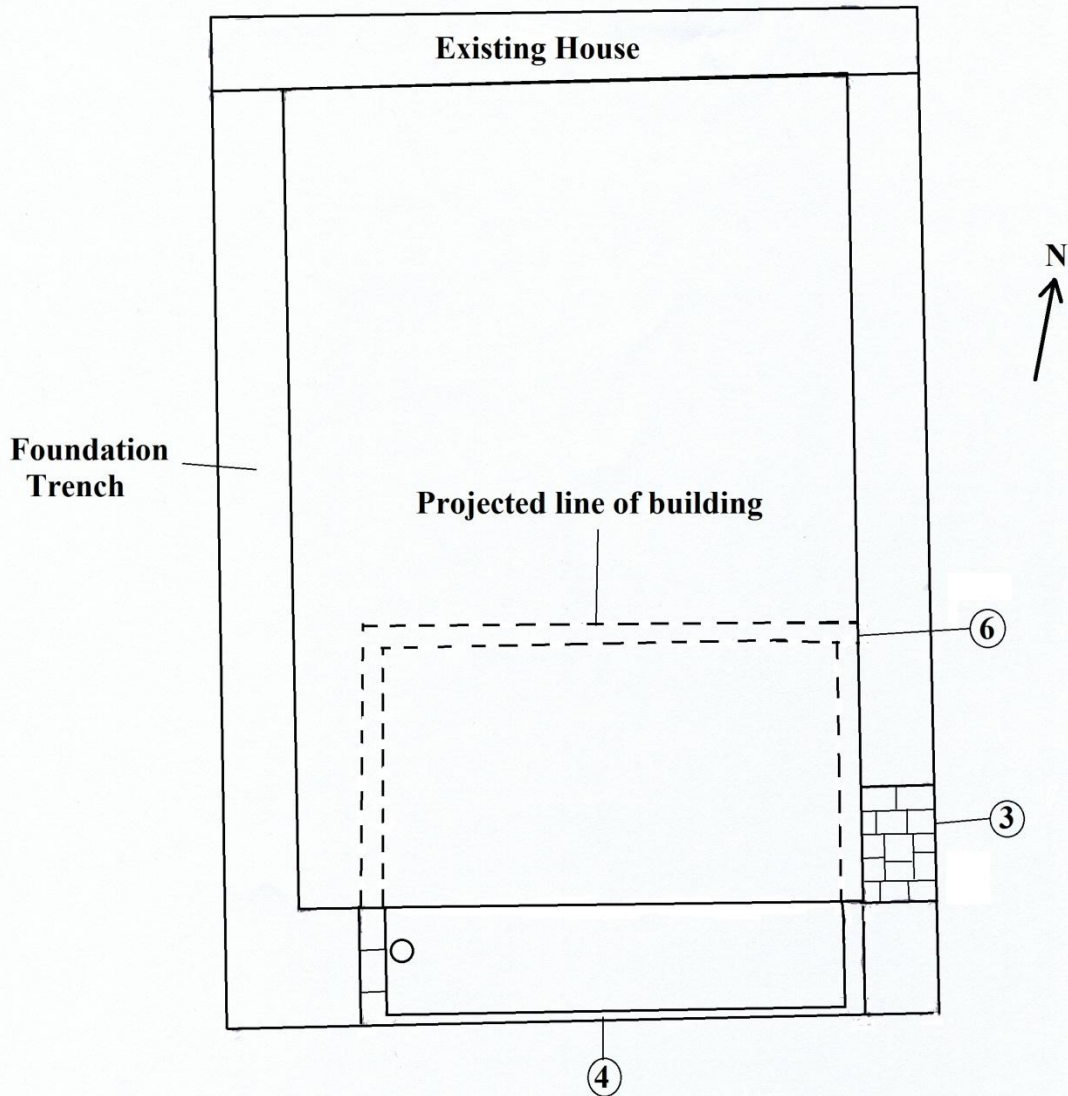
Fig. 5: The Yews, Lewes Road, Ringmer: Plan of areas monitored, showing features noted in text.

- 4.3** At 5.9m in from the northern end of the eastern footing trench (Fig. 5), a brick built structure was discovered (Context **3**). This cut both Contexts **1** and **2** to the full depth of the excavated footing trench (>800mm and had a width of 1m) It was constructed from frogless bricks which measured 230mm stretchers, 120mm headers with a depth of 90mm. The bricks were laid in a random bond, but with large proportion were laid in stretcher bond, to a height of eight courses, and bonded with a mid grey mortar. The structure was apparent across the whole width of the trench on an east west alignment. Across the upper surface of the structure there was an orange plastic pipe running on an east-west axis. Only a small area of this feature was uncovered during the excavations making interpretation very difficult, but with a thickness of 1m, it appeared to be too thick for a wall, but may have been a plinth in association with Context **4**.

- 4.4** Context **4** comprised the remains of three walls of a brick-built structure, and was located at the southern end of the footing trenches (Fig. 5). The southern wall of the structure was running along the baulk of the south-eastern trench, and was preserved in section to its full extent of 5.2m. The eastern wall had been badly damaged, most likely during the demolition process. The remains of the walls were 900mm high and 130mm wide, with the southern wall being cement rendered. The interior of the western wall had a complicated construction of bricks laid in stretcher bond with a cement rendering. The cement render also bonded a layer of red ceramic tiles to it. The outer surface of the tiles was then cement rendered, with a layer of slates as a final layer, however only fragments of the slate covering were noted during the excavations. The structure had a concrete floor at a depth of 1m, with a circular hole of 350mm diameter being discovered at the western end of the floor surface.

- 4.6** Context **6** was only apparent in the western section of the east trench (Fig. 5), and was possibly a remnant of the north wall foundation of the structure (Context **4**). This was constructed of red brick with a bonding material of mid grey mortar. Although badly damaged the foundations of this wall would appear to be 130mm in width.

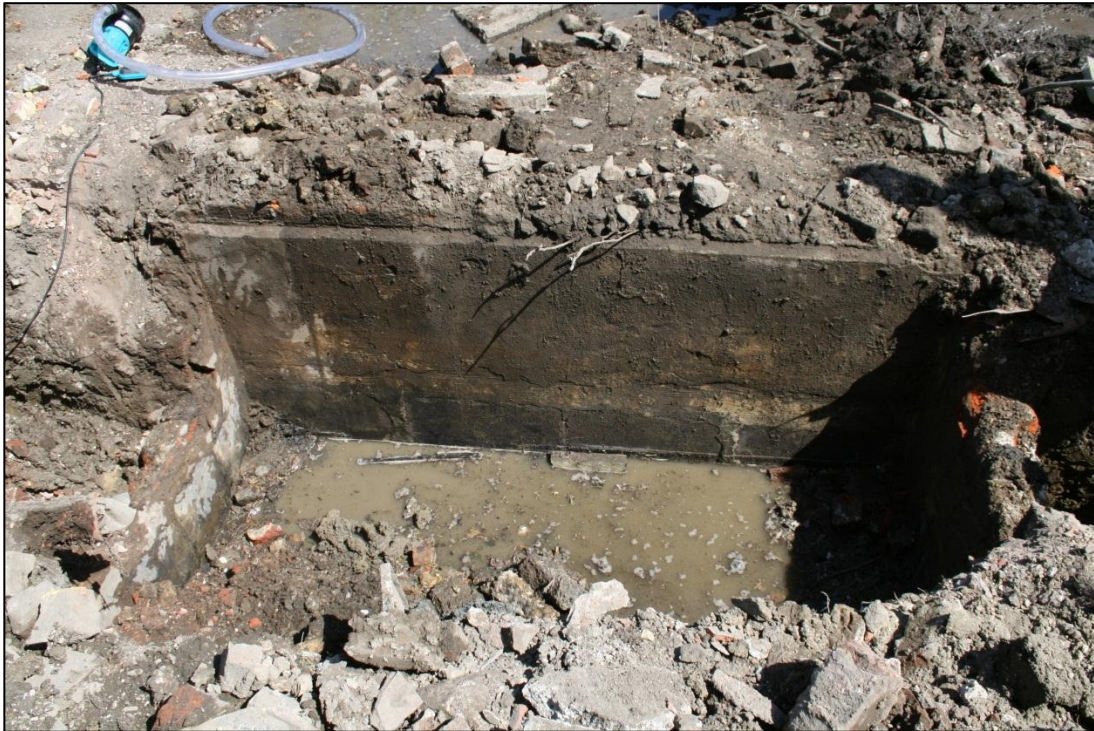
Fig. 8: The Yews, Lewes Road, Ringmer: 19th century milk cellar

- 4.5** Context **5** was material that had been used to backfill Context **4**; this was a very dark brown sandy silty loam with a loose consistence containing many voids. The inclusions were of CBM (25%), mortar (5%) and metal sheeting (2%). Artefacts recovered from this deposit comprised pottery, other building materials and glass; also noted but not recovered was a tiled fireplace surround possibly belonging to the scar of a fireplace noted on the south-eastern elevation of the building.

6.2 However, evidence was discovered for one of these earlier buildings that had occupied the site. The remains of this structure (Context **4**) comprised the south wall and parts of the east and west walls. The south wall had been cement rendered internally, but details of the complicated construction of the west wall could also be seen. On a sketch drawn by a former employee of The Yew, and in the owners' possession (Fig. 6), this part of the site is shown to be occupied by a barn, store and stables with a milk cellar below. The presence of a milk cellar is further suggested by the construction of the wall which would have kept the cellar cool for storage of the milk. The watching brief revealed that the concrete floor to the cellar was intact and had a circular hole, most likely for drainage, at its western end. The larger brick-built structure (Context **3**) on the east side of the building appears to be butted against the east wall of **4**, and appears too substantial for a wall, and may therefore have been a buttress.
