An Archaeological Watching Brief at New Cottage, Winchelsea, East Sussex

(RR/2011/1099)

December 2011

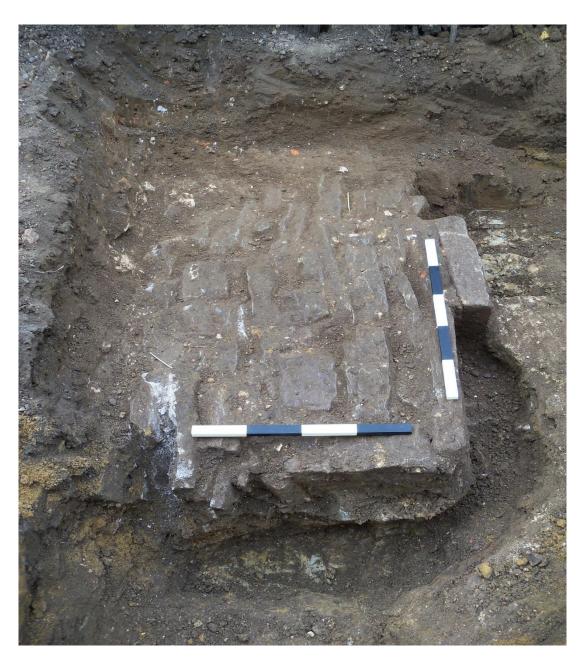
Fig.5: The Rough Hewn stone Feature in the south east corner, with the abutting mortar layer shown at bottom right.

- 4.5 In the south-east corner, at the junction of the eastern and southern trenches a layer of rough-hewn mortared stone was discovered, 600mm x 400mm made of pieces of up to 500mm x 250mm x 70mm (3005). It lay directly on a layer of clay and

appeared to have no other footings. Although the western and north edges could be traced, both the eastern and southern edges lay beyond the excavation.

- 4.6 An additional feature (3006) was revealed immediately to the west of the stones feature and this was a layer of mortar which appeared to be cut by the stones. This feature was at a depth of 150mm and was 50mm 100mm thick, being similar to that found in Test Pit 2 during the evaluation excavation.¹⁴
- 4.8 Immediately above the stone feature (3005) was a layer of Topsoil (3002) similar to that found during the evaluation excavation and that which is common across the garden. This layer was between 250mm 300mm in depth with inclusions of Pea Beach at <1%. This layer lay beyond the edge of the patio forming a flower bed that rose in a bank to the walled and raised garden to the south.
- **4.10** There were no other archaeological features or deposits noted during the evaluation excavation.

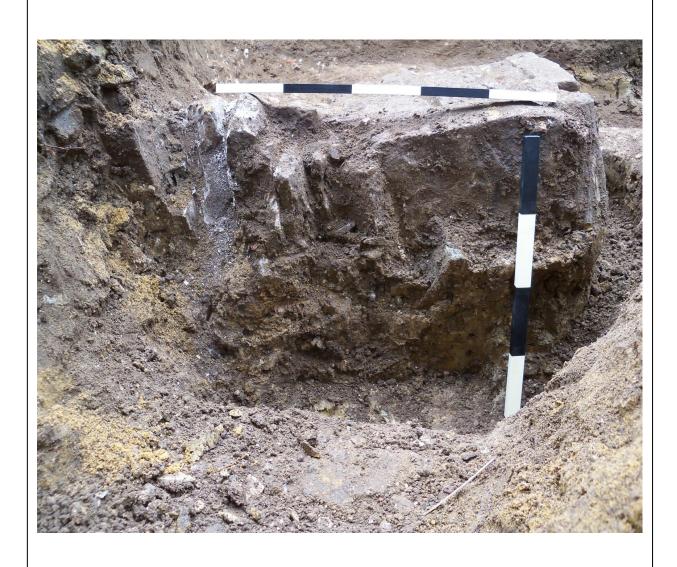
Fig. 6: Rough Hewn Stone feature north facing section, viewed along the eastern trench, note the layer of clay immediately beneath the stones.

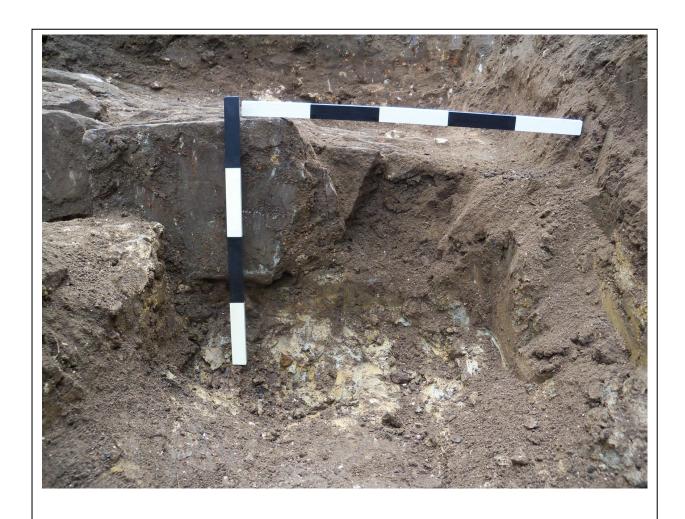
Fig. 7: Rough Hewn Stone feature west facing section viewed along the southern trench, again, note the layer of clay immediately beneath the stones.

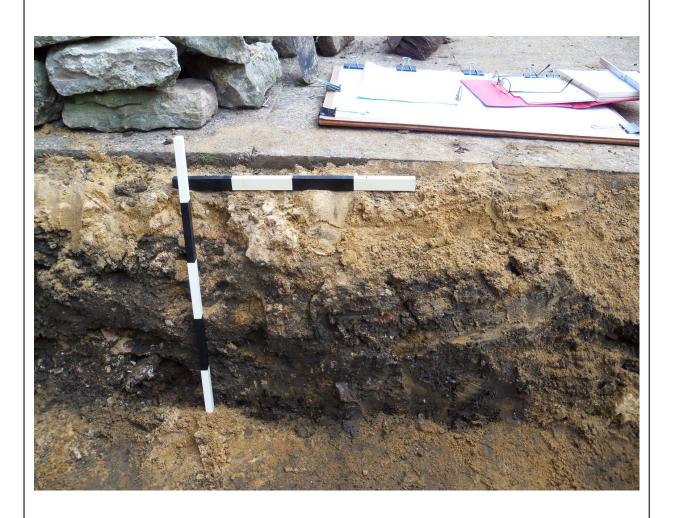
Fig. 7: West facing section of eastern trench, showing sandy layer levelling the patio and the topsoil/building debris layer immediately above the natural clay.

- 4.1 The Eastern Trench, running south from the line of the house wall revealed a loose layer of builders sand, immediately underneath the 25mm thick paving slabs which formed the patio (3001). This layer was 140mm deep and contained some particles of soil similar to that found across the garden and undoubtly constitutes a levelling/foundation layer for the patio.

- 4.2 Beneath this was Context 3003, a layer of friable soil with some clay inclusions (15-20%), to a depth of 350mm. It was generally dark grey in colour and contained modern CBM inclusions typical of the materials used on the house. This deposit appears to have been formed when the foundations for the house were dug out and then later backfilled.

- **4.3** Beneath this was a layer of natural sandy clay found across all the trenches, here appearing at a depth of 700mm.
- 4.4 The above stratigraphy continued around the footing trenches at similar depths, but less CBM was found in the southern trench away from the house.
