An Archaeological Evaluation at the car park of the Burlington Hotel, Eastbourne, East Sussex

Project No. CBAS0259

by
Dr Caroline Russell

January 2012

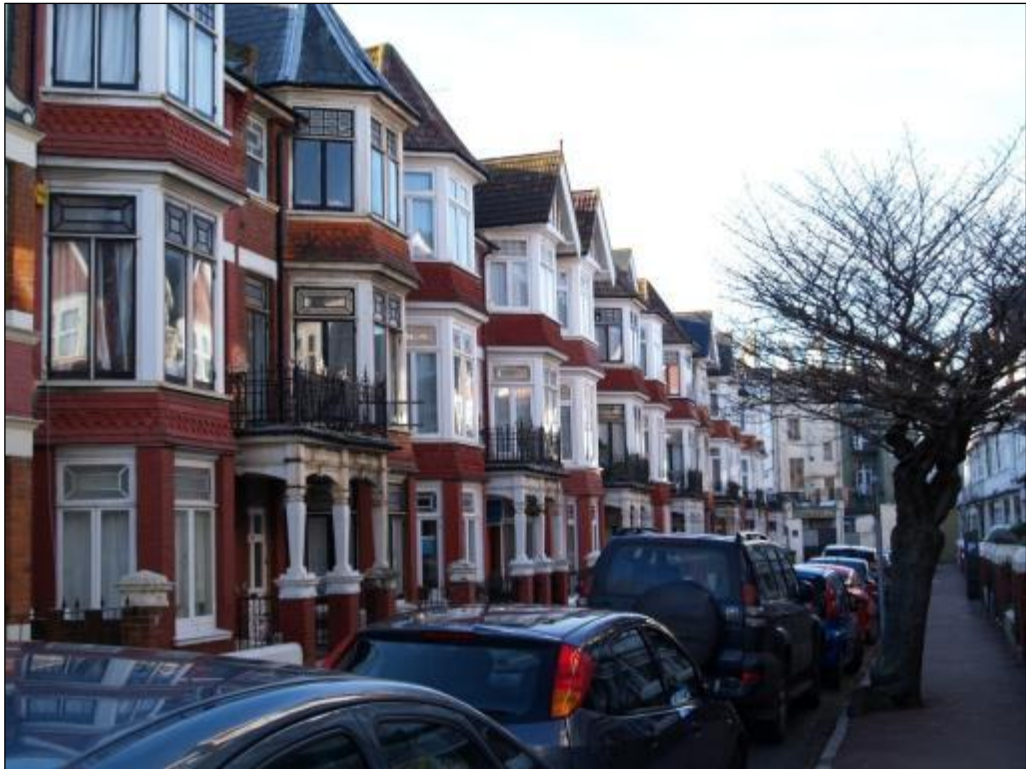
original with no obvious indication of structural rebuild (Plates 1 and 2). This perhaps suggests that the bombs fell further in from Elms Avenue, closer to the site.

Plate 1: Burlington Hotel, Eastbourne: The front of the terrace on Elms Avenue, built c.1901, showing a consistent line of buildings with no indication of rebuilding; looking west

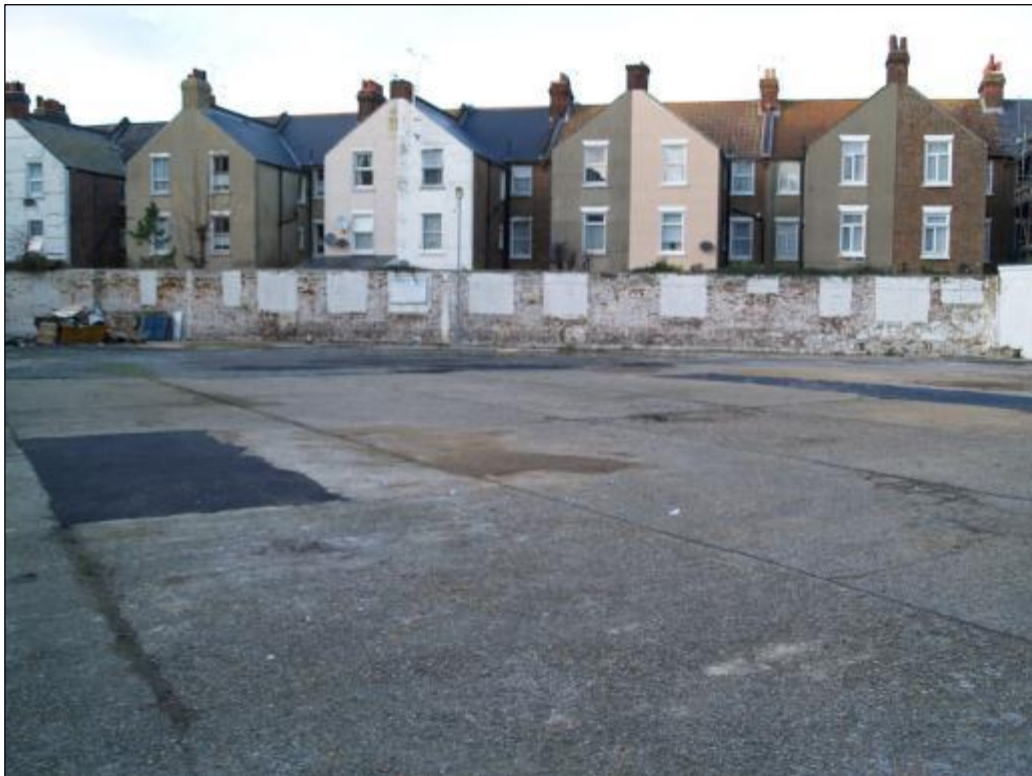
Plate 2: Burlington Hotel, Eastbourne: The rear of the terrace on Elms Avenue reinforces the opinion attained from seeing the front; looking northwest from the site

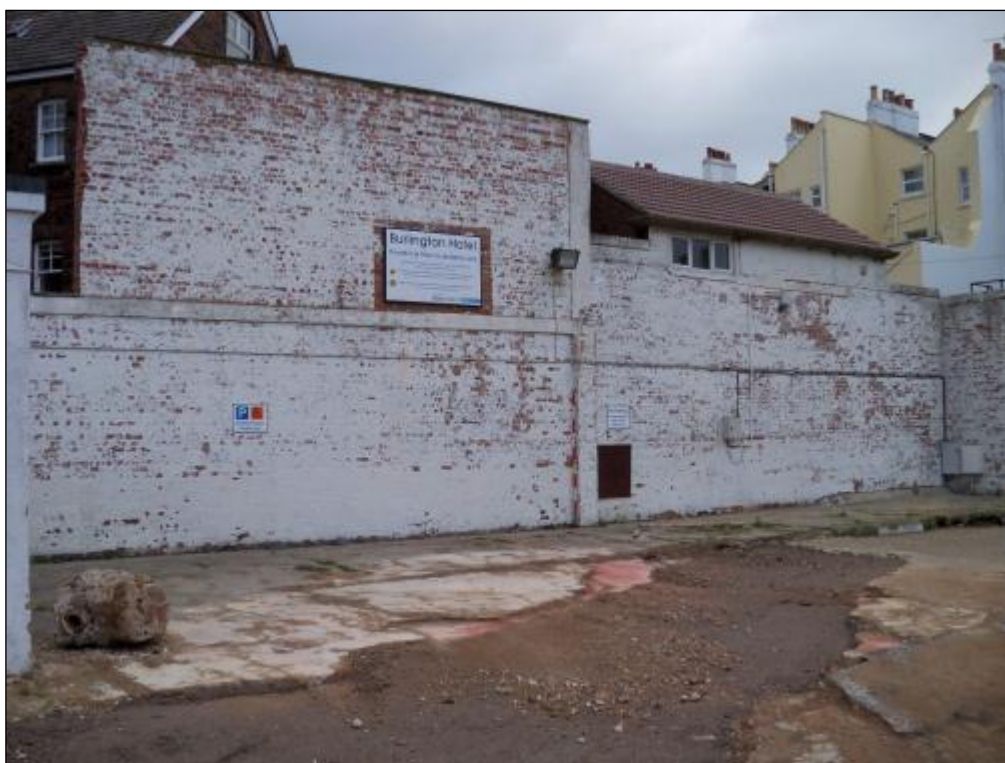
Plate 3: Burlington Hotel, Eastbourne: The only remaining double storey walling of the former garage on site; looking east

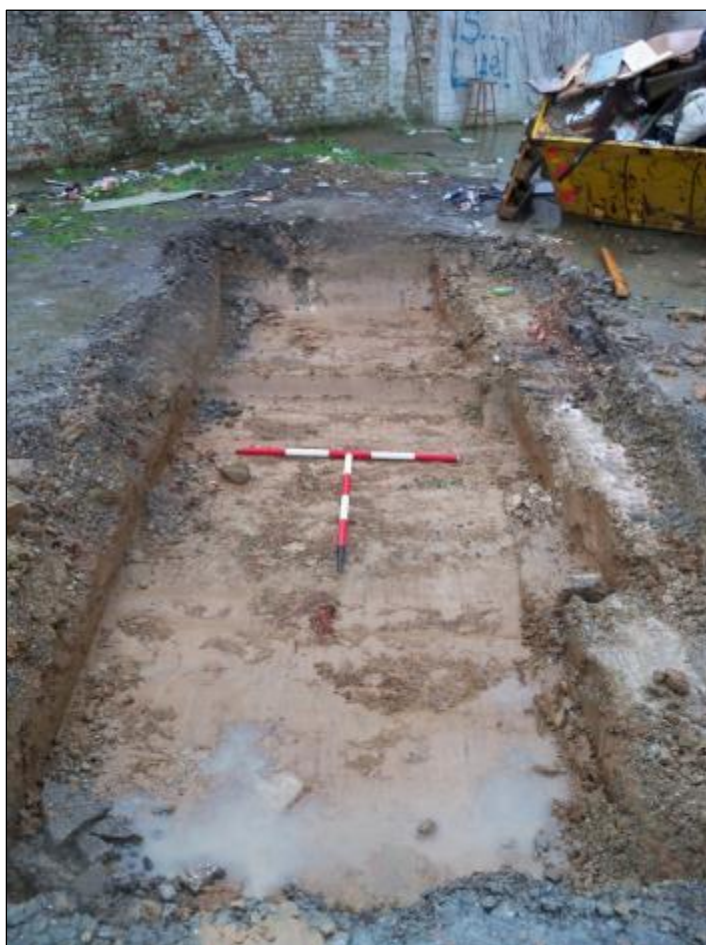
Plate 4: Burlington Hotel, Eastbourne:
Trench 1; looking west

- 4.1** As all six trenches generally only contained relatively recent made ground, not all the types encountered have been described below.
- 4.2** In **Trench 1** (Plate 4), the stratigraphy to the north side of the trench was different to the south side, with the simplest stratigraphy having been recorded to the west end (south side) of the trench. Here, the compacted gravel and shingle surface of the trench (Context **1/001**) had an off-white pebble based concrete (Context **1/002**) separating it from the natural Head deposit (Context **1/003**). The Head was reached at a depth of 0.17m below the ground surface whilst it was exposed at a maximum depth of 0.28m in the middle of the trench. As elsewhere on the site, this deposit was a friable mid orange-brown clay that contained frequent small inclusions of mid yellow-brown and pale off-white sandstone.

- 4.3** A stretch of concrete was exposed in Trench 1 along three-quarters of its north side, 0.23m below the ground surface. This concrete comprised two types: Context **1/008** to the west side and Context **1/009** to the east side. Both were separated from each other by a small drain cover with gravel infill. The concrete overlay the Head deposit (Context **1/003**). It had an exposed width of 0.30m and depth of 0.08m to its west end and an exposed width of 0.25m and depth of 0.02m to its east end. Separate concrete (Context **1/010**) was observed in the northeast corner of the trench. This lay at a slightly deeper depth of 0.32m below the ground surface. It had an exposed width of 0.55m and was at least 0.16m thick, having cut into the Head. A ceramic drain pipe was partly exposed running northwards towards the drain cover.

- 6.4** In Trench 1, concrete of three different types was exposed along the north side, with one having been laid at a slightly lower level than the other two which were associated with a drain. All three almost certainly served as floor levels. Trench 6 contained concrete within its northwest end, flush with the top of the Head deposit. An old gas pipe ran along the length of one of the two exposed sides to the concrete. This concrete is likely to have served as the foundation of a building for which no brickwork was recorded. Trench 4 was the only trench devoid of archaeological features, although it did contain a layer of fragmented red brick above the Head which may indicate the former presence of buildings nearby.

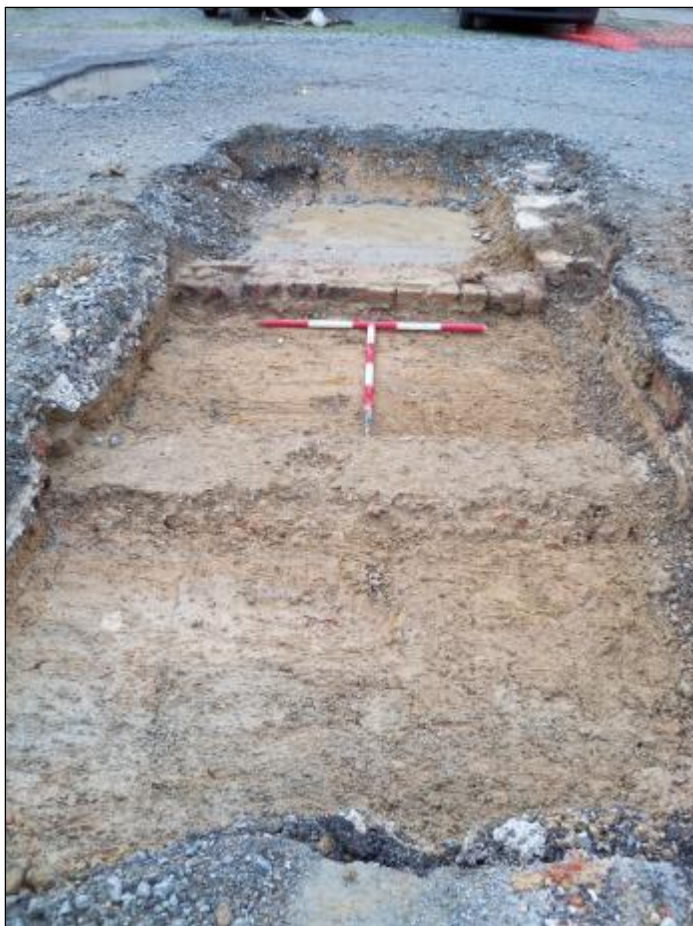
Plate 5: Burlington Hotel, Eastbourne:
Trench 2; looking southwest

- 4.4** **Trench 2** (Plates 5 and 6) contained the parallel remains of two walls, aligned northwest to southeast and about 1m apart. That to the northeast (Context **2/009**) comprised one course of red brick before this was peeled off by the machine. The bricks were laid on a concrete wall footing, of pebble composition, which was up to 0.60m wide. Red bricks appear to have lined the sides of the wall footing.

- 4.5** The remains of the other wall (Context **2/011**) also had just one course of red brick surviving on top of it, and this was left in situ. The brick course was exposed at a depth of 0.14m below the compacted gravel and shingle / tarmac surface. It was 0.36m wide and comprised three bricks laid side by side on top of, and centrally within, its concrete wall footing. A thin layer of sandy mortar, up to 0.02m thick, was observed overlying the brick course.

- 4.6** The cut for each wall had been excavated through the Head deposit (Context **2/004**) and was probably defined by the extent of the concrete wall footing. Both walls are no doubt contemporary, having been of the same construction and width. They had no associated floors.

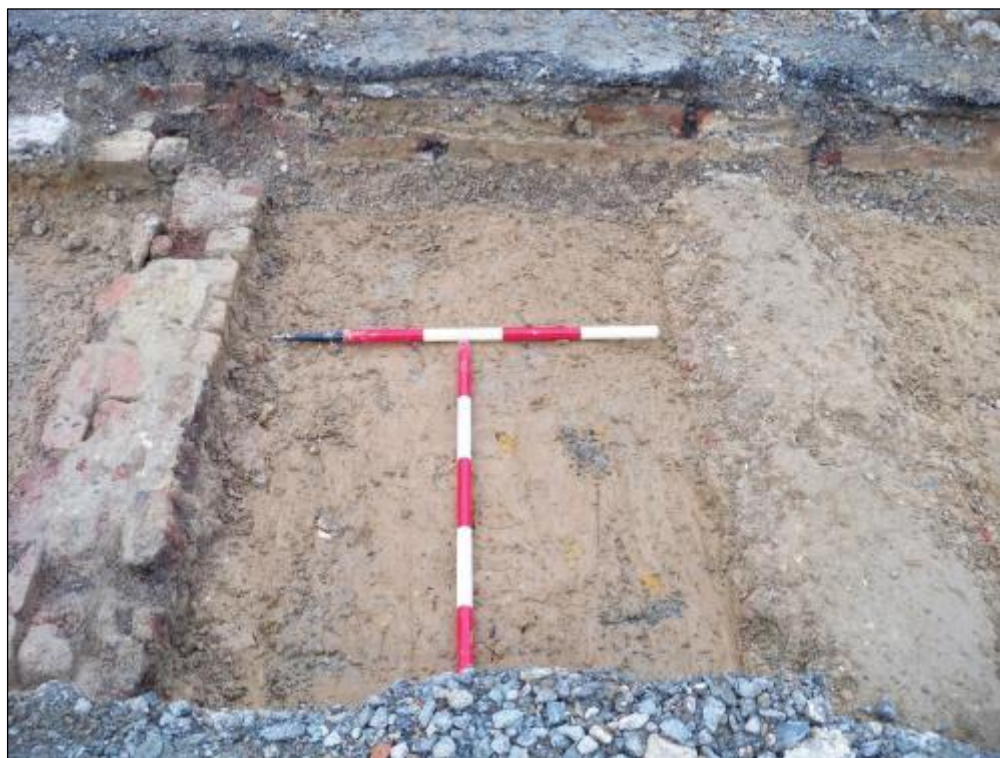
Plate 6: Burlington Hotel, Eastbourne:
Close up photograph of wall footings (Contexts 2/011 and 2/009) in Trench
2; looking northwest

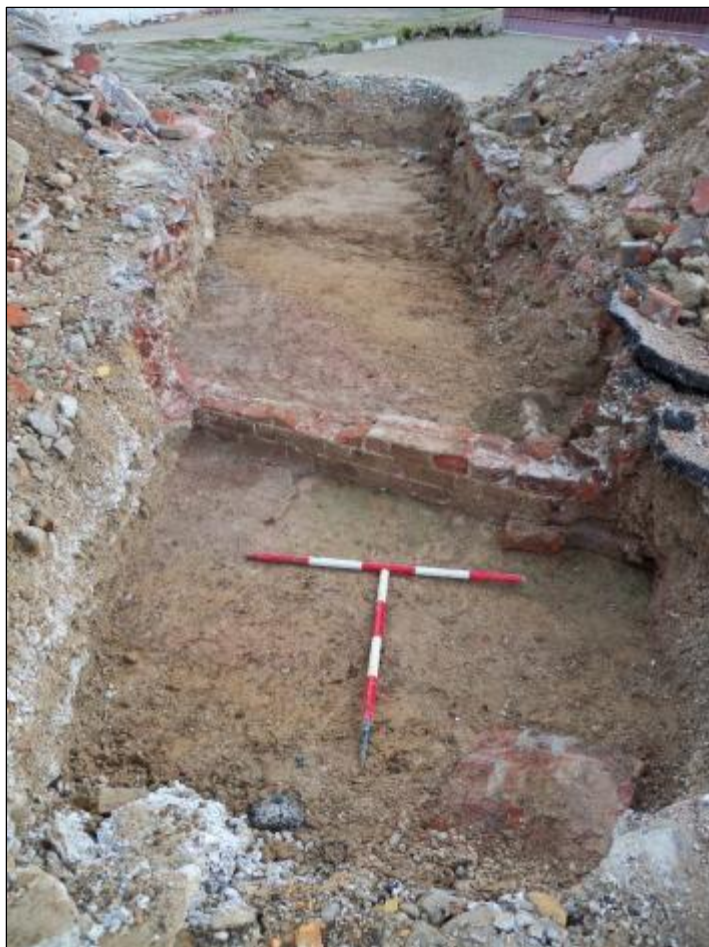
Plate 7: Burlington Hotel, Eastbourne:
Trench 3; looking east

- 4.8** **Trench 3** (Plates 7 and 8) also contained building remains. A red brick wall (Context **3/017**) ran broadly southwest-northeast across the width of the trench. This wall survived to a height of 0.43m above the Head deposit (Context **3/019**) and was overlain by the concrete hard standing of the car park (Context **3/001**). It was 0.46m wide (i.e. the width of three bricks laid side by side).

- 4.9** A second wall (Context **3/020**) ran at a right angle from Context **3/017**, in a broad southeast direction, into the north-facing baulk of Trench 3. Only one side of this wall was therefore exposed. It survived to a height of five courses.

- 4.10** Brickwork connected these two walls together to leave a rectangular void in the corner. This looks to have been a drain which presumably drained rainwater away from the gutters and into the ceramic drain pipe that was exposed as running into the north-facing baulk of the trench.

- 4.11** A third red brick wall (Context **3/015**) extended at least 0.54m out from the west end of Trench 3. It had a width of 0.49m wide and ran in the same direction as the wall of Context **3/020**, to which it did not join. A possible entrance, therefore, looks to have been positioned at the exposed end of this wall. The cut and backfill of this third wall were visible (Contexts **3/013** and **3/014** respectively).

- 4.12** A hard mortared / concrete surface (Context **3/018**), measuring up to 2.15m long and up to 1m wide, was exposed above the Head deposit, to the east of the southwest-northeast aligned wall (Context **3/017**). As it was stained red in colour, it may have been the foundation for a red brick floor. The sharp edge to this deposit suggests that it was cut away. A smaller surface of the same description (Context **3/016**), measuring 0.60m long and 0.60m wide, was recorded to the other side of the wall (Context **3/017**), against the south-facing baulk of the trench. It is possible that both sides of the wall could have stood within the interior of a sub-divided building, although the archaeological evidence is inconclusive on its own.

- 6.8** Trench 3 has a floor of laid bricks across it, abutting the surviving height of one of the walls. These bricks have been dated to *c.*1800-1920. However, the brick floor in the adjacent Trench 4 is believed to be an extension of that recorded in Trench 3, and its brick can be definitely dated to 1910. This would imply that the stable blocks had gone out of use by around this time, when the motor car was first being sold. The buildings that replaced the stable blocks may, therefore, have been garages.

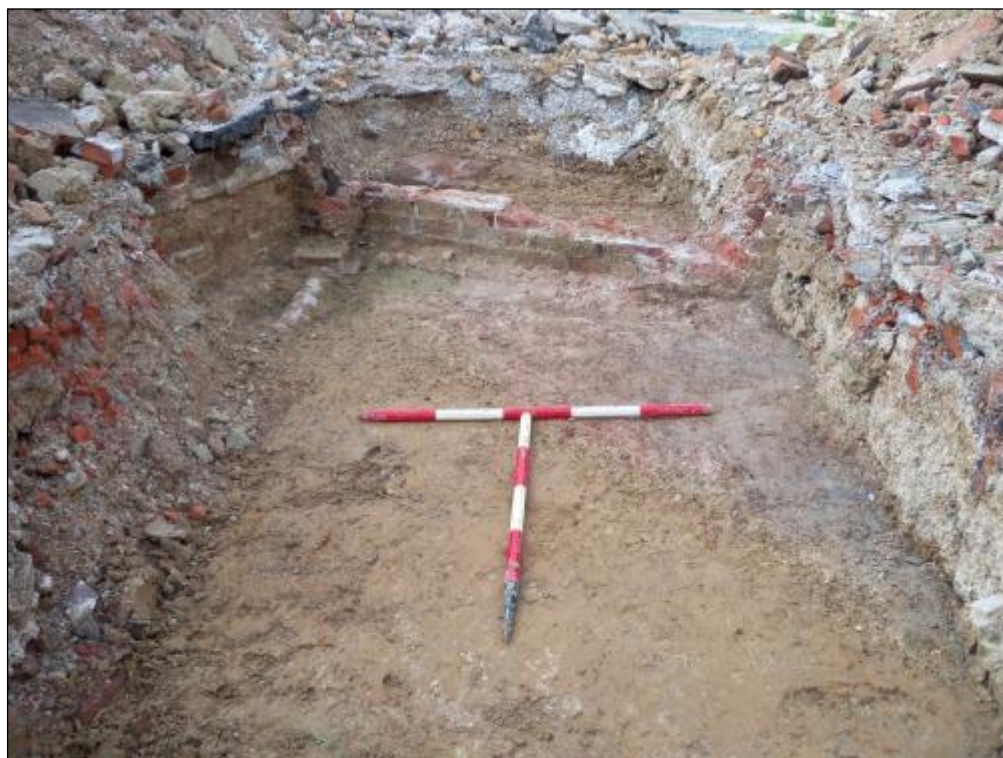
Plate 8: Burlington Hotel, Eastbourne:
Close up photograph of southwest end of Trench 3; looking west

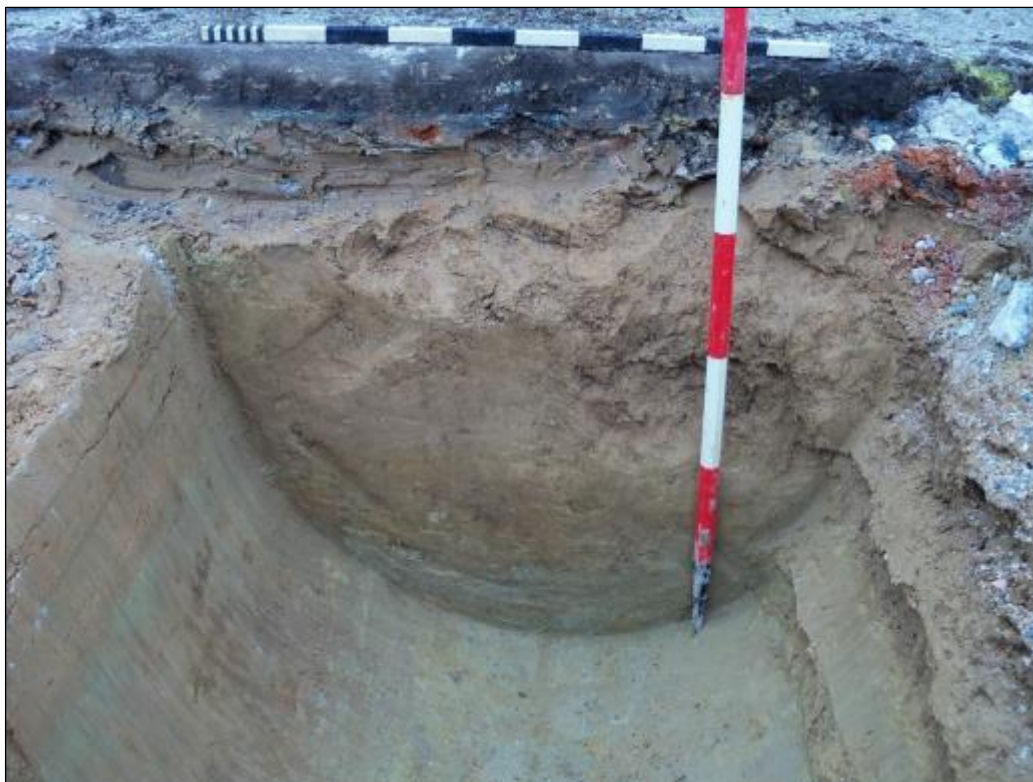
Plate 11: Burlington Hotel, Eastbourne:
Trench 1: Stratigraphy in northwest sondage of Trench 5; looking southwest

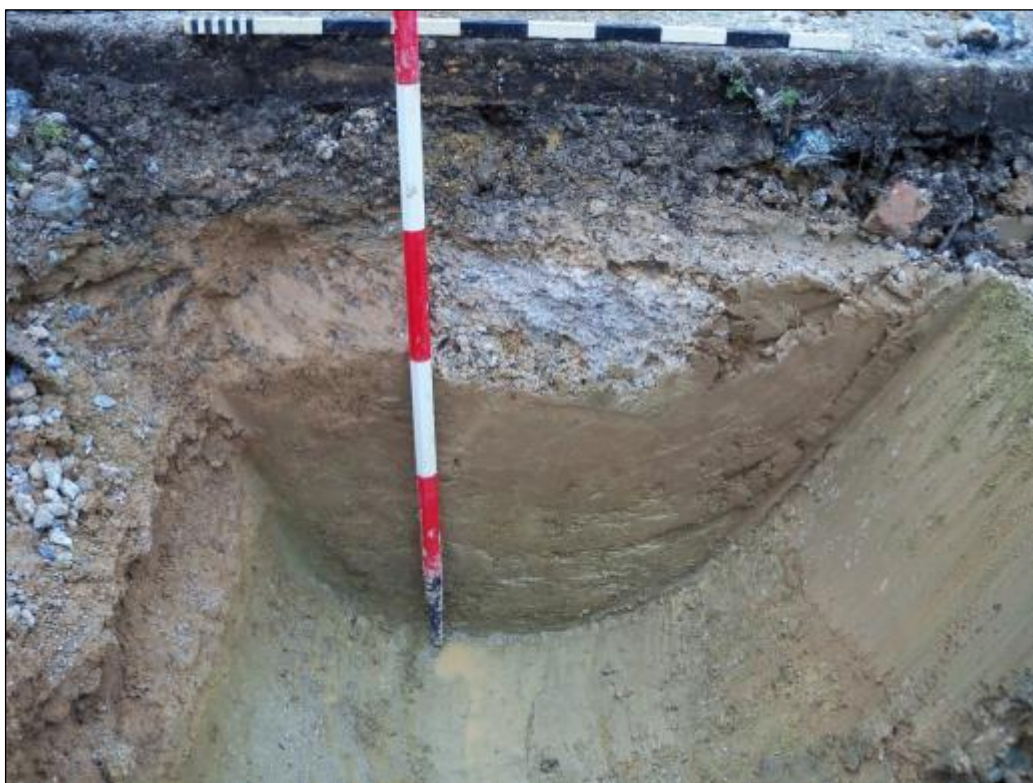
Plate 12: Burlington Hotel, Eastbourne:
Trench 1: Stratigraphy in southeast sondage of Trench 5; looking southwest

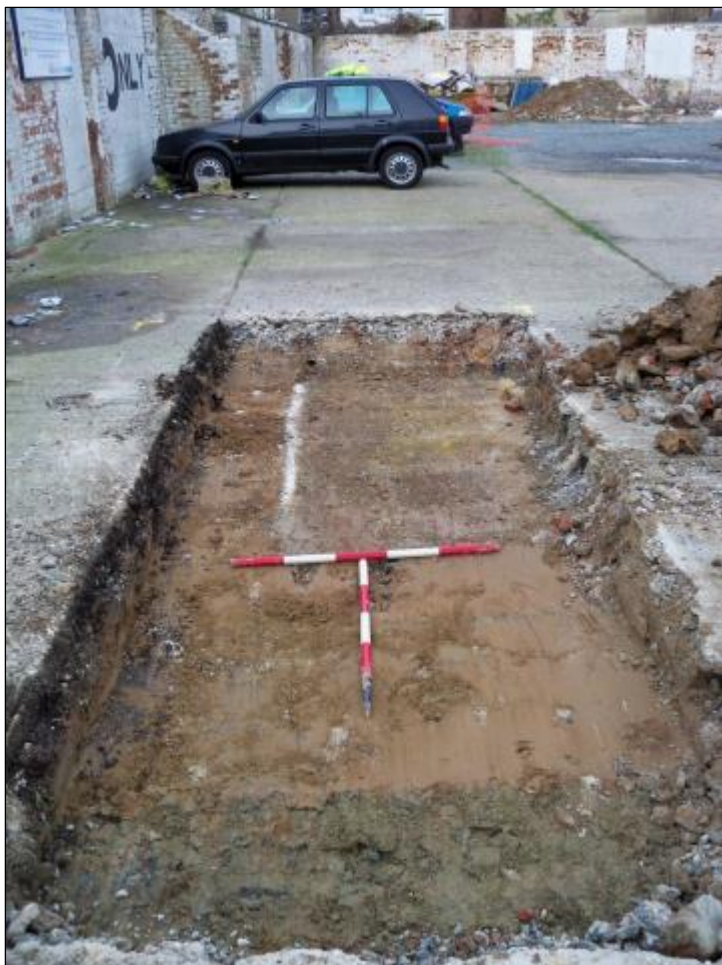
Plate 13: Burlington Hotel, Eastbourne:
Trench 1: Trench 6; looking northwest

- 6.10** The concrete foundation in Trench 6 may relate to the building built once the southern stable block had been demolished sometime between 1910 and 1931, and that may have been a garage that then existed until its demolition in 1992.
- 6.11** A complete absence of archaeological material on site pre-dating the 19th century suggests that the site had been extensively cleared at one time, presumably upon demolition of the stable blocks. This clearance work may in places have truncated the Head deposit. The proposed development will not disturb or destroy any archaeological remains of significance. The ground works for the scheme can be undertaken without the need for any further archaeological intervention.
