**An Archaeological Watching Brief at  
The Crown, All Saints Street,  
Hastings,  
East Sussex**

HS/FA/12/00704

Project No. CBAS0398

September 2014

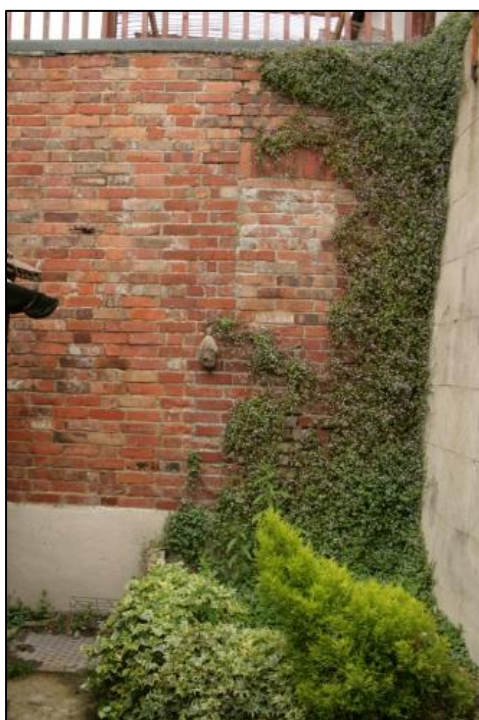
**Plate 1:** North Wall of Sunken Courtyard with Blocked Window at Eastern End

- 4.1 The two outbuildings are located on the southern side of a sunken courtyard, with the western side of the courtyard being the eastern wall of the public house (Fig. 11). The eastern wall of the courtyard is concrete blocks with an incised cement rendered finish this is topped by wooden panel fencing. The northern wall is the boundary wall between the public house and the property to the north. This is of red brick construction, with the bricks being laid in a random bond. At the eastern end of the north wall there is a blocked window, this is evidenced by the slightly arched solid course at the head of the former window (**Plate 1**). The two buildings on the southern side of the sunken courtyard are attached, with building **A** at the western end of the two buildings. The join of the buildings is concealed by the western wall of Building **B** having a cement rendered finish.

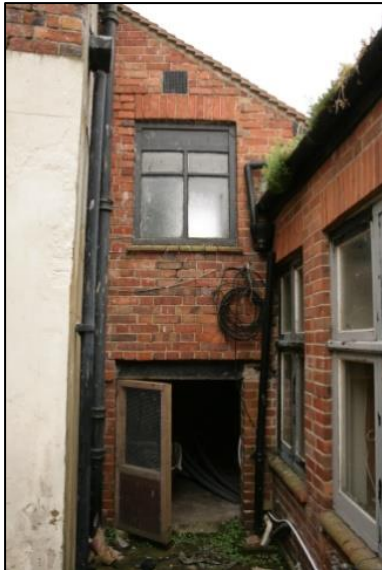
**Plate 2:** Northern Elevation Building

- 4.2 The northern elevation of Building **A** is the only one visible from the courtyard (**Plate 2**), and is of red brick construction. Building **A** comprises a store room on the ground floor and a WC on the first floor. The bricks are laid mainly in Flemish bond (alternating headers and stretchers). The ground floor level is currently used as a store, and is accessed by a pair of double doors. Only the door on the eastern side is *in-situ*, and is constructed of a wooden framework with wire mesh fitted to the outer face of the framework. The opening has an RSJ serving as a lintel, with the RSJ being 'H' shaped in section. The interior of the store on the ground floor of Building **A** is of bare brick walls with a concrete floor (**Plate 3**). The ceiling is also of concrete.

**4.4** The first floor of the northern elevation of Building A consists of a half gabled end sloping to the west, and has a single wooden framed window of four lights, with the top half of the upper lights boarded over with a wooden panel. There is a soldier course at the head of this window. Above the soldier course there is a ventilated brick which has been painted black.

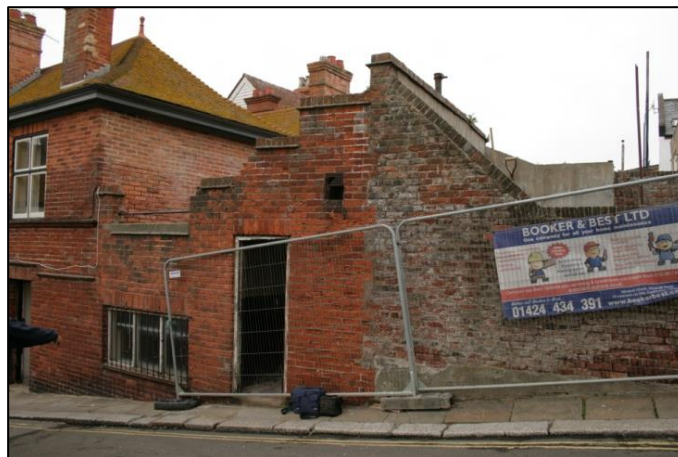
**Plate 4:** Southern Elevation of the Buildings from Crown Lane

**4.5** The southern elevations of the two buildings are only apparent from Crown Lane (**Plate 4**) and consist of the first floor of Building A at the western end. This is of red brick construction and appears to be contemporary with the construction of the public house. The half gable is stepped and slopes down to the west, with the brick work being laid in a random bond. There is a single entrance at the western end to the WC in this part of the southern wall, fitted with a door of vertical plank construction (which at the time of the survey was leaning against southern interior wall of the WC). The interior walls were of rough cast cement finish with a plastered ceiling. The floor was of concrete construction. No other features were noted in this room.

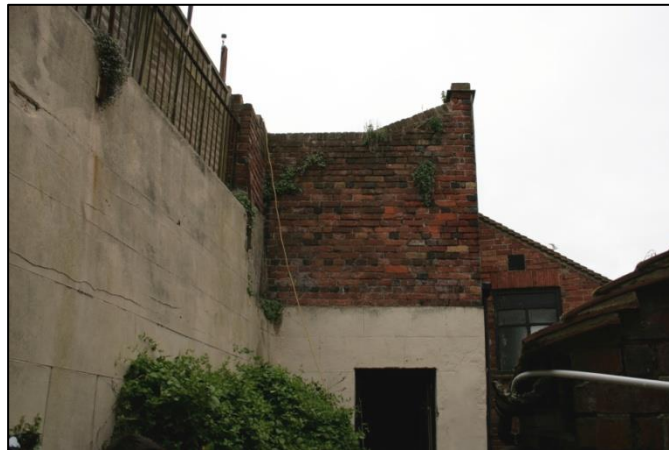
**Plate 5:** Northern Elevation of Building B

- 4.5** To the east of Building A is Building B, which is of a single storey. The building is of cement block construction, which has an incised and painted cement render finish. On the top of the concrete block construction of the walls, there is a brick built wall which surrounds the flat roof of the building at the level of Crown Lane. Building B projects into the courtyard from the northern wall of Building A. The only entrance to Building B is located to the west of centre in the northern wall and is accessed via two steps. The entrance is fitted with a modern four panelled door. There are no other openings in this or the western elevation (**Plate 5**).

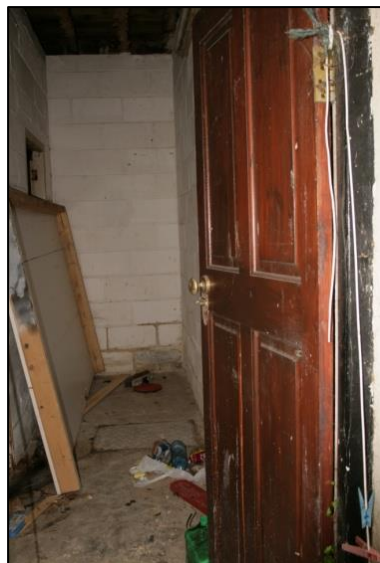
**Plate 6:** Corridor Building B

- 4.6** There are two rooms and a corridor on the single floor of Building B. The two rooms are located on the eastern side of the building with the corridor on the western side. The corridor (**Plate 6**) has walls constructed of white painted concrete blocks, with a ceiling of exposed joists a north south alignment. The floor is of concrete construction with two metal manhole covers.

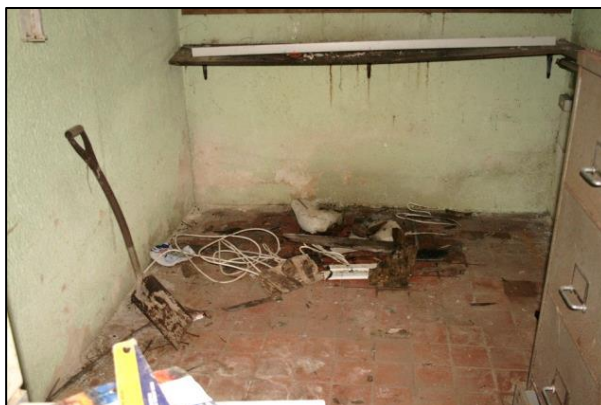
**Plate 7: Northern Room Building B**

- 4.7** The room at the northern end of Building **B** (**Plate 7**) was entered from the corridor via an entrance in the centre of the western wall of this room. The entrance is fitted with a plain modern door. The walls of this room have a painted cement render finish, with a ceiling of exposed joists on a north to south alignment. The joists were originally covered with plasterboard sheets, but this only remained in a few areas. Closely adjacent to the centre of the northern wall there was wooden framed roof light or vent inserted into the ceiling. The floor was covered in red ceramic tiles, each measuring 100mm square. There were no other features noted in this room.

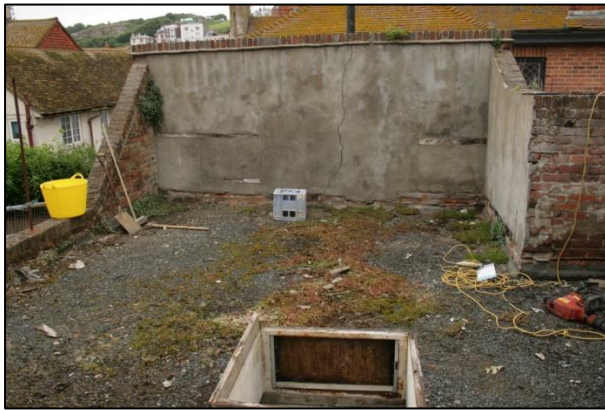
**Plate 9:** Western Enclosing Wall of the Roof to Building **B**

- 4.10** The eastern end of the southern wall of Building **A** is bonded into the southern surrounding wall of the flat roof of Building **B** (**Plate 9**). This wall has a sloping section at its western end, with the rest of the wall being flat topped until its eastern end where it is slightly higher. As with the southern elevation of Building **A** the

brickwork of this wall has been laid in a random bond. The western wall of the enclosing wall of the flat roof of Building **B** is of brick construction with a cement rendered finish at the southern end. This wall then projects to the east, with the rest of the wall at the northern end being of bare bricks which are laid in a random bond (**Plate 9**). The northern wall is of the same brick construction as that of the western wall. The eastern wall is of brick construction, with the bricks being laid in Sussex bond with three stretchers between the headers. This wall is only butted up to the eastern end of the southern wall suggesting that it is later than the southern wall; this is also implied by the different bonding of the bricks (**Plate 11**). The flat roof of Building **B** is covered in ashfelt, with the roof light or vent of the northern room in Building **B** inserted at the eastern end of the roof.

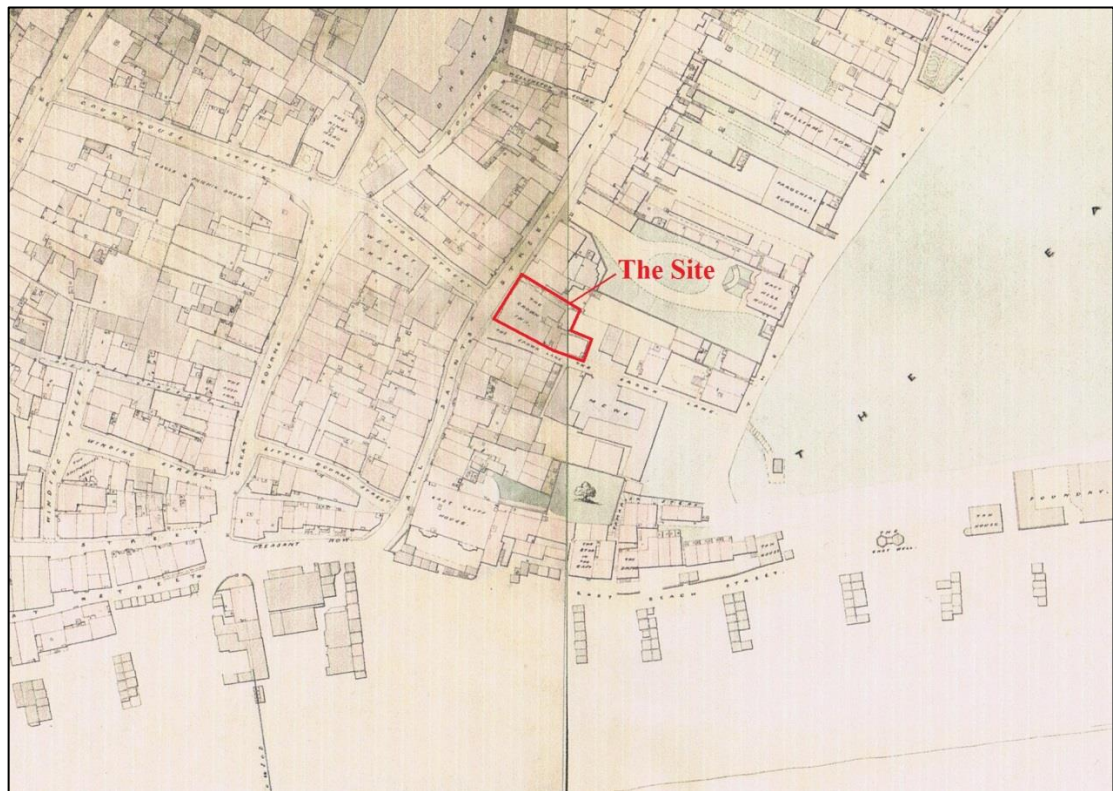
Fig. 4: Crown Inn, Hastings: Map of 1852

- 2.15** Creightons map of 1835 is not sufficiently detailed to be helpful. Gants Survey of Hastings dated 1852<sup>22</sup> is the first map to clearly show the site (Fig. 4). This shows the Crown Inn with possibly two rectangular buildings located to the rear of the inn (MES21154). The inn (MES21146) was apparently built in the late 18th century, opened in 1816, and the adjacent Crown Lane was named after the inn; the lane was

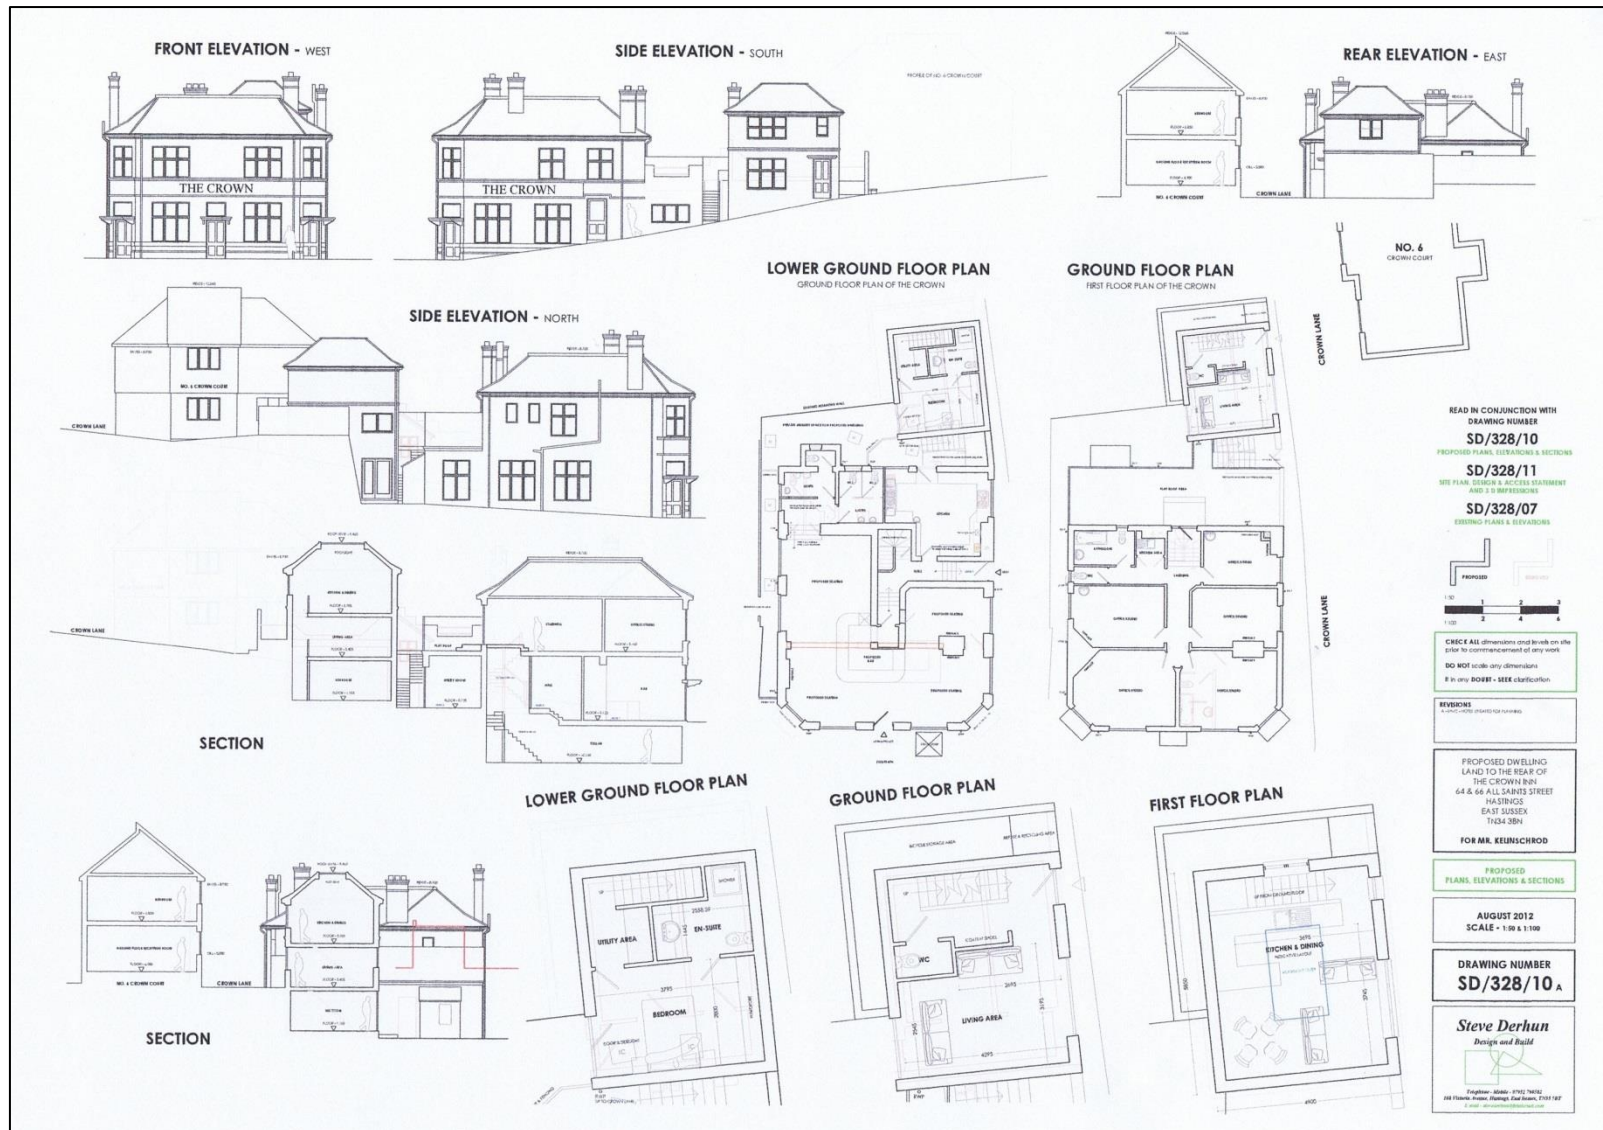
Fig. 10: Crown Inn, Hastings: Development Plan

1.6 The appropriate programme of archaeological work comprises an archaeological watching brief to include the recording and analysis of the standing walls at the site prior to any works commencing, and the monitoring of any groundworks during the development (Fig. 10). A written scheme of investigation covering the watching brief, and was submitted and approved by local planning authority.
