**An Archaeological Watching Brief at  
Church Cottage,  
Sandhurst,  
Kent.**

13/02567/HOUSE/TW

Project No. CBAS0451

March 2015

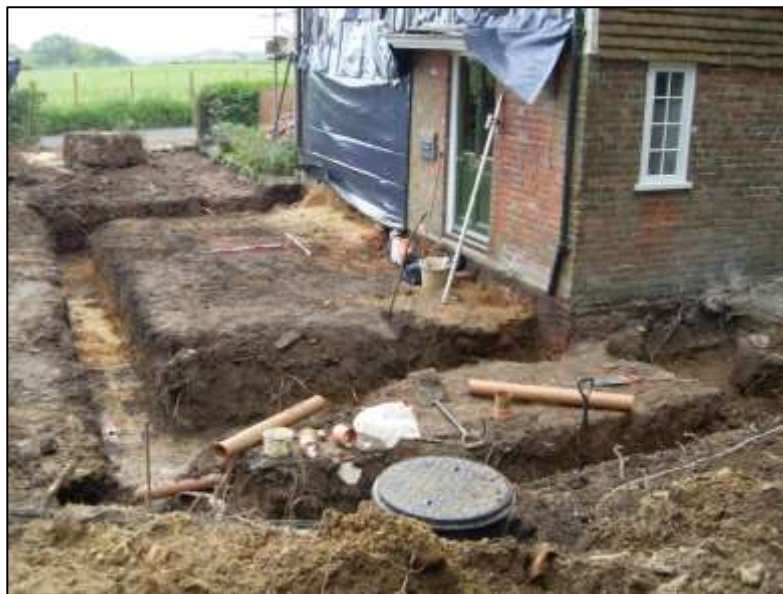
Plate 1: Excavated footing trenches

- 2.1 The archaeological work was carried out in accordance with the KCC Specification and the CIfA Standards and Guidance
- 2.2 Ground works began with the excavation of the drainage run from an existing man-hole before moving onto the excavation for the footing trenches, some 650mm wide by 900mm deep and were excavated under archaeological supervision to a depth of 230mm by a Volvo EC25 with a toothless ditching bucket.

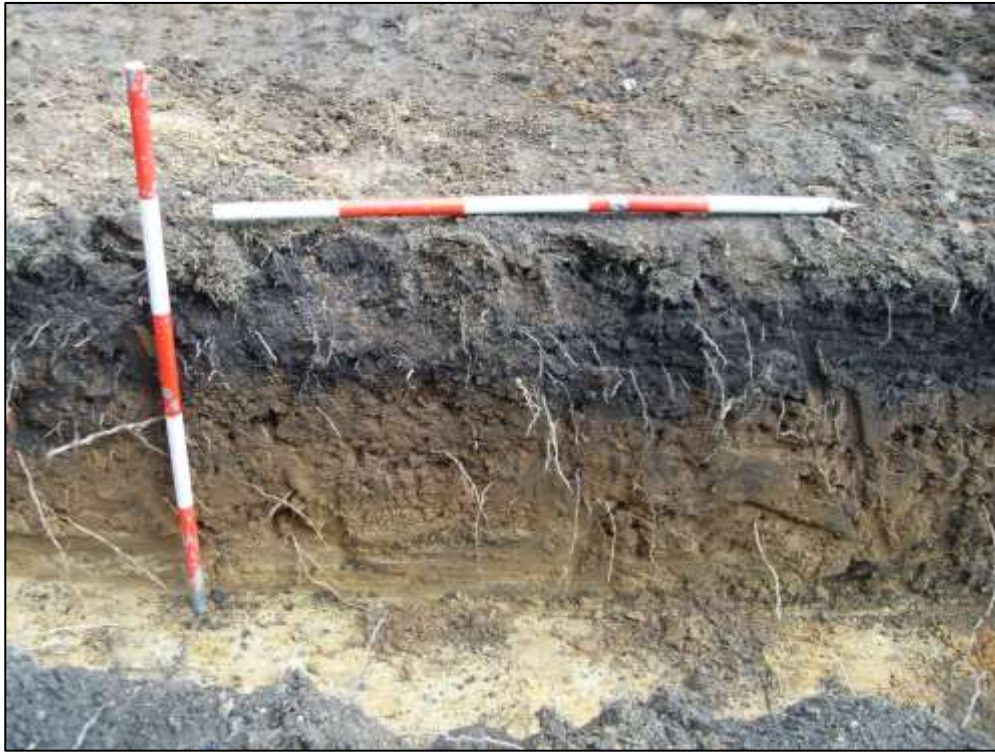
Plate 2: South facing section of the drainage run-Contexts 1 to 3.

- 3.1 Context 1 was topsoil deposit. It was a soft black, sandy-silt, 260mm thick and containing roots at 3% and two sherds of late 19<sup>th</sup> to mid 20<sup>th</sup> century china (not retained). This sat immediately above the subsoil, Context 2.

- 3.2 Context 2 was the underlying subsoil and was a soft black, sandy-silt, 300mm thick and was sterile apart from roots at 1%. This sat immediately above the natural, Context 3.
- 3.3 Context 3 was the natural sandstone bed. It was a soft deposit and a mix of dark and light yellows and buff in overall colour. It contained very occasional sandstone at 1% and was 230mm to the limit of excavation.
- 3.4 No archaeological deposits or features were found during the watching brief
