**An Archaeological Watching Brief
at 7 The Street, Kingston,
East Sussex**

SDNP/13/04030

Project No. CBAS0446

May 2014

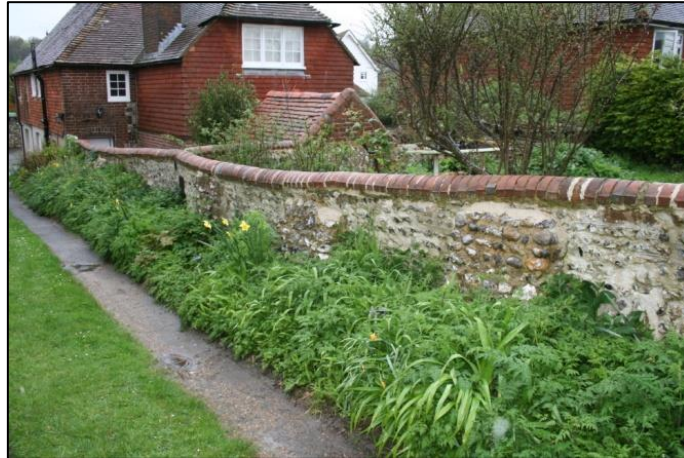
Plate 1: South-western Boundary Wall

- 4.1 The south-western boundary wall of the property was on a south-east by north-west alignment (Fig. 8) and had a length of 31.2m and a variable thickness of between 200mm and 250mm. The south-western wall of the house forms the far north-western end of the wall (**Plate 1**).

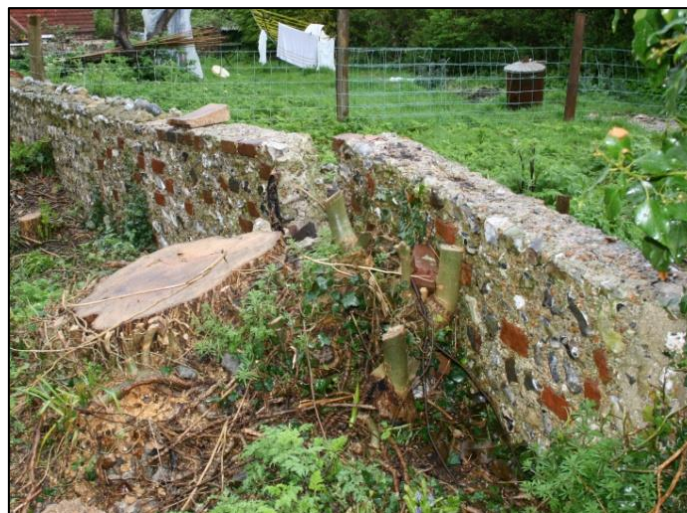
Plate 2: South-eastern End of Wall

- 4.2 The wall construction is of mostly unknapped flint nodules which are coursed, with some of the nodules being roughly faced. The exception to this is the last 4.2m from the south-eastern end of the wall which has the inclusion of red brick (c.5%) (**Plate 2**). The wall has various types of mortar used in its length reflecting extensive repair work that has taken place over time, some of the mortar repairs appear to be of a recent date. The main mortar used is a light grey sandy mortar, but at the south-eastern the mortar has the same texture but is slightly darker in colour.

- 6.2** All the artefacts recovered were of a recent date, and were small sized and domestic in nature.
- 6.3** In the recording of the south-western boundary wall of the property it is thought that the south-eastern end of this wall was either a complete rebuild or a later extension to an existing wall. This part of the wall also had brick inclusions which were not apparent in the rest of the wall construction. The wall appeared to have had four flint built buttresses constructed against its south-western face at some point after its construction, which were later augmented by two additional brick built ones. The main body of the wall was impossible to date due to its construction of flint nodules.

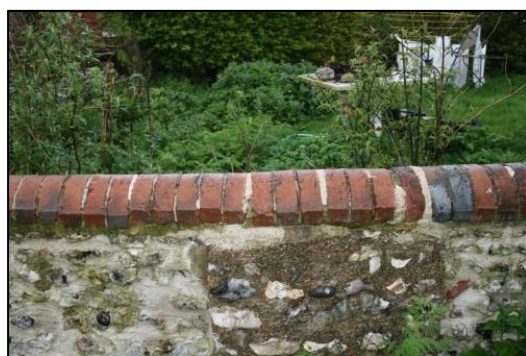
Plate 3: Capping Bricks

- 4.3** The wall has a capping of red clay semi circular bricks (**Plate 3**), which are present along the top of the wall except for the final 7.3m at the south-eastern end. The wall has an entrance between the south-eastern wall of the house and the start of the wall. The entrance is fitted with a gate constructed vertical wooden planks. The wall has a brick built quoin between the entrance and the north-western end of the wall. The wall has six buttresses supporting the wall located on the south-western side of the wall. The buttresses are of two different types. There are four buttresses constructed of flint nodules, which are located at 5.4m, 11m, 13.2m and 15.2m from the north-western end of the wall, these would appear to be of a later construction than the wall, evidenced by the use of a different mortar and the buttresses only butting up to the main body of the wall. To the north-west and the south-east of the first flint buttress there is a later brick built buttress, which are slightly narrower than the flint buttresses and are also lower. These buttresses are located at 2.6m and 6.1m from the north-western end of the wall (**Plate 4**).

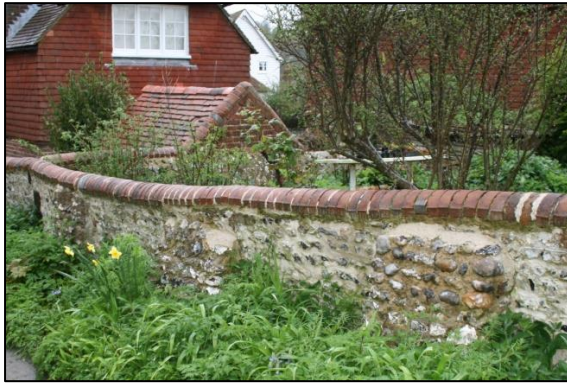
Plate 5: South-Eastern Wall with Out-Building

- 4.4** At 9.5m from the north-western end of the wall there is a second wall attached to the north-eastern side of the boundary wall, which is on a south-west by north-eastern alignment. This wall is of the same coursed flint nodule construction and has semi circular capping bricks. Approximately 3m in from the south-western boundary wall, this wall incorporates the north-eastern brick-built gabled end of a small out-building (**Plate 5**). There were two metal plates that appeared to be strengthening the joint between the two walls (**Plate 6**).

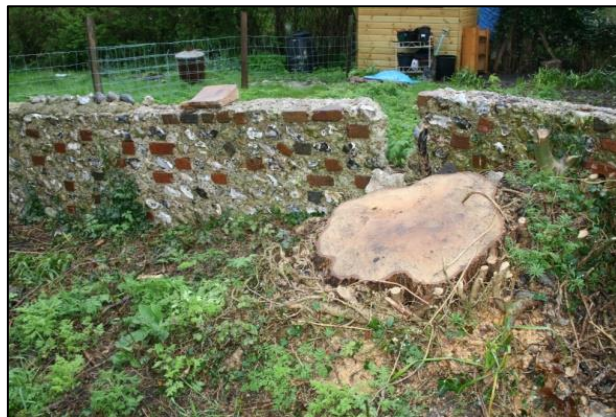
Plate 7: Tree Damage to Wall

- 3.2** The watching brief was maintained during the removal of the stumps of two large trees, located on the south-western side of the flint boundary wall. These were in front of the 5m length of wall that was to be removed. The trees had caused a large vertical crack in the wall at a distance of 1.9m from the south-eastern end of the wall.

- 4.5** A length of the wall measuring 5m at the south-eastern end was demolished by the machine to provide an entrance for the proposed off-road parking spaces. This revealed that the south-eastern end of the wall had very shallow foundations and had a total height of 850mm. The different mortar and materials used in the construction of this part of the wall would suggest that the south-eastern end of the wall was either of a later extension, or alternatively a total re-build of this part of the wall.
