**A Desk-based Assessment
at
Bridge Point,
Rock Channel,
Rye, East Sussex**

Project No. CBAS0385

By
Dr Caroline Russell

June 2013

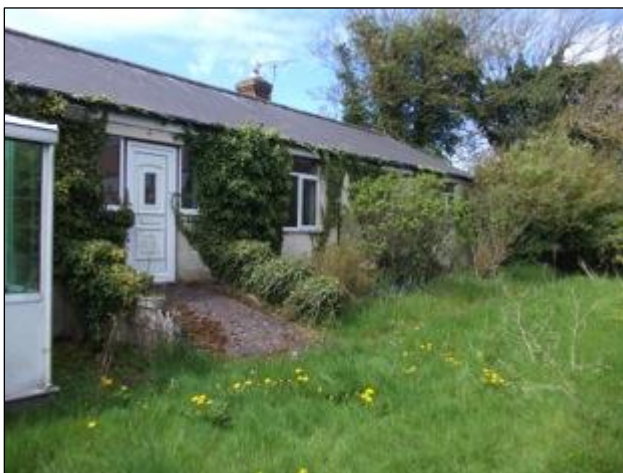
Plate 1 (left): The cottage, looking northwest
Plate 2 (right): The lamp-post, looking northeast

- 3.6** One gate has a paved path that leads south between an overgrown lawn and flower bed to a raised central door in the east side of the cottage, which is reached by a ramp. The cottage has plastered walls of brick construction (Cover Plate and Plate 1). It is a considerably long building but its one chimney may suggest that it originated as just one residence. The cottage has undergone recent renovation having been re-roofed and had a PVC conservatory built and a PVC door and double-glazed windows fitted.

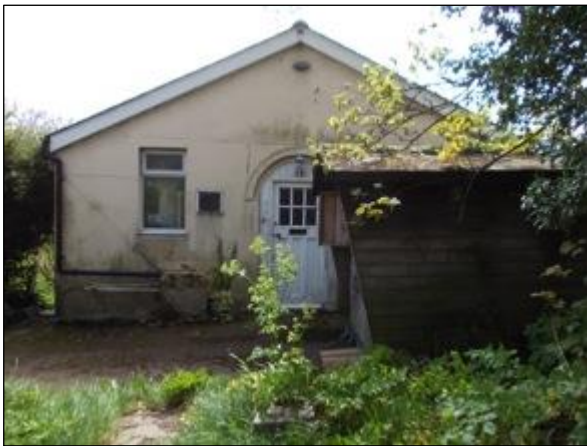
Plate 3: Cottage, yard and shed,
looking south

3.9 The double gate to the property gives entry to the north end of the premises. This area comprises a yard with a wooden shed and a small lawn with a paved path that leads to a corrugated garage (Plates 3 and 4). The main doors to the garage face Rock Channel. The cottage has a wooden door fronting the yard. A gate beside the cottage provides access to a footpath that runs alongside the building up to the ramp for the PVC door.

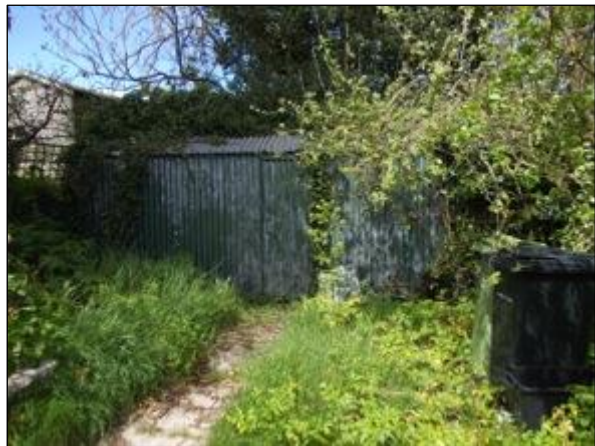
Plate 4: Lawn and garage,
looking north

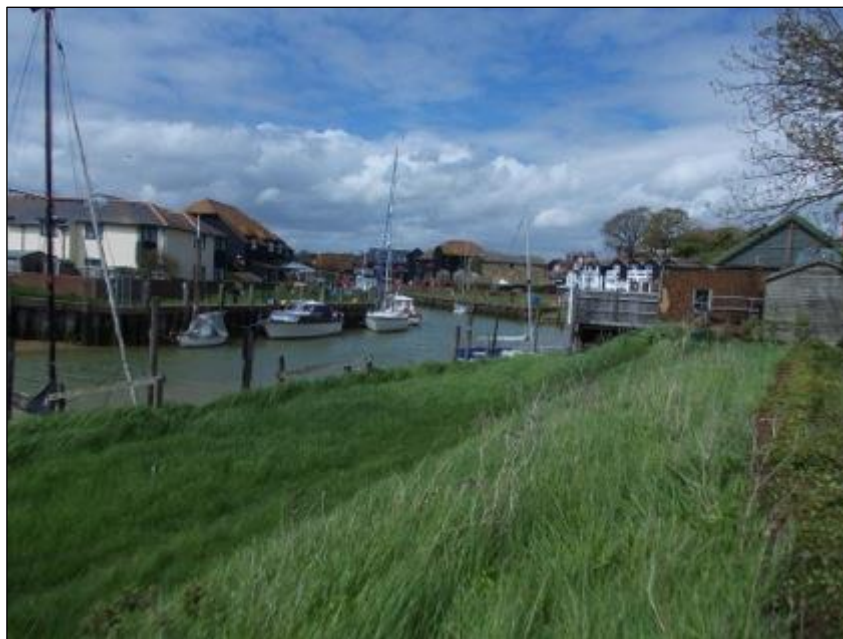
Plate 5: Sea defences and moorings behind the
Site with the former warehouses of the quayside
in the background, looking north

3.10 A bank with a fence bounds the west side of the Site. It is part of the sea defences, which comprise a sea wall flanked on both sides with a bank (Plate 5). The Site is overlooked to the north by the buildings that stand on Watchbell Street along the top of the southcliffe.

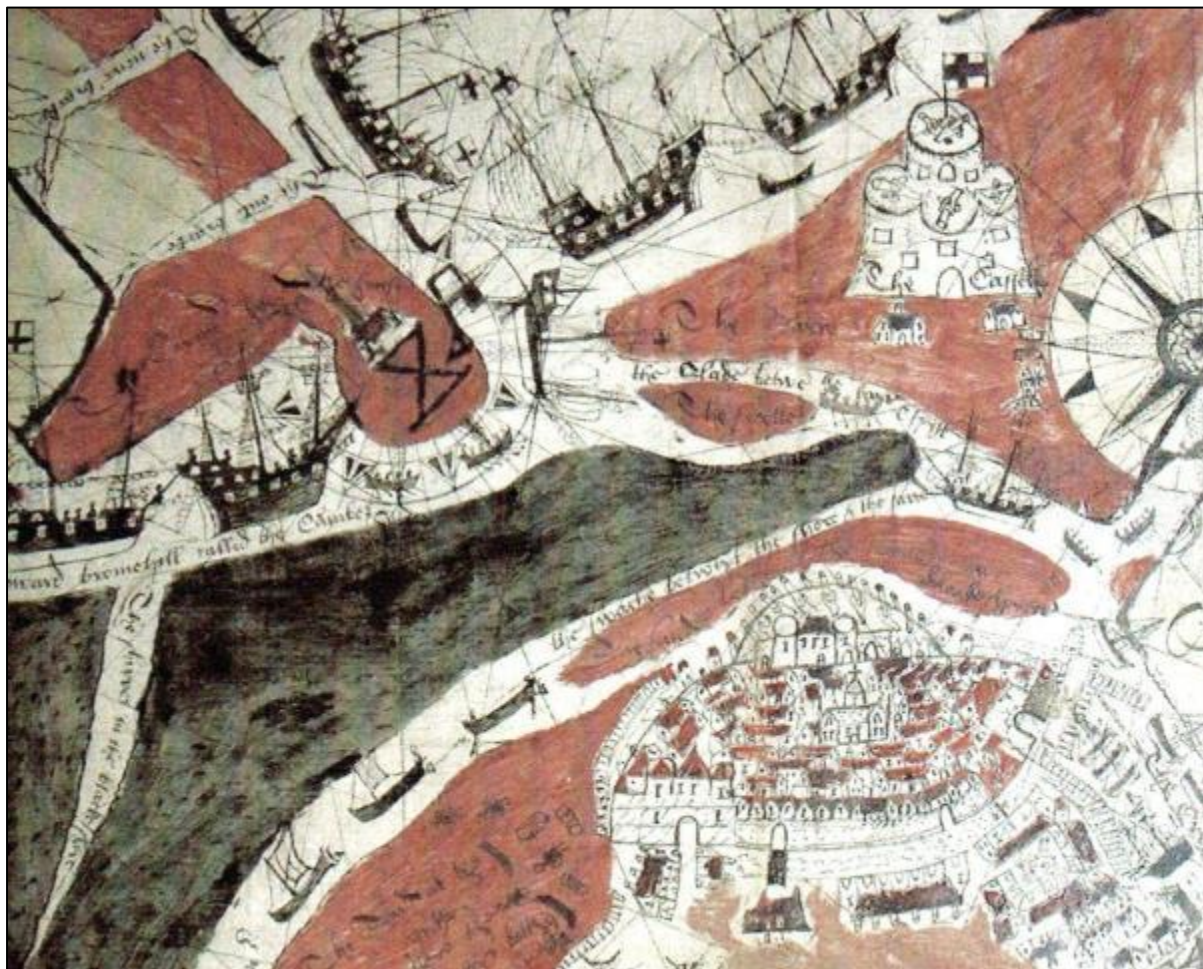
Fig. 4: Bridge Point, Rock Channel, Rye:
John Prowze's map of Rye harbour in 1572
(PRO MPF 212)

- 4.9.1 Rye continued to boom into the 1570's, due in part to the decline of Winchelsea. Its prosperity is shown on John Prowze's map of Rye harbour in 1572 (Fig. 4), which shows ships moored at the Strand, larger ships standing off in the bay and moored in The Camber and boats and barrels lying on the mud between the Rother and the town gate. A strip of land, labelled as 'the marsh between the shore and the land', curves around the south side of Rye between two water channels, one of which runs alongside the south cliffs beneath the Gun Garden (MES19857). The Site may be located on this marsh. A plan of Rye in the late 16th century does not show the full extent of the waterways to the south of the town, making an interpretation of this area difficult.

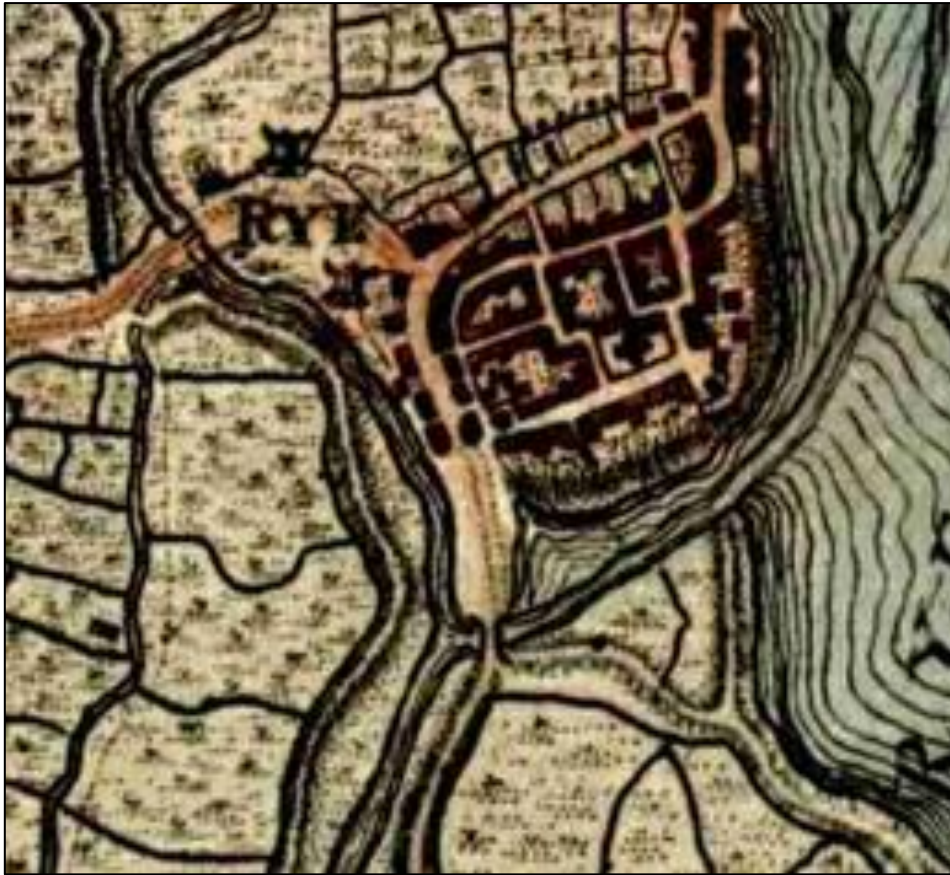
Fig. 6: Bridge Point, Rock Channel, Rye: Yeakell and Gardner's map of 1778-1783
(<http://www.envf.port.ac.uk/geo/research/historical/webmap/sussexmap/sussex.html>)

- 4.9.5 Yeakell and Gardner's map of 1778-1783²⁷ (Fig. 6) depicts a piece of land that projects from the Strand with the Rock Channel road and its south bridge but no remains of the north water channel and its bridge. The track continued south to flank the east side of the River Brede towards Winchelsea.

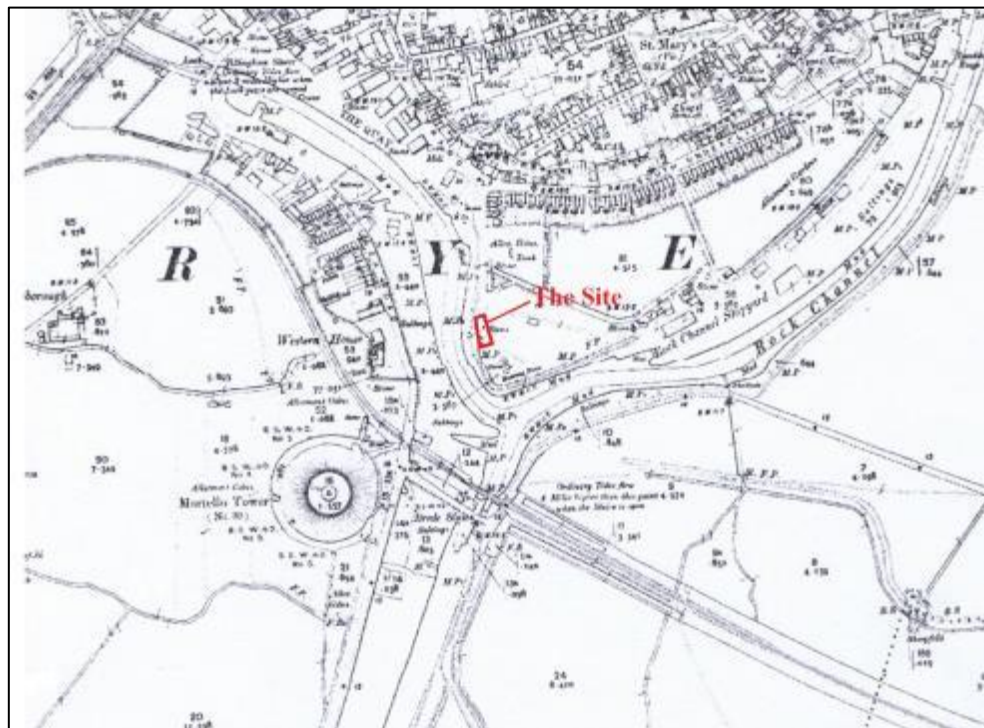
Fig. 9: Bridge Point, Rock Channel, Rye: 3rd Edition OS map (1909)

- 4.9.12 As seen from the 3rd Edition OS map (Fig. 9), there is no change to the immediate area around the Site by 1909. The west strand is labelled a footpath. The housing has extended west over the former timber yard and more allotment gardens have been established to the south of this new housing.
