**An Archaeological Watching Brief  
at  
Morley Manor,  
Shermanbury,  
West Sussex**

TQ 20803 19774

Planning Ref. DC/14/0905

December 2015

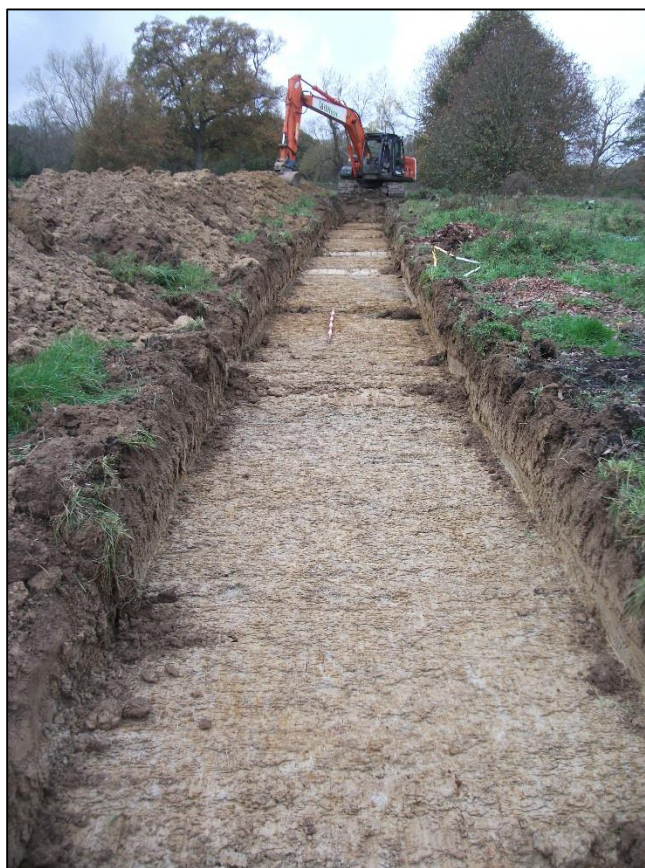
**Plate 1:** Initial trench excavated across the site

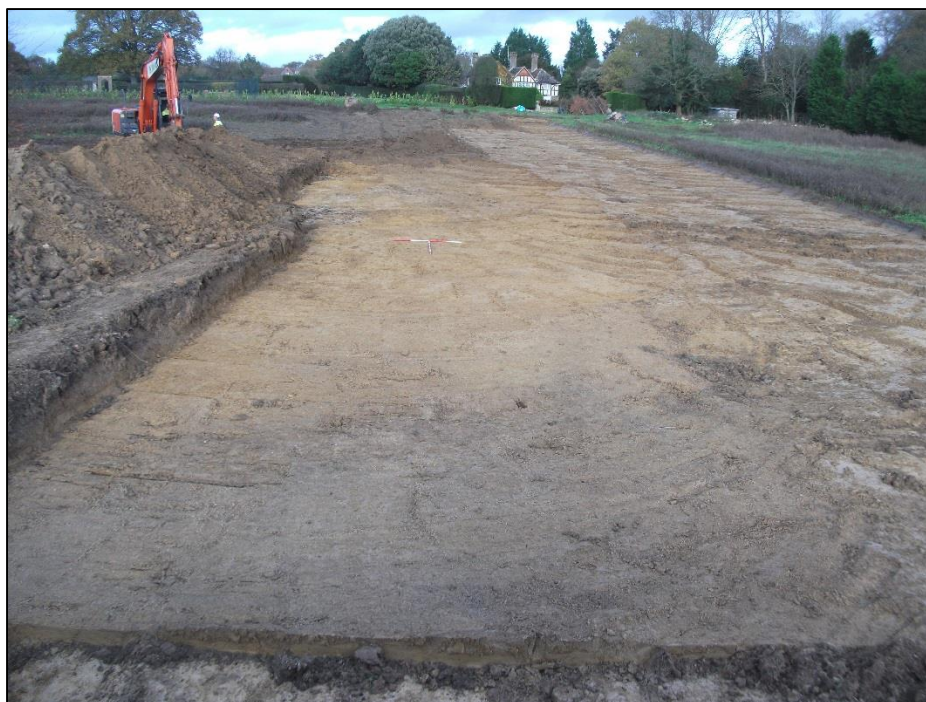
**Plate 2:** Part of site stripped of topsoil

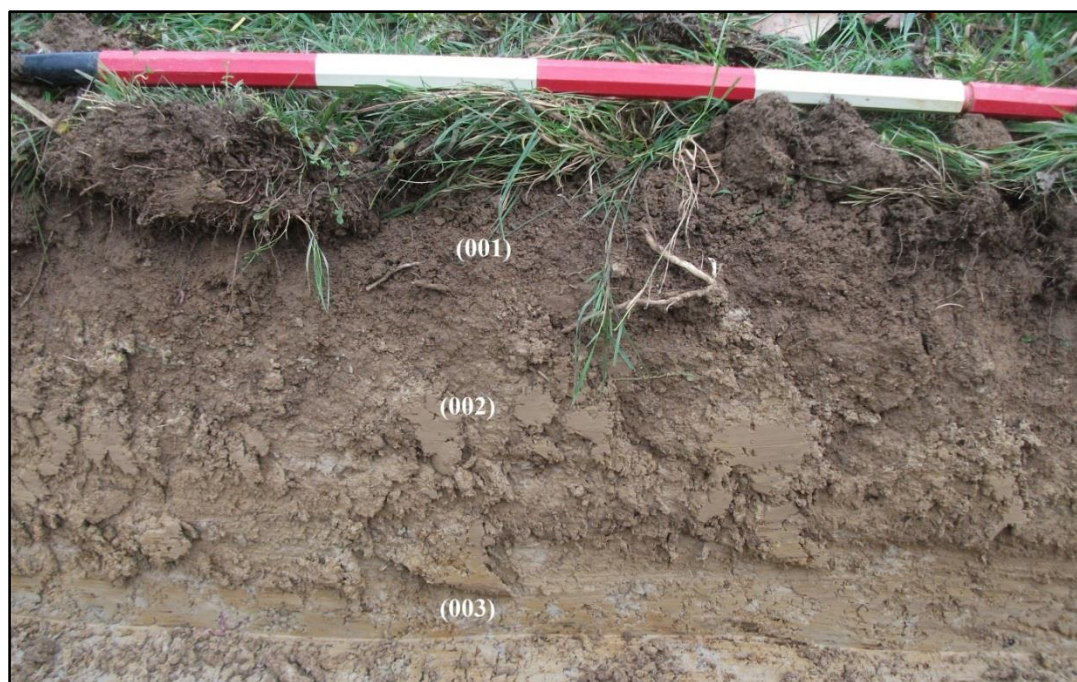
- 4.1 The topsoil across the Site (Context **001**) comprised a soft mid greyish brown silty clay, between 100-150mm thick, containing <1% rooting inclusions (Plate 3).

**Plate 3: Contexts 001 to 003**

- 4.2 The subsoil across the Site (Context **002**) was found below Context **001** across the Site. This comprised a soft, mid greyish brown silty clay, 250mm to 300mm thick, containing *c.*5% inclusions of manganese flecks.

- 4.3 The natural deposit (Context **003**; Plate 3) was found below Context **002**, and comprised a mid-firm, mid yellowish brown clay containing *c.*20% chunks of iron rich sandstone between 100mm and 250mm in size.

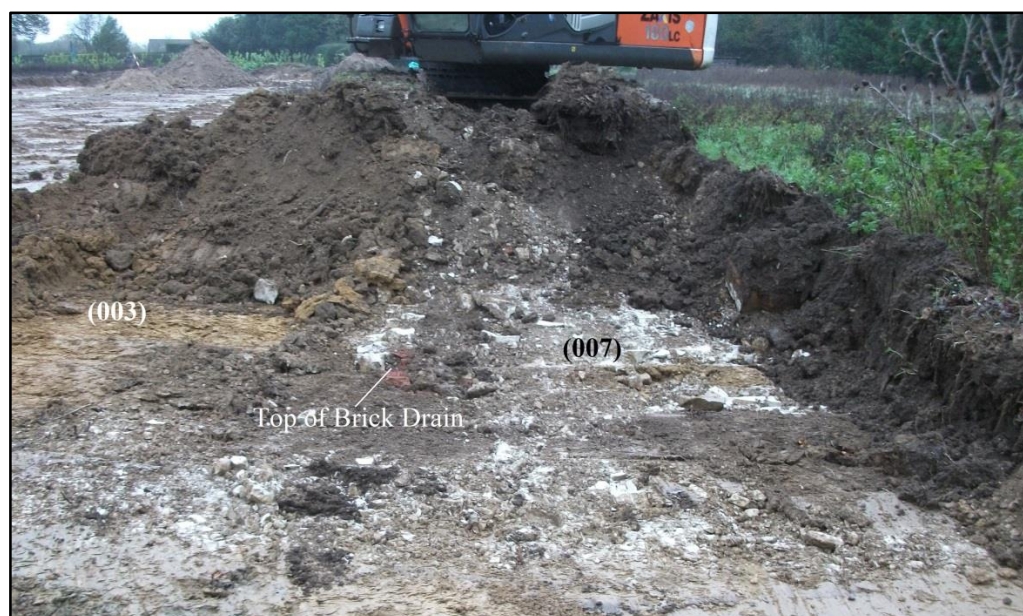
- 4.6 The service pipe (Context **005**) was associated with a brick drain, set into a layer of compacted chalk (Context **007**; Fig. 9). Context **007** (Plate 4) was observed to follow the line of a removed fence over an area of 4m by 6m, with a thickness of 200mm. Unfortunately the pipe broke whilst stripping this area, levering up the drain, and badly damaging the chalk surface, meaning that the best photographic record of this feature is a working shot (Plate 6).

**Plate 6:** Working shot of chalk deposit (007)

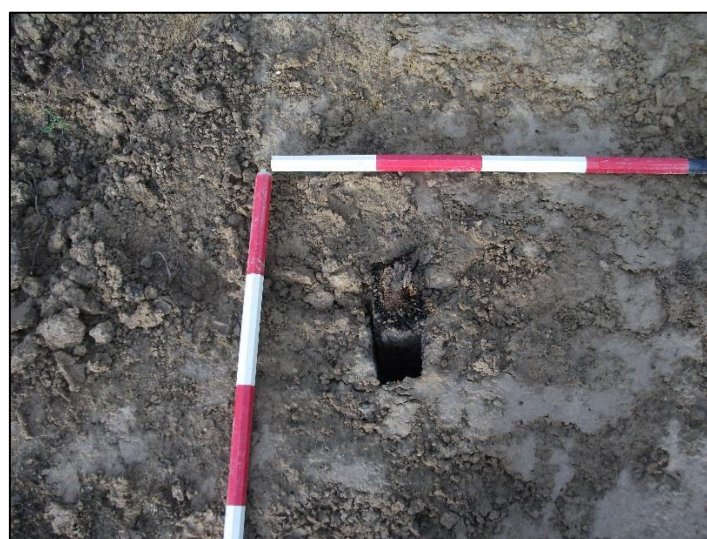
- 4.7 A line of 12 rectangular post holes was observed across the Site on the line of a removed field boundary. Historic mapping shows this boundary on the tithe (1840), and to have been removed by 1911, and not present in 1976; however it is shown on the current OS map (Fig. 1). The postholes were marked on the Site plan, but were otherwise not recorded. The lower portion of the wooden posts remained *in-situ* (Plate 7).

**Plate 7:** Posthole along removed field boundary

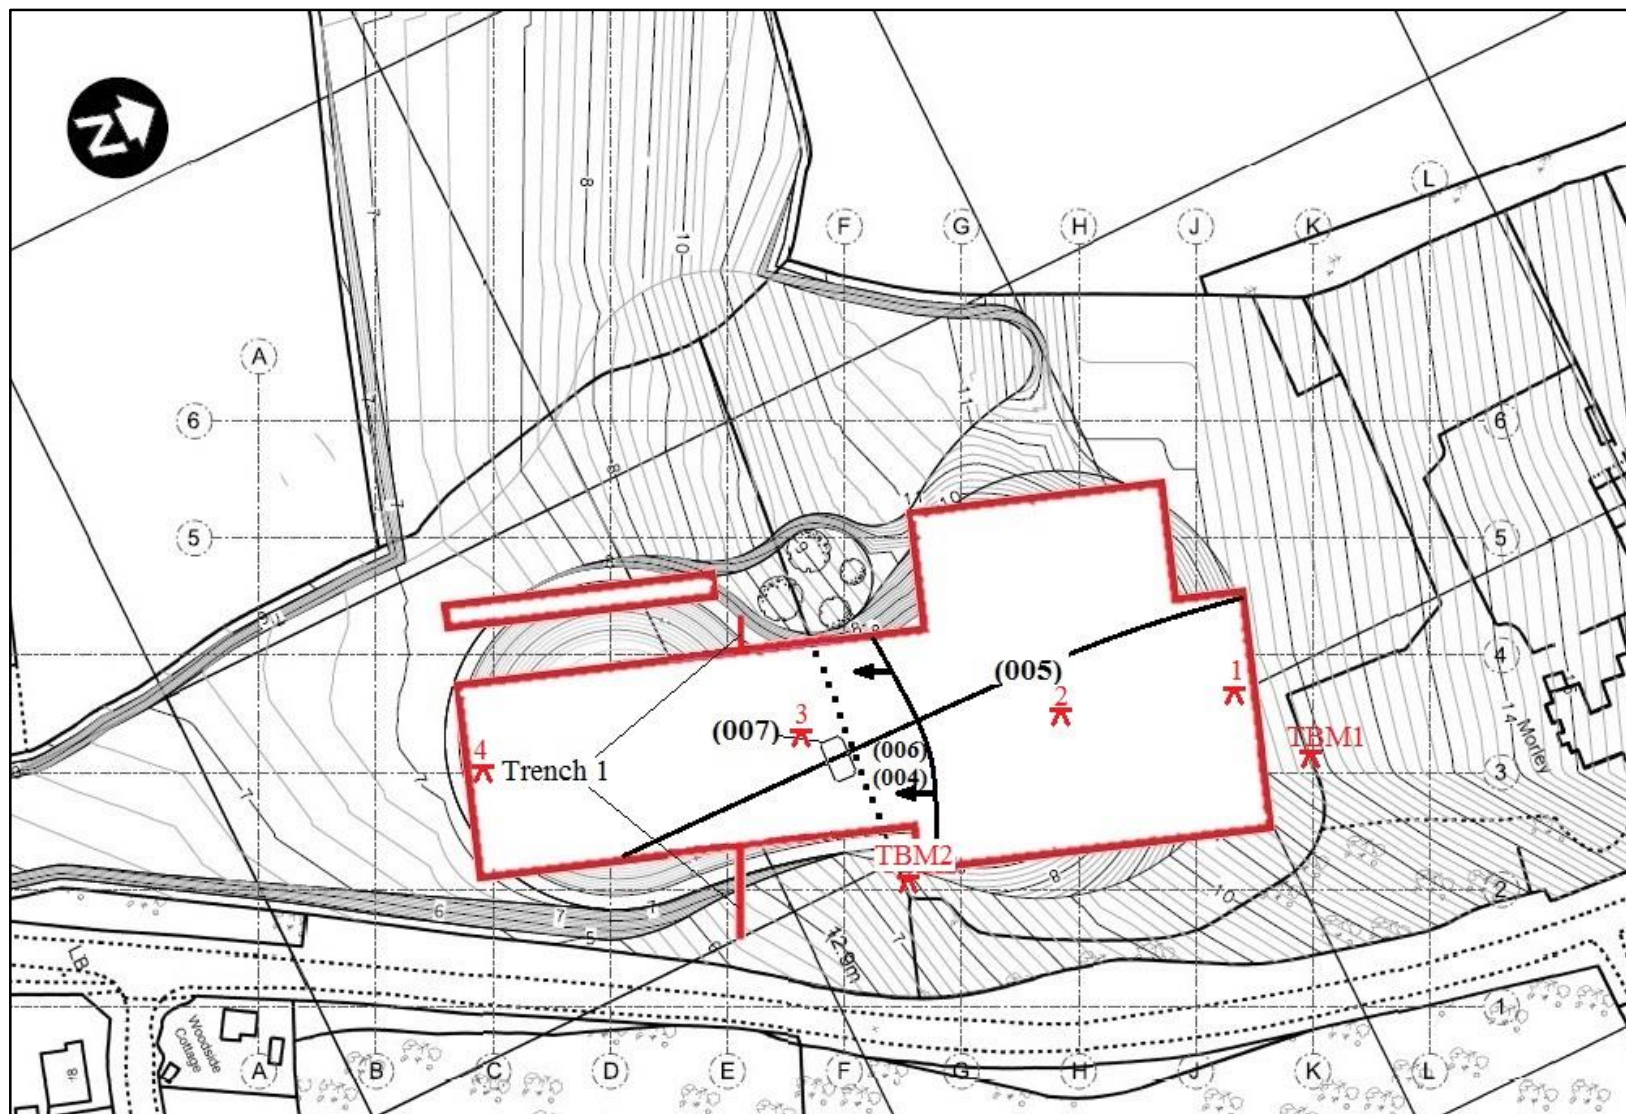
- 3.8** The Site was levelled from two Temporary Bench Marks (TBMs) shown in Figure 9. The level for these Temporary Bench Marks (19.971m aOD) was tied into the Ordnance Survey grid system, from an OS Bench Mark, located on no. 2 Morley Cottages (TQ 2087 1992).

Fig. 9: Morley Manor, Shermanbury: Site plan showing area monitored  
Ordnance Survey © Crown copyright All rights reserved. Licence number 100037471
