An Archaeological Watching Brief at Frame Farm, Iden Green Road, Benenden, Kent

Planning Ref. 16/505552/LBC

Project No. CBAS0828

August 2018

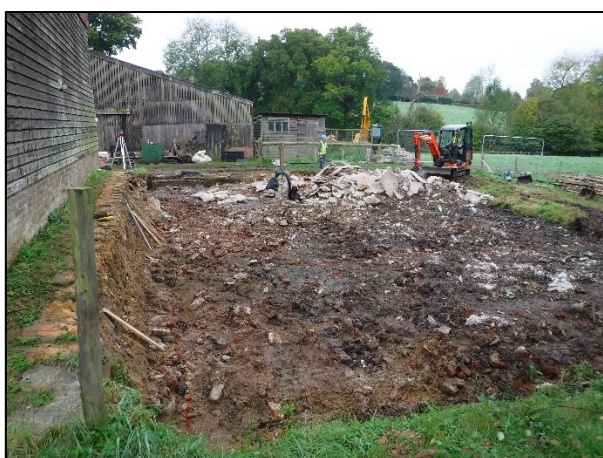
Plate 2: Brye after demolition

- 4.3 The existing byre building (Fig. 3) had been demolished and its existing floor had been broken up (Plate 2). After removal of the resulting rubble, foundation trenches were excavated using a Kubota 3 tonne tracked 360° excavator, and after inspection were immediately concreted (Plate 3). Trenches were up to 2.3m deep and 600mm wide.

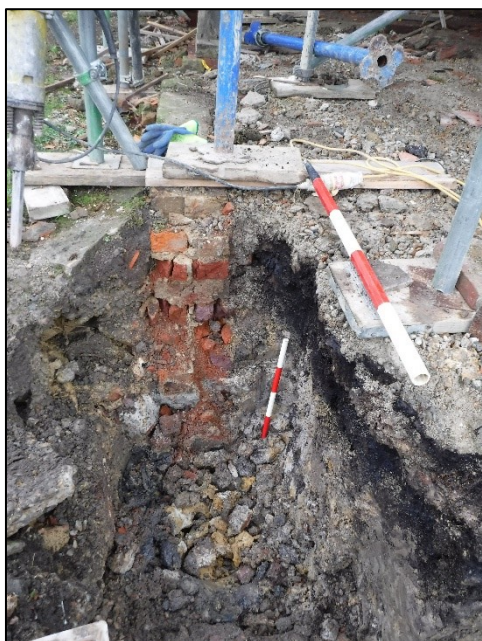
Plate 4: Barn foundation work

- 4.4** Work on the barn (Fig. 3) comprised the removal of some existing brick wall and the excavation of foundation trenches up to 1m deep (Plate 4), underpinning work on the existing barn walls, lowering of the approach ramp to the barn (Plate 5) and lowering of the floor level. The existing concrete floor was broken up with a hand breaker, and then the ground level was reduced using a Kubota 3 tonne tracked 360° excavator (Plate 6). The final area of ground reduction was to the south and south west of the barn (Plate 7).

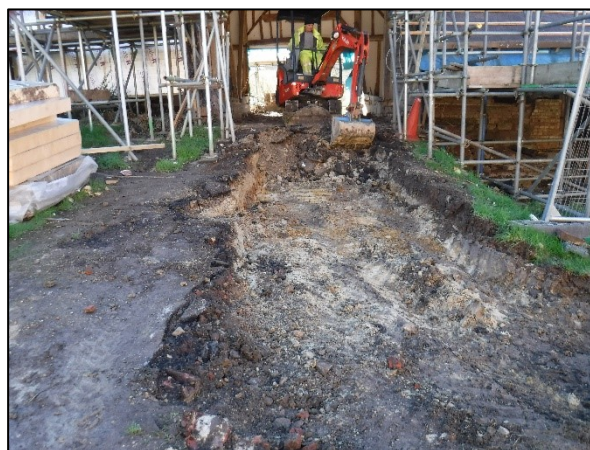
Plate 5: Lowering of ramp to barn

5.3.1 Initially the level of the ramp leading into north-east side of the Threshing Barn was reduced (Plate 5) prior to any reduction within the barn itself. The tarmac surface (Context **3/001**) was a hard black/dark grey mix of sub angular igneous rocks < 5mm in diameter, and was 90mm thick.

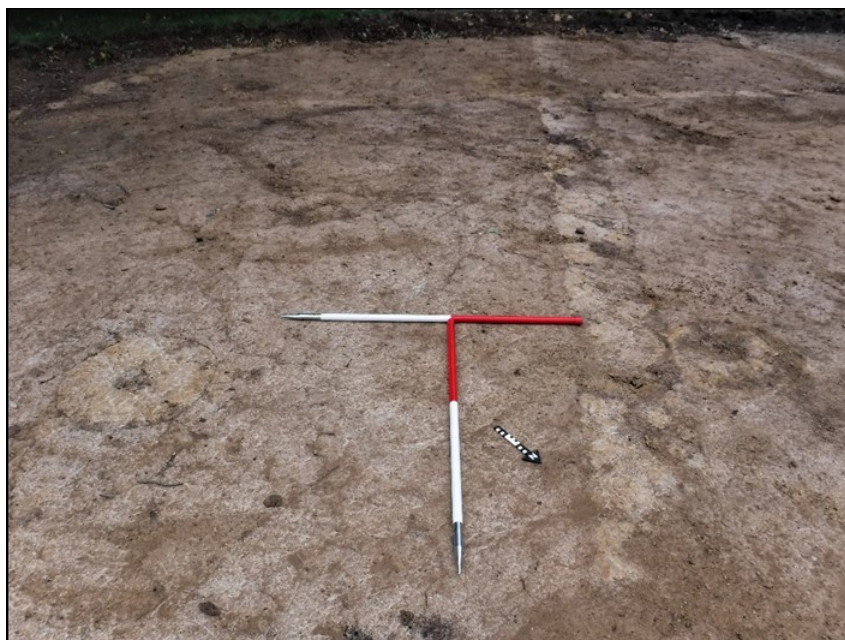
Plate 8: PH1 & PH2 (truncated by WP 2) with LD1, WP1 and WP3 behind, looking south-west.

- 5.1.5** Cut into the natural deposit, a number of linear features were clearly seen running across the car park area (Plate 8). These comprised four land drains (LD1, LD2, LD3 & LD4) and three waste pipes (WP1, WP2, WP3). The land drain trenches average a width of 200mm and the waste pipe trenches average 350mm in width. Waste pipes WP1, WP2 & WP3 all lead to the farm installed Sewage Treatment Works. Two further waste pipes (WP4 & WP5 – not shown on Fig. 4) continue downwards to the south-west beyond the Site towards a small stream; WP5 has smaller width of 150mm. As these were all clearly modern features, none were archaeologically investigated.

- 5.1.6** Four post holes were revealed (PH1, PH2, PH3 & PH4). These are all circular in shape and measured 520mm in diameter. PH1 (Context **1/004**) was excavated and found to be 230mm in depth with straight sides and bottom (Plate 9), and contained a firm light orange clay fill (Context **1/005**). Within this was a post pipe (Context **1/006**) representing the original post, part of which was found in the bottom of the post pipe. The post pipe was 115mm in diameter and 340mm deep, extending deeper than the surrounding post hole. The fill of the post pipe was the same soft, mid-brown clayey silt as the subsoil. No artefacts were recovered from the posthole or post pipe. The other postholes were not excavated as they were clearly of the same date and structure.

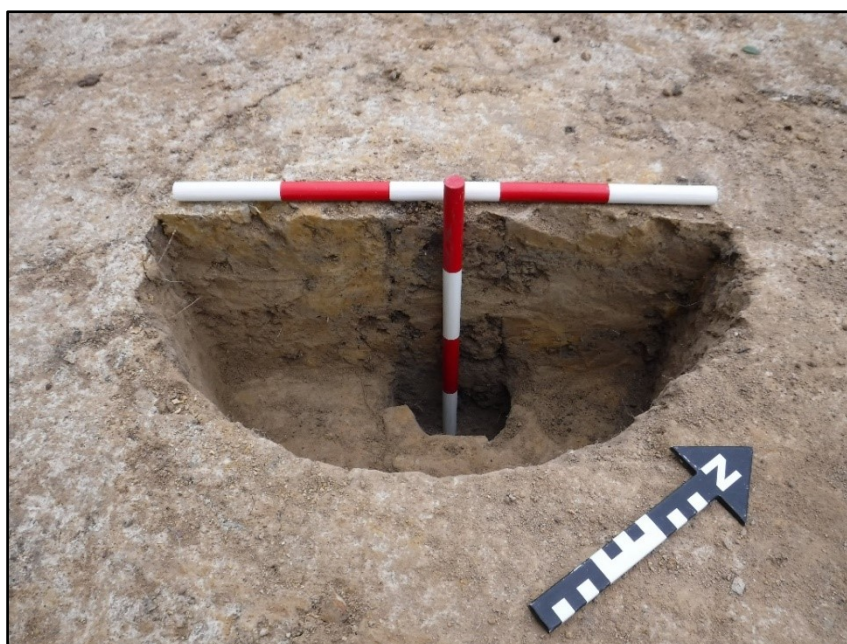
Plate 9: PH1, showing south-east section.

5.1.7 The consistent shape and size of these suggest they have been created with an ‘Auger Drill’ rather than dug by hand. The position of these post holes may relate to the small open fronted structure first seen on the 1956 OS map (Fig. 8).

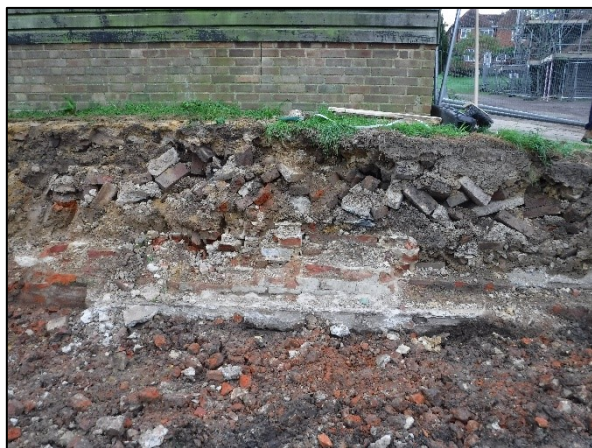
Plate 10: Wall of Byre on northern edge
of excavation

- 5.2.4** Excavation of the new foundation trenches revealed the lower foundation of the former wall of the byre (Context **2/004**), which extended to a length of 6m on the north side (Plate 10), 8m on the south side and 13m on the east side. At the northern end of this wall its cut was encountered at a depth of 800mm, containing a dry monk bond of bricks 400mm in width, sitting directly on the natural clay (Context **2/005**), which was the same as Context **1/003**. A ceramic pipe was noted at the base of the wall foundation, running on the same orientation.

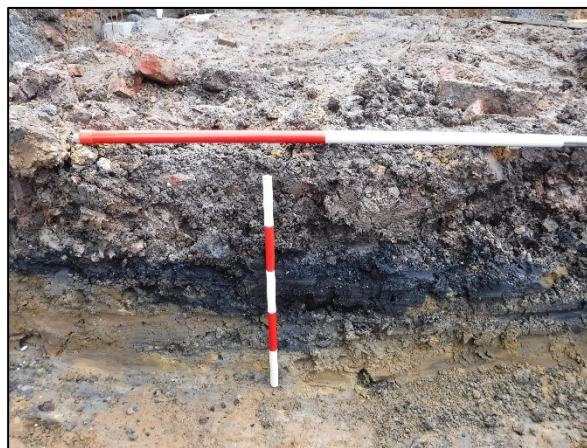
Plate 11: Deposit **2/006**

- 5.2.5** Another deposit (Context **2/006**) was seen above **2/005** between the former walls of the byre. This was a soft dark grey/black silty clay up to 220mm in depth containing well-rotted grass fibres and straw, with a smell of pond mud. This combination suggests it was the areas original surface of former bedding material that had periodically been covered by water as the area is known to flood easily and has two ponds adjacent to it.

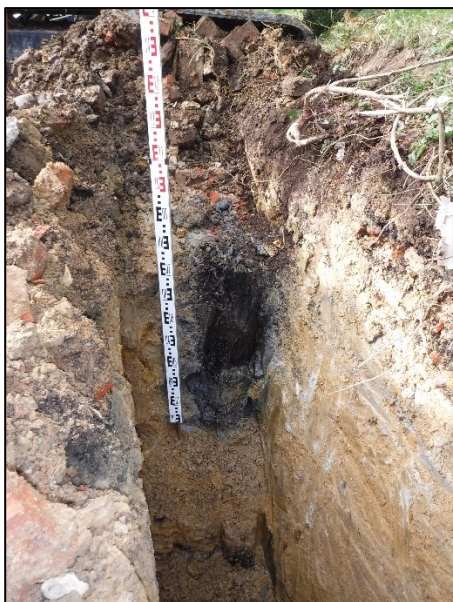
Plate 12: Post A in-situ

5.2.6 The new foundation trenches also revealed the lower portions of seven former wooden posts/supports (A, B, C, D, E, F, G & H) that would have supported the buildings sloping roof (Plates 12 – 14). These ranged in size between 500 to 720mm in length and 200 to 360mm in diameter, A, B, C & E being simply unworked sawn off tree branches. F, G & H were seen to be made of prepared timber, with G being an additional packing post for F.

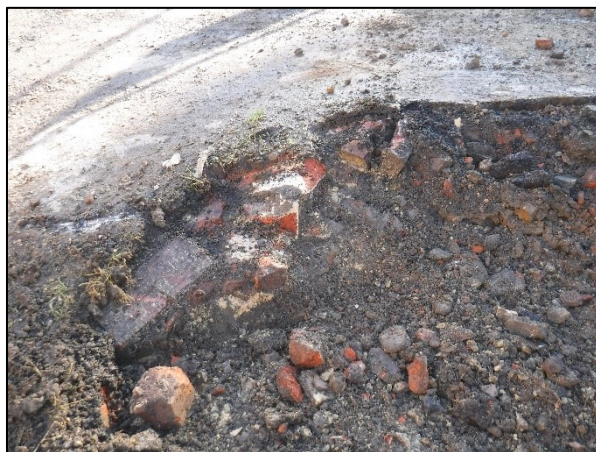
Plate 15: Tarmac and underlying bricks forming ramp

5.3.2 Below **3/001** was an irregular layer of brick cobbles (Context **3/002**), to a depth of 70mm (Plate 15), however this did not extend as far as the entrance to the barn. The bricks were unfrogged and hand made, and measured c.235mm x 105mm x 70mm. There was no bonding material, although some of the bricks had a sandy mortar adhering to them. It is not clear whether these formed an earlier surface or were re-used bricks providing a hard core base for the tarmac, although the latter seems more likely.

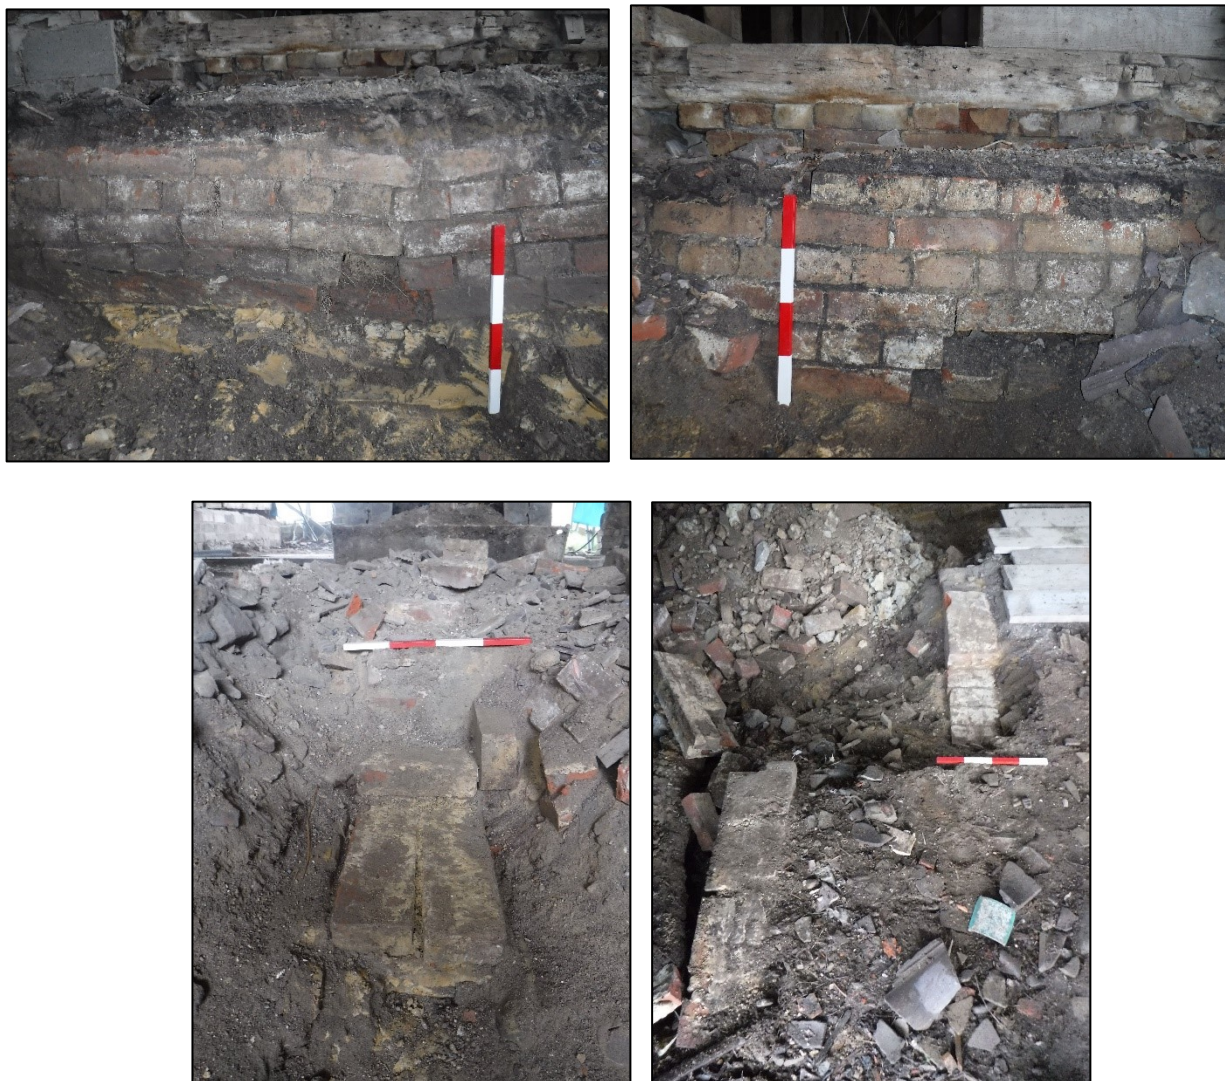
Plate 16: Sleeper walls supporting wooden threshing floor

5.3.5 Below the made ground were five parallel sleeper walls, extending from northeast to southwest across the centre on the barn (Fig. 7). The four longer walls (**3/005**, **3/006**, **3/008** & **3/009**) were all c.9m long and extended the full length of the floor. The central wall (**3/007**) did not extend to the north wall of the barn, and was interrupted by an inserted metal tank in its centre. All of the walls have been truncated by the insertion of the later concrete floor and only survived to a height of one or two courses, except for the two walls (**3/005** & **3/009**) adjacent to the east and west sides which survived to a maximum of six courses.

5.3.6 The walls (Plate 16) were formed of un-frogged bricks, each measuring c.235mm x 105mm x 58mm, in English Bond, and were bonded with a weak yellow-buff sandy mortar. The bricks in each of the walls appeared to be of the same type, which suggests they are all of the same phase, and originally supported the wooden threshing floor.

- 7.4 During the survey of the barn¹¹ it was noted that a possible sleeper wall may have supported a suspended timber threshing floor that was no longer *in situ*. The monitoring work has confirmed the presence of further sleeper walls which did indeed originally support a wooden suspended threshing floor covering this bay of the barn. The original 18th century threshing floor would have been supported on wooden joists¹², and the evidence from the monitoring suggests that these were replaced by brick sleeper walls in the later 19th century, perhaps at the time of other modifications to the barn¹³.

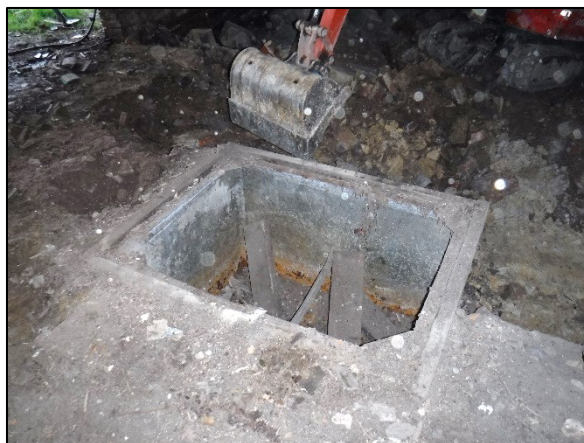
Plate 17: Metal tank

5.3.7 A large metal tank (Plate 17) had been dug into the concrete floor of the barn and was covered with wooden planks. It measured c1.5m x 1m in size and was c1m deep, and had apparently been used as an inspection pit for servicing tractors. It had been cut through the central brick sleeper wall (3/007).
