**An
Archaeological Watching Brief
at Highworth Farm
Charlwood, Surrey**

MO/2014/0269 & MO/2014/0305

By
David Atkin

April 2018

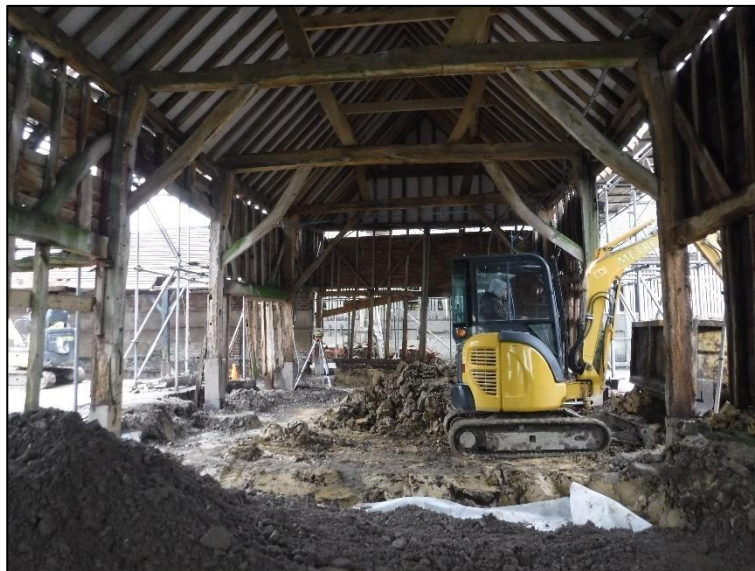
Plate 1: Working shot looking south in the barn

3.4 A thorough examination was made of the exposed Weald Clay natural of the barn, stables and the cart shed for any cut features, although none were seen in any of the buildings. Unfortunately, the northern bays of the barn had also had a deposit of road stone deposited upon a terram membrane (see Plate 1), and therefore this area could not be examined to any great extent. The excavation in the barn and stables exposed the natural Weald Clay over which lay a mid to dark grey material containing late 19th and 20th century material consisting of white china, concrete and glass inclusions, with this deposit surviving best in section in the south-west corner of the barn. A photographic record was kept of the visit and brick samples were taken, where available, for dating. No other finds were forthcoming.

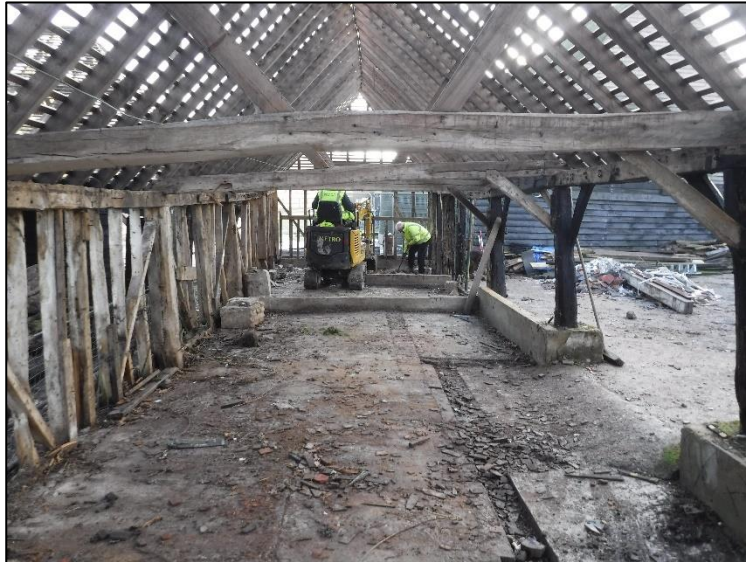
Plate 2: Inside the cartshed

3.3 Unfortunately the floor of the main barn had been removed by machine and excavation undertaken into the underlying deposits, including the underlying natural Wealden Clay to an overall depth of some 600mm prior to the archaeological monitoring beginning. The majority of the eastern foundation wall had also been removed prior to the watching brief beginning (see Plate 1) with just a small section surviving in bay I (see separate building report) at the northern end. The floor to the adjoining stables has also been removed to a depth of 200-300mm. However, the removal of the floor in the cart shed (Plate 2) was monitored during its removal in spits by machine down to the top of the natural clay.

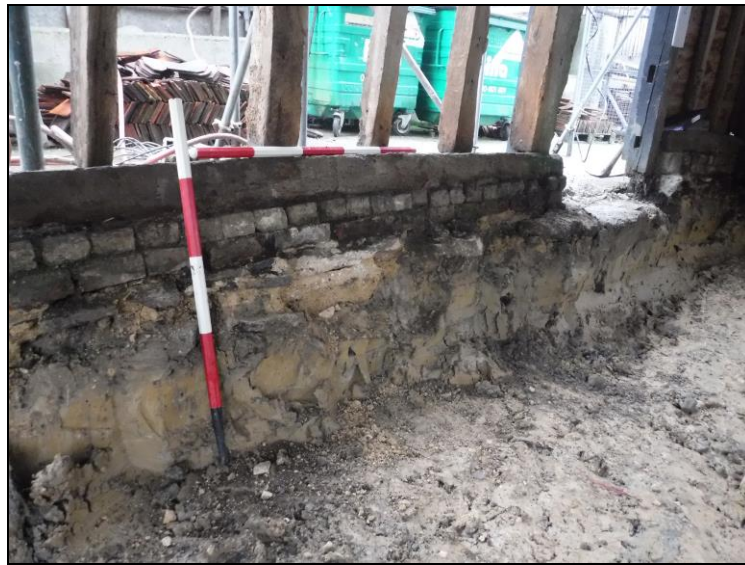
Plate 3: Southern interior elevation showing all contexts

4.1 Context 1 was assigned to the mixed brick and stone courses that were acting as a support for the soleplate for the barn. It consisted of two courses of brick, one laid in a stretcher bond topped off with a single course of header bond in the southern elevation (see Plate 3), and the southern end of the western elevation where it was constructed from sandstone pieces in four irregular courses, bonded with a buff mortar (Plate 4). Where it survived in the eastern elevation, and at the north end of the barn the foundation comprised four rubble courses of mixed brick and stone pieces (Plate 5).

- 4.2** Context 2 was a mixed deposit containing brick fragments, concrete and a buff coloured stone with a possible buff coloured mortar or concrete at <3% and chalk pieces 5%. This was presumably a rubble deposit or under pinning for either the floor and/or the foundation wall, (Context 1) and was 120mm thick.

- 4.3** Below Context 2 and next in the stratigraphic sequence, was Context 3. This was a soft mid-grey, silty grey deposit containing concrete, white stone china from a toilet or sink and a few pieces/fragments of undiagnostic modern glass (not retained) and was 200mm in depth.

- 4.4** Underlying Context 3 was the natural geology of Wealden Clay (Context 4). The excavation in the barn removed approximately 340mm of natural before reaching the limit of excavation (hereafter LOE).

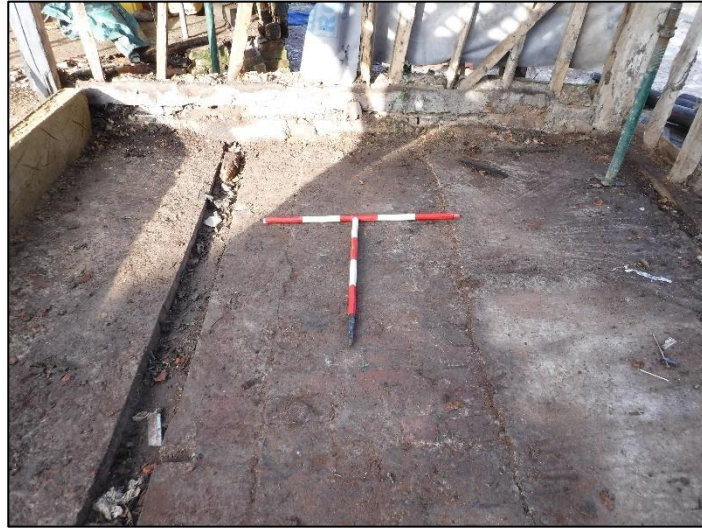
Plate 6: Brick (Context 5) and concrete (Context 6) in cart shed

- 4.5** Excavation then focused on the cart shed to the rear of the main barn. This building had a brick floor (Context 5) running up the middle with of the cart shed with concrete to either side, built using re-used bricks of a late 19th to early 20th century set in an early 20th century mortar. The bricks were of differing fabrics (samples taken – see finds report) and in one case had its previous mortar still adhering to it, strongly suggesting that have been reused from elsewhere. A strip of brickwork along the northern end of the floor had had its bricks laid on their stretcher side rather than on the base of the bricks. The brick floor ran the length of the cart shed but was interrupted at one point towards the western end, by a small concrete dwarf wall.

4.6 Bounding the central aisle of brick for most of the length of the cart shed were two strips of 20th concrete running east-west along the length of the cart shed. This was allocated Context 6. The brick and concrete floors had been laid on sand immediately above the natural clay (Plate 7).

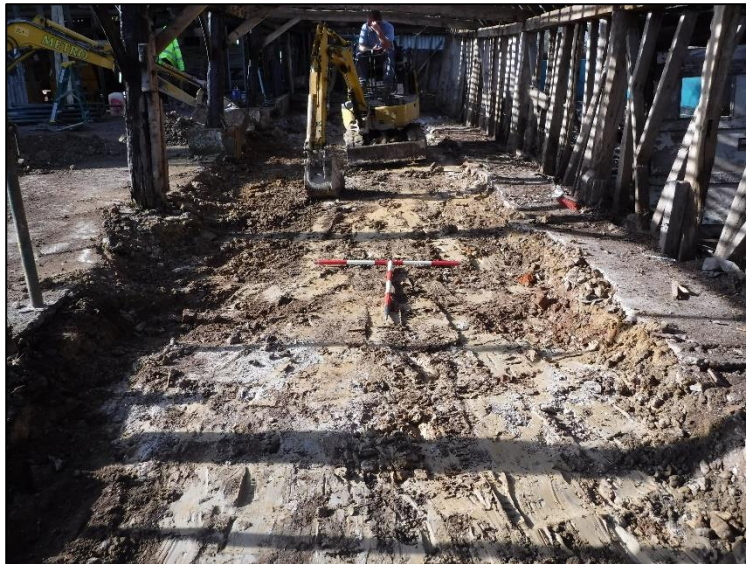
Plate 7: Natural directly below floor in cart shed

- 6.2** The removal of the early 20th brick floor and concrete in the cart shed to the rear of the barn, revealed the clean surface of the natural clay with no features or floor levels. This may be because partly down to the later brick and concrete having removed any traces of any earlier floor, which may have been nothing more than bare earth.

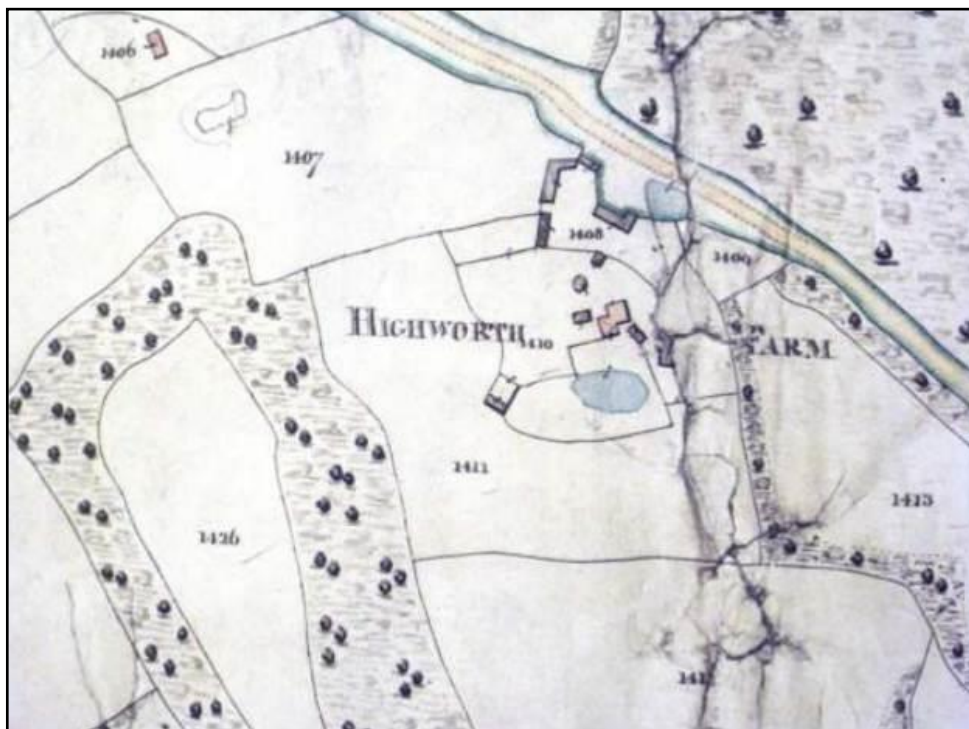
Fig. 8: Highworth Farm: 1840 Charlwood Parish Tithe Map
Surrey History Centre (SHC: 865/1/3-4).

- 2.8** The Map to the Tithe Award for Charlwood Parish (Fig. 8), drawn up around 1840 with the associated Apportionment being dated 1842 (SHC: 865/1/3-4). This map shows that Highworth Farm was owned by Mary Richards and 'occupied' by William Gibbs. Very little change is seen between the Tithe map of 1840 and the 1st Edition of the OS map of 1876 (Fig. 9). However it should be noted that the Grade II Barn at Highworth Farm about 40 metres to north-west of the Farmhouse (on the Tithe map) is different to that shown on the 1876 map. This leads to the question of whether the building has been remodelled in the 36 years between the two maps. The 2nd Edition OS map of 1896 (Fig. 10) shows that the basic form of the farmyard remains as it was shown on the 1876 Edition.

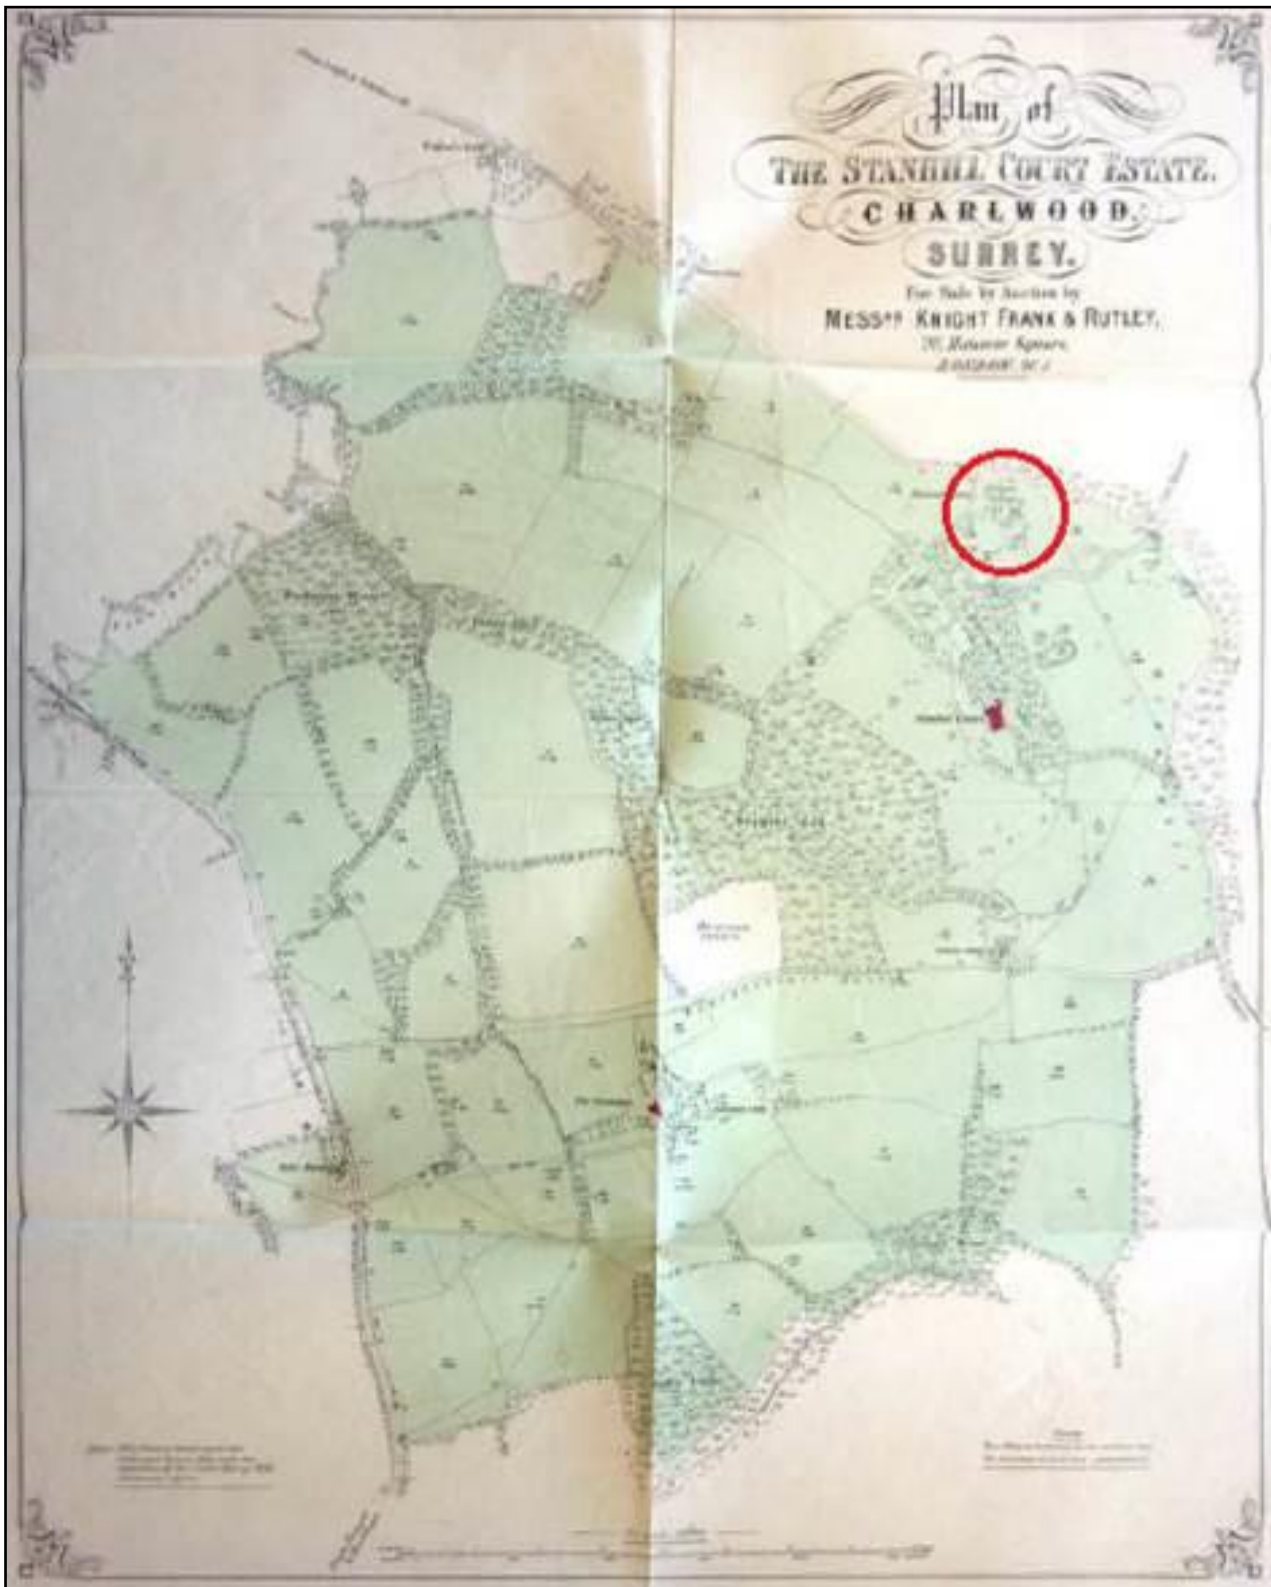
Fig. 12: Accompanying Estate Plan to the 1920 Sales Particulars for the Stanhill Court Estate Surrey History Centre (CC99/21/1) with site location.

- 2.9** A detailed description of the Farmstead buildings and their usage is to be found in the May 1920 Sales Particulars for the Stanhill Court Estate (Fig.11) which included Highworth and Greenings Farms (Surrey History Centre: CC99/21/1). The Sales Particulars are accompanied by a Plan of the Estate (Fig. 12) based on the 1914 Edition OS map (Fig. 13).
