**An Archaeological Watching Brief
at
The Parlour, Manor Farm,
Greatham,
West Sussex**

Planning Ref. SDNP/15/05125/FUL

Project No. CBAS0680

July 2016

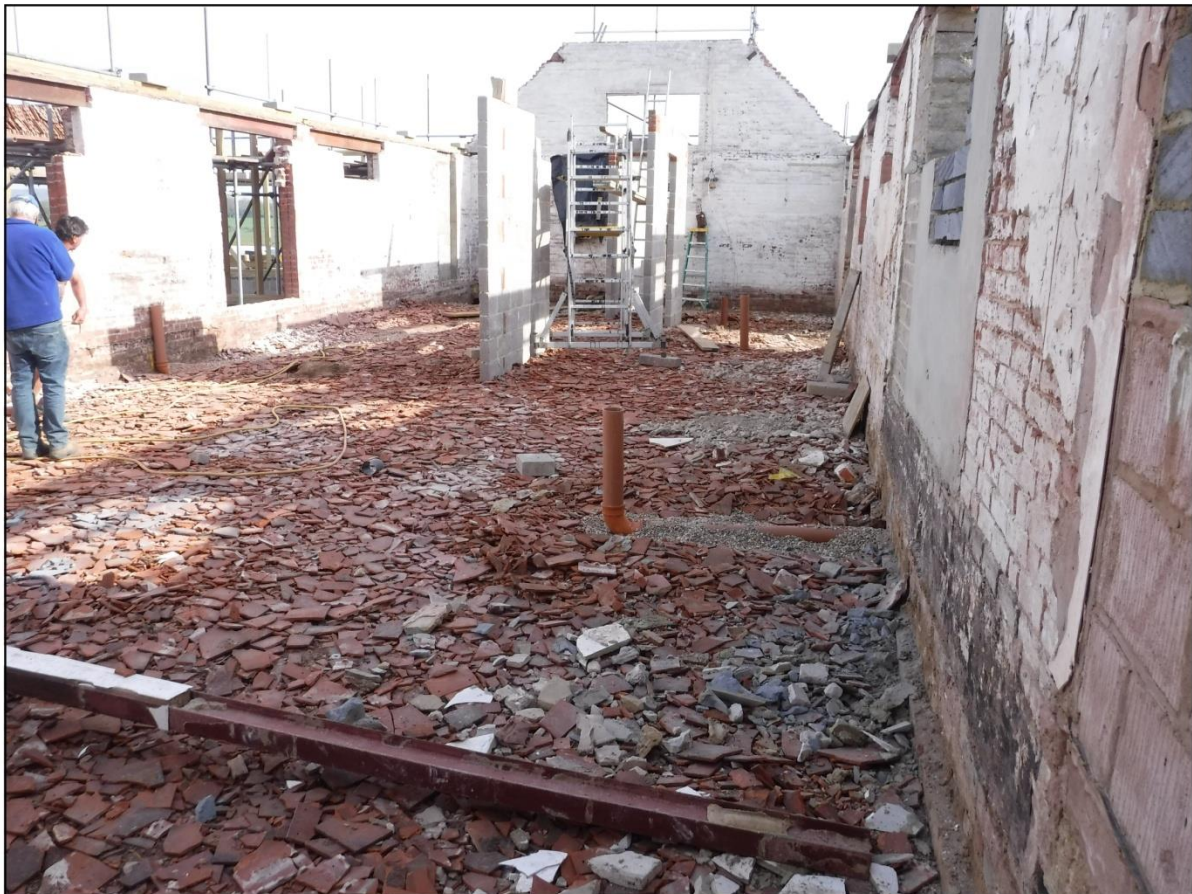
Plate 1: Internal view of the Parlour Building, facing north

4.1.1 The Parlour building was a rectangular structure on a northeast-southwest alignment, the new extension extends northwest from the northwest corner, making the Parlour into an L shaped building. The roof, doors and windows had been removed from the Parlour, with many of the doorways were in the process of being bricked up at the time of visit. The ground surface was not metal detected as the large amount of tiles and roofing nails would have made this impractical (Plate 1).

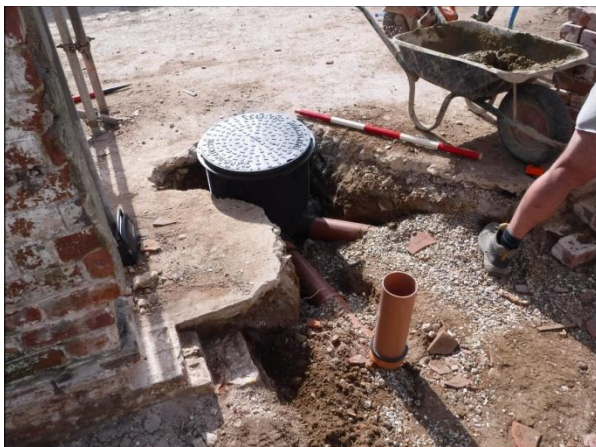
Plate 2: Manhole in east wall of parlour building, facing east

4.1.2 Six services trenches had been excavated within the Parlour building, three of these connecting to manholes, positioned outside (Plate 2), and three internal walls had been erected in the centre of the northern end of the Parlour (Plate 1). A small area was cleared at the south east corner of the Parlour building (Plate 3), exposing a mid orange-brown, silty sand subsoil of indeterminate depth (**001**).

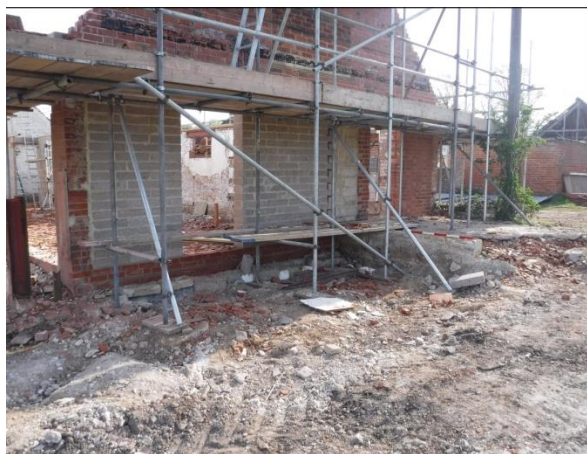
Plate 4: South wall of the Parlour, facing northeast

4.1.3 Outside the Parlour building, the concrete ground level was reduced to the south and west, with repairs to the south wall having been made with steel below ground level, and brick and block work above (Plate 4).¹⁰ The footings trenches for the extension at the southwest corner of the Parlour had all been filled, meaning that there was no useful information about the stratigraphy within them available (Plate 5).

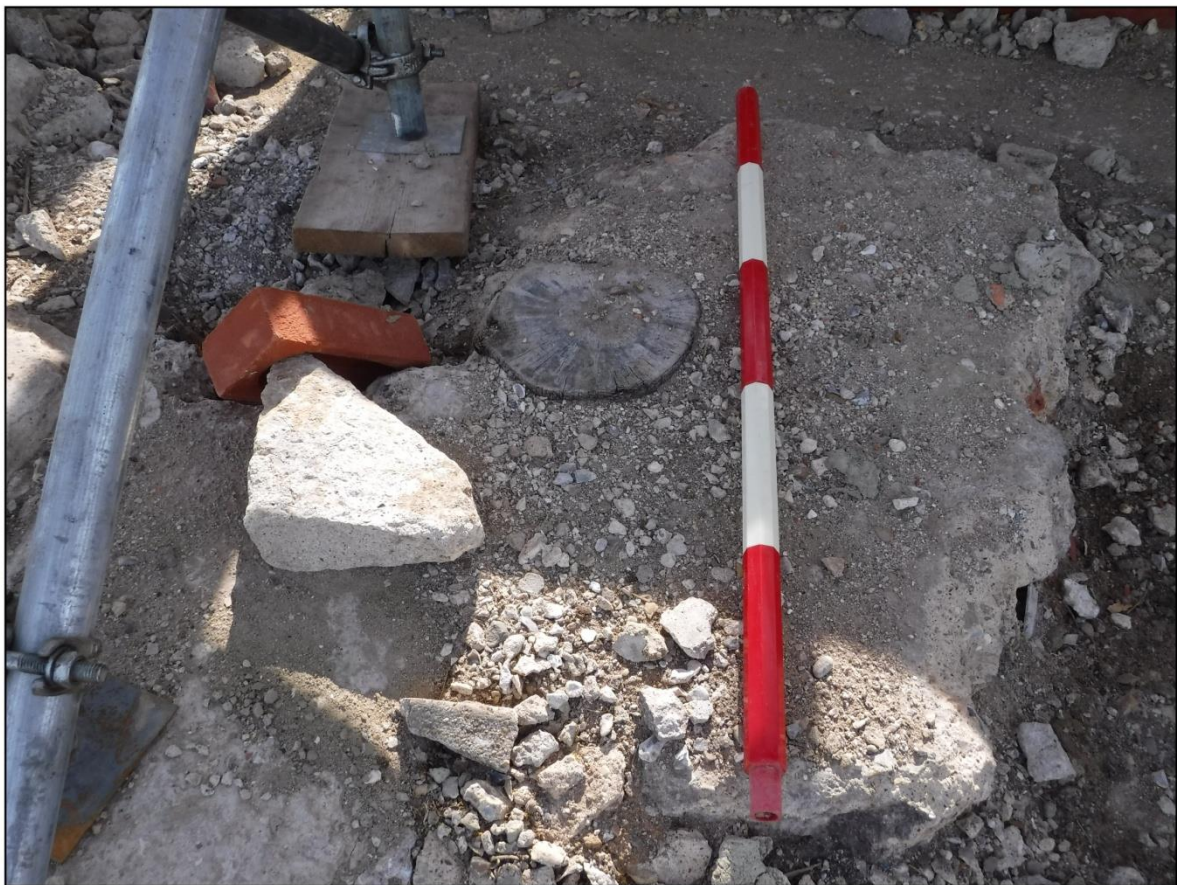
Plate 6: Easternmost of group **002c** posts, facing east

4.1.4 In the yard to the northwest of the parlour are three distinct groups of posts, cut off at ground level. These were revealed with the removal of the concrete floor layer. While these are most likely modern, as in places they show through the concrete (Plate 6), however, given their layout (Fig. 13) they may possibly relate to an earlier farm building such as a post barn. These postholes have been described as Context **002**, and consist of a northern linear group of four round posts in a northwest-southeast alignment (**002a**), two square posts at 90° to the southwest of group **002a**, referred to as **002b**, and a southern group of three round posts in a northwest-southeast alignment (**002c**). These posts are all of 200-350mm diameter and are of unknown depth.

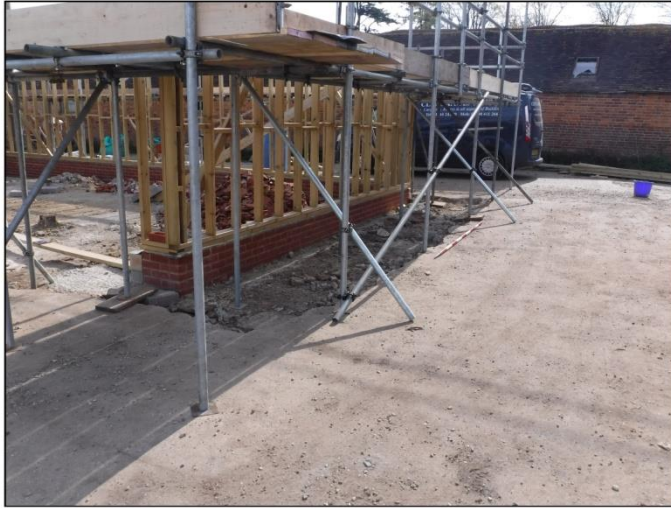
Plate 7: Southwest corner of the Store, facing east

4.2.1 The new Store building is a rectangular structure on a northeast-southwest alignment, situated north of the Parlour, between the Parlour and the new Stables. The concrete floor layer was left in place between the Store and the Parlour, only being lifted around the footprint of the new build (Plate 7). As with the Parlour building, there was no information to be gained from an inspection of the visible footings, with only c.100-150mm of these left open (Plate 8).

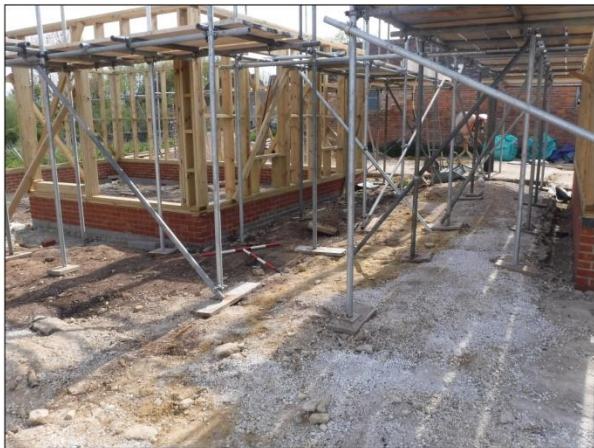
Plate 9: Southwest corner of the Stables’ east wing, facing east

4.3.1 The Stables building is an ‘L’ shaped structure on a northwest-southeast alignment, with a short eastern wing on a northeast-southwest alignment, situated just north of the Store between the Parlour and the new Stables. The concrete floor layer was removed across the whole area on which the Stables was built, just north of the Store (Plate 9), although it did not extend across the whole of the Stables’ footprint, evidenced by grass along the northern wall of the stables (Plate 10). Again there was no information to be gained from the visible footings, with only the upper c.50-100mm of these left open (Plate 10).

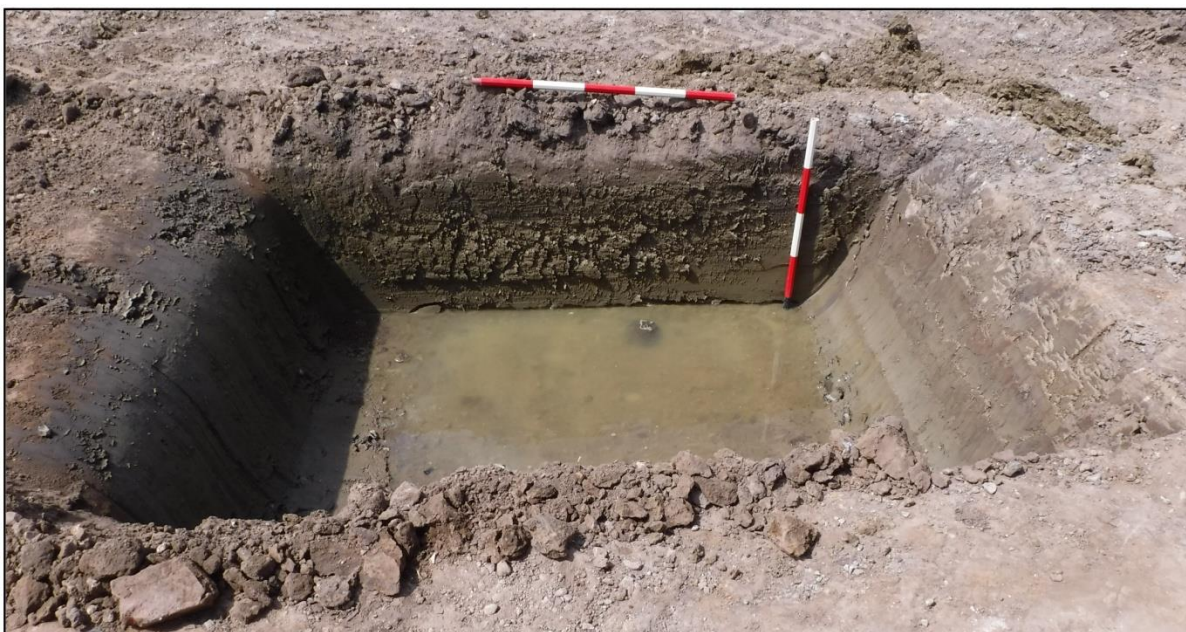
Plate 11: East facing Section of Test Pit 1 (1m scales)

4.4.1 Test Pit 1 (Plate 11) was located 4m west of the extension to the Parlour building (Fig. 13); it was 3m long, 2m wide and 0.9m deep. The Natural Context **1/002** was encountered 200mm below the surface, but the Test Pit was deepened to check this. A head deposit of flints was revealed at 0.8m depth, and after tidying up loose spoil in the bottom of the Test Pit, excavation ceased. The topsoil covering this area is presumed to have been stripped prior to laying the previous concrete surface that had been removed at the start of the groundworks. The subsoil (Context **1/001**), had possibly also been truncated by this topsoil strip. Context **1/001** was a firm, light reddish brown sandy silt, with inclusions of *c.*5% fragments of ceramic building material (CBM) up to 50mm in size. This deposit was found to a depth of 200mm across Test Pit 1.

4.4.2 The Natural (Context **1/002**), was a mid-firm dark green grey sandy clay. This deposit was found to a depth of 0.7m across Test Pit 1, the bottom 100mm of this was formed of a flint gravel head deposit. No finds or features were observed in Test Pit 1.

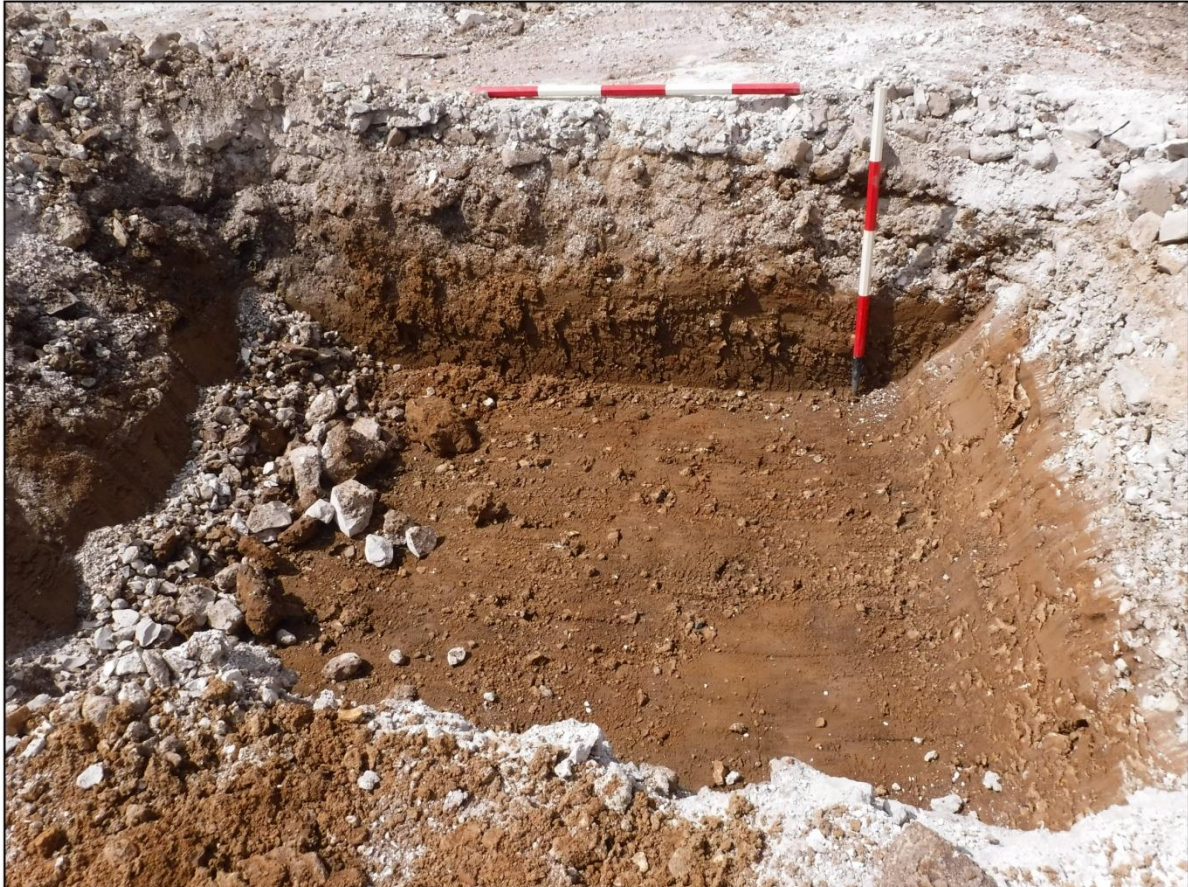
Plate 12: East facing Section of Test Pit 2 (1m scales)

4.5.1 Test Pit 2 (Plate 12) was located 5m south of the Parlour building (Fig. 13); it was 3.3m long, 2m wide and 0.9m deep. The Natural Context **2/002** was encountered 300mm below the surface, but the Test Pit was deepened to check this. A head deposit of flints was revealed at 0.85m depth, and after tidying up loose spoil in the bottom of the Test Pit excavation ceased. The top and subsoils covering this area is presumed to have been stripped prior to laying the concrete surface that was removed at the start of the groundworks. A layer of made ground (Context **2/001**) consisting of a very firm, off white crushed and compacted chalk, with chalk block inclusions of to 260mm by 100mm in size. This deposit was found to a depth of 0.6m across Test Pit 1, and is interpreted as an earlier possible floor surface, replaced by the concrete layer.

4.5.2 The Natural (Context **2/002**), was a mid-firm dark orange sandy clay. This deposit was found to a depth of 300mm across Test Pit 2, the bottom 50mm of this was formed of a flint gravel head deposit. No finds or features were observed in Test Pit 2.

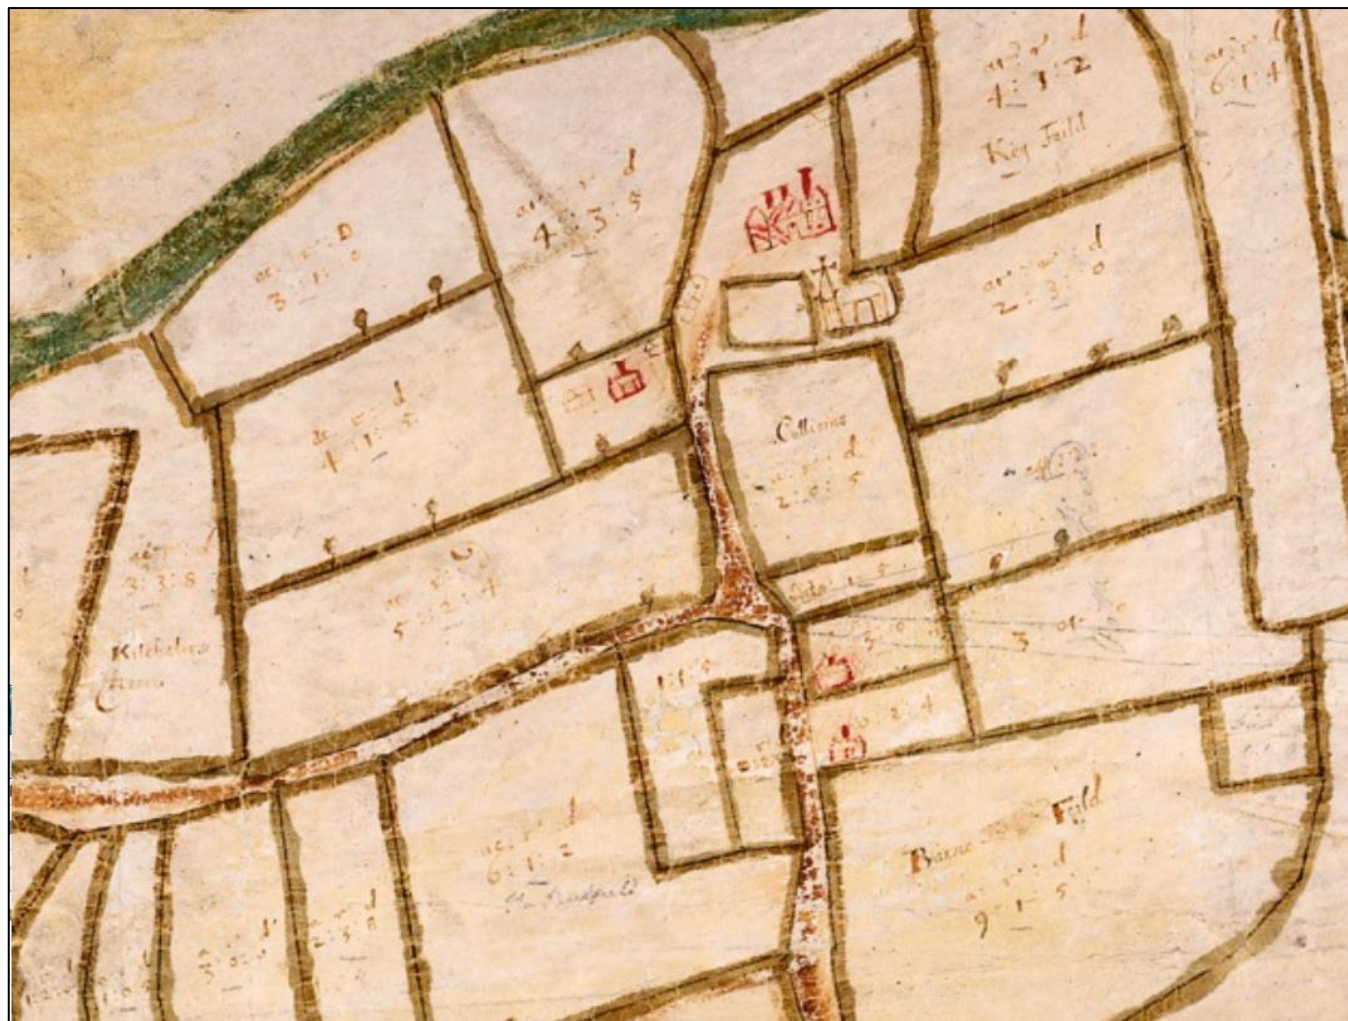
Fig. 6: The Parlour, Greatham: *'Plan of the Mannor of Great Ham'* (c. 1680)
(Source: MacCullagh, R. 2013: *Greatham Barns Milking Parlour, Manor Farm, Greatham, West Sussex Heritage Significance and Planning Justification Statement*. RMA Heritage)

- 2.7** The historic map regression draws on the combined work of Dr. Annabel Hughes and Richard MacCullagh, found in a Heritage Statement for this Site.⁴ There is nothing shown on the footprint of the Parlour in the c.1680 *'Plan of the Mannor of Great Ham'* (Fig. 6). The manor is shown in red with 3 chimneys with the church to its southeast. A further building is shown to the southwest of the manor near the lane and this is shown in brown, so it is assumed this is a barn or stable. Another red building with a central chimney is shown in the field to the southwest, the location of the current farm building. Two further buildings are shown in brown on this site, so presumably these are farm or outbuildings.

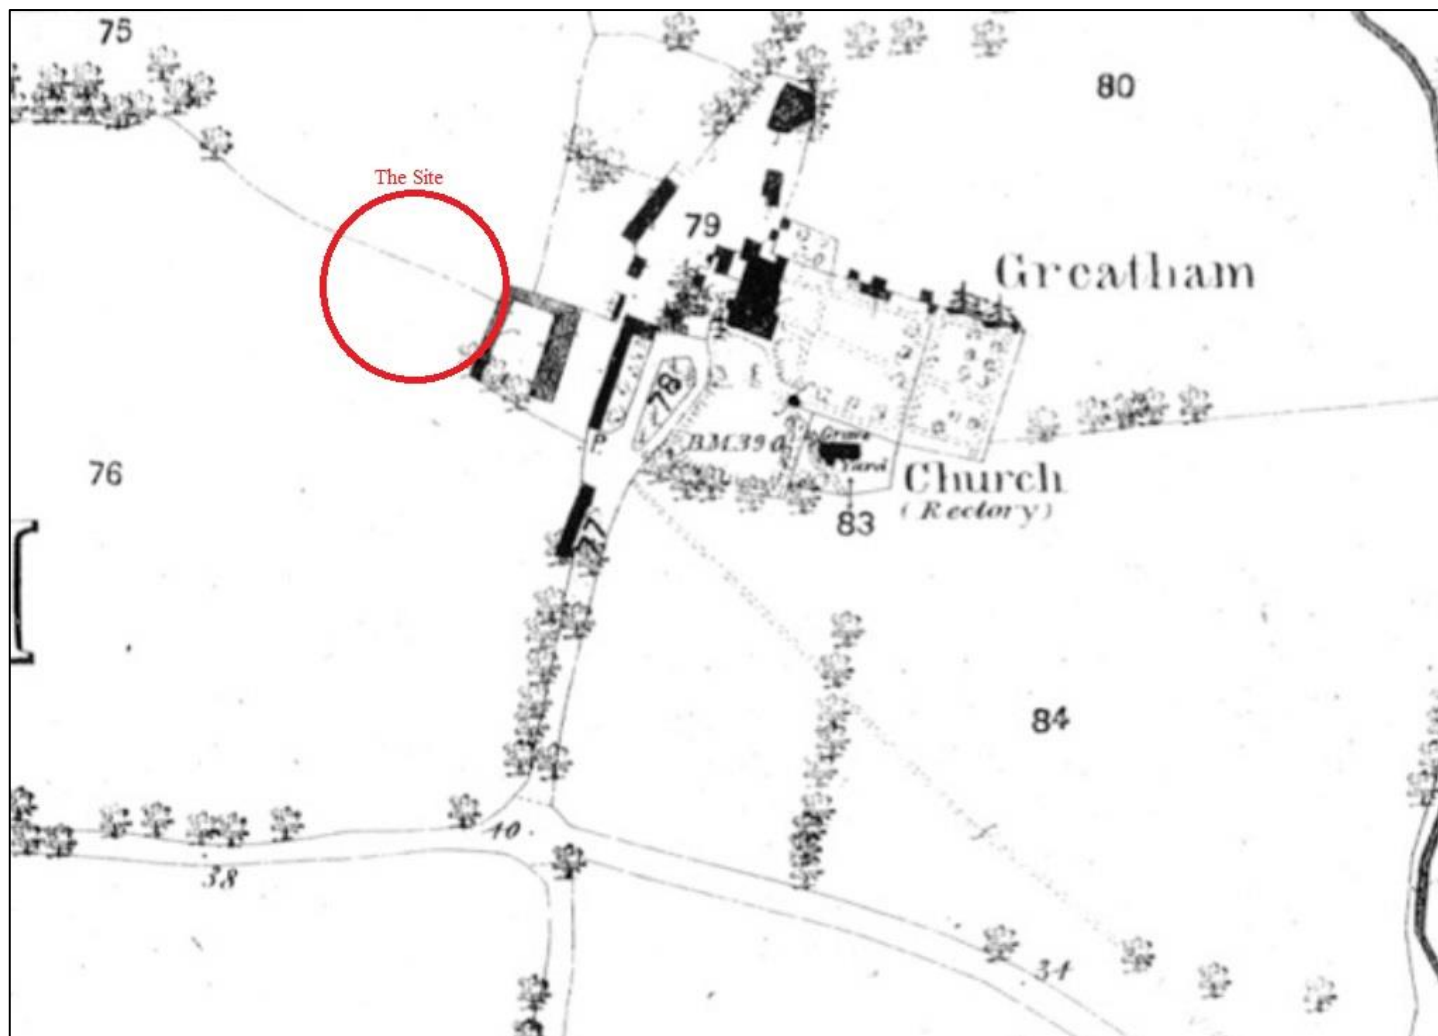
Fig. 8: The Parlour, Greatham: 1st Edition OS (1876)

- 2.9** The 1st Edition OS map of 1876 (Fig. 8) shows extensions to the granary to the north and east, forming an 'n' shaped building, the basic shape of which remains until 1973. The 2nd Edition OS map of 1897 (Fig. 9) shows a south wing has been added to the Granary. A building shown along the farm track in the 1827 and 1876 maps is no longer present at this time.

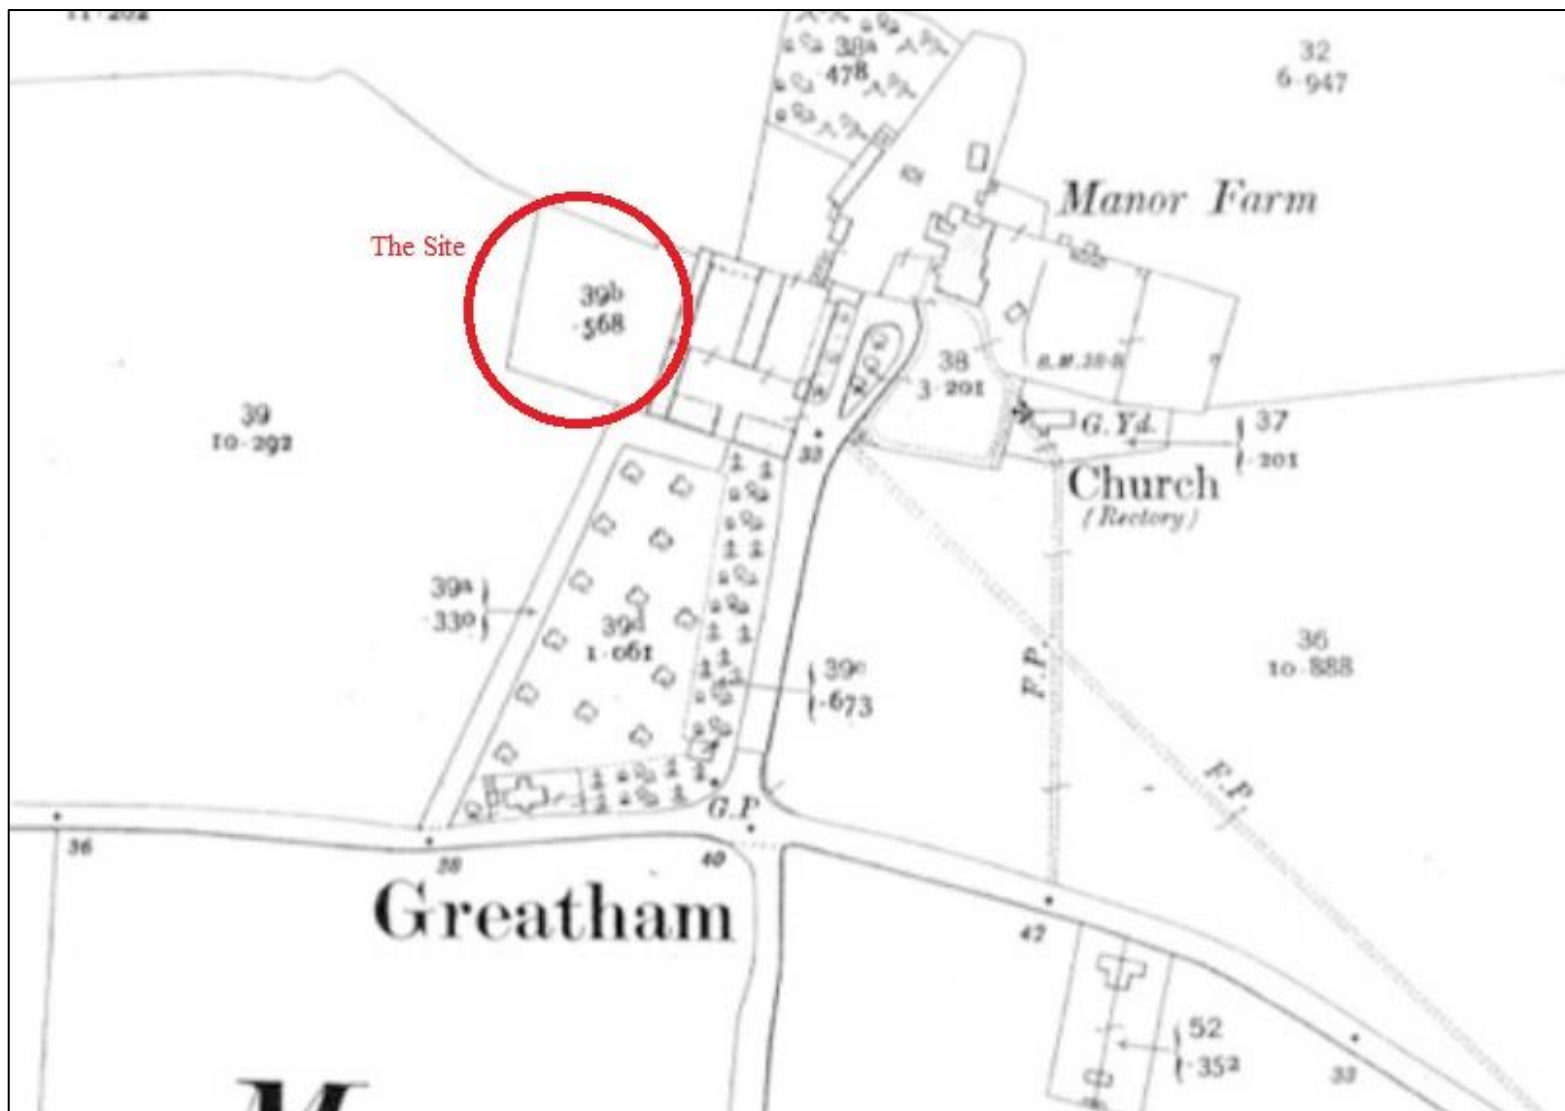
Fig. 10: The Parlour, Greatham: 3rd Edition OS (1911)

- 2.10** Manor Farm was built after the 1897 OS, after the farm buildings were sold off and separated from the Manor. The new farmhouse and track leading to the farm buildings is shown on the 3rd Edition OS Map of 1911 (Fig. 10). There is a gap in the 1:2500 scale maps until 1973, and there is no map evidence of any structure being on the site of the current parlour until that time; however the linear building shown to the west of the dairy building on a 1947-49 RAF Aerial Photograph (Fig. 11) is likely the parlour building.⁶

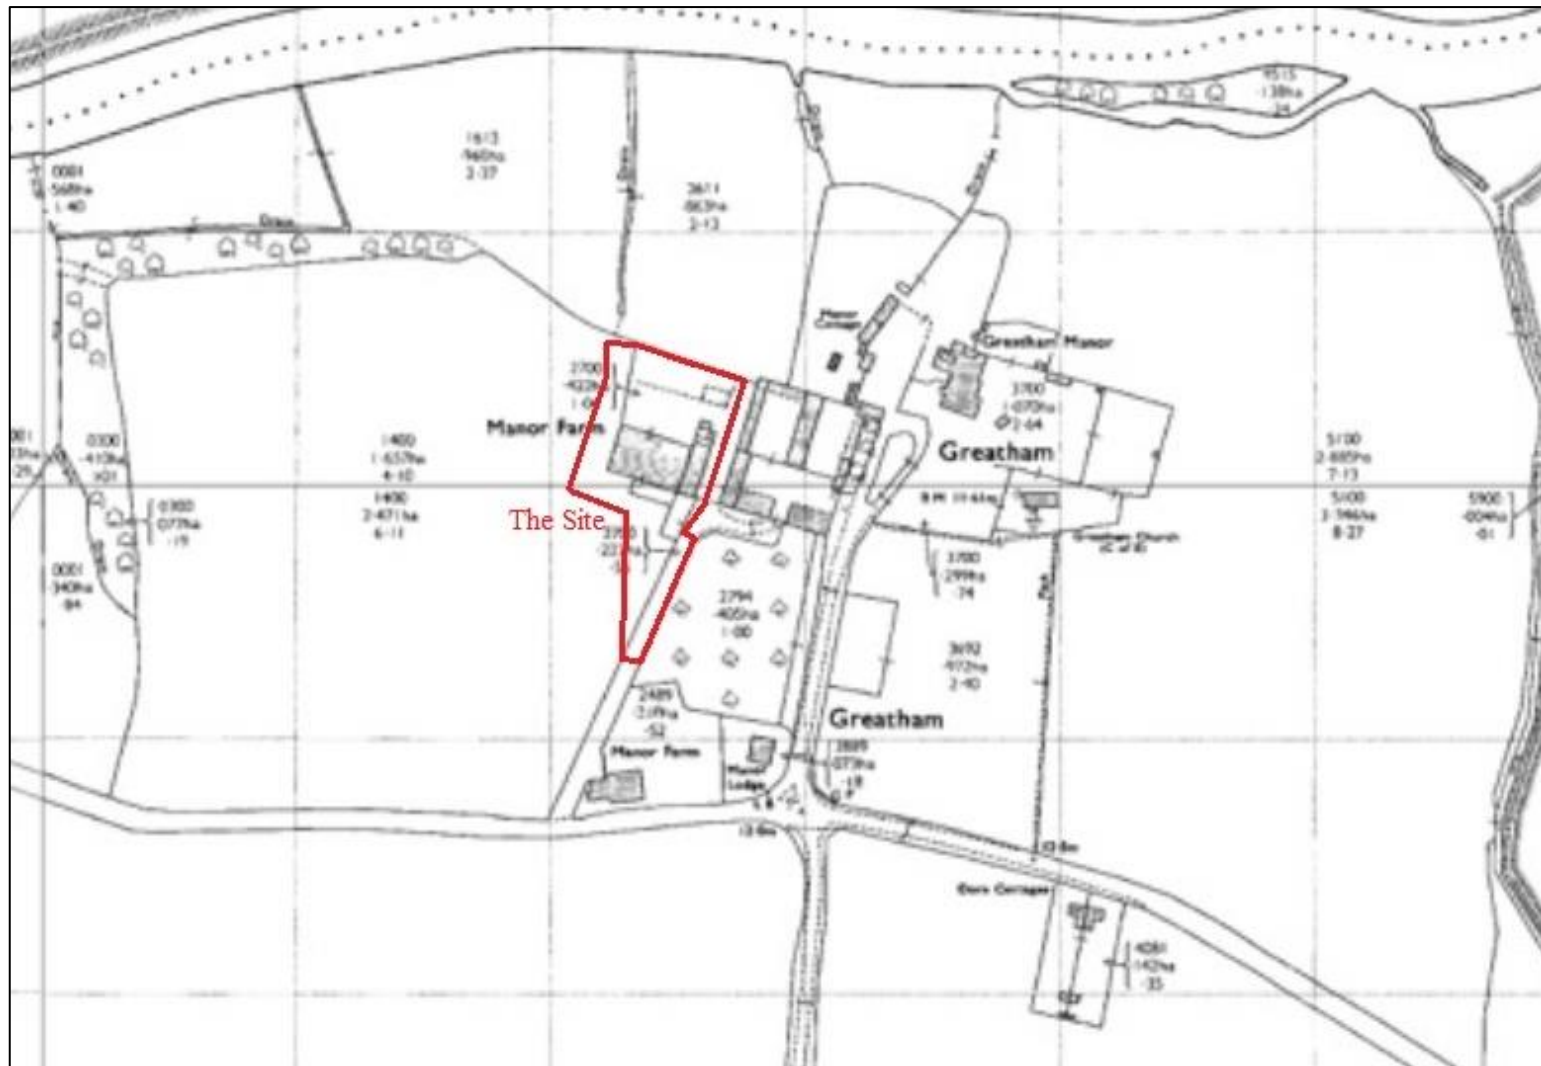
Fig. 12: The Parlour, Greatham: 1973 Edition OS

- 2.11** A concrete gun emplacement (MWS5575) hidden amongst the buildings at Quell Farm facing NW to cover the road bridge over the Arun was erected during WWII⁷. The 1973 Edition OS map (Fig. 12) shows the farm much as can be seen today, the trackway has been repositioned around 30m to the west of the position shown in the 1973 map, some buildings have come down, and more modern buildings erected.

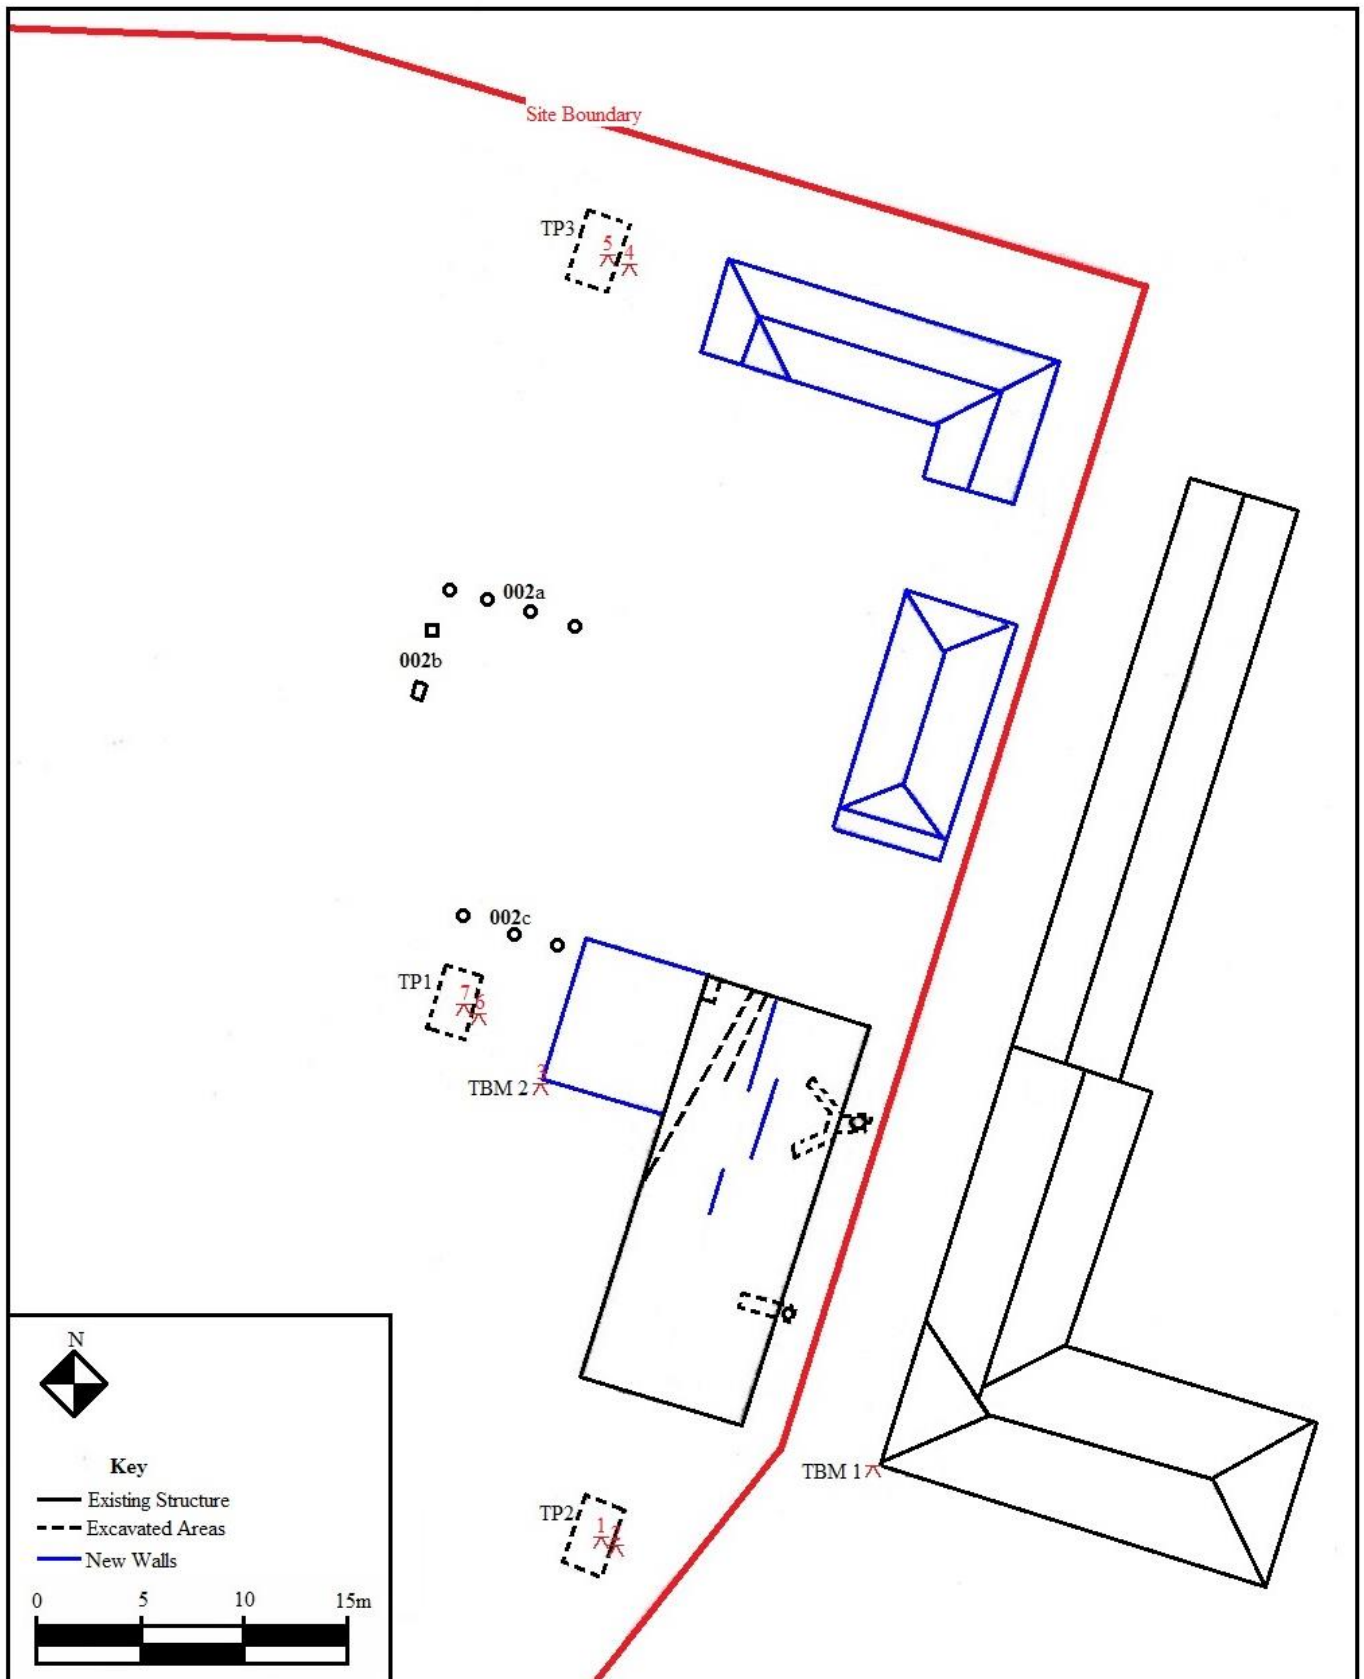
Fig. 13: The Parlour, Greatham: Site Plan
Adapted from architect's plan.
Ordnance Survey © Crown copyright. All rights reserved. Licence number 100022432

3.6 The Site was levelled from two Temporary Bench Marks (TBM) established at ground level on the corner of the L shaped building to the east of the Parlour (TBM1; Fig. 13), and at the southwest corner of the extension to the Parlour building (TBM2). The levels for these TBMs were tied into the Ordnance Survey grid system, from a levels plan produced by T2 architects.
