**An Archaeological Watching Brief  
at  
Chailey Moat, Chailey,  
East Sussex.**

**(LW/09/0668)**

by  
Keith Butler PCIFA

August 2015

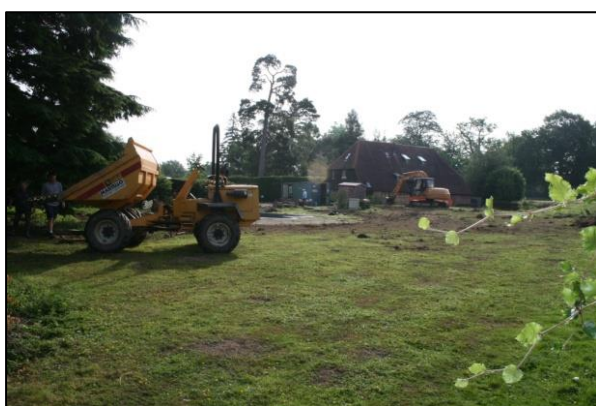
**Plate 1:** The Site taken from the south-west

**3.1** A watching brief was maintained on the reduction of the ground surface in association with the creation of a new garden and the construction of raised beds. The excavations for a new swimming pool were also watched. All the reductions of the ground surface and the excavation of the new swimming pool was carried out using a 7.5ton 360° tracked excavator, fitted with toothless bucket of various widths. The site of the excavations was under grass, with hedges forming the south-eastern boundary to the site and between the small swimming pool and the house to the north-west (**Plate 1**). To the south-east is a barn which has been converted into a dwelling.

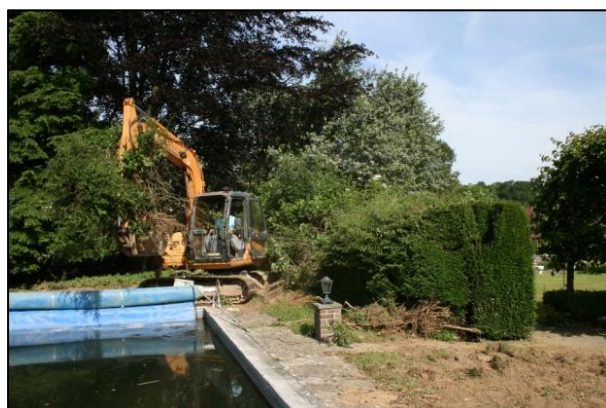
**Plate 2:** The grubbing-out of the Hedge to the north-west of Site

**3.2** On the 1<sup>st</sup> July 2010 the hedge was grubbed out between the swimming pool and the house (**Plate 2**). There was only one deposit apparent in this part of the excavation. Context 1 was a mid brownish-orange sandy loam with a loose consistence. The trench for the removal of the hedge was up to 300mm in depth and had inclusions of sandstone pieces up to 40mm (<1%), sub-angular pieces of flint up to 30mm (<1%) and heavy rooting. This deposit produced artefacts of pottery and ceramic building material, with no archaeological features noted.

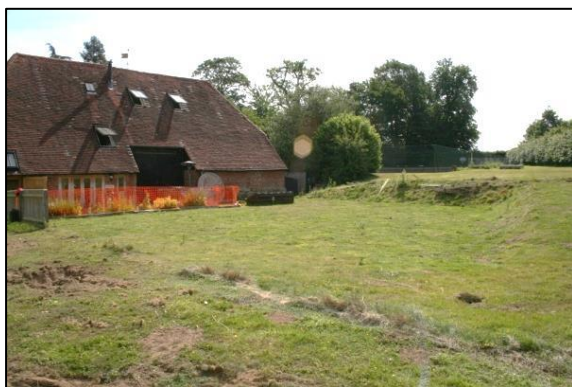
**Plate 3:** Converted Barn with Bank to the south-west

- 3.3** The watching brief on the reduction of the ground surface was maintained on the 1<sup>st</sup>, 2<sup>nd</sup>, 5<sup>th</sup> and 7<sup>th</sup> July 2010. The reduction of the ground surface was on two levels, the lowest at the north western end of the site. The higher level being to the south-east of the converted barn, where there was a bank on a north-eastern to south-western alignment (**Plate 3**) which formed the division between the two levels. The north-eastern lower part of the reduction measured 24m south-west to north-east by 49m north-west to south-east, the higher south-eastern end measured 24m south-west to north-east and 55m north-west to south-east. Both of these areas were reduced by up to 400mm.

- 5.2** It is thought that the site had been landscaped before this latest work began with the bank to the south-west of the converted barn suggesting that approximately 400mm to 500mm of ground had been reduced at the north-western end of the site. It is therefore likely that any archaeological features or deposits will have been removed by this earlier work.

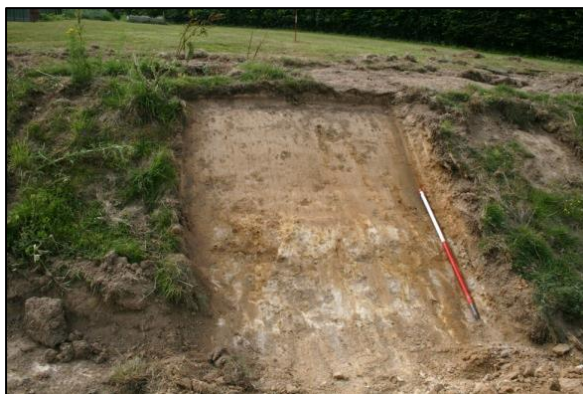
**Plate 4:** Section cut into Bank dividing the two areas of the reduction

- 3.4** There were three deposits apparent in the reductions of these areas. Context 2 was the topsoil which was a mid brown sandy loam with a loose consistence. This deposit was up to 260mm in depth and had inclusions of sandstone pieces up to 40mm (<1%), sub-angular pieces of flint up to 40mm (<1%) and light rooting. No artefacts were recovered from this deposit. Below Context 2 was Context 3 which was only apparent in the upper south-eastern end of the reduction, and was brownish orange silty clay with a firm consistence. This deposit was up to 400mm deep as seen in the bank dividing the two areas of reduction (**Plate 4**), and had inclusions of sandstone pieces up to 70mm (<1%) and sub angular pieces of flint up to 80mm (1%). Artefacts recovered from this deposit comprised pottery, ceramic building material and glass.

- 3.5** Below Context **3** in the south-eastern end of the reduction and directly below Context **2** in the north-western end was Context **4** which was the assumed natural silty clay. This deposit was buff orange colour with patches of light grey silty clay with a firm consistence. This deposit was not fully excavated and had inclusions of sandstone pieces up to 40mm (<1%). No artefacts were recovered from this deposit.

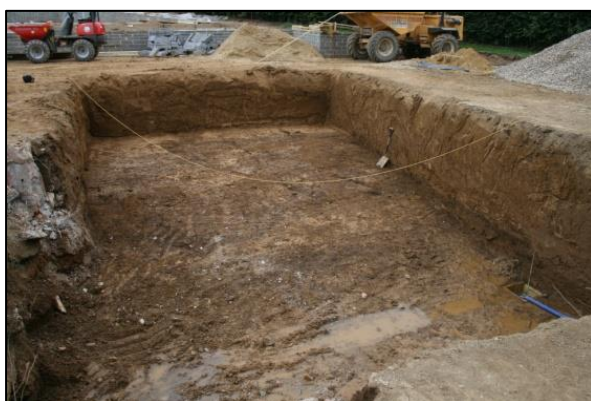
**Plate 5:** Trench for the new Swimming Pool

- 3.6** On the 18<sup>th</sup> August a watching brief was maintained on the excavation of a new swimming pool. This measured 11.5m north-west to south-east by 5.2m north-east to south-west. The trench for the pool was 1.7m in depth (**Plate 5**). The new pool occupied a position to the north-west of the original pool which it slightly clipped in the northern end of the eastern side of the trench. At the time of this visit to the site the old pool had been broken up and piled up to the north of the excavations, and the flagstones around the edge had been removed.

- 3.7** In the excavation of the trench for the new swimming pool there was only one deposit apparent. Context **5** was the assumed natural and was apparent to the excavated depth of 1.7m. The deposit was orange-buff in colour with a few patches of grey (5%) and had a firm consistence. The deposit had inclusions of sandstone pieces up to 60mm (1%) and manganese panning at depth (<1%). This deposit was the same as Context **4** but had a more uniform colour. No artefacts were recovered from this deposit.

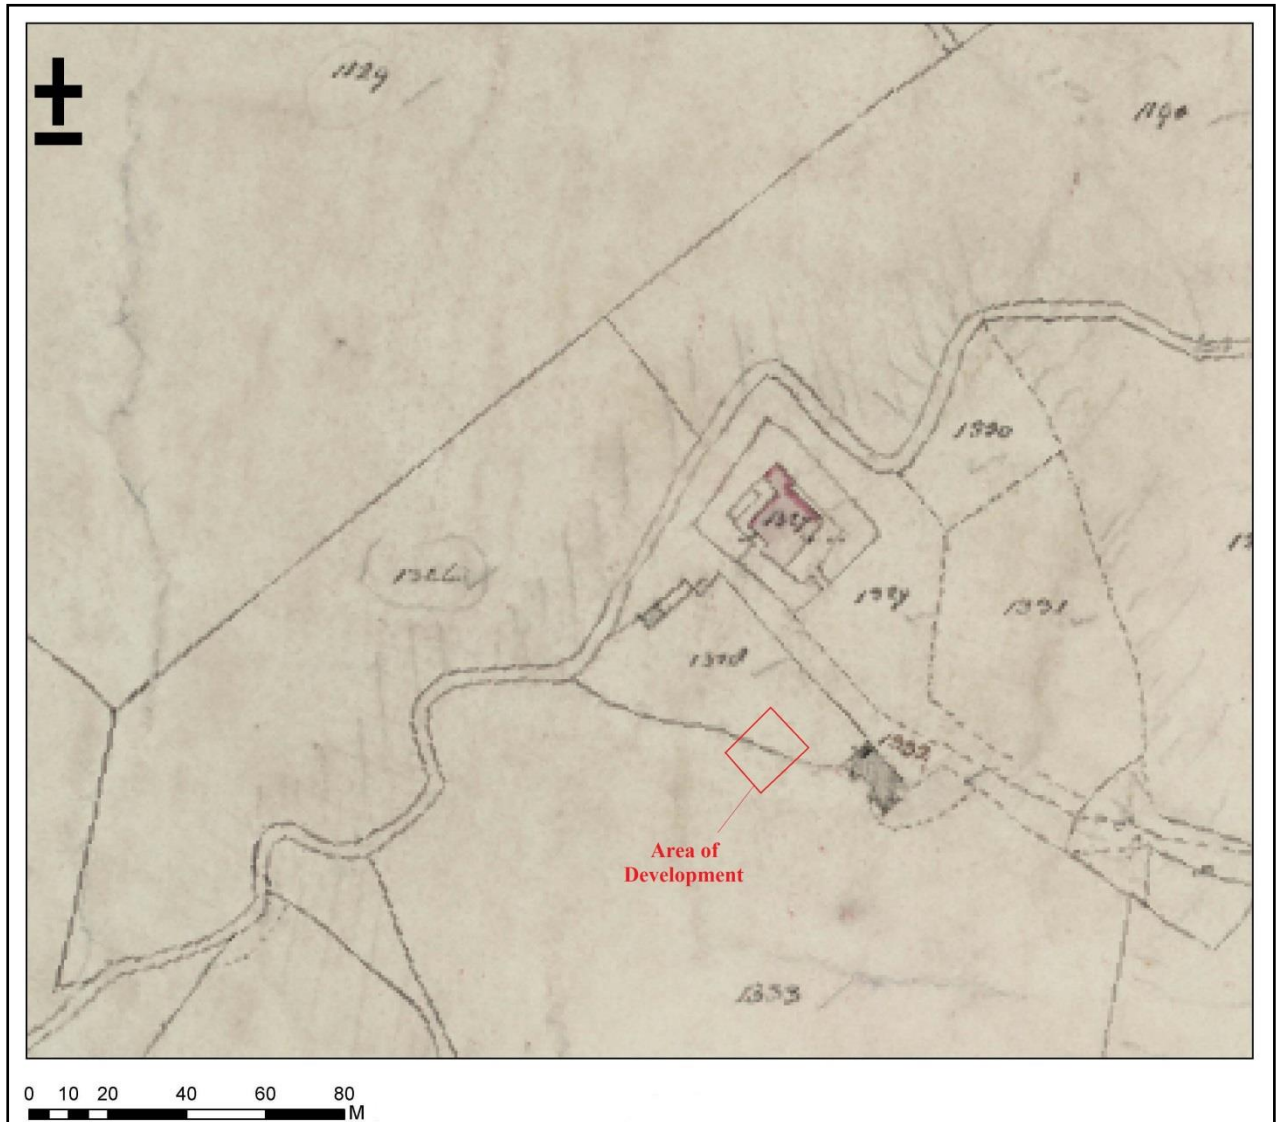
Fig. 3: Chailey Moat, Chailey: Tithe Map

- 2.6** The Chailey Tithe map of 1840<sup>7</sup> shows the house located within the moat, and two other buildings, outside the moat, to the west and south of the house (Fig. 3). The adjacent stream runs along the north-west side of the moat, and then turns sharply to follow the north-east side before heading northwards. The site of the swimming pool and garage appears to be open ground.
