**An Archaeological Watching Brief
at
1, Cricketfield Road, Seaford, East Sussex**

LW/09/0672

Project No. CBAS0227

October 2011

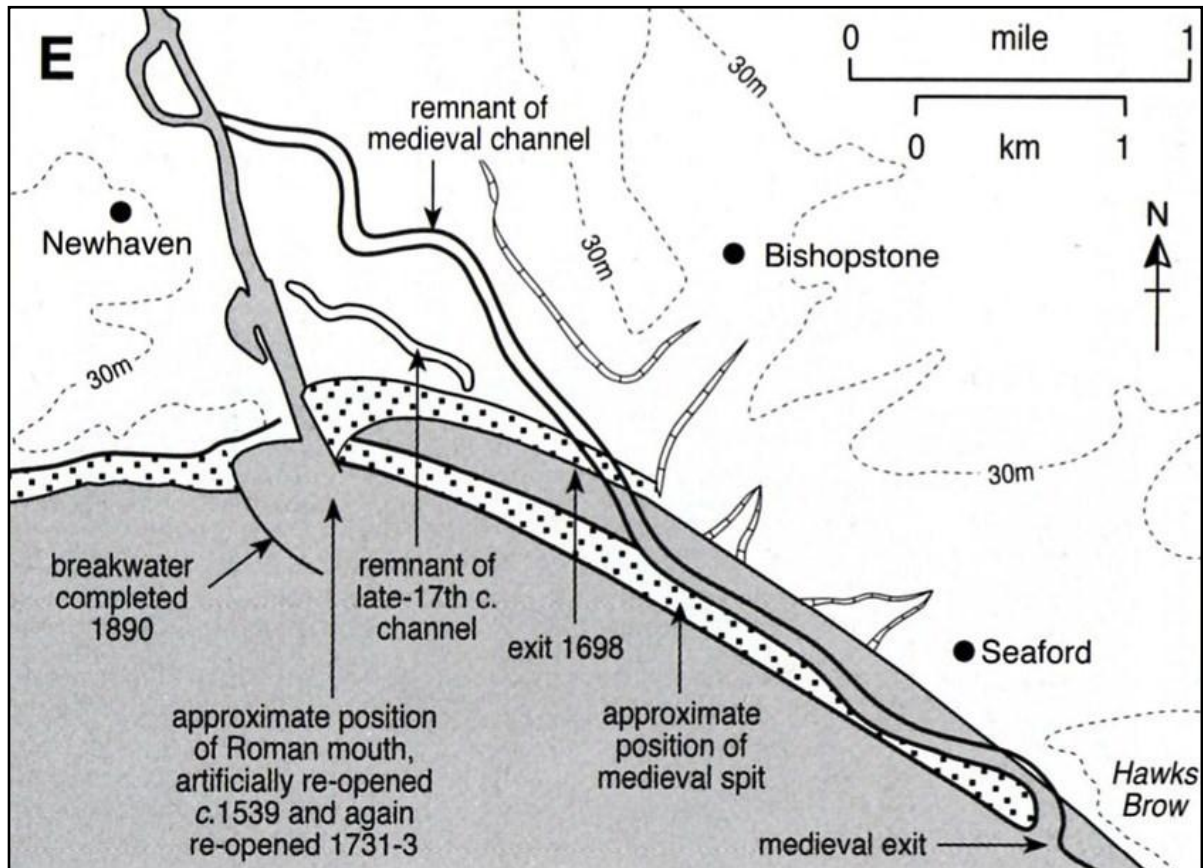
Fig. 3: 1 Cricketfield Road, Seaford: Map showing the changing coastline, and the course of the River Ouse
(Adapted from Woodcock 2003)

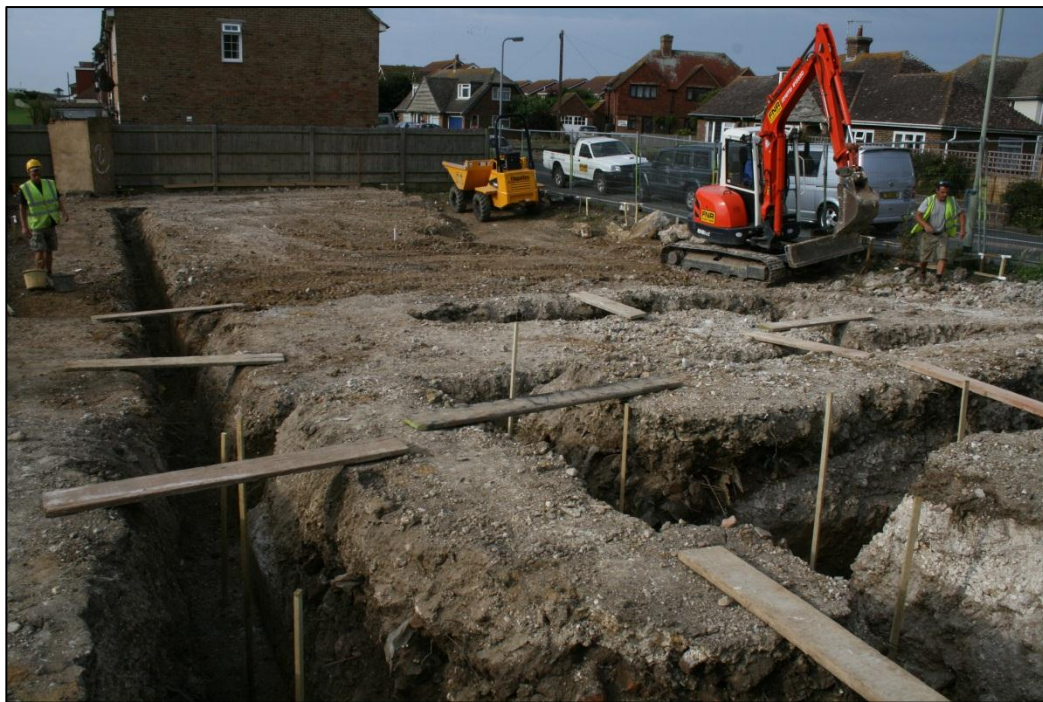
Fig. 7: 1 Cricketfield Road, Seaford: General view of site looking south

- 3.1** On arrival at the site on the 25th July 2011, the north end of the site had been cleared of all the rubble from the demolition of the house. The site had been levelled and three terraces created, with the highest being at the northern end of the site on Plot 5 (Fig. 0). The central platform had been constructed for the house to be built on Plot 4. At the southern end of the site was the lowest platform for Plots 2, 3 and 4. Both the platform at the north of the site and the central one had been built up by the importation of spoil from other sites owned by Mr Wiley.

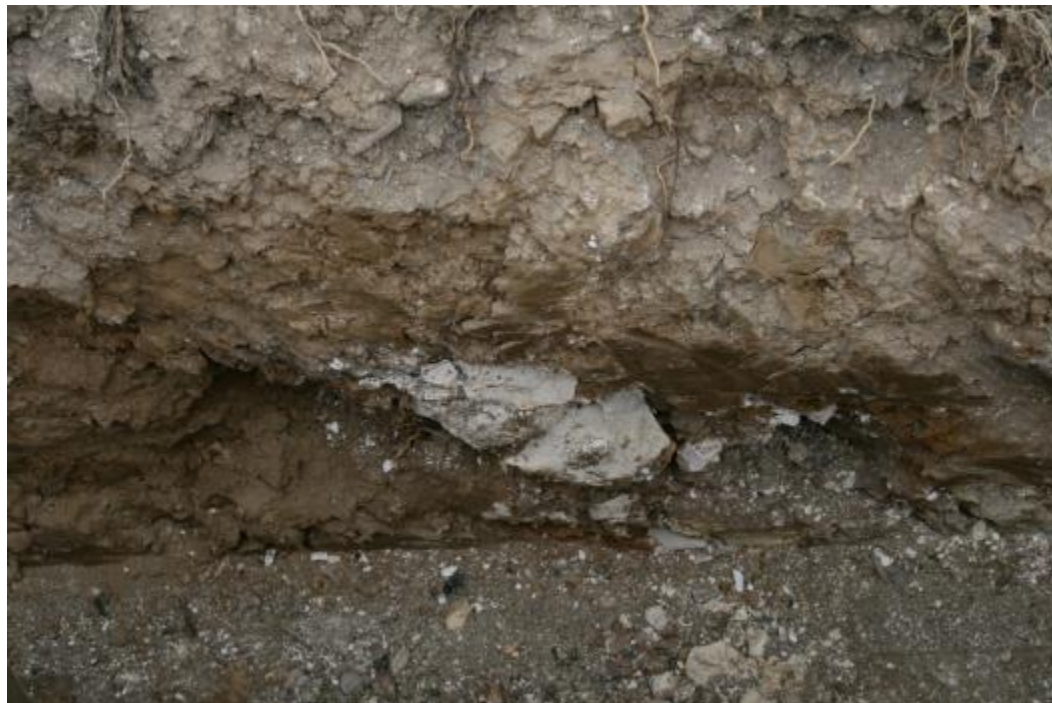
Fig. 8: 1 Cricketfield Road, Seaford: Context 106 in section

- 4.7** Context **106** was noted in the sections of the excavated footings from the south trench of Plot 5 through to the south footing trench of Plot 3. This feature was made up of band of chalk pieces running north to south, 2m to the west of the eastern footings trench. The chalk pieces measured up to 200mm, most pieces being smaller, with pieces of sandstone up to 120mm (<1%). The band of chalk had an irregular form, being 1.3m at its widest point. This feature was interpreted as a natural out crop of chalk pieces or the remains of a drain from the original house.

- 6.3** The only feature noted appear in the sections of the footings of the houses to be built on two terraces at the northern end of the site, and consisted of a band of chalk pieces running on a north south alignment (Context **106**). No artefacts were recovered in association with this feature, which prevented dating it. This was interpreted as the possible remains of a drain from the demolished house, and may have been the same feature (Context 23) as was encountered in Trench B during the evaluation.
