**Archaeological Watching Brief  
at  
Methersham Manor,  
Hobbs Lane,  
Beckley,  
TN31 6TX**

Project No. CBAS0991

by  
Dr Caroline Russell

January 2019

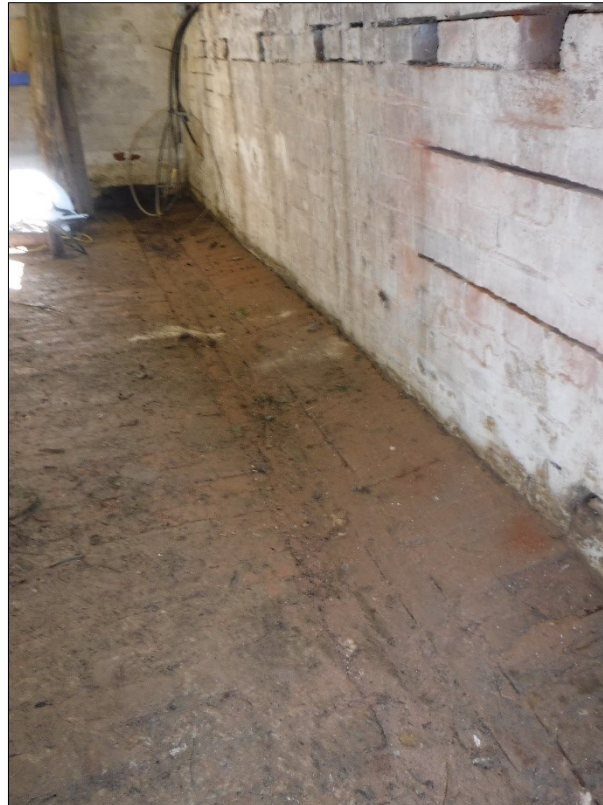
**Plate 1:** Gully running alongside the northeast wall

5.1 The cellar floor (Context **001**) was built of red bricks, measuring 230mm x 105mm x 65mm thick. The bricks were not frogged, nor were they laid with bonding material. A complete brick was sampled and dated to the 18th - 19th centuries. A shallow gully, 190mm wide, was incorporated into the brick floor alongside the northeast wall (Fig. 7).

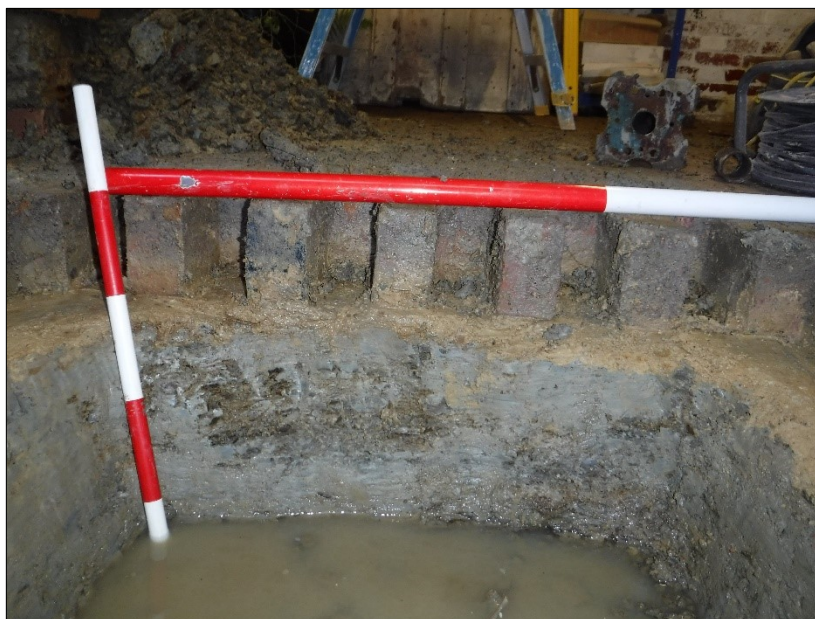
**Plate 2:** NE-facing section of Foundation Pit 1

5.3 Context **002** was also recorded in Foundation Pits 1, 2 and 4, directly below the brick floor (Context **001**). It had a depth of 25mm - 55mm and as in Foundation Pit 5, it overlay the firm mid orangey and greyish brown clay of the natural deposit (Context **003**). The natural contained relatively frequent angular stone inclusions (up to several 10mm<sup>3</sup>) and one or more lenses of dark orangey brown stone, up to 30mm thick, in most of the foundation pits. The bedding material of Context **002** did not extend fully across Foundation Pits 2 and 4, and was not present in Foundation Pit 3.

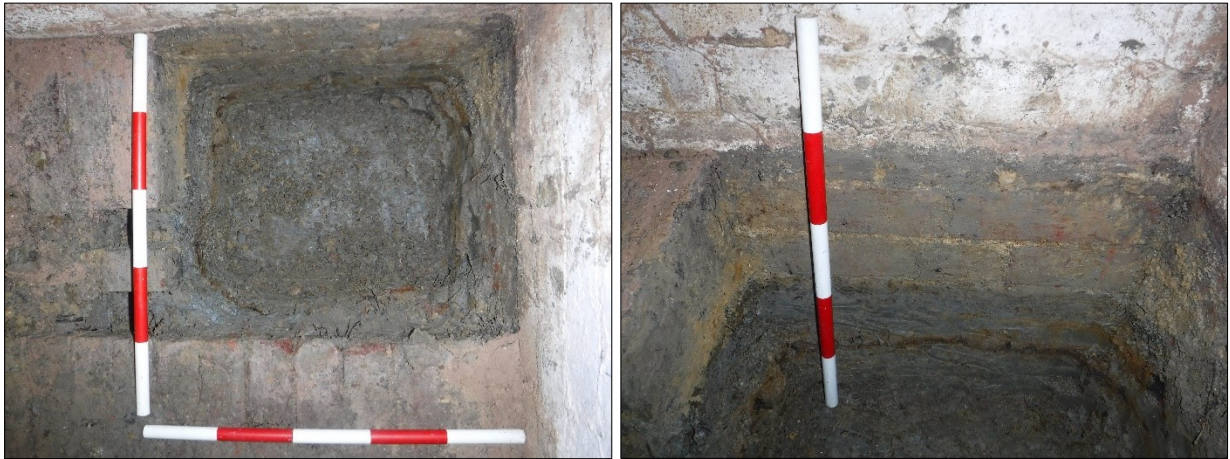
**Plate 3:** Foundation Pit 2 and its SW-facing section

- 5.6** No cut was observed for the northwest cellar wall. Just over two full courses of this wall (160mm) were exposed below the cellar floor (Context **001**) in Foundation Pit 2.

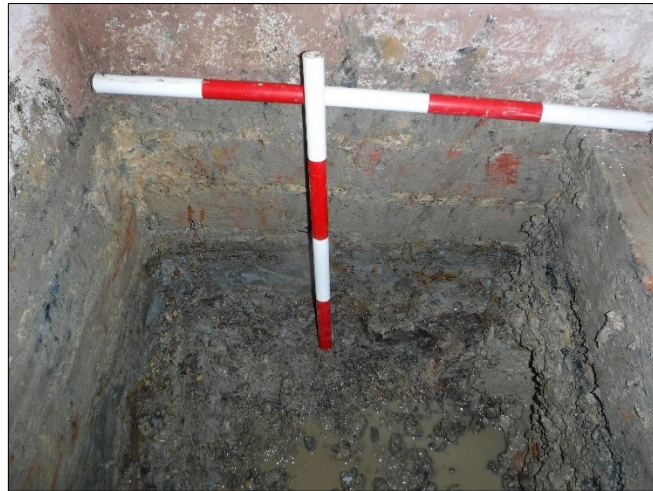
**Plate 4:** NE-facing section of Foundation Pit 3

5.2 In Foundation Pit 3, the bedding material for the brick floor (Context **001**) was a black, finely ground cinder-like material (Context **004**), 30mm - 40mm thick. The deposit also extended partly into the adjacent Foundation Pit 5, where it overlay a fine pale orangey and yellowy brown sand (Context **002**). This lower layer of bedding material was up to 50mm thick.

- 5.4** A cut (Context **006**) for the southeast cellar wall (Context **005**) was seen in Foundation Pit 5. It was 215mm wide up to the wall. The mixed backfill (Context **007**) was seen in Foundation Pit 3, opened up in the south corner of the cellar, against the southwest and southeast walls. The backfill in this foundation pit underlay the cinder-like bedding material (Context **004**) and had a depth of 240mm down to a natural deposit (Context **003**). Slightly over two full courses (200mm) of the southwest wall were exposed below the cellar floor (Context **001**).

- 5.5** The backfill (Context **007**) contained brick fragments and of the four samples taken (all from Foundation Pit 3), the only fresh fragment dates to the 18th - mid 19th centuries and may be taken to date the construction of the southeast wall of the cellar.

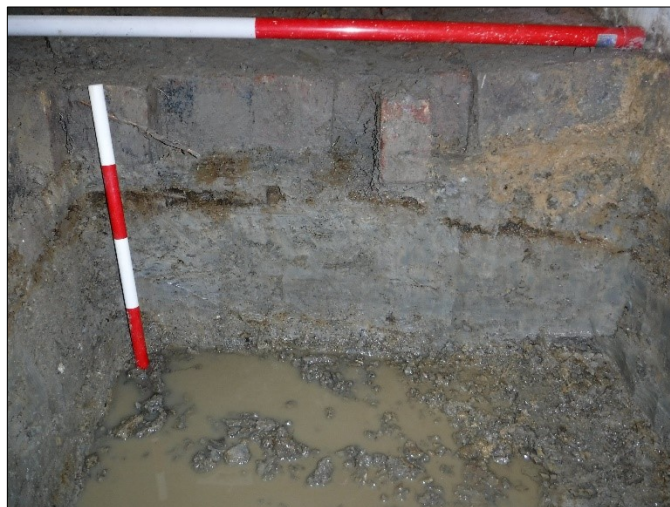
**Plate 5:** SE-facing section of Foundation Pit 4

- 5.7** The water table was reached in Foundation Pits 1 and 4, causing both to fill with water.
