**A Standing Building Survey
at Tower House, High Street,
Hurstpierpoint, West Sussex.**

**Project Number CBAS 0273
TQ 2820 1638**

by
Keith Butler PIfA

March 2012

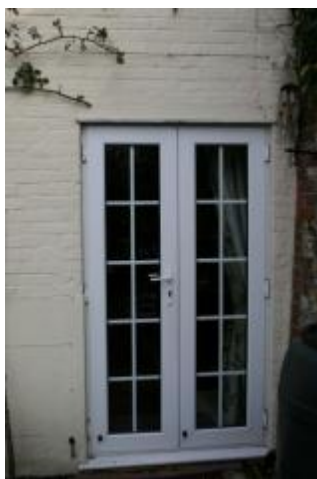
All of the casement windows on this elevation are of UVPC construction, with the double doors at the eastern end and western to the east of the arched entrance also being of the same construction. The only scar noted on the brickwork was around the top part of the eastern door, which possible replaced an earlier window (**Plate 1**). Projecting from the centre of this elevation is the only chimney stack of the property (**Plate 2**). This is of un-painted red stock bricks, which are interspersed with random vitrified headers. The brickwork surrounding a decorative panel of flint cobbles. The cobbles are bonded with a greyish brown mortar. There is a single tall chimney pot on the stack.

Plate 1 Tower House Scar in brickwork.

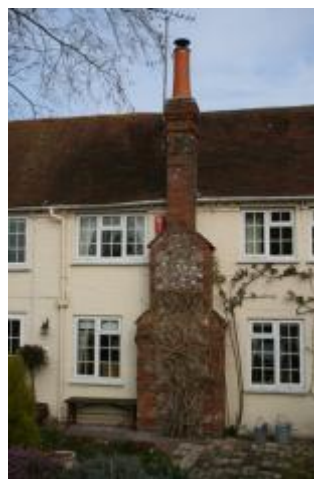
Plate 2 Tower House Chimney Stack

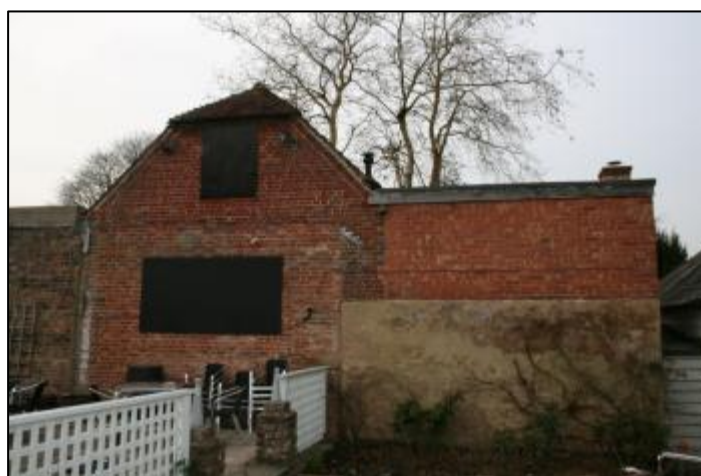
The eastern elevation can only be seen from the beer garden of The New Inn. The brickwork of the top of the wall of this elevation is laid in English bond. In the rest of the wall the red stock bricks have been laid in Flemish bond. Randomly interspersed in both areas of brickwork are vitrified headers. At the top of the wall in the centre there is a boarded over window (noted in the eastern end of the roof space). There is a small length of lead flashing on the northern end of this wall, and also an area of less weathered bricks (**Plate 3**), which suggests there was another building located against this wall (see 3rd Edition OS map – Fig. 6). However, this area is smaller than the change to Flemish bond in the brickwork, suggesting that this may have been an earlier repair or alteration.

Plate 3 Tower House Eastern Elevation

- 6.3** The eastern elevation has been extensively repaired, which has left no evidence for any features, for example openings for doors or windows. The exception is the blocked in window in the upper part of this elevation, which by its construction would appear to be of more a recent date.

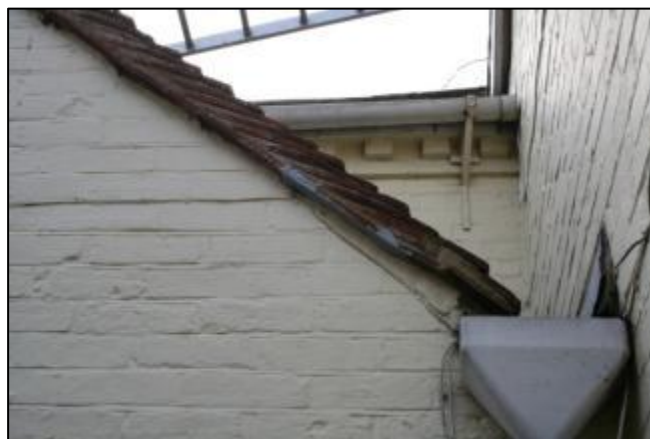
The exterior north wall original building is now mainly encased within the house, with only a small area visible between the two later extensions (**Plate 4**). The rest of this elevation being made up of the northern walls of the two later extensions, which are constructed of stock red bricks, laid in stretcher bond.

Plate 4 Tower House North wall of original house

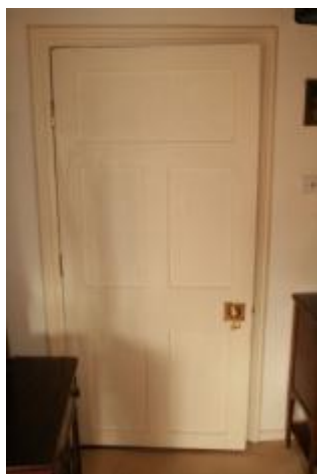
Room **G2** is the only room on the ground floor within the original building. The room is rectangular in plan, measuring 4.45m north to south by 7.95m east to west. There are two entrance doorways in the north wall from **G1** and **G4**. This wall is the original northern exterior wall with a width of 400mm. Both of these are fitted with different designs of door. The one at the western end of the north wall is of wooden construction, and could possible date to the Georgian period, although it is not the more usual six-panel type, having only five panels, the dimensions of the door would suggest an 18th or early 19th century date (**Plate 5**). The design of the door has same-sized pairs of panels at the bottom and in the middle with the top being of a lengthways single rectangular panel. The door at the eastern end of the north wall is a modern wooden framed door with three columns of five glazed panels.

Plate 5 Tower House Door **G2**

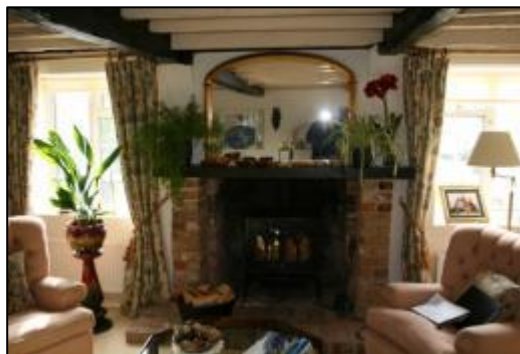
Plate 6 Tower House Fireplace **G2**

All the openings, comprising two doors and two windows, in the southern wall are of modern UVPC construction. In the centre of this wall is a brick built fire place, the bricks in the recess of the fire appear to be of an older type than those of those of the two jambs which support a timber mantel shelf (**Plate 6**). The eastern wall of the room is of bare brick work with a decorative arch feature at the eastern wall. The brickwork appears to be a later feature, using modern bricks. The brickwork of the decorative arch on the eastern wall and that used in the construction of the fireplace are of the same type suggesting they are contemporary with each other.

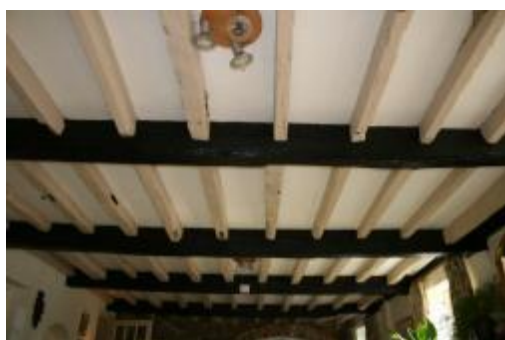
The ceiling is constructed from re-used timbers, evidenced by empty and filled-in mortices apparent on their soffits, north and south faces (**Plate 7**). Some of these timbers also appear to have been cut vertically to reduce their width. On one of the joists at the western end of the ceiling, which appears to of been reduced in width, has a row of five circular empty auger holes possibly intended for staves (**Plate 8**). The floor above is supported by five girders which are on a north to south alignment, measuring 220mm by 170mm in section. The girder at the western end of the ceiling has been truncated at its southern end. The joists are only loosely mortised into the girders.

Plate 7 Tower House Ceiling in **G2**

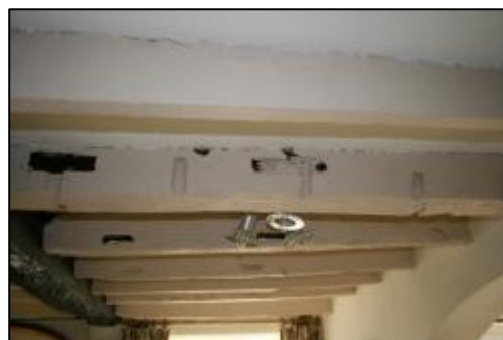
Plate 8 Tower House Possible stave holes **G2**

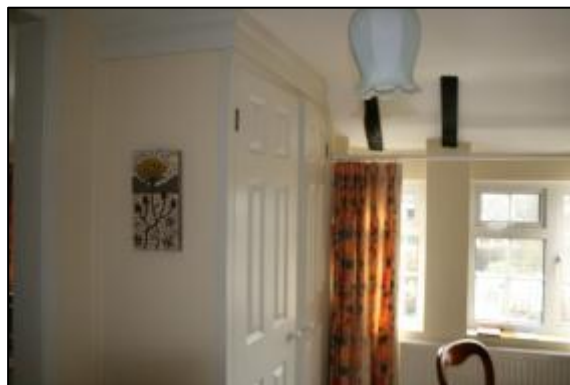
F3 was originally a single room by is now divided by a partition stud wall, 2.52m in from the western wall, with the eastern side of the room currently being used as a study. The western side of the room is a bedroom. Overall the room measured 3.6m north to south by 4.84m east to west, with access to both parts of the room by a single entrance from **F4** in the northern wall of the western room. Both of the doors were modern four-panelled type. This room is located at the eastern end of the original building. The wall and the ceiling are plastered, with the ceiling sloping at the sloping at the southern side. The walls had a low modern skirting board at their base. The ends of three rafters were apparent in the sloping part of the ceiling, one in the eastern room and two in the western (**Plate 9**). The hatch to the roof space was located in the ceiling adjacent to the eastern wall, in the eastern part of the room. In the north-eastern corner of the eastern room there was a modern four-panelled door to the cupboard housing the boiler.

Plate 9 Tower House Bottom of rafters in **F3**

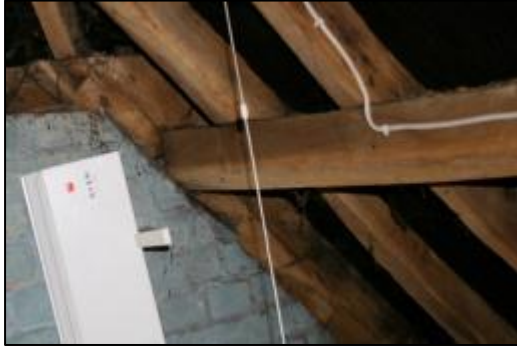
The roof over the original building is constructed from both reused timbers, evidenced by many empty joint sockets, and timbers of a more recent date. The roof is of paired rafters with stagger clasped purlins, with a central ridge plate at the apex of the rafters. The corners of the purlins are chamfered. The roof over the original building has four pairs of principal rafters. Both of the pairs of principal rafters at the eastern and western ends have been cut suggesting that the roof was possibly originally gabled at both ends (**Plate 10**), although the jack rafters of the now enclosed west end of the roof still have the jack rafters of the hipped end *in-situ*.

Plate 10 Tower House Cut principal rafter
East End

- 6.4** The roof of the building appears to have been modified a number of times, and uses both replacement and reused timbers. The truncated principal rafters at both the eastern and western end of the roof over the original building suggest that the roof was originally gabled at both ends. The gables were then replaced with hipped ends. At the time of the construction of the 'L' shaped extension on the western and northern side of the house the roof was re-tiled as evidenced by the use of modern roofing felt.

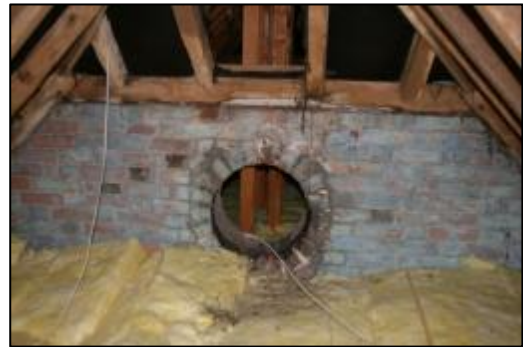
The middle two principal rafters both have low set collars which are mortised and pegged. The original upper part of the western wall of the building is still in place, and is constructed of bricks laid in Flemish bond. A number of the headers are vitrified. In the centre of this wall there is a circular opening, this was possibly a window but there is no evidence of a frame to hold the glazing (**Plate 11**).

Plate 11 Tower House Circular opening

- 6.2** Encapsulated in the roof space, the upper part of the western wall has been preserved; this is also of bricks laid in Flemish bond. In the centre of this part of the wall there is a circular opening which does not appear to have ever been glazed. This could have lit the upper floor of the building, or more likely hints that the building was originally open to the roof. The reused timbers used in the ceiling of Room G2 would also suggest that this ceiling (and therefore the first floor) was a later addition, and inserted when the building was converted into a dwelling.

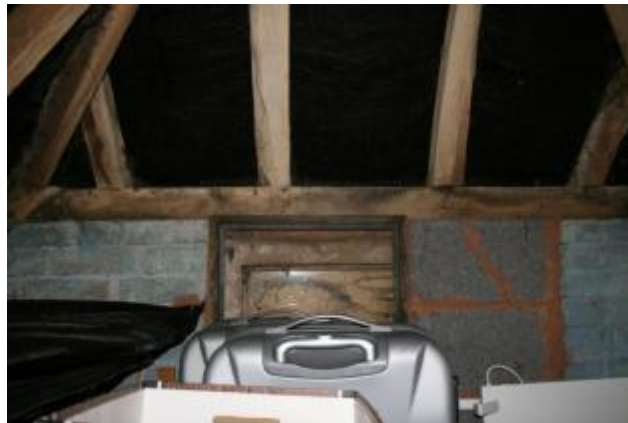
The upper part of the eastern wall has been greatly modified over the course of time, and is now constructed of mixture of bricks and breeze blocks. In the centre of this wall there is a window of panes of glass in a wooden frame. Behind this there is a second window which is glazed and has been boarded over as noted on the exterior on this wall (**Plate 12**). There is also evidence from the use of modern roofing felt that the roof has been repaired in recent times.

Plate 12 Tower House Windows in East Wall

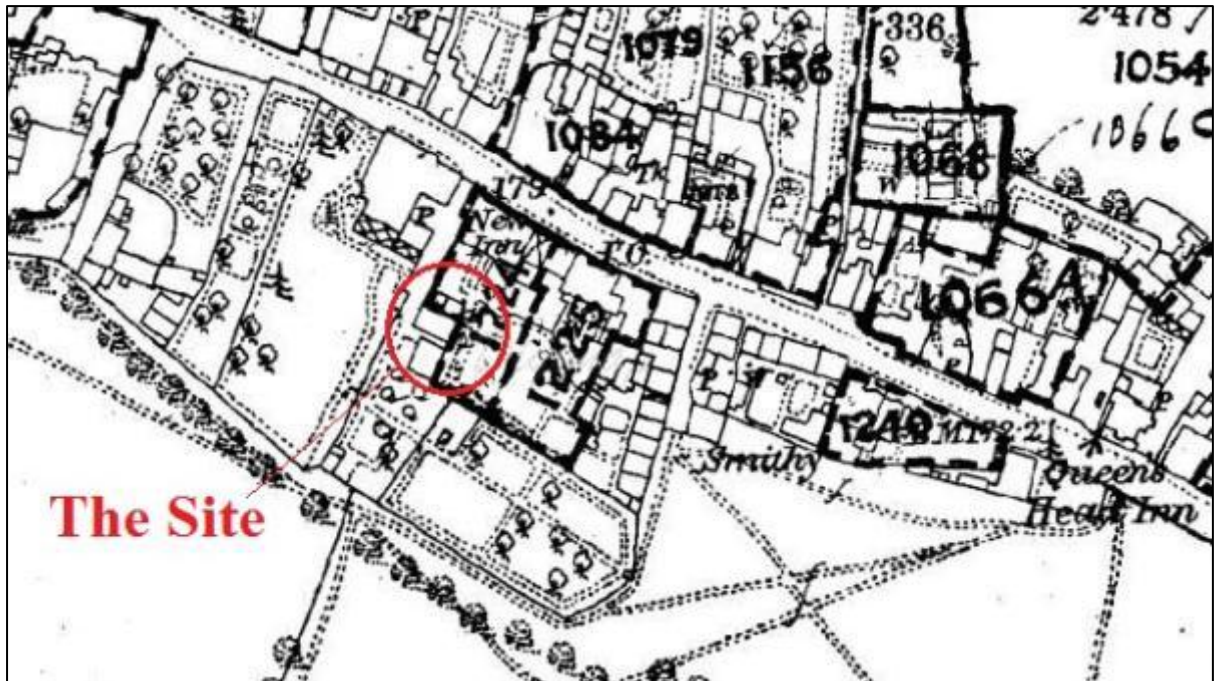
- 2.10** The 1st Edition OS map of 1875 (Fig. 5) shows the building to the rear of the new Inn. It is unchanged from the Tithe map, although another building now stands immediately to its south instead of the pond. By the 3rd Edition OS map of 1910, other buildings have been added to the east and adjoining Tower House, and between Tower house and the New Inn (Fig. 6). The situation is unchanged on the 4th Edition OS map of 1937.

Fig. 5: Tower House, Hurstpierpoint: 1st Edition OS Map (1875)
