**An Archaeological Watching Brief
at the
Wish Tower Café,
Eastbourne,
East Sussex.**

(EB/2012/0020)

CBAS0274

January 2013

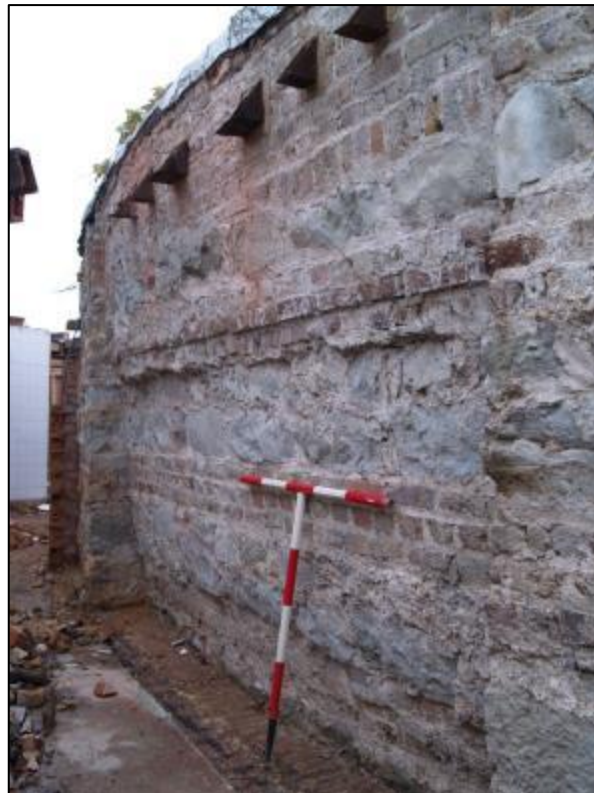
Plate 1: Revealed Counter Scarp wall

- 4.2** The Counter Scarp Wall surrounding Tower 73 was largely exposed during this visit so a photographic record was taken in sections from West to East (e.g. Plate 1). The demolition rubble was examined for any significant archaeological features/artefacts but all was contemporary with the former Café. The remaining building was surveyed for any exposed features, particularly to the west of the building where the floor slab was lower and where the No.2 Gun of the Second World War Battery would have been sited, although nothing was noted.

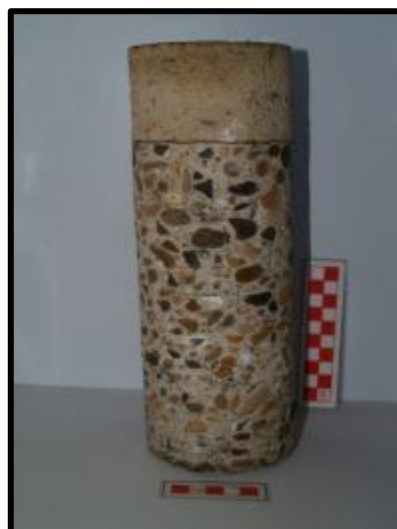
Plate 2: Core sample
taken from the
Suspended Concrete
Floor. 4th July 2012

- 4.4 The suspended floor is 360mm in depth, the lower 290mm consisting of a grey concrete with 50 – 60% inclusions of flint pebbles up to 20mm in size; no reinforcing was visible. The upper part of the floor slab is of a light-brown/buff coloured cement floor scree with no inclusions (See Plate 2).

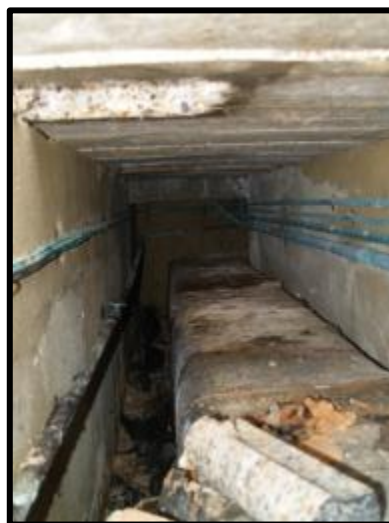
Plate 3: View east along the exposed services void showing trunking cornering to the south.

- 4.6** The visible southern extent of the void has a similar supporting beam between the floor slab and the foundation slab so inspection of the area underneath the suspended floor slab was restricted. Eastwards along the void, the trunking turns south against a further concrete beam (Plate 3). An attempt to lift the adjacent manhole cover, to further investigate this was unsuccessful as it was welded closed.

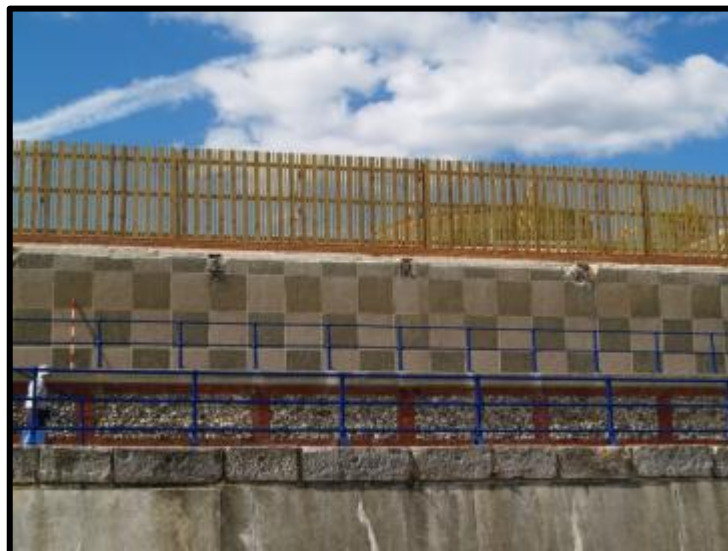
Plate 4: The Cantilever Balcony has been removed exposing the southern edge of the concrete slab and ends of its supporting RSJ's.

4.7 The cantilever Balcony, that originally over hung the Promenade was removed exposing the southern face of the concrete slab in section and possibly any indication of any existing archaeology, the supporting RSJ's being cut flush with the Promenade Wall and left exposed (Plate 4). The Café had now been completely demolished and all debris removed from the site, inspection still showed no evidence of any surviving archaeology.

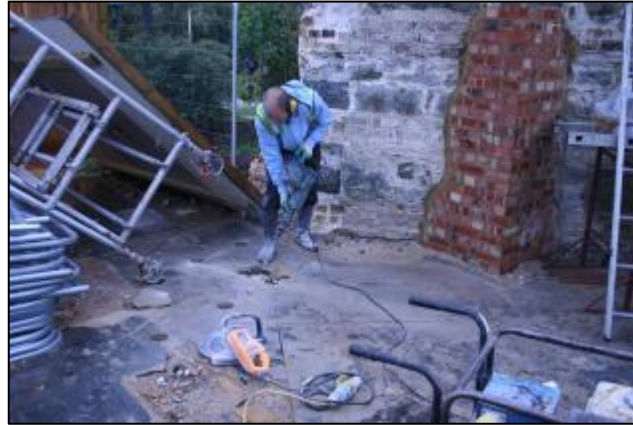
Plate 5: Location of Test Pit 24th September

- 4.10** A Test Pit, 700mm east to west, by 600mm north to south was excavated through the concrete at a point 400mm south of the Counter Scarp Wall (Fig.12 and Plate 5), for proposed foundations for a new buttress. Initial excavation, through the concrete was by drilling which showed that the floor slab of the restaurant was 250mm deep at this point Context **100**. This context was of a very firm, mid grey concrete with 5% inclusion of pebbles.

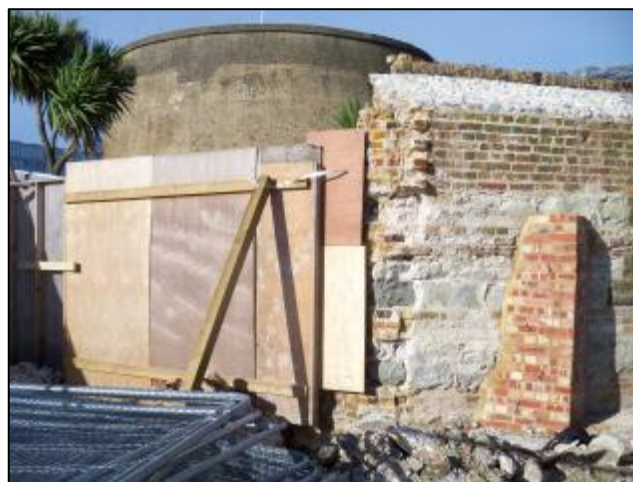
Plate 6: Location of Test Pit 4th October

- 4.13** A Test Pit was dug, prior to the arrival of CBAS on site, 0.62m west of the existing triangular buttress in the Counter Scarp Wall (Fig. 12 and Plate 6); this was to determine the depth of foundations of the Counter Scarp Wall surrounding Tower 73, before a supporting buttress was built, as the earlier test pit had not been of sufficient depth. Fig. 4 shows the plan of this pit. This test pit revealed three distinct Stratigraphic formations.

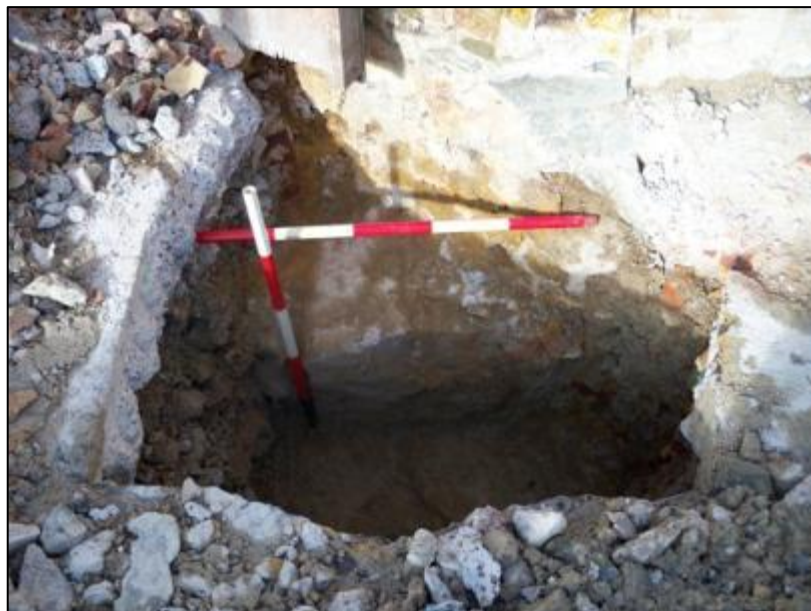
Plate 7: South facing section showing Counter Scarp Wall foundation

- 4.15** Directly beneath this was a ledge of a Greensand stone and mortar wall foundation layer, Context **104**, forming the foundation of the Counter Scarp Wall. The bonding mortar was pale off-white in colour with inclusions of flint, under 0.51cm³ in size, with chalk and charcoal flecks. This foundation was exposed 0.56m below the ground surface, the original depth of the pit may have exposed the limit of these foundations at one end, but this local sondage had been backfilled before CBAS arrived on site. The foundation continued down beyond the limit of excavation so it was not possible to determine its true extent (Plate 7).

- 4.16** The excavation had removed a red brick wall which appeared to have run up to and over the foundation ledge from east to west, evidence of this walling was seen at the opposite end, particularly where the wall had been sliced through, the date of this wall is uncertain.

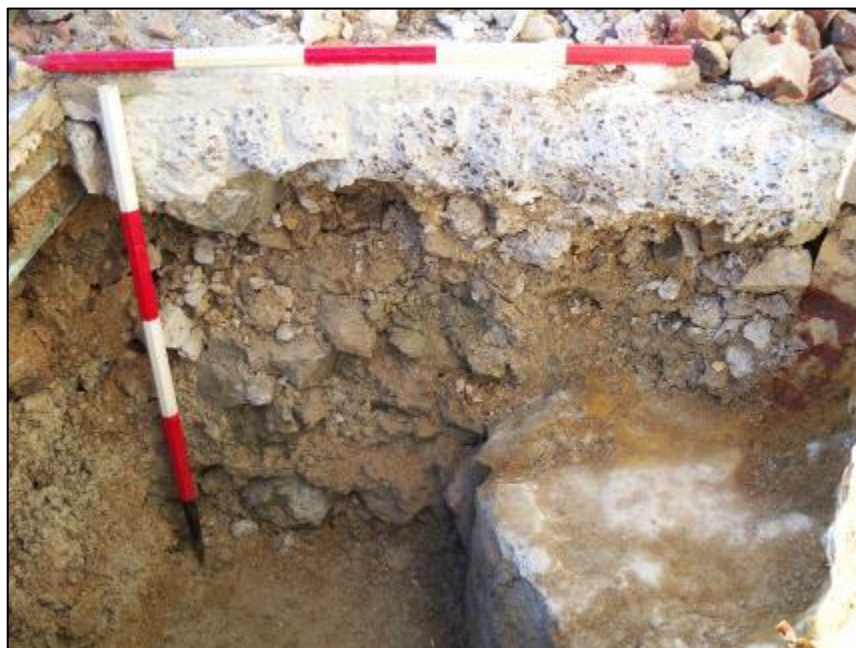
Plate 8. East facing section of the Test Pit recorded on the 4th October 2012

4.17 Stratigraphy 2 – This Stratigraphy formed the East Facing Section of the Test Pit and consisted of an upper Context **105** of two courses of tile, 7cm in depth over a layer of concrete (Context **106**) of 190 – 200mm thick. This concrete sat on Context **107** of Grey Clay with inclusions of Greensand Stone fragments and grey, gritty gravel 0.76m in depth; the context appeared similar to Context **110**, found in Stratigraphy 3, See below, but contained noticeably more Greensand Stone fragments (Plate 8).

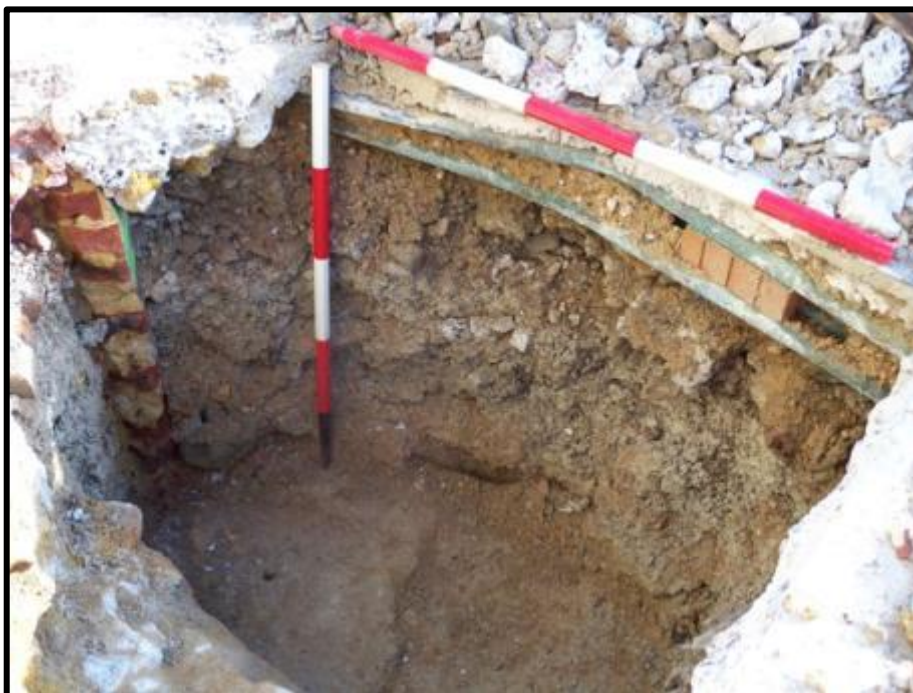
Plate 9. North Facing Section of Test Pit recorded on the 4th October 2012 showing Stratigraphy 3.

4.19 Underlying this there was revealed whitish/grey clay (Context **110**) which contained greensand and brick fragments and extended for an overall depth of 0.63m below Context **109**. At the base of this deposit a rusted pipe ran east to west across the Test Pit, its purpose was not clear. The brick and sandstone fragments along with rusted pipe and also that this context lies on top of the Counter Scarp Wall foundation indicates that it is made ground. The base of this exposed stratigraphic sequence was formed by Context **111**. This consisted of a whitish/brown mortar with occasional charcoal and small orangey sandy flecks with flints of less than 1cm³ in size. This context was at least 70mm in depth to the limit of excavation. A sondage had been excavated through this layer at one end of the trench, which could have determined its absolute depth but had been backfilled, with Context **108**, prior to CBAS being on site. This layer appeared to be a foundation of some sort, but to what was unclear.

- 4.20** Several features were exposed in this test pit which are worthy of special attention. At the base of the Test Pit a foundation layer, Context **111**, which initially appeared to be a floor surface, was exposed. See Plate 9. This had already been dug into at the eastern end and backfilled (Forming the Sondage mentioned above.) From the remaining sondage it could be seen that this layer was at least 70mm in depth to the limit of the excavation and consisted of a whitish/brown mortar with occasional charcoal flecks, small orangey sandy flecks and flints of under 1.0cm³ in size. This layer continued into the surrounding sections and up to a ledge against the South Facing Section.

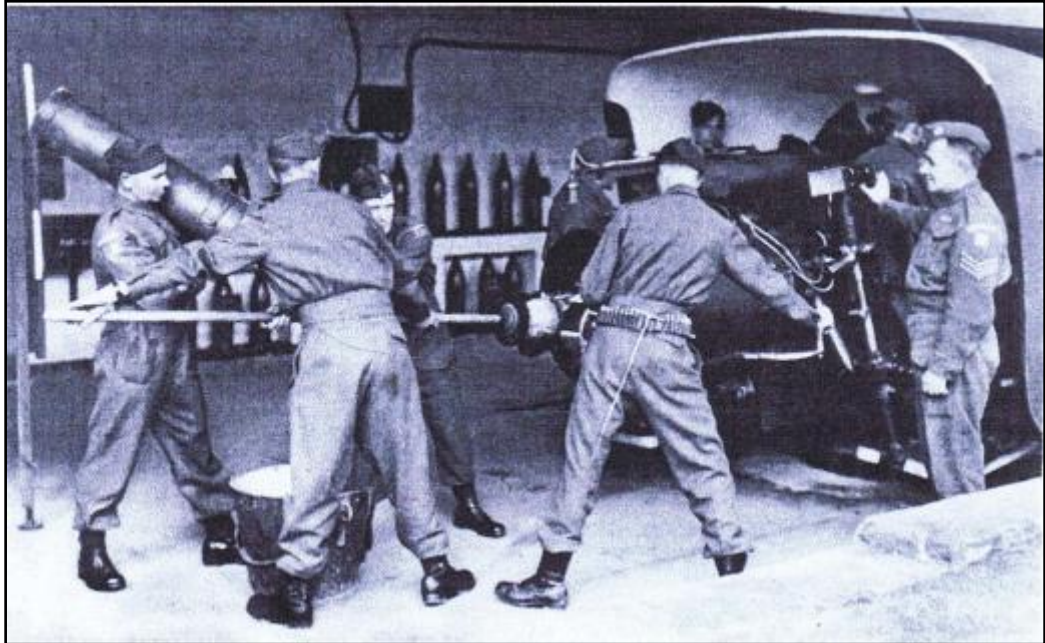
Fig. 7: Wish Tower Café, Eastbourne: Photograph of one of the guns in the ECB manned by Home Guard

- 2.3 During the Second World War the Wish Tower was requisitioned, and a two-storey concrete structure was added to the roof, and used as an observation post and magazine for an Emergency Coastal battery (Fig. 7). The two gun positions, containing First World War 6" guns, were mounted immediately in front of the Tower. The guns were initially manned by 342 Coast Battery, then later by 343 Coast battery, and finally by the Home Guard⁵.
