**An Archaeological Watching Brief  
at  
The Wish Tower,  
Eastbourne,  
East Sussex**

Project No. CBAS0919

January 2019

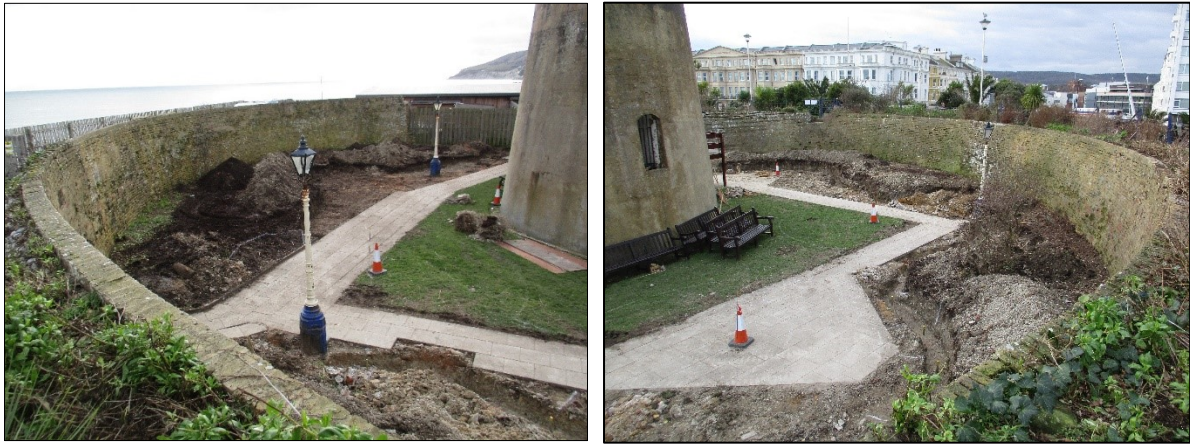
**Plates 1 & 2:** General views of the Site looking south and southwest, showing the groundworks

- 4.2** The archaeological monitoring consisted of watching the groundworks for new retaining walls and footpaths (Plates 1 and 2). Existing 20<sup>th</sup> century low walls and paving were removed during the watching brief, and the ground level was reduced by c.500mm in the existing flower beds (Plate 3). Footing trenches for the new walls were excavated to a depth of c.300mm below the current ground surface (Plate 4). A photographic record was made of the outer wall of the Martello Tower and the existing 19<sup>th</sup> century lampposts in the garden at the start of the watching brief.

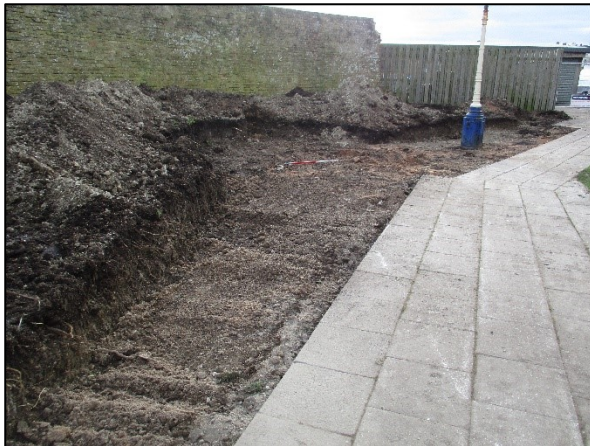
**Plate 3:** Ground reduction of flower beds on south side of the moat

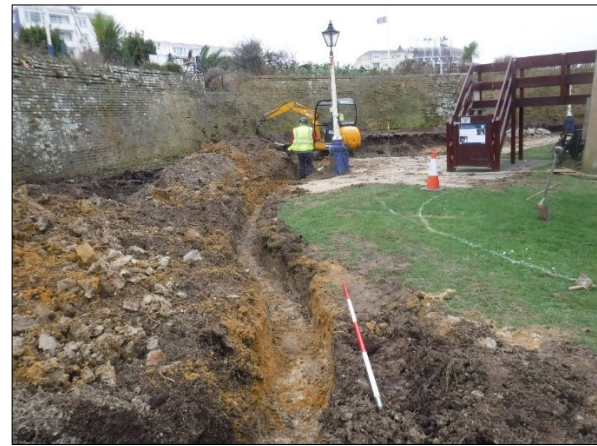
**Plate 4:** The Site looking northwest showing the footing trench for the new retaining wall

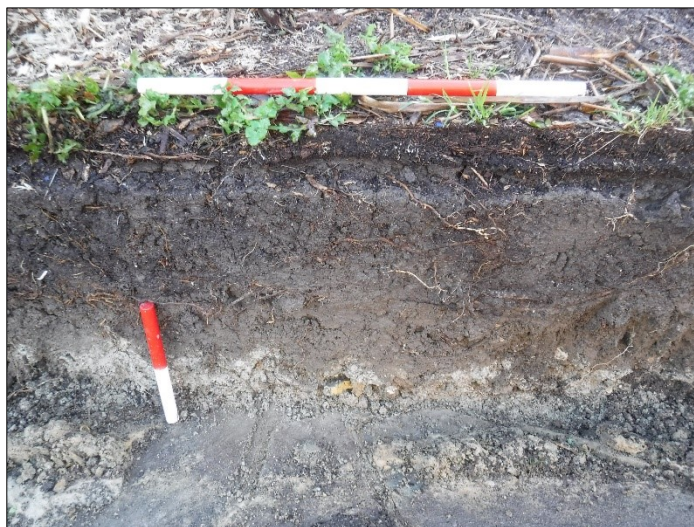
- 5.1 The first context revealed by the groundworks was the existing garden topsoil, Context **001** (Plate 5). This context consisted of friable mid-greyish brown silty clay and measured 100mm-200mm thick. Context **001** contained frequent fine-medium roots, and rare sub-angular chalk pieces up to 50mm by 50mm in size.

- 5.2 Context **001** immediately overlay the subsoil, Context **002**. Context **002** was made up of light yellowish-brown sandy clay, containing frequent fine roots and rare concrete fragments up to 50mm by 50mm. This context measured 200mm thick.

**Plate 5:** Northwest-facing section of footing trench showing Contexts **001** and **002**

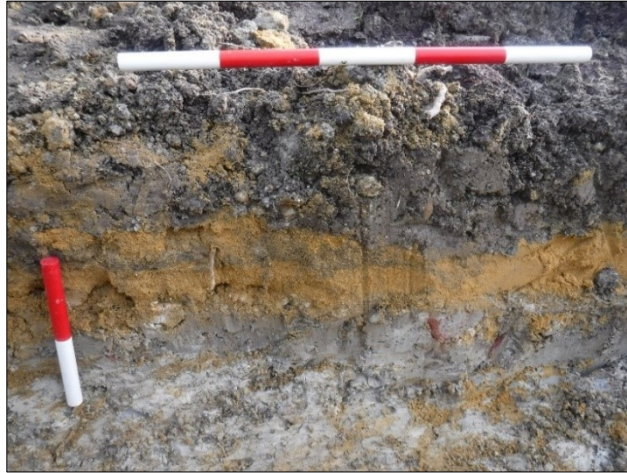
- 5.5 Context **005** was seen below Contexts **001**, **002** and **004** in different parts of the Site (Plate 6). Context **005** consisted of soft light grey clay, containing rare CBM and pottery fragments, shell, sandstone and flint pebbles. Context **005** measured 100mm thick to the base of the footing trench. This context was interpreted as redeposited natural clay.

**Plate 6:** Southwest-facing section of footing trench showing Contexts **001**, **004** and **005**

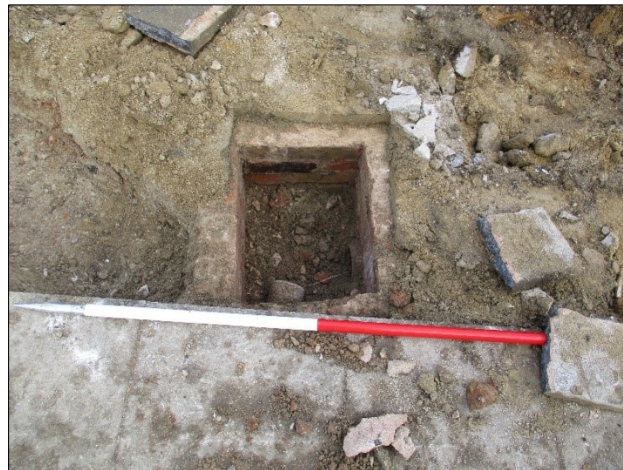
- 5.6** A brick built drain, Context **006**, was found in the northern part of the Site (Plate 7). Context **006** was rectangular in shape, and measured 300mm by 400mm in plan, and c.350mm deep. The drain was built from variable red and yellow bricks bonded with grey cement. A ceramic pipe was seen on the south side of the drain. Context **006** was interpreted as an early 20<sup>th</sup> century drain built when the tower moat was originally landscaped.

**Plate 7:** The brick built drain, Context **006**, looking east

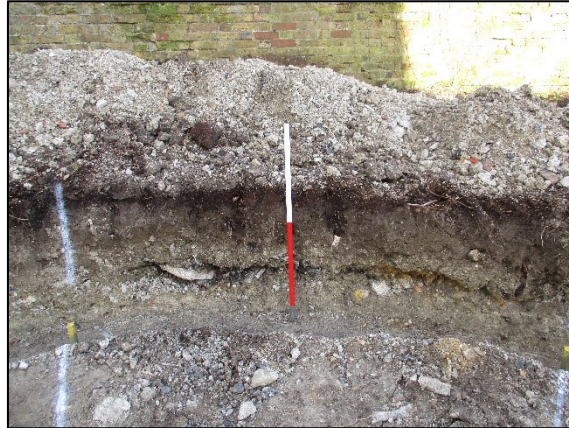
- 5.7** Context **007**, a demolition deposit, was seen in the footing trench in the southern part of the Site. Context **007** lay below Context **002** and above Context **005**. This deposit was made up of concrete rubble with 20<sup>th</sup> century CBM fragments, and measured 100mm-200mm thick (Plate 8).
- 5.8** No other archaeological features or deposits were encountered during this watching brief.

**Plate 8:** Demolition deposit **007** in section

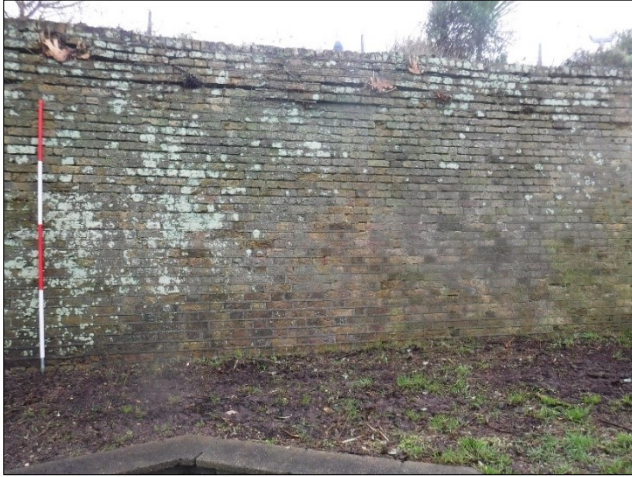
5.9.1 The counter scarp wall was photographed at the start of the watching brief, to record the entire surviving length of the wall on its inner side. Part of the wall on the south side was removed during the construction of the café in 1961. The rest of the wall remains intact, although it was noted that an area on the west side of the wall has been damaged by vegetation (Plate 9). The counter scarp wall was not directly impacted by the groundworks for the new memorial garden. The overlapping photographs are in Appendix 3 to this report and retained in the site archive.

**Plate 9:** The counter scarp wall looking west, showing the damage caused by plants

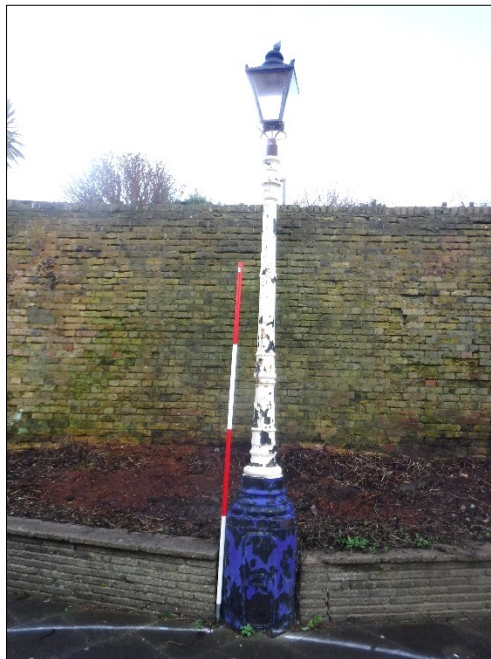
5.9.2 The 19<sup>th</sup> century lamp posts within the garden were also photographed at the start of the watching brief (e.g. Plates 11). The lamp posts were numbered 1-5, and their locations are shown on the site plan. In addition, a representative drawing was made of Lamp Post 2, which had the best preserved decoration (Fig. 6). The photographic record is retained in the project archive.

**Plate 11:** Lamp post 2 looking northwest

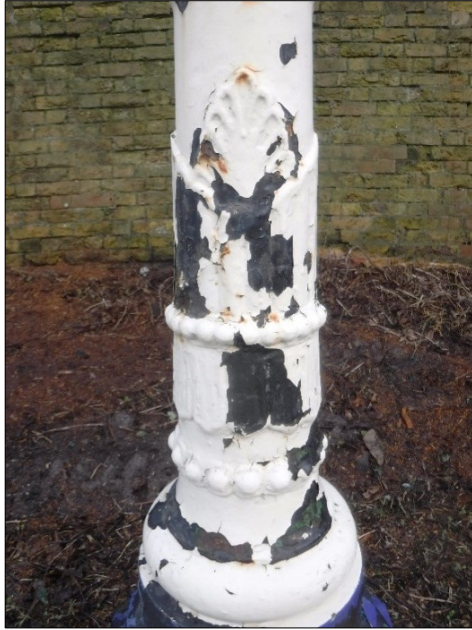
5.9.3 The lamp posts at the Wish Tower are made of cast iron, and were made between 1852 and 1899 by the Morris foundry company based in Eastbourne and Lewes<sup>6</sup>. Each lamp post has identical moulded decoration (Plate 12), and a square base which originally housed a gas meter (Plate 13). The doors in the bases of the lampposts have varying inscriptions referring to the Morris Company. Several stages of painting can be seen on the surface of the lamp posts, with the earliest phase being plain black. The original lanterns have been replaced with modern electric lamps, and all the lamps have lost their ladder arms.

**Plate 12:** Close up of decoration on Lamp post 2

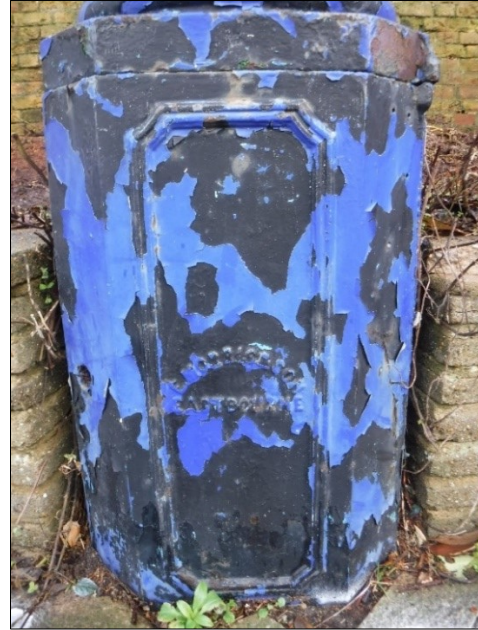
**Plate 13:** The base of Lamppost 2, with inscription reading "E. Morris & Son Eastbourne".

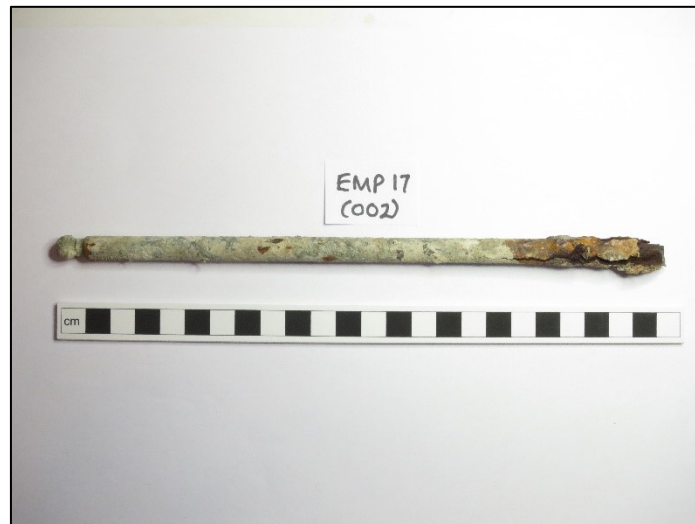
- 6.4.1 An unstratified length of iron rod with a round finial at one end and broken at the other was retrieved from Context **002**. It was 245mm in length, 9.6mm in diameter and weighed 130g (Plate 14). This is a horizontal ladder arm support from one of the cast iron Victorian lamp posts, each lamp post originally having two to support the gas lighter's ladder.

**Plate 14:** Lamp post ladder arm

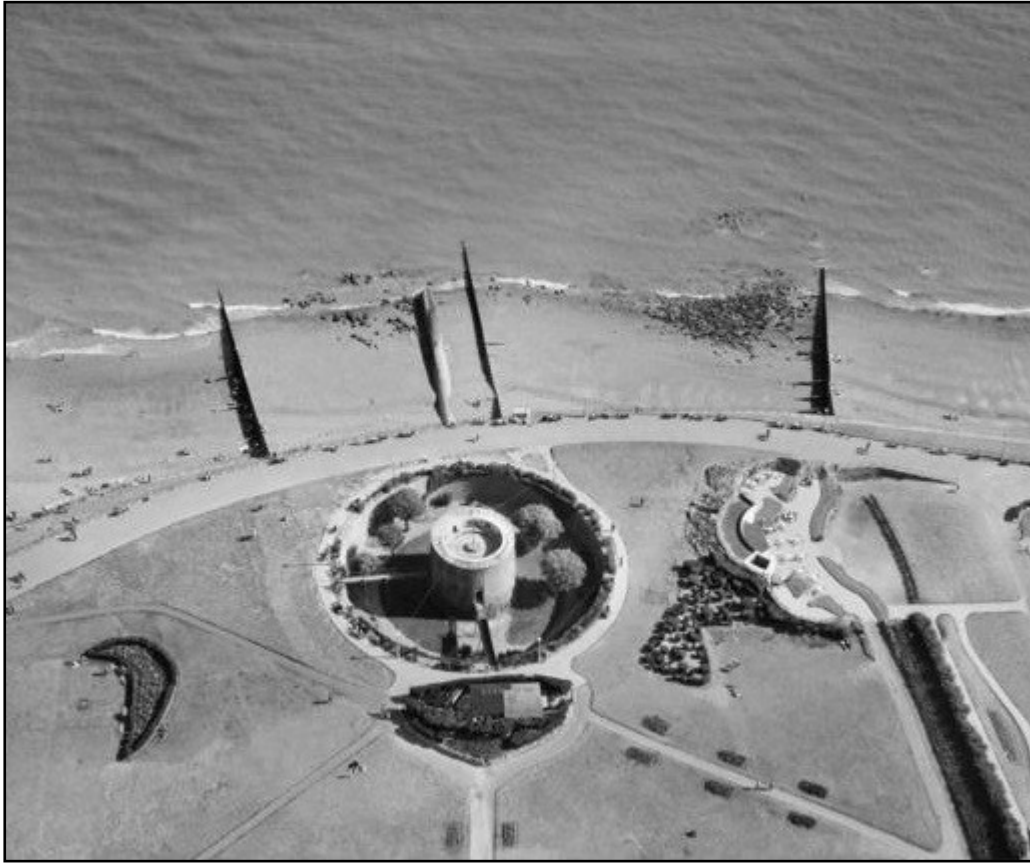
Fig. 3: Wish Tower, Eastbourne: 1949 Aerial Photograph  
Copyright: Historic England

- 7.4** The evidence found during the watching brief is consistent with the conclusions reached after the earlier evaluation excavation, which was that the deposits found seem to suggest a single event of made ground on the inside of the counter scarp wall. This suggests that the moat was kept clean until the 1960's when the cafe was constructed on the southwest side of the site and the moat was landscaped. The aerial photograph of 1949 (Fig. 3) shows that the moat had also been a garden prior to the 1960's.

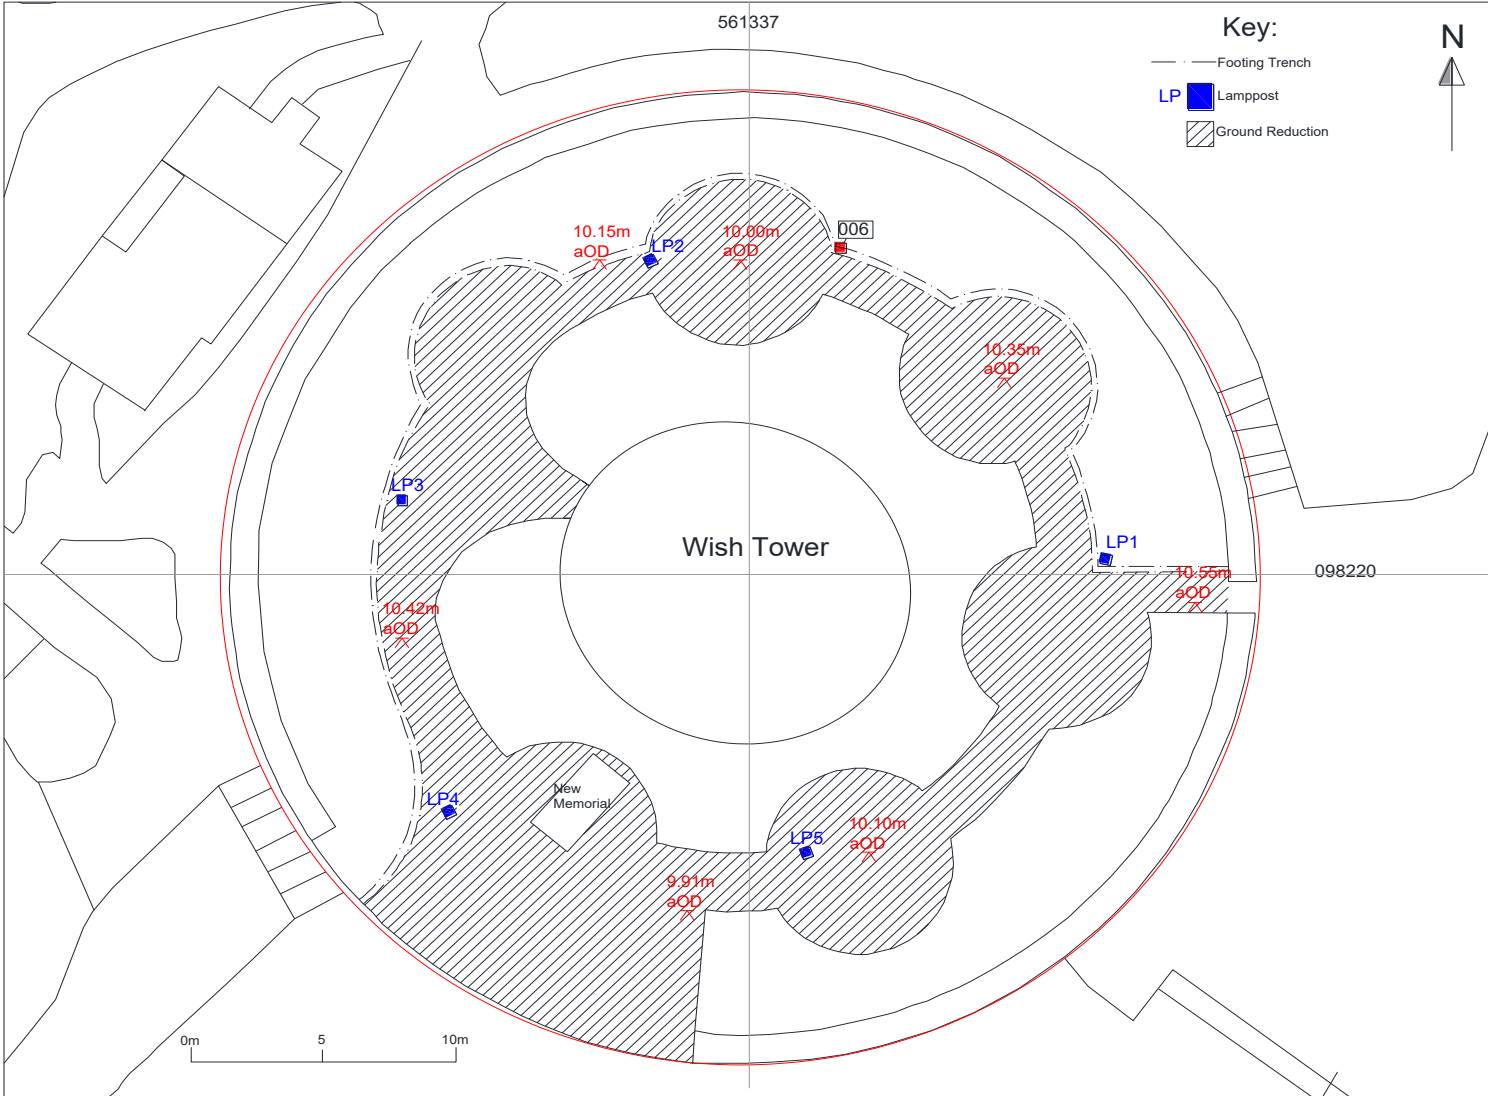
Fig. 5: Site plan showing the location of the groundworks  
Adapted from architect's plan

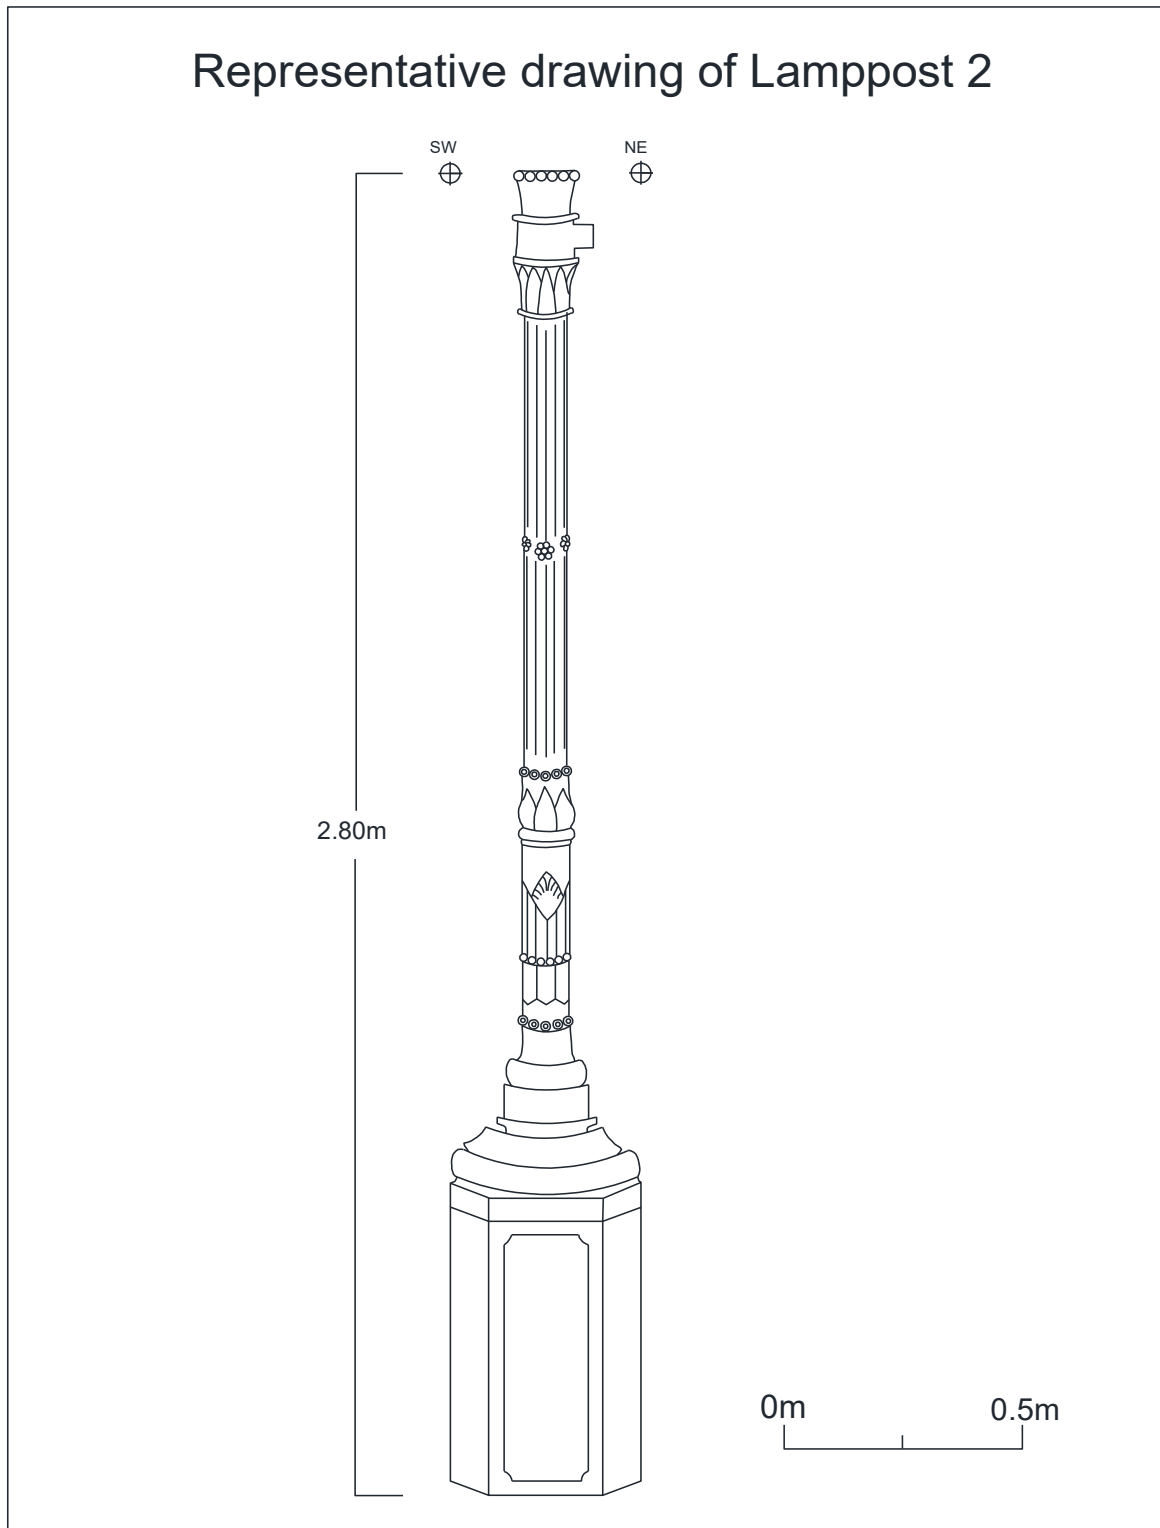
Fig. 6: Representative drawing of Lamp post 2, showing the decoration present on all the lamp posts

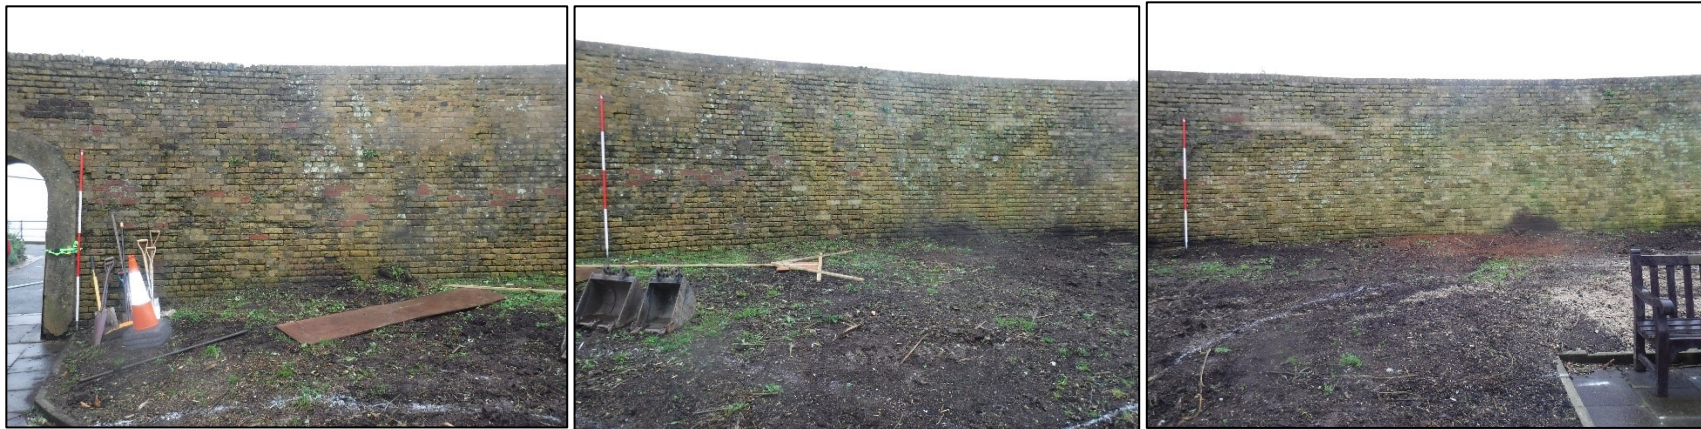
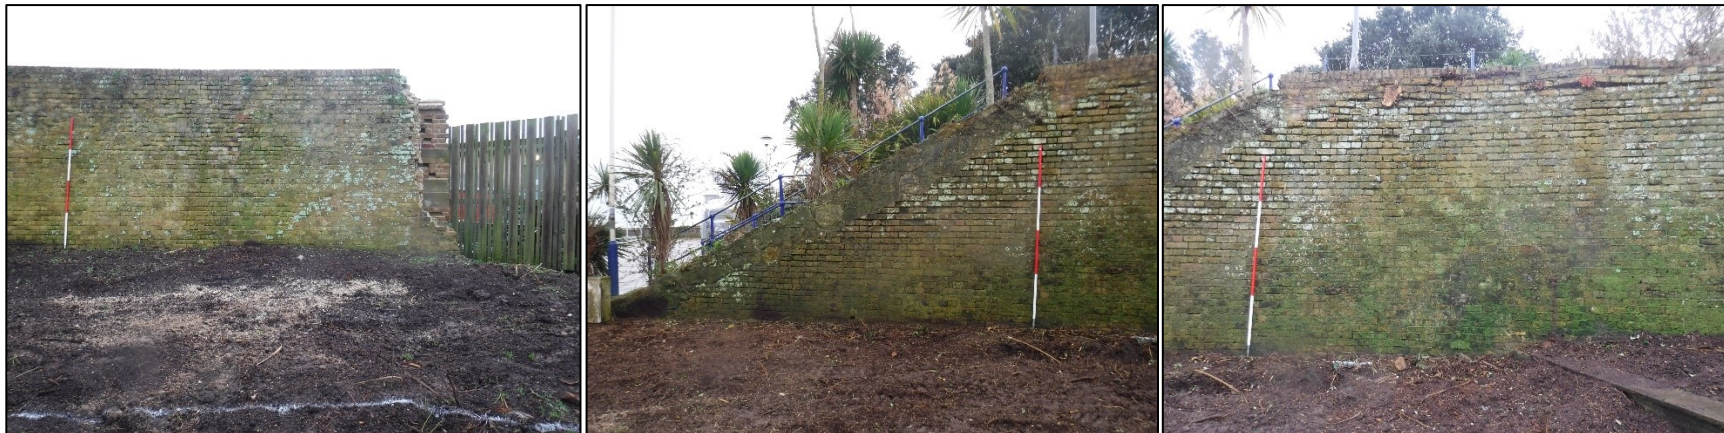
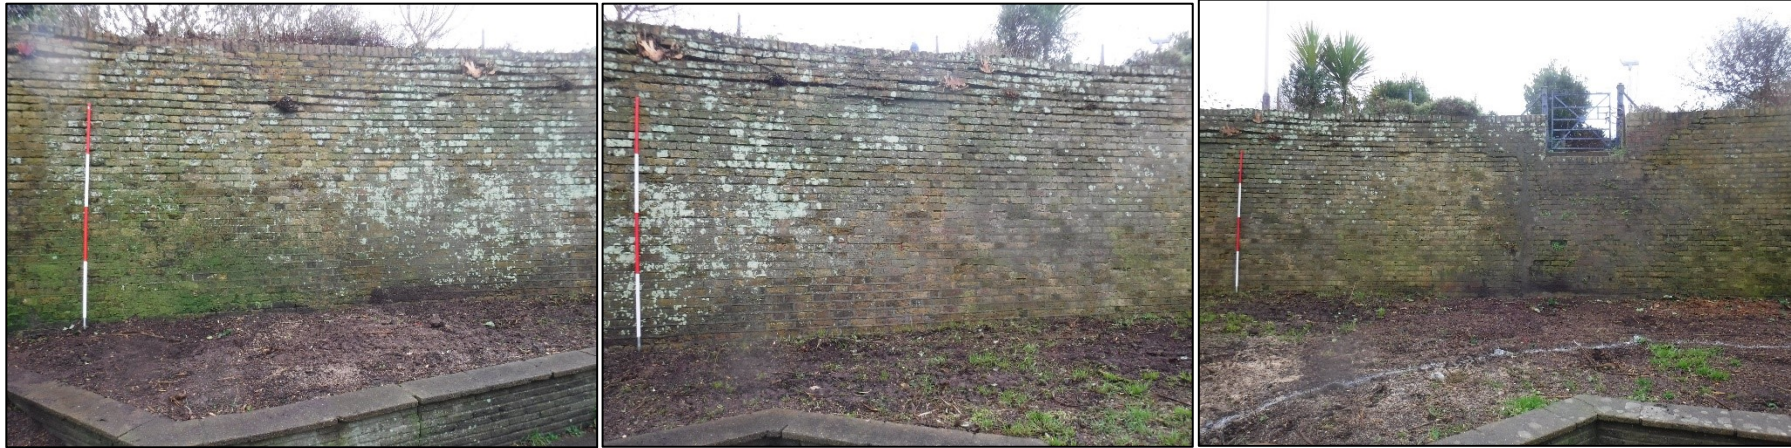
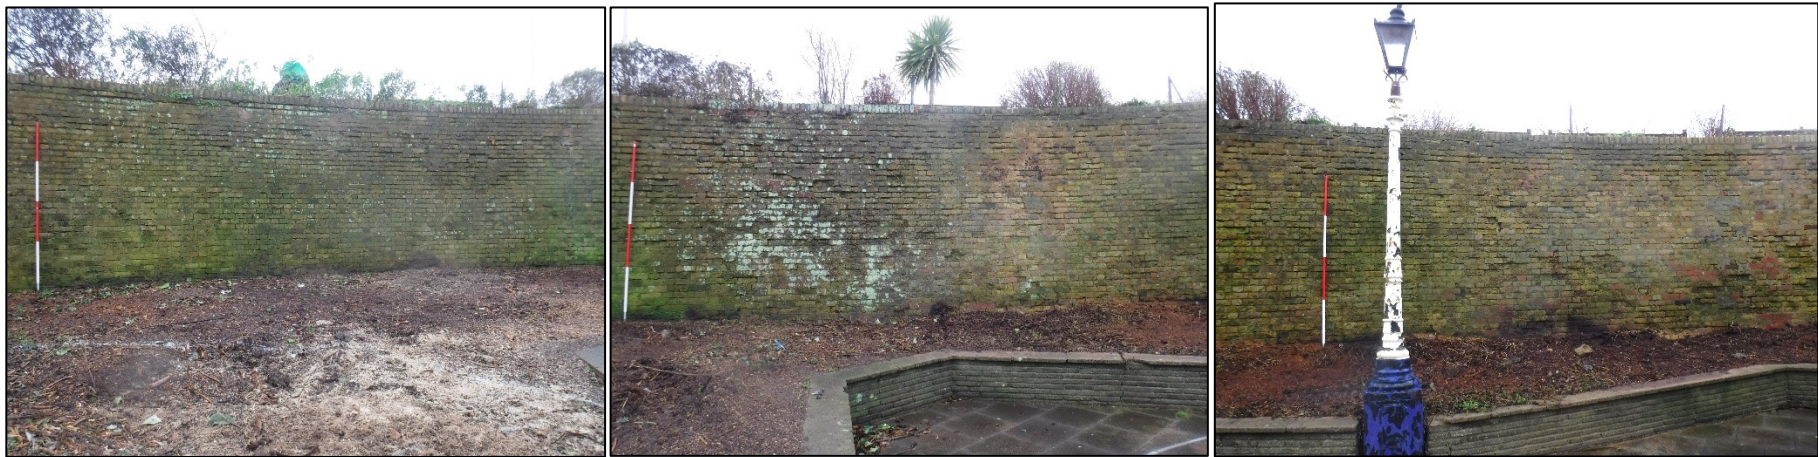
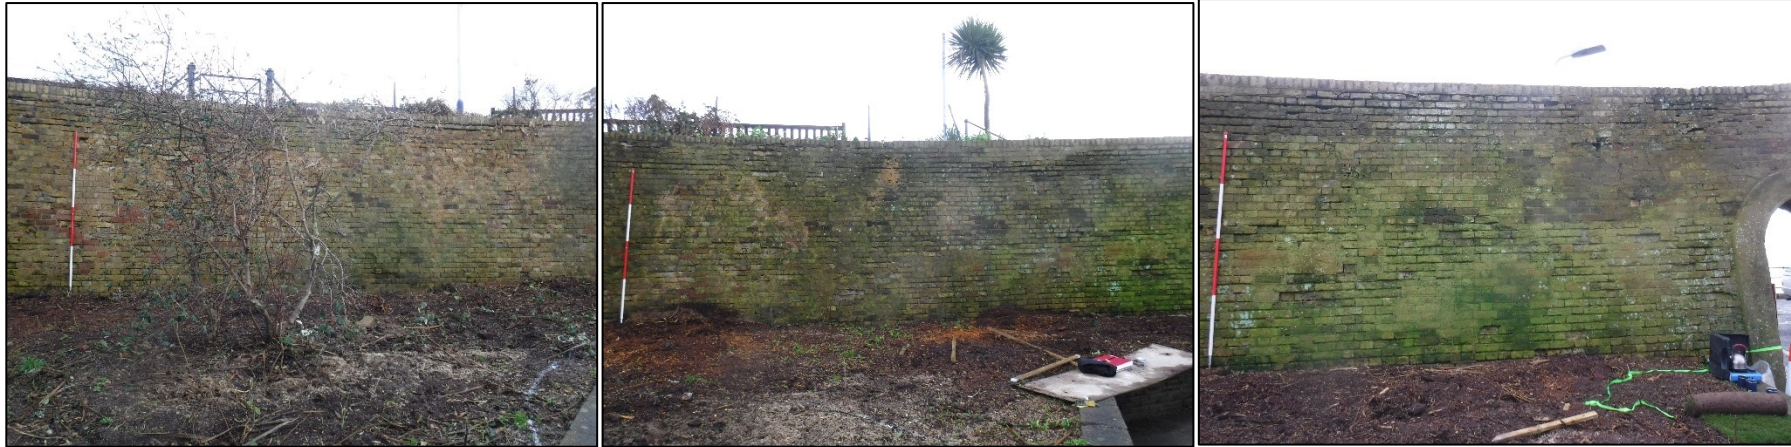
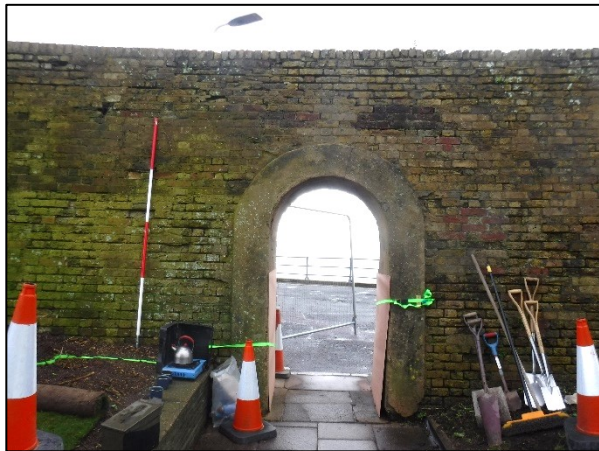
### Appendix 3: Photographic record of the interior of the Counter Scarp Wall

(The overlapping photographs start on the south side of the entrance in the east of the wall and progress around the interior wall to the west, where there is a gap where the 1960's café was located, then around the north side returning to the entrance in the east)
