**An Assessment of Significance  
of St Margarets, West Street,  
Ditchling, West Sussex**

TQ 32478 15205

by  
Keith Butler PIFA

March 2012

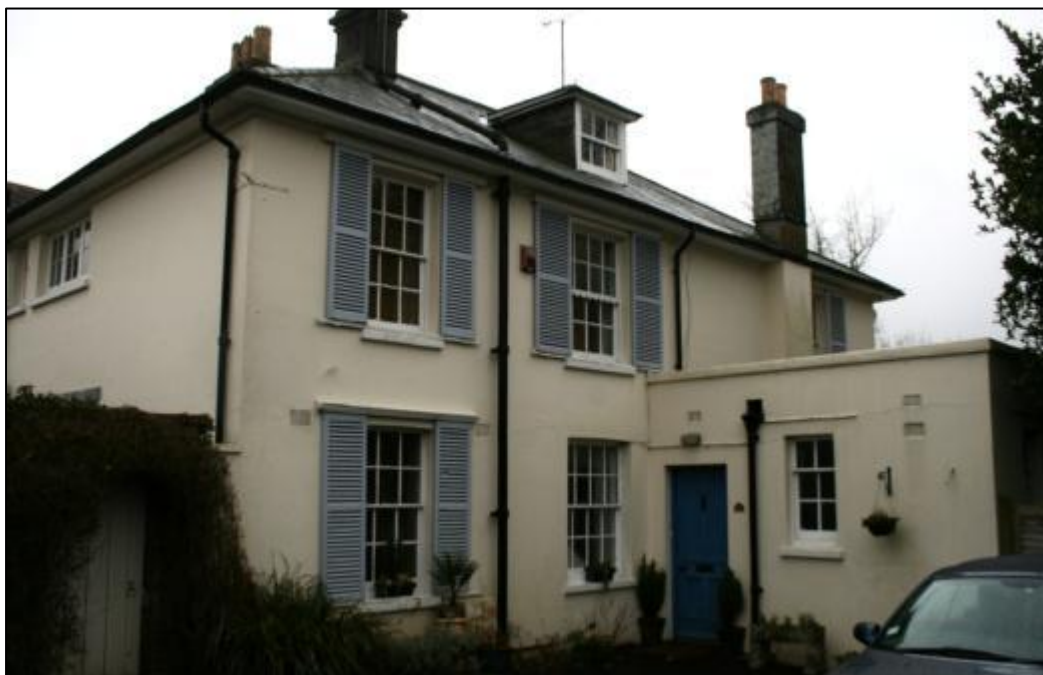
Plate 1: St Margarets Western Elevation (Cover)

- 3.1 Externally there is no evidence of the original two flint cottages, with all of the walls have a rendered finish, which has been painted white. There is a small single storey projecting from the southern end of western elevation, which has a flat roof. There are five sash windows in the western elevation, all having Venetian shutters excepting the southernmost window of the ground floor. The sash windows of the first floor on the southern elevation also have the same type shutters (these appear to be a later addition). The southern elevation has three fluted pilasters with Ionic Capitals (**Plate 2**). The pilasters on the eastern elevation are much plainer and do not date to the original pair of flint cottages, but they are Georgian features (c.1800 – 1832) and most likely date to the conversion of the cottages into a single house at that time. Also projecting from the western end of the southern elevation there is a later extension with angled sides, with a sash window in the south and western walls. There is a door with eight glazed panels in the eastern wall.

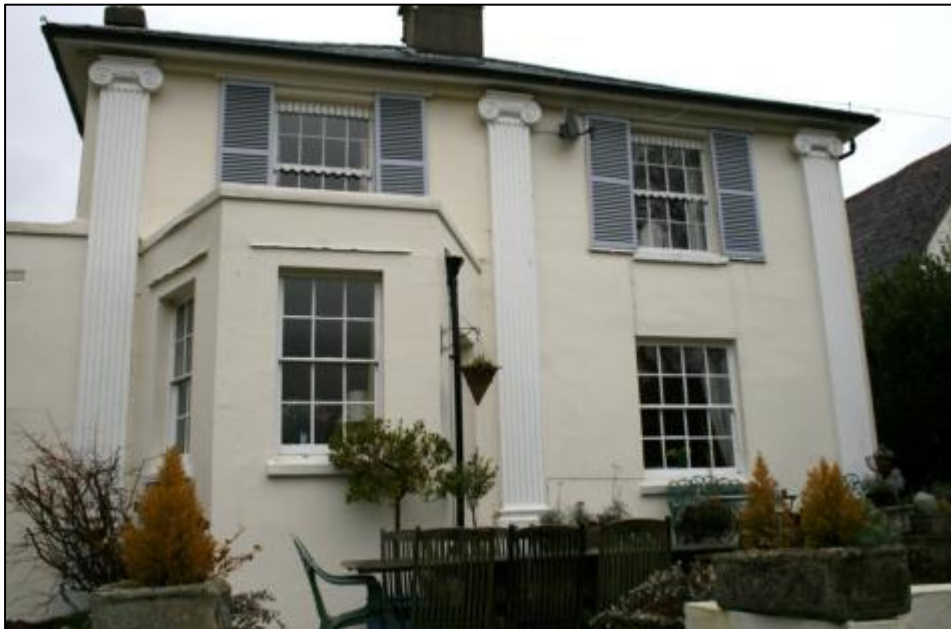
**Plate 2:** St Margarets Southern elevation

- 3.2 The roof hipped roof has a covering is of slate. There are two chimney stacks, both with rendered finish. The main chimney stack is located at the southern end of the ridge of the roof; the second smaller chimney stack is on the outside of southern end of the western wall. There is a single dormer window inserted in the west and eastern sides of the roof.

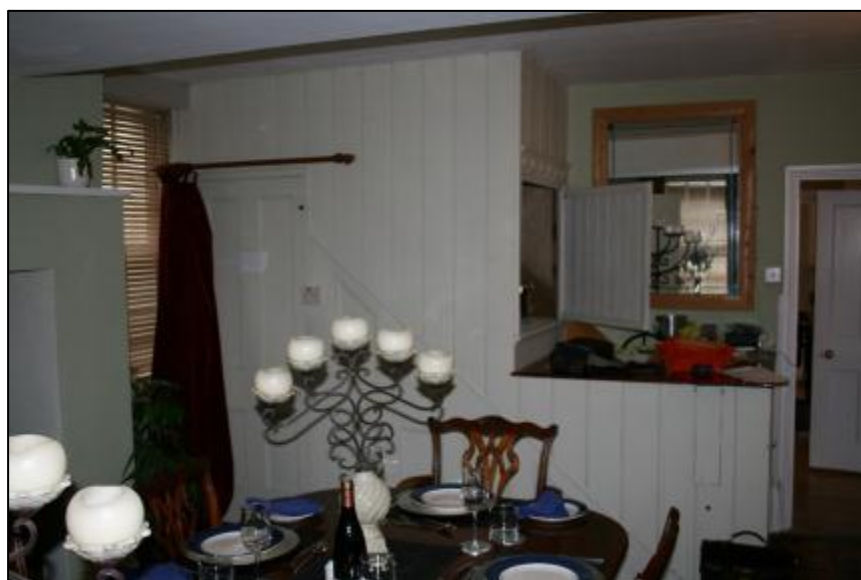
**Plate 3:** St Margarets The boxed-in staircase

- 4.1** The staircase is located adjacent to the southern wall of the dining room, with the original dividing wall of the two cottages to the west. The staircase is now boxed-in, with this space being used as two cupboards. The lower cupboard to the west contains the lower four stairs, with the upper cupboard having another four. The lower part of the staircase is of wooden panelling following the line of the staircase, with upper part and the lower boxing-in of vertical tongue and groove planks (**Plate 3**). It is difficult to be precise about the dating of the boxing-in as there are no significant features, however the style and workmanship would be typical of the late 19<sup>th</sup> or early 20<sup>th</sup> century. Both of the cupboards have doors constructed of narrower vertical wooden planks, with the upper cupboard having a band of decorative moulding above the door.

**5.1** There is very little visible remaining of the two original flint cottages, with only the cellars remaining, and most likely the boxed-in staircase, which does appear to be original. There appeared to be no features remaining of the western cottage above the cellar, due to the alterations when they were converted into a single dwelling during the Georgian period and on later occasions. The later alterations appear to be the addition of at least two extensions, the single storey on the western elevation and the projection on the eastern end of the southern wall of the drawing room. The alterations over the life of the building also include the removal in part or completely of the internal dividing walls, and the access to the cellars being re-located.

**6.1** It is my opinion that although the boxed-in staircase is most likely one of the few visible features remaining of the original pair of flint cottages, it has no particular architectural or archaeological interest or merit. Combined with this it now serves no purpose as it is in complete isolation, and therefore there seems to be no real purpose to its retention.

**6.2** If the staircase is to be removed, it is recommended that it is recorded as part of an English Heritage Level 3 survey of the entire building<sup>4</sup>. This might possibly reveal more information of the earlier phases and the subsequent development of the building, and allows an opportunity to record the later Georgian house, whilst ensuring a full record of the staircase is preserved within its context before it is removed.

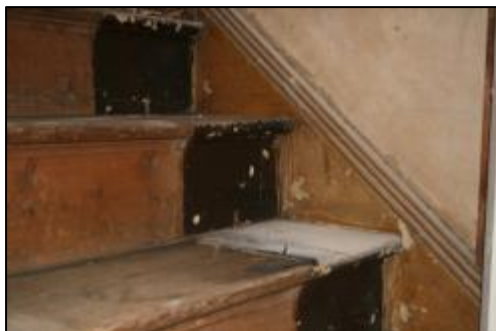
**Plate 4:** St Margarets Detail of stairs

- 4.2** The stairs are of plain wooden construction, with a band of moulded beading running horizontally at the top of the risers (**Plate 4**). The northern and southern edges of each stair have been painted, leaving the bare wood exposed in the centre. Running up the southern side of the staircase is a wooden skirting board with a moulded three grooves decoration on their upper part. The underside of the staircase viewed from the access stairs to the basement has been blocked in with lathes and plaster (**Plate 5**). During the survey the bathroom above the staircase was visually inspected for any evidence for the upper part of the staircase, or the access to the staircase from the first floor; none was evident.

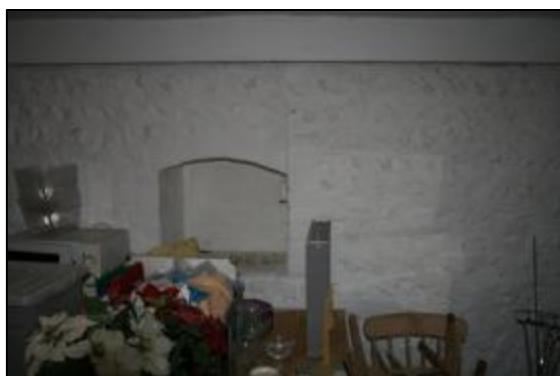
**Plate 6:** St Margarets Flint walls of Cellar

**4.4** Both of the original cottages had cellars located under their southern end, both of these remain. This the only place noted during the survey were the original flint construction of the walls of the cottages is visible. There is only access to the cellar of the eastern cottage. This is currently accessed by a flight of brick built steps under the boxed-in staircase. This is a later entrance as originally the cellar was reached by a trap door in what is now the kitchen<sup>3</sup>. The only current access to the cellar of the western cottage is through an opening in the northern end of the west wall of the other cottage. The cellars are mirror images of each other, with the supports for the main chimney being in the centre of the dividing wall between them (**Plate 7**).
