**An Archaeological
Watching Brief
on the route of the
Sovereign Harbour Cycleway
Network,
Phase 2A,**

(Ringwood Road to Lottbridge Drove)

Project No. CBAS0260

June 2012

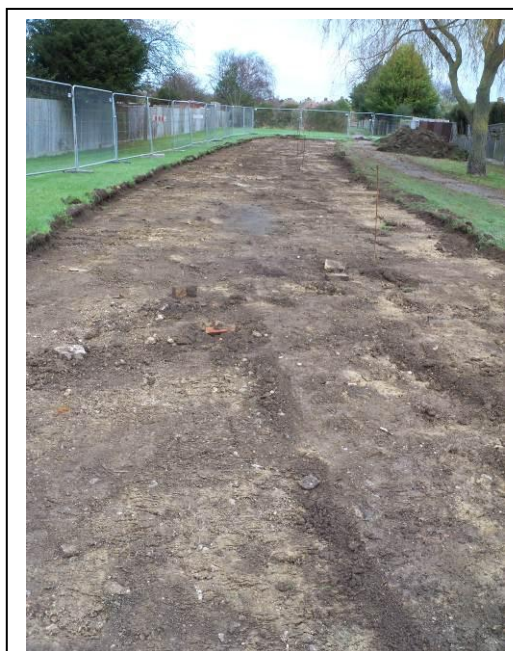
Plate 1: Ringwood Road to Bridge 3
Section looking NE, note how no
impressions of the original track
remain.

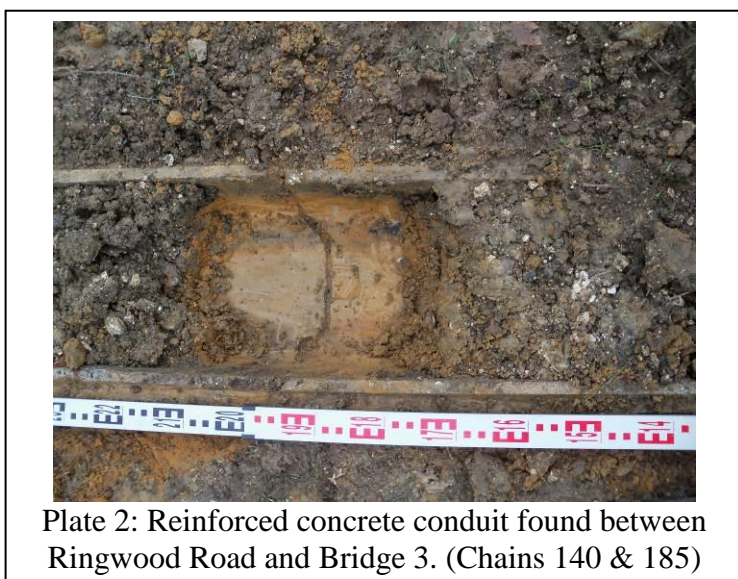
4.3 To the eastern side of the excavation, at Chain 140, a reinforced concrete Cable Conduit was located (Plate 2). Another conduit appeared on the opposite side of the original track line at Chain 185; both of these continued along the line of the track until disappearing immediately south of Bridge 3. This was possibly the conduit which contained high voltage electric cabling from the railway's later period.

Plate 2: Reinforced concrete conduit found between
Ringwood Road and Bridge 3. (Chains 140 & 185)

5.3.3 A section from the U-shaped concrete conduit found at Chain 185 was recorded. The piece was 950mm long, 381mm wide and 182mm deep, with the concrete sides being 42mm thick. The lid had similar length and width dimensions, and was 50mm deep.

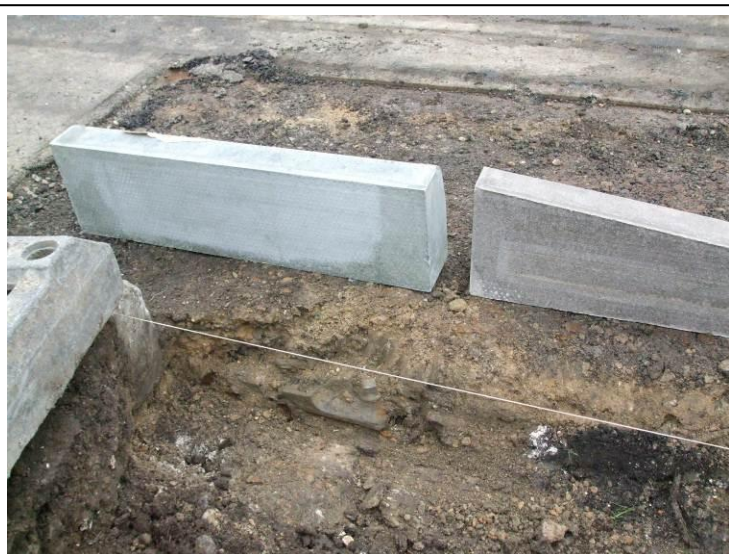
- 4.4 At the end of the watching brief, when the new cycleway was being linked to the existing footpath on the northeast side of Ringwood Road a complete sleeper, with its Rail Chairs in situ was found in the ground (Plate 3); however its removal would have involved extending the excavation and removing part of the Ringwood Road footpath. This does, however, indicate that there may still be discreet areas to the west where parts of the railway may still lay undisturbed.

Plate 3: Detail of intact Sleeper and Rail Chair found at the junction with Ringwood Road (Chain 0.0)

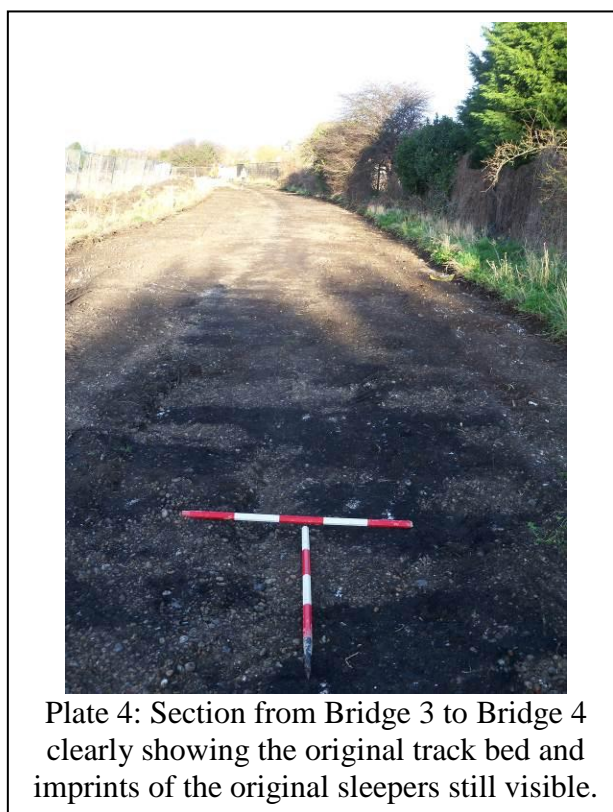
4.9 Beneath this Ballast layer was a layer of topsoil (Context **200**), 6cm in depth, similar to that found in the surrounding area of a soft, brown, silty/clay, with pebbles evident at its upper boundary with (Context **201**). The deposit of soil (Context **201**) had beneath it a layer of crushed chalk (Context **203**). This was the extent of the depth reached on that side of the excavation.

4.10 The track bed section was only visible on the eastern side of the excavation, on the western side the section consisted of topsoil (Context **200**) directly above a natural layer (Context **202**) of a firm, orange/brown, clay which showed up no finds or inclusions and was typical of the local natural clay. See Fig. 9: Drawing A2.

Plate 4: Section from Bridge 3 to Bridge 4 clearly showing the original track bed and imprints of the original sleepers still visible.

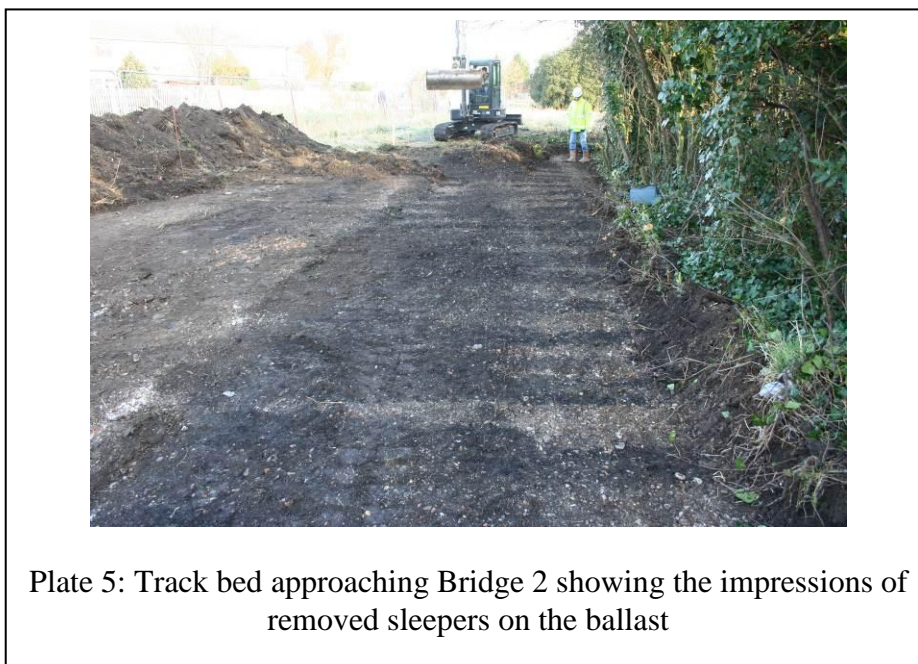
Plate 5: Track bed approaching Bridge 2 showing the impressions of removed sleepers on the ballast

- 4.15** Approaching Bridge 2 the imprints of removed sleepers could be seen in the top of the ballast (Plate 5). At Chain 360 the full width of the ballast was exposed, which measured 4.1m. An area of burning starting 1m before Chain 380 and continuing to Bridge 2 covered the ballast and extends outside the area excavated. This layer of burning (Context **204**) was up to 50mm thick and comprised ash, cinder, charcoal and burnt pieces of ballast, and appears to represent in-situ burning that had taken place after the removal of the railway sleepers.

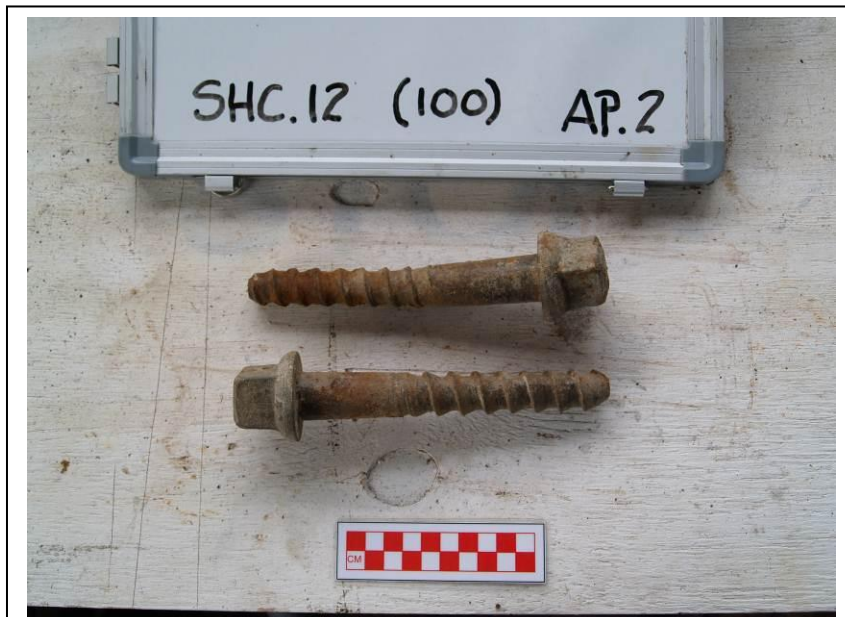
Plate 8: Two Rail Chair Screws found in the Rail Chair shown above

- 4.6 Within this section of the construction a secondary deposited Rail Chair, partly broken, with two Rail Chair Screws still in-situ was discovered in the topsoil at Chain 150. This Rail Chair was slightly different from others found, in having only three securing holes, one of which still retained a wooden insert inside. Some scattered fragments of Porcelain and later Stoneware were also discovered, these, as with the Railway furniture above had been disturbed by the late footpath development. Sadly little remained of the original railway over this stretch of the development; those artefacts that were uncovered had obviously been disturbed and were not in their original locations.

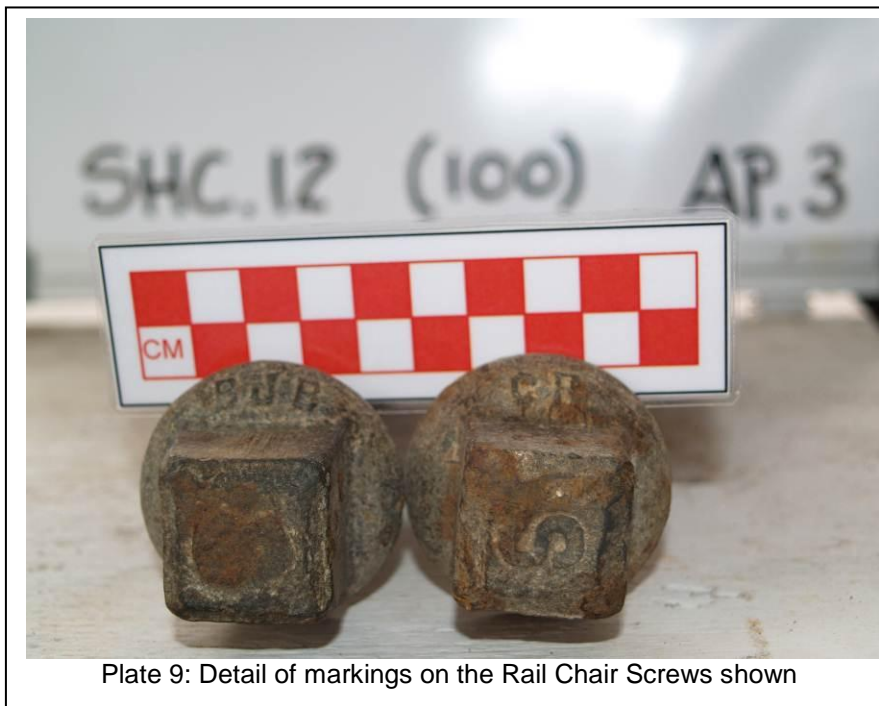
Plate 9: Detail of markings on the Rail Chair Screws shown

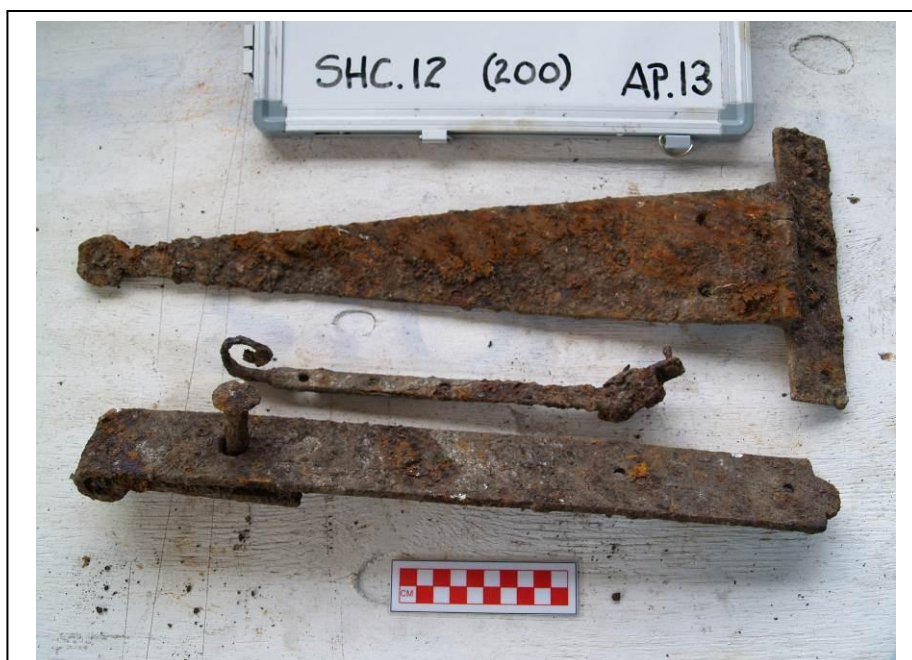
Plate 10: A collection of building furniture found around Chain 230, indicating that there was once a building around this point, possible a Points, or Gangers Shed.

5.4.3 At around Chain 230 two hinges, and a window stay were found, nearby was the movement and face of a pocket watch, indicating the possibility of a trackside building and activity in this area, near to a known set of points. Part of a cast iron enamelled bowl and a chromed brass shaft seal were recovered from Context **300**, Chain 647, the latter probably not contemporary with the Railway. A pair of scissors was recovered at Chain 320.

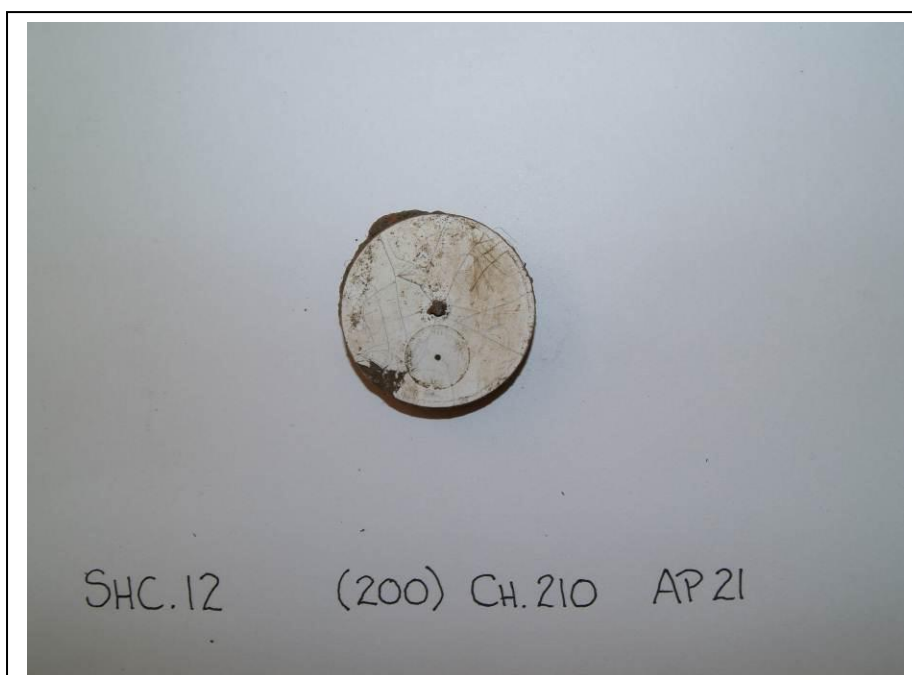
Plate 11: Pocket watch movement found in context (200) at Chain 210.

5.5.3 A pocket watch movement was found in Context **200** (Plate 11). There were no makers marks or other distinguishing features on it.
