**A Standing Building Survey
of 224, High Street,
Lewes,
East Sussex**

Project No. CBAS 0281
TQ 4192 1024

by
Keith Butler PIfA

March 2012

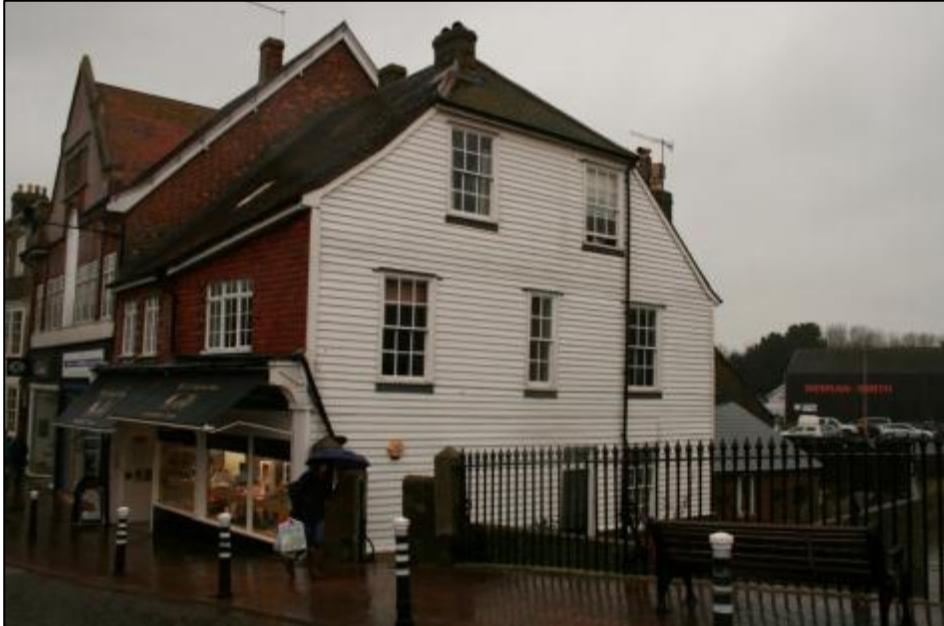
The wall of the eastern elevation is covered with horizontal weatherboarding which has been painted white (**Cover photo**). There is an entrance to the first and second floor accommodation in the centre of the ground floor of this elevation, fitted with a wooden door with a single panel below with three rows of four panes of glass above. To the north of this doorway there is a single wooden framed sash window. There are three sash windows lighting the first floor, with the window in the centre being narrower. The second floor has two wooden framed sash windows. On the eastern elevation of the north-western extension there is a single sash window. All of the sash windows except the centre one on the first floor are of three rows of two panes in both the upper and lower part of the window. The narrower window in the centre of the first floor is of two rows of two panes. On the eastern elevation of the north-western extension there is a single sash window of the type described above.

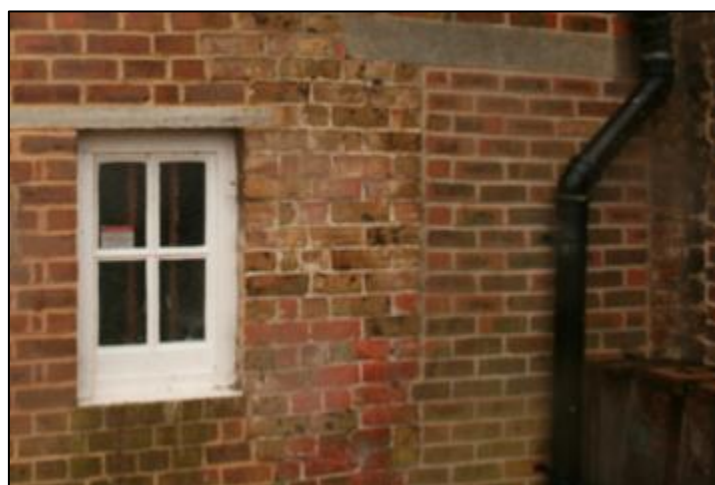
3.2 The single storey extension in the north-east is constructed of red stock bricks laid in English bond, which changes to stretcher bond in the upper part of the north wall. The extension has a single span roof which has a covering of slate. This part of the building is lit by a wooden framed casement window of different design in the east and north walls. There is a scar in the brickwork at the western end of the north wall describing an earlier doorway; this area has been patched with bricks laid in stretcher bond (**Plate 1**).

Plate 1: 224 High Street: Scar of earlier entrance in north wall of the north- eastern extension.

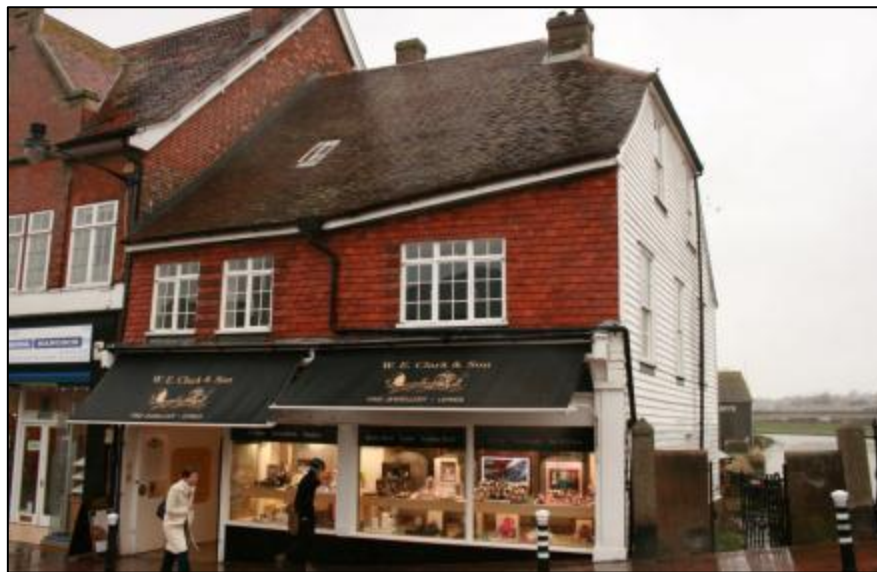
- 3.3** The lean-to structure attached to the northern elevation of the north-western extension is constructed of red stock bricks, laid in stretcher bond. This part of the building is in a very poor state of repair. The northern wall is in a poor state of repair and has been constructed of wooden panels. The single span roof which slopes down to the north is constructed of corrugated iron sheets with a row of Perspex's sheets at the front of the roof.
- 3.4** The southern elevation faces the street and is of a large double display window of the jewellery shop, with an inset doorway at the western end. The elevation above the glazed shop front is tile hung (**Plate 2**). Within, the tile hanging there are three wooden framed casement windows, the window to the eastern end being larger than the two others at the western end of the building.

Plate 2: 224 High Street: Southern Elevation

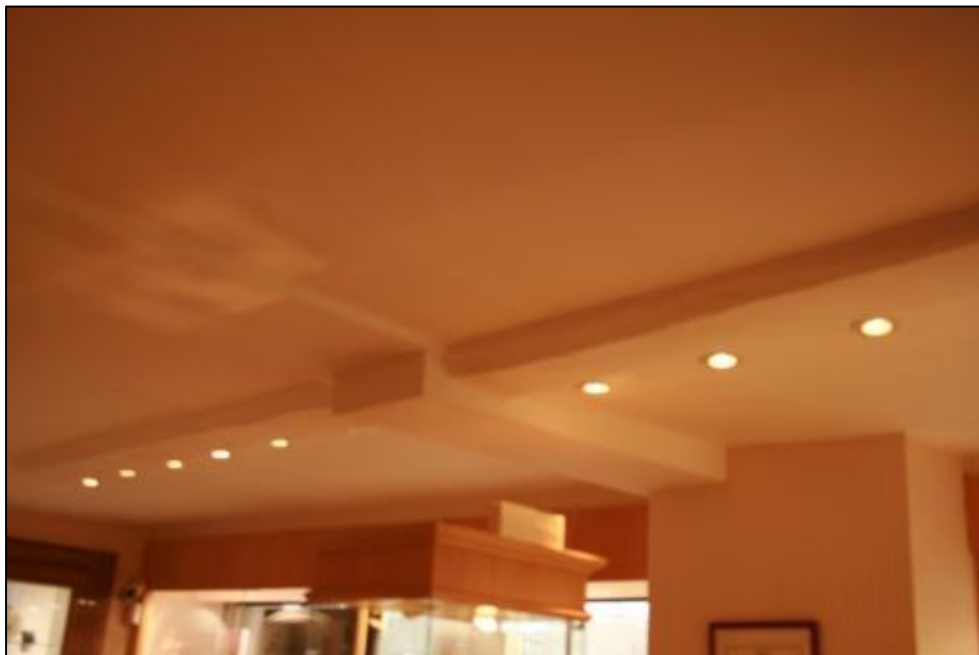
The shop is 'L' shaped in plan and measuring 13.45m north to south by 8.48m east to west at its widest point. The shop is entered via a door in the western end of the southern wall from the High Street. The shop is lit by the double shop windows in the southern wall, with display units in front of the window. The walls and ceiling are plastered. There are various modern glass display units located against a number of the walls, with a modern counter located against the eastern wall, behind which is the access to the office (G2). During the survey two pieces of timber were noted. These consisted of a beam running parallel, and approximately a metre to the north, of the shop window (**Plate 3**), with a second beam on a north to south alignment located to the east of the doorway to the shop. This beam had a length of approximately 2.5m. Both of the beams had been incorporated into the ceiling plaster, and had been heavily painted but appear to have no diagnostic features, and appear to be more decorative than structural.

Plate 3 224 High Street Wooden beam in shop (G1)

- 5.1** The Grade II listing of 224 High Street describes it as an early 18th century timber framed house which is now a shop, however, during the course of this survey no evidence for any timber framing could be seen. The only timbers that were noted were in the ceiling of the southern end of the ground floor shop. These consisted of a beam running parallel with the shop window, and a second beam which was running in a north south alignment at the western end of the first beam; the two beams were not joined. Neither of the beams showed an evidence of empty mortices or any other feature in their soffits and appeared to be decorative rather than structural.

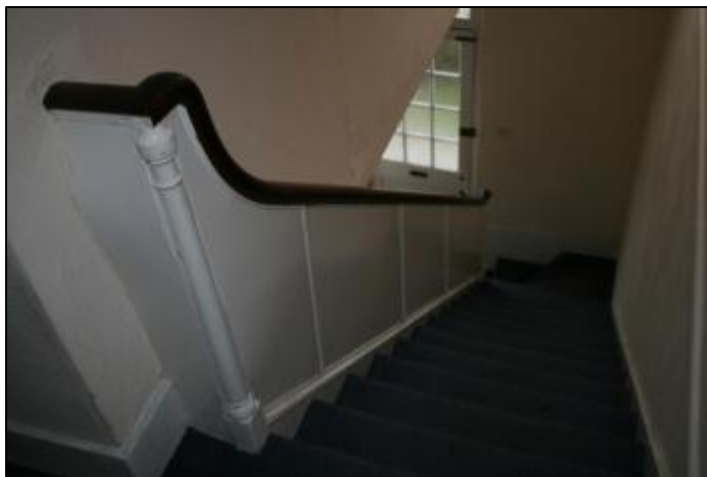
Room **G5** was located to the north of the shop and provided access to the accommodation on the first and second floor. The hall measured 1.1m north to south by 2.85m east to west. The hall was accessed by a modern door with three rows of four panes of glass above. Located at the southern side of the hall was the staircase to the first floor, which was of wooden construction. At the top and bottom of the staircase was a turned wooden newel post, with a wood hand rail. The balustrades had been boxed-in with wooden sheets (**Plate 4**). The wall had a wood chip covering with a modern plain wooding skirting board at their base. On the first floor level lighting the staircase was a sash window with twelve panes of glass as described before. The floor was covered with carpet.

Plate 4: 224 High Street: Staircase **G5**

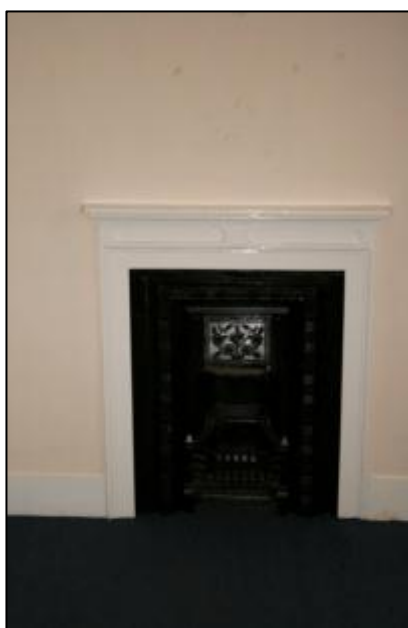
F4 is located on the eastern side of the landing **F7**, and is accessed via a modern plain door located in the southern end of the eastern wall. The room measures 4.35m north to south by 3.85 east to west. The walls and ceiling are plastered, with the wall being covered in wallpaper. At the base of all the walls is a modern high skirting board. The room is lit by a sash window in the centre of the eastern wall, this is of the same two-pane design as described in **F3** above. In the centre of the northern wall is a small cast iron Victorian fireplace with a decorated fire hood. The fire has wooden surround and mantel shelf above (**Plate 5**).

Plate 5: 224 High Street: Victorian Fireplace **F4**

- 5.2** During the course of the survey very few datable features were noted, possibly due to having been modified and adapted throughout its later life as a shop. The features that were noted, for example the fireplace in **F4**, the staircase and possibly the small area of wooden panelling in **F6**, most likely date to the 19th century. This also applies to the sash windows noted in both the eastern and southern elevations.

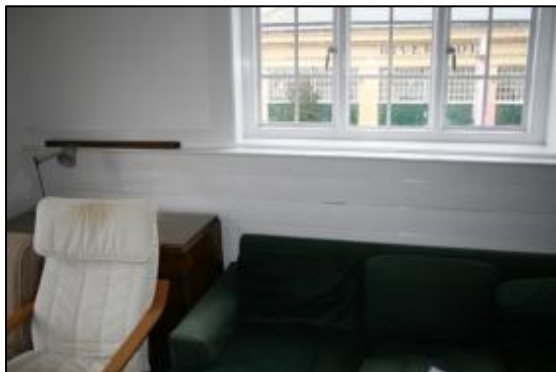
F5 is located at the southern side of the building, to the south of **F4**. The room measures 4.35m north to south by 4.86m east to west. The room is accessed from **F7** via a doorway in the west end of the eastern wall, with a modern plain door fitted. The room is lit by two windows; a wooden framed sash window in the south end of the eastern wall (same type of twelve panes as above) and a metal casement window of three sections with the outer sections opening in the centre of the southern wall. The walls have a modern plain skirting board at their base. The ceiling and walls are plastered, with the walls being wallpapered. The exception being the lower part of the southern wall which is covered with white painted horizontal beaded tongue and groove planks (**Plate 6**). This panelling is 1.1m high above floor level. In the centre of the northern wall is a chimney breast fitted with a fireplace with wooden surround and mantel shelf (**Plate 7**). The inner part of the surround is formed from cream-coloured ceramic tiles. The fireplace looks to date from the 20th century.

Plate 6: 224 High Street: **F5**
Tongue & Groove panelling

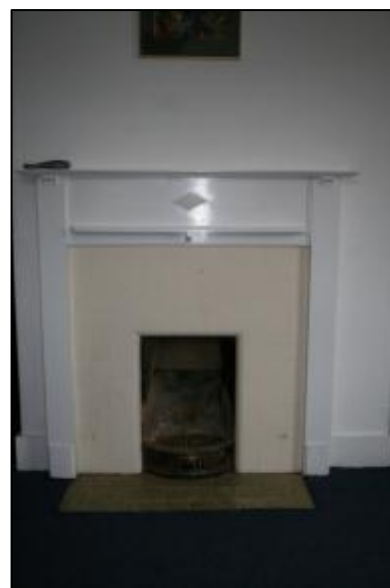
Plate 7: 224 High Street: Fireplace **F5**

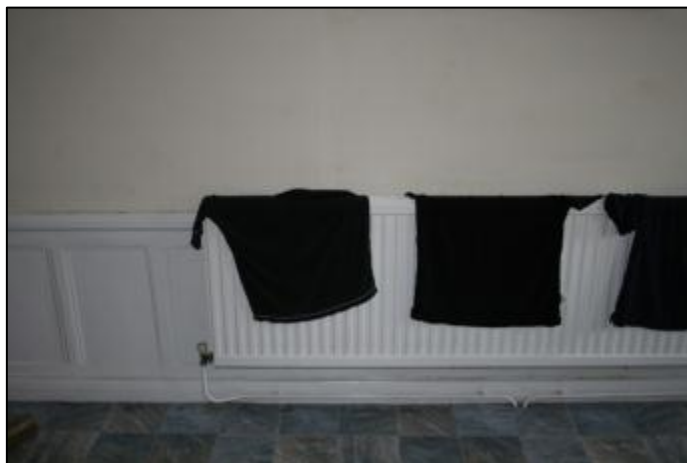
F6 is located at the southern side of the building to west of **F5**, and measures 7.95m north to south by 3.35m east to west. The room is accessed from **F7** by a doorway in the north end of the western wall and is fitted with a modern plain door. The northern end of the room is the kitchen area which is fitted with modern units with ceramic tiled splash-backs. The room is lit by two metal framed casement windows in the southern wall. Both the walls and ceilings are plastered, with a modern low skirting board at the base of the wall. In the dining area of the room the eastern wall has wooden panelling which has been painted white, on the top edge of the panelling is a fitted chair rail. The panelling is 700mm high. The modern skirting board appears to have been fitted over the base of the panelling which suggests that the panelling is of an earlier date, possibly 19th century (**Plate 8**). Vinyl tiles cover the floor in both areas. In the north wall is the two paned window seen in **F3**, which has been painted over on this side. A hatch to the roof space is located in the north-west corner of the kitchen area.

Plate 8: 224 High Street: Panelling **F6**

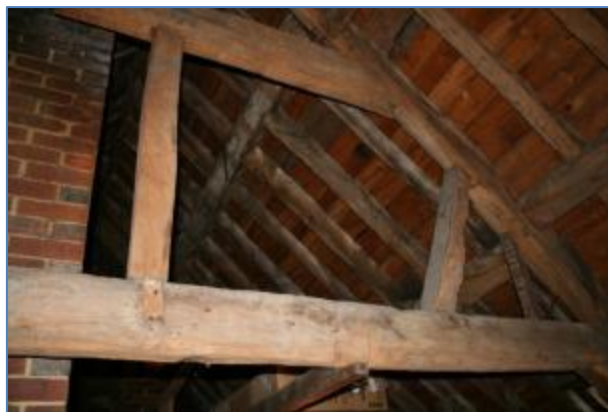
The roof space is of three bays, with the two roof trusses being of different construction. The western truss is of the principal rafters having a lower collar, with above this an upper second collar. The lower collar has angled braces at both its southern and northern end, which are joined to the principal rafters. A post in the centre of the lower collar is jointed and pegged into the upper collar. This central brace appears to be a later addition, evidenced by the wide mortise which is wider than the post (**Plate 11**).

Plate 11: 224 High Street: Western Roof Truss

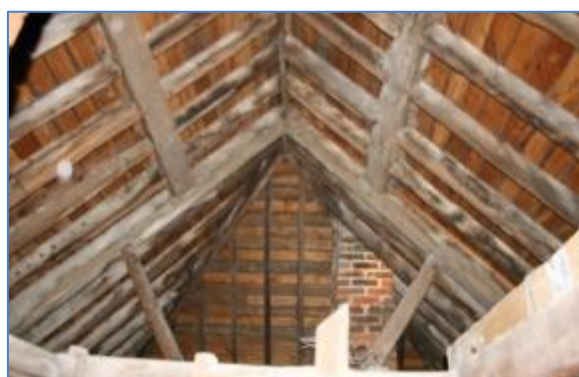
The eastern roof truss appears to consist of two angled end braces rising from a collar, which are jointed to the principal rafters; due to the wall of the two rooms at the eastern side of the roof no collar could be seen (**Plate 12**). The sides of the roof are formed from two staggered back purlins. There is a small amount of evidence for a few of the roof timbers being reused; e.g. empty peg holes and mortices. There is also evidence for either repairs or modification to the roof in that the eastern and central roof bays have a ridge plate, whereas, in the western bay the ends of the rafters are joined at their tops. The internal face of the roof has been boarded over using horizontal wooden planks.

Plate 12: 224 High Street: Eastern Roof Truss

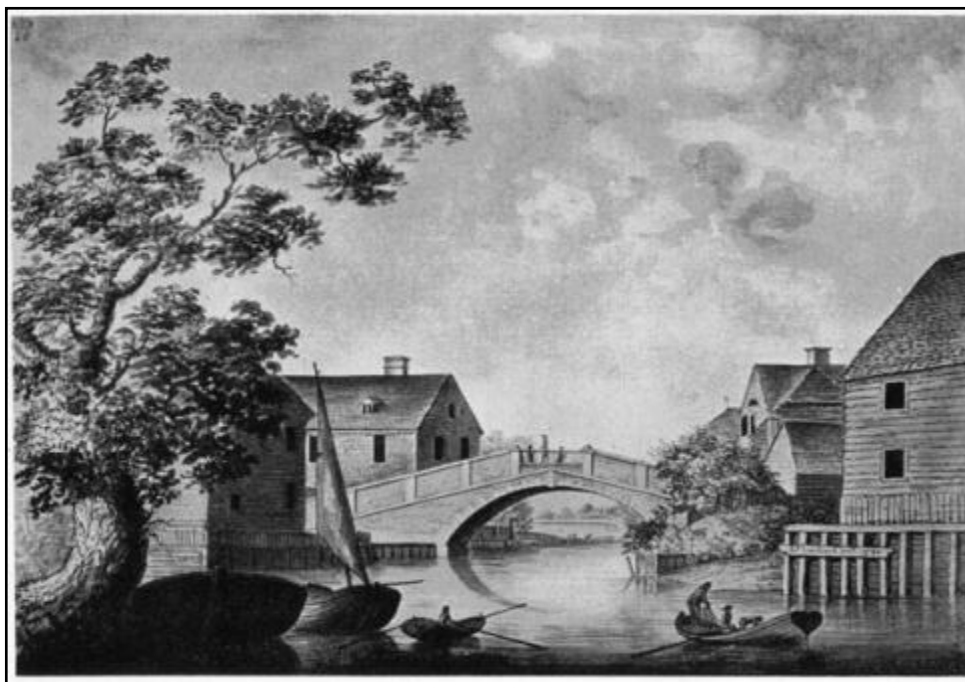
- 5.3** Two drawings 1781 and 1782 of Lewes Bridge⁴ both show the eastern end 224 High Street. There are slight differences between the two pictures, but both show that the eastern end of the building was gabled, not as today with a half hipped roof. The 1782 drawing also shows a dormer window inset into the southern side of the roof, for which there is no evidence today. On this drawing the number of windows shown on the southern elevation has also changed from two to four. However, the eastern elevation appears similar to that seen today, with the exception of the gabled eastern end of the roof. It therefore seems likely that the building present in these drawings is the same building that stands today, albeit much remodelled.

Fig. 7: 224 High Street, Lewes: Drawing of Lewes Bridge 1782
(<http://www.austenfamily.org/images/Lewes-Bridge-1782>)

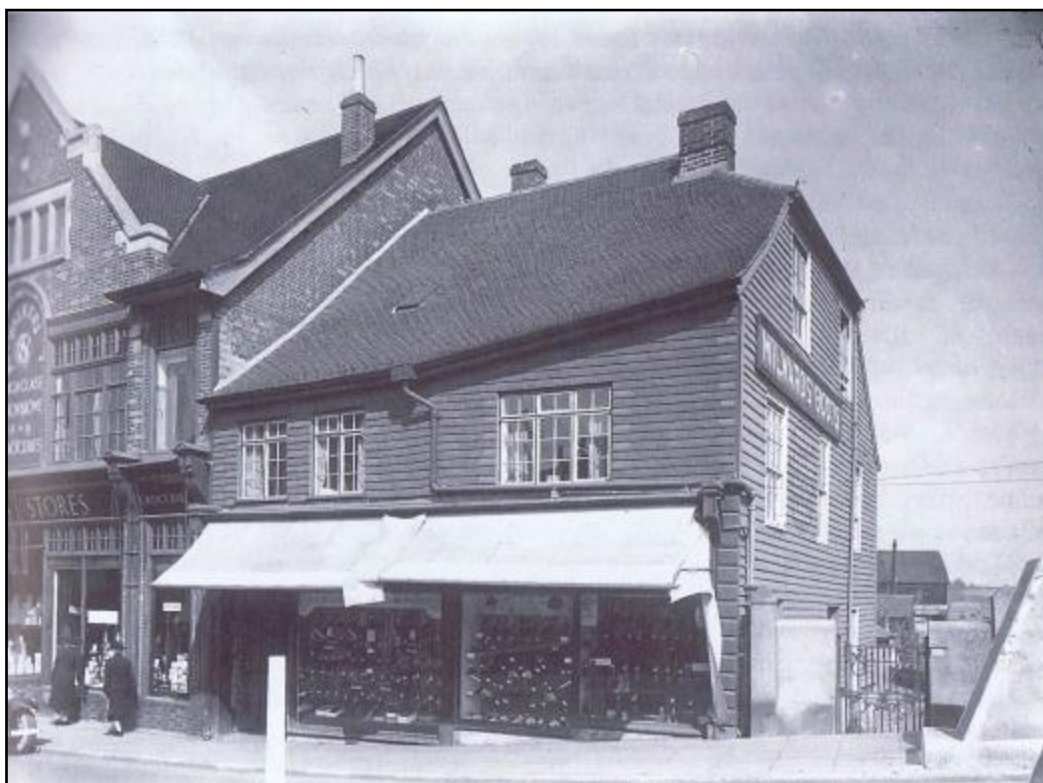
- 5.6** By the 4th Edition OS map (1932) an extension has been added to the north-west corner of the building, but there is no further change to the building or property outline shown on any of the later OS maps. A photograph of 1943 shows the shop front to have been changed to its current form, and a change in the roof design has occurred since the 1922 photograph.

Fig. 9: 224 High Street, Lewes: Photograph dated 1943
