**An Archaeological Evaluation
and Watching Brief at
St. Mary Magdalene Church,
Whatlington, East Sussex.**

Project No. CBAS 0332

Keith Butler PIfA

July 2015

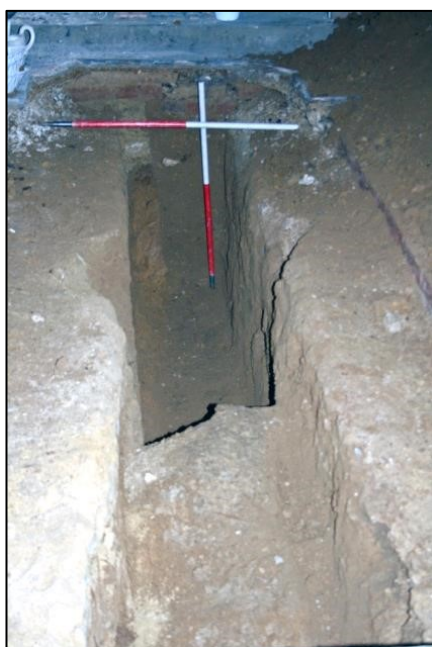
Plate 3: Trench A in centre of the Chancel

- 4.1 Trench A was located in the centre of the Chancel on an east to west alignment (Fig. 5 & Plate 3). Context 1 was mid orange-brown silty clay loam deposit of very disturbed ground and having a very loose consistence. Context 1 continued to the full 900mm depth of the trench, and had inclusions of sandstone pieces up to 60mm (1%), ceramic building material (<1%) and pieces of mortar (<1%). Recovered from the fill were artefacts of bone (Human), ceramic building material, metal, pieces of stained glass and window lead and clay tobacco pipe. This context formed the major deposit within Trench A and also filled all of the grave cuts found within this trench, there being no discernible difference in this deposit.

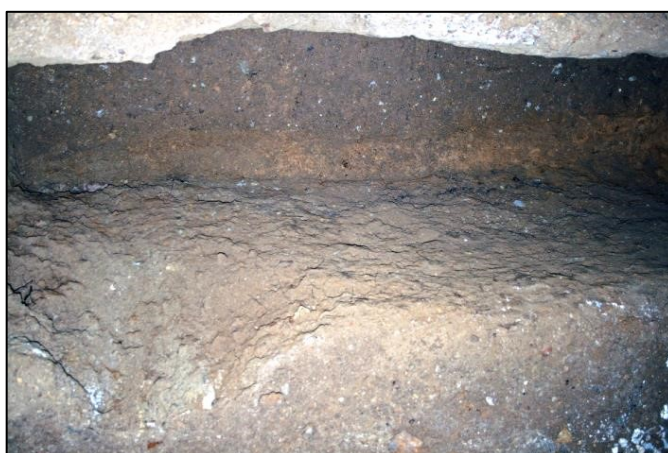
Plate 4: Sandstone Lip of Primary Grave (Context **3**)

- 4.4** Context **3** was a cut into the natural (Context **2**) adjacent to the northern baulk of Trench **A**. The edge of the cut was noted by the 120mm wide lip of sandstone on an east west alignment, which was apparent in the base of the trench on the northern side of the trench (**Plate 4**). The western end of the cut was slightly rounded in plan, and the cut was filled by Context **1**. The side of the cut appeared to be vertical but was only excavated to a depth of 50mm, and no burial was encountered. The feature was on an east to west alignment and was interpreted as a grave cut. It was truncated by a later grave cut (Context **4**) at its eastern end.

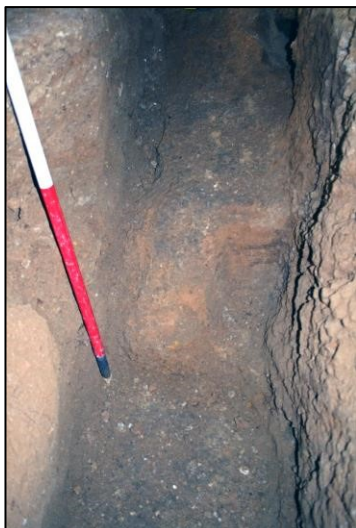
Plate 5: Semi Circular Cut (Context 19)

- 4.6** Context **19** was a located in the eastern edge of the deposit of the assumed natural (Context **2**) at the western end of Trench **A**. This was a semi-circular cut with width of 300mm and a length of 300mm before it became truncated by Cut **3** (**Plate 5**). The feature was 250mm deep, and had a gradual break of slope at the top which led into steeply sloping sides. The base was flat, and the cut was filled with Context **1**. The feature was on an east to west alignment, and was most likely another grave cut but because it was heavily truncated, it is difficult to be certain.

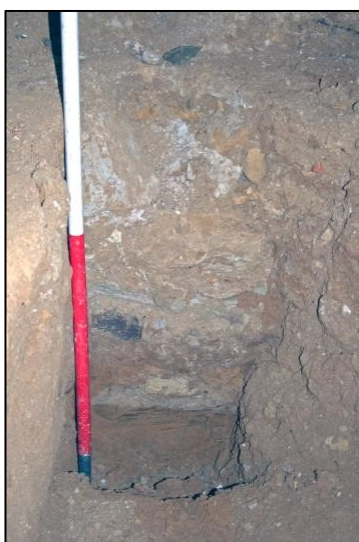
Plate 6: Foundations of Eastern Wall of Chancel (Context 18)

4.8 Context 18 was the foundation of the eastern wall of the chancel (**Plate 6**), located at the eastern end of Trench A. The foundations stepped out 200mm from the main body of the eastern wall of the Chancel, and were 760mm deep. The blocks were roughly worked with a size up to 600mm. They were coursed and bonded with a mid grey sandy mortar. The foundations were directly above the assumed natural silty clay (Context 2) with no cut for a foundation trench being in evidence, but this is not surprising due to the disturbance of the multiple graves in this area.

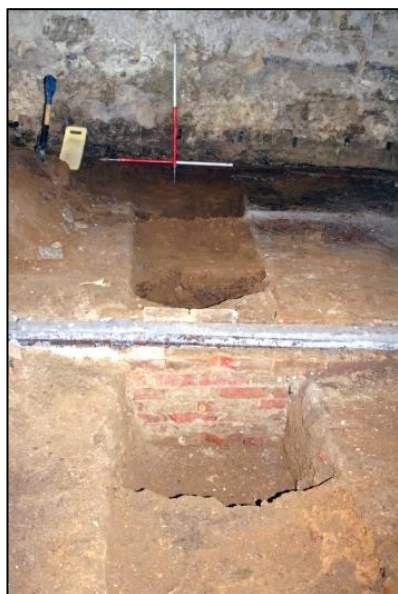
Plate 7: Trench B

- 4.9** Trench **B** was positioned 6m in from the western wall of the nave (Fig. 4), and was excavated to a depth of 465mm (**Plate 7**). After the site meeting on the 27th October it was decided that the ground level of the nave was to be excavated to a depth of 315mm or the natural clay if reached first. The results of both elements of the work are described here.

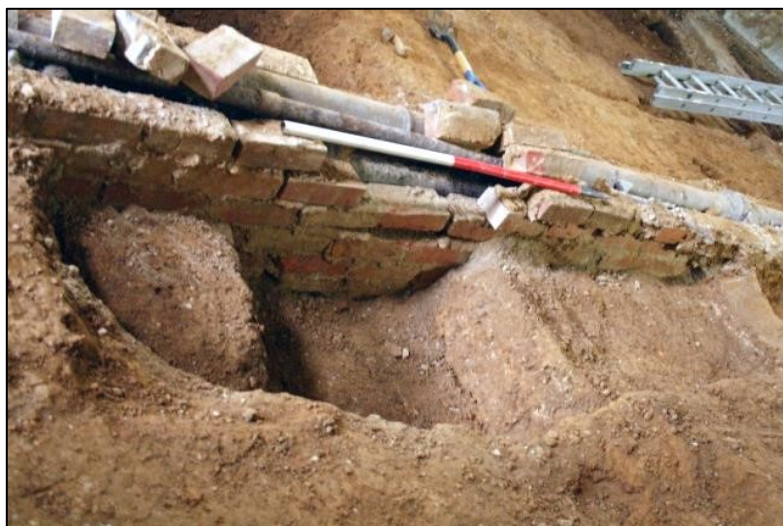
Plate 8: Grave Cut (Context **10**)

- 4.15** To the south side of Context **14** were two probable grave cuts. Context **10** was first noted in Trench **B** where it was excavated to a depth of 500mm, the rest of the excavation was to the impact level of 315mm. The grave cut was on an east to west alignment, and was 2.3m in length with a width at its widest point of 700mm, which narrowed to 400mm at the eastern end, (Plate 8). The northern side of the grave was truncated by the pipe run (Context **14**). The corners of the cut of the grave were slightly rounded, with a sharp break of slope at the top of the cut. The feature was not excavated to its full depth but the sides appeared to be vertical. The grave cut had three fills (Contexts **7**, **11** and **15**).

- 4.16** The upper fill (Context **7**) of the grave cut Context **10** was a dark greyish-brown silty clay loam with a firm consistence. The fill had a depth of up to 140mm and inclusions of ceramic building material (1%) and chalk pieces up to 20mm (<1%). Artefacts were of ceramic building material.

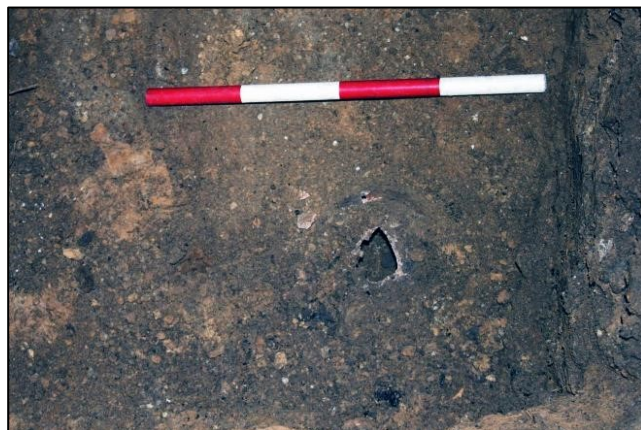
Plate 9: Childs Skull *in-situ* Context **7**

- 4.17** Context **11** was the fill below Context **7**, a friable yellowish-brown clayey silt with a depth of up to 130mm. The fill was disturbed and had inclusions of sandstone pieces up to 30mm (<1%) and ceramic building material (<1%). The artefacts recovered from this fill were of a child's skull with a possible shroud pin at the rear of the skull (**Plate 9**), also recovered from this fill were a number of pins.

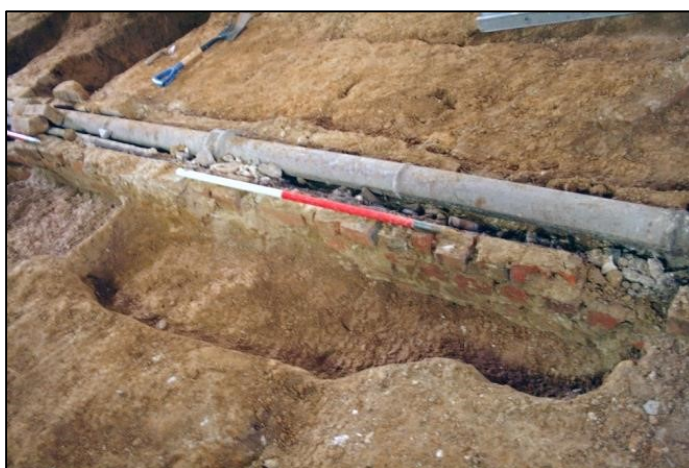
Plate 10: Grave Cut (Context **27**)

- 4.19** Context **27** was a second grave cut located to the east of Context **10** (Fig. 4). The plan of this grave cut was of an irregular linear shape on an east to west alignment (**Plate 10**). This feature had been truncated on the northern side by the heating pipe run (Context **14**). The grave cut was 1.95m in length with a width of 500mm at its widest point, with the eastern end of the feature being stepped in to a width of 250mm. This grave cut was only excavated to the impact level of 315mm, but the break of slope at the top was slightly rounded with vertical sides. The excavated depth comprised a single fill (Context **28**).

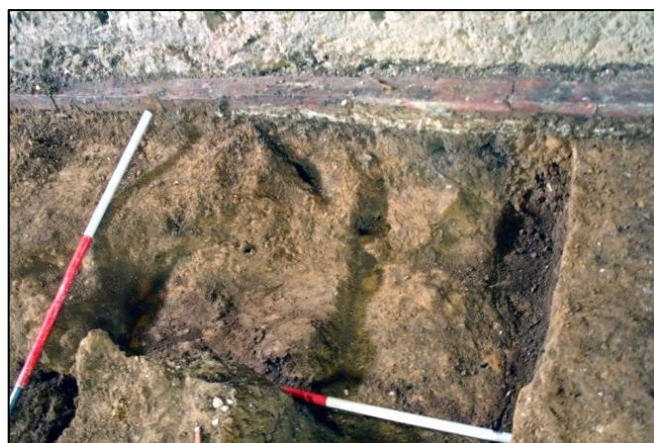
Plate 11: Medieval Features (Contexts 8 and 22)

- 4.22** To the north side of Context **14**, it was much more disturbed than the southern side. Adjacent to the north wall of the Nave were the earliest features discovered during the excavations. These consisted of two shallow Medieval pits; Contexts **8** and **22** (**Plate 11**). Context **8** was first discovered during the excavation of Trench **B**. A heavily truncated, irregular oval shaped feature with a squarer cut projecting on its western edge, cut into the assumed natural (Context **16**). The feature measured 700mm in length east to west, and a maximum width of 520mm. The pit had an irregular break of slope at the top of the cut on the north side and a sharper edge on the western side. The break of slope at the base of the feature was irregular with an irregular dished base.

- 4.23** Context **9** was the single fill of Context **8**, a dark brown clayey silt with a firm consistence with a depth of up to 310mm. The inclusions in the fill comprised charcoal flecks (1%) and sandstone pieces up to 30mm; some of these were burnt. Artefacts recovered from this fill comprised Medieval pottery and bone.

- 4.24** Context **22** was located to the east of Context **8**, and cut into the assumed natural Context **16**. This feature was first noted as a square cut in the western end of Context **5**, which sealed its eastern end. Cut **22** was curved at the western end with the eastern end and southern edge being cut by possible grave cuts Contexts **29** and **30**. The feature also appeared to be cut by the north wall of the Nave. The dimensions of this feature were approximately 800mm in both a north to south and east to west directions. The break of slope at the top was rounded which led to gradual but irregular sides. The break of slope at the base was gradual, and the base was irregular but sloped to the eastern end before being truncated by the possible Grave Cut **29**. The base also had a step down at the western end. This feature was interpreted as a second Medieval pit, however it could be the same pit as Context **8** but because of the various truncations it was very difficult to define the actual edges of both features.

- 4.25** Context **23** was the single fill of Context **22** and had the same matrix as the fill of Context **8**. This was a dark brown silty clay with a firm consistence, and was up to 300mm deep. The inclusions in the fill were of charcoal flecks (1%) and sandstone pieces up to 30mm (<1%), some of which appeared to be burnt. Recovered from this fill were a number of sherds of Medieval pottery.

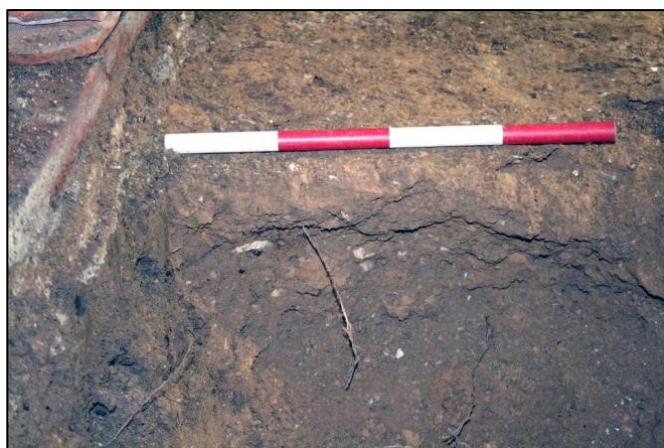
Plate 12: Remnant of Pummelled Earth Floor (Context **5**)

- 4.26** Context **5** was the remains of a pummelled earth floor which was most apparent during the excavation of Context **22**, where it was noted overlying the southern and eastern edges of that feature (**Plate 12**). The floor had a thickness of up to 30mm and was a compact mid orange-brown silty clay. The dimensions of the feature were approximately 800mm north to south by 700mm east to west at its widest point. The surface of the floor had chalk flecks (1%). No artefacts were recovered from the floor layer.

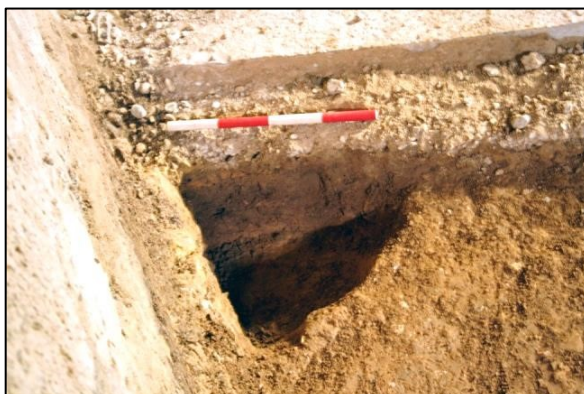
Plate 13: Truncated Un-dated Semi-Circular Pit (Context **25**)

- 4.29** Context **25** was a semi-circular cut in the north-east corner of the Nave (**Plate 13**), and was adjacent to the north wall of the Nave or possibly cut by it, and cut into the assumed natural Context **16**. The eastern side of the feature was truncated by the angled drain run of ventilation for the pews (Context **25**). The feature measured 390mm north to south by 400mm east to west. The break of slope at the top was sharp which led to steeply sloping sides. The break of slope at the base was gradual, with the base being dished.

- 4.30** Context **26** was the single fill of Context **25**. This had a similar matrix to the two Medieval features Contexts **8** and **22**. This was a dark brown clayey silt with friable consistence, with inclusions of pieces of sandstone up to 70mm (<1%). The fill was up to 180mm deep. Although, the fill was of a similar type to those in the Medieval features no artefacts were discovered, which means that this feature could not be dated with any certainty.
- 4.31** Context **30** was a linear cut which truncated the south sides of the Medieval features (Contexts **8** and **22**). The cut had a degraded break of slope at the top, which led to almost vertical sides, which were excavated to depth of 700mm at which depth the limit of excavation was reached.
