**An Archaeological Watching Brief
at Forge Cottage, Thursley Road,
Elstead, Surrey.**

Project No. CBAS0356

WA/2012/1090
SU 90664369

July 2015

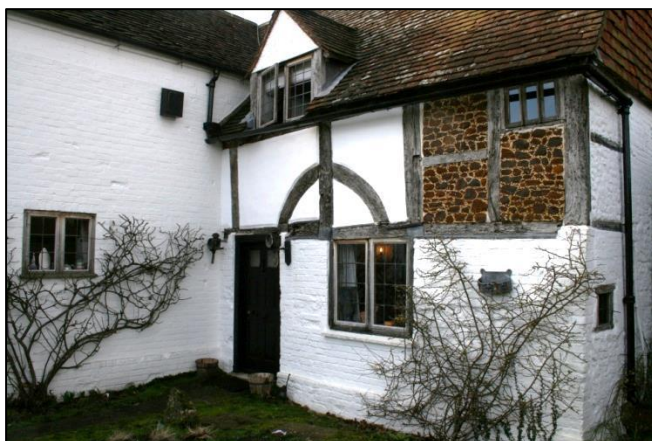
4.2 The walls of the original cottage are visible externally on the eastern, northern and western elevations. On the eastern elevation (**Plate 1**) there is no timber framing apparent on the ground floor of the building, and has been completely in-filled with brick. The brick work is painted white. The timber framing externally visible on the first floor of this elevation consists of the two northernmost principal posts (C and D). There are also three wall studs with the second stud from the southern end has a downward curving brace joined to it on either side. These rise from the side girt. The side girt has the pegs still *in-situ* for the wall studs to the ground floor. The side girt appears to have been replaced at the southern end over the front door to the property.

Plate 1: The Eastern Elevation of the Original Cottage

4.3 At the northern end of this elevation, principal post C has a rail at mid height running to the northern wall stud. Between the last stud and the principal post D, there is a small high set window which appears to be in its original position (evidenced by the rail morticed and pegged into the stud and principal post D). There is a third stud positioned above the southern side of the door, the top of which is pegged and morticed into the wall plate. The small panel framing on this elevation appears to be of lime rendered wattle and daub, with the exception of the panels at the northern end of the building, which are in-filled with pieces of ironstone. The mortar between the ironstone has been galleted with smaller pieces of ironstone.

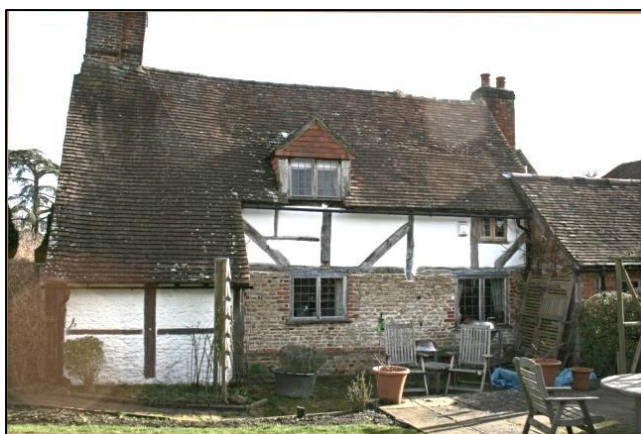
- 4.4** A large section of the western elevation of the original cottage is visible (**Plate 2**). As with the eastern elevation the ground floor level has been in-filled, but on this side of the house it is mainly of stone blocks with occasional bricks around the windows and as a string course approximately 500mm below the base of the windows. There is a slightly later outshot extension located at the northern end of the elevation which houses the staircase (no longer used). The outshot is also of small panel timber framing, which has been in-filled with stone on the northern and western walls. The southern wall is of brick around the door with stone above. All the walls have been painted white. On the northern elevation of the outshot, there is a timber sloping down from the first floor level to the west, which appears to be the northern bearer of the staircase (**Plate 3**).

Plate 2: Western Elevation of Original Cottage

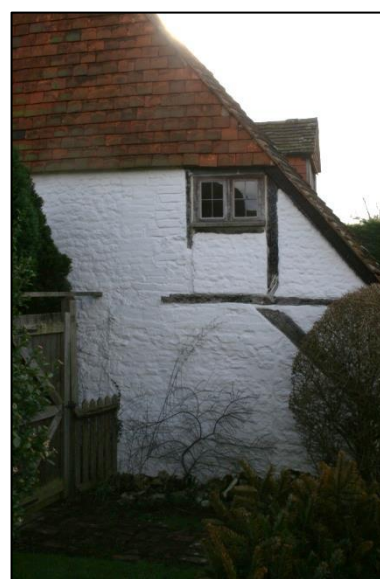
Plate 3: Sloping Timber on North Wall of Outshot

the studs. Above the rail is a small window, which was possibly the location of an original window. It was noted that the cross beam appeared to continue across into the staircase outshot which would suggest that the outshot is contemporary with the 16th century cottage (**Plate 3**). The gable is tile hung with red clay tiles.

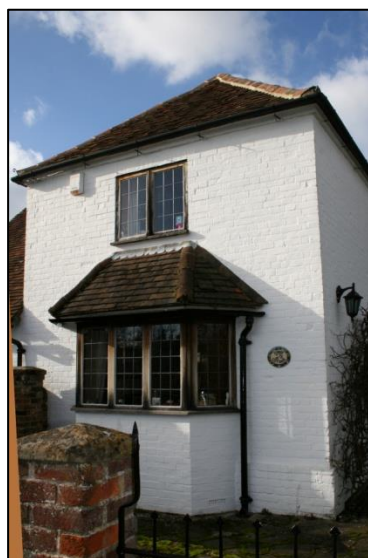
4.8 The late 18th century two-storey extension to the eastern side of the original cottage is of brick construction. The bricks are laid in mainly Flemish bond but in some areas are laid in random bond. The western elevation on the ground floor has a modern bay window at ground level and modern casement window on the first floor. There is also a small modern ground floor casement window in the centre of the northern wall of this extension. The roof is covered with clay tiles and is hipped at its western end.

Plate 4: 18th Century Extension

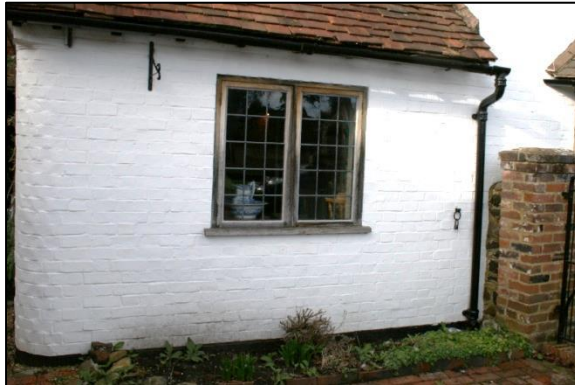
4.9 Attached to the southern side of the 18th century extension is a possible 19th century addition. This part of the building is on two storeys at its western end reducing to a single storey at the eastern end. The roof is covered with clay tiles and a gable at the southern end. This was the garage before it was converted into a fourth bedroom with bathroom above¹⁰. On a close inspection of the junction of this part of the building with that of the 18th century extension, no obvious joint could be seen (**Plate 5**), which suggests that this could have been a modified part of the 18th century extension.

Plate 5: 19th Century Extension

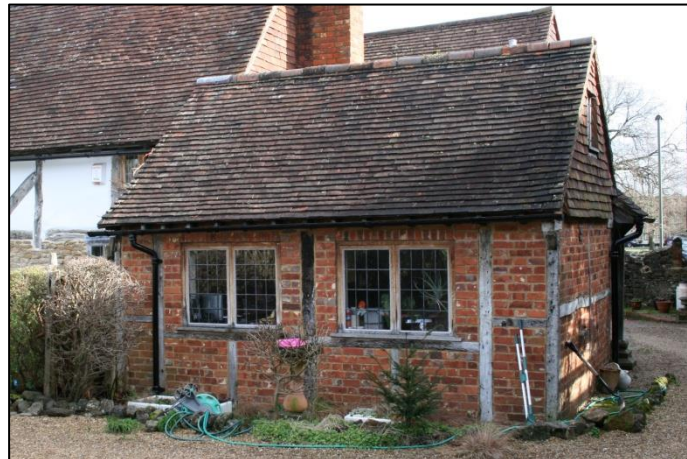
- 4.10** In both of these parts of the building the brickwork is the same type of bond, which is Flemish bond. The brickwork has been rounded on the south-eastern corner of this part of the building. This was usually done to create easier vehicular access.
- 4.11** The latest phase of the building is the single storey kitchen extension on the south-western corner of the property (**Plate 6**). This was constructed in 1993 and is of brick construction, laid in Flemish bond. This part of the building has timber framing incorporated into the brickwork, but is more decorative than structural. This has modern casement windows fitted. Between the western end of the kitchen and the east of the 19th century there is a small in-fill building which appears to be contemporary with the kitchen block.

Plate 6: South-western Corner Kitchen Extensions

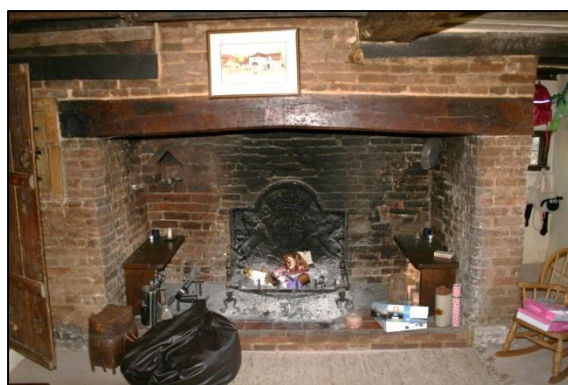
5.1 The original cottage has two rooms on the ground floor and two rooms on the first floor. The main entrance to the interior of Forge Cottage is located in the western wall of the Drawing Room. The Drawing Room is dominated by an inglenook fireplace within the northern wall of the room (**Plate 7**), this most likely dating to the 16th century and is contemporary with the chimney stack. This is of brick construction with a thick timber lintel above the hearth. Above the lintel the cross beam between the principal posts C and C-C is cut by the breast of the inglenook fireplace. In the hearth there is a metal fire basket with a cast iron fireback depicting a lion and unicorn. On the western side of the fireplace there appears to be the remains of a bread oven. Just to the west of the fireplace there is a small cupboard which is possibly the original spice cupboard. At the northern end of the western wall of the Drawing Room is the doorway to the outshot staircase projection. The frame to this doorway appears to be constructed using re-used timbers.

Plate 7: The Inglenook Fireplace

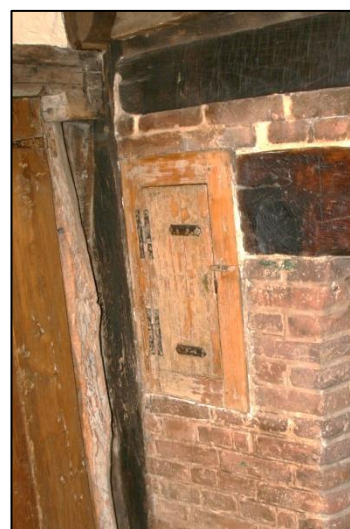
Plate 8: Possible Original Spice Cupboard

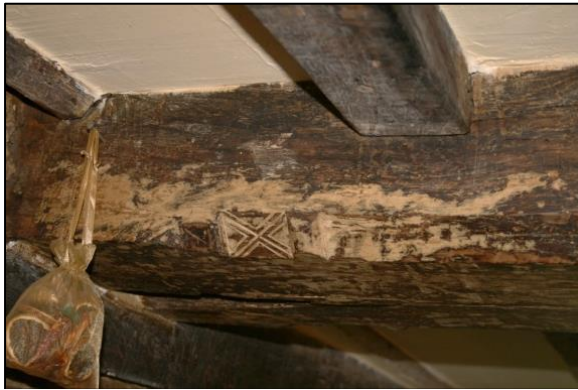
5.3 The ceiling of the Drawing Room consists of a central girder which is chamfered and stopped at both ends. Also noted was a small saltire design just before the stop (**Plate 9**), this design also appears on the end of the door latch of the door to the north western staircase (**Plate 10**). The central girder is on a north south alignment and has twelve joists on either side on an east west alignment.

Plate 9: Saltire Design on Central Girder

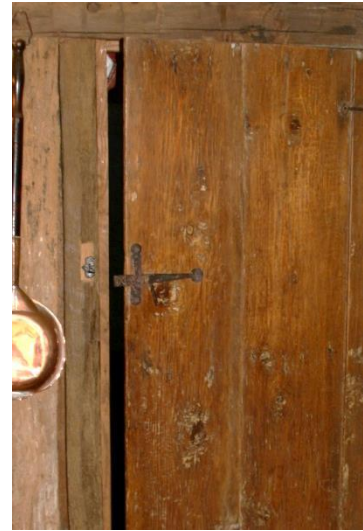
Plate 10: Design on Door Latch

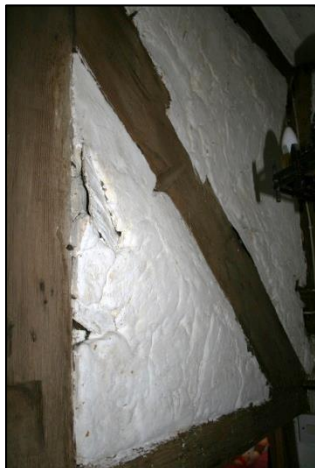
- 5.4** The door at the northern end of the west wall in the Drawing Room leads to the disused staircase in the projection of the building at the northern end of the western wall. The eastern wall of the stair well is the western wall of the original house. In evidence on this wall are a straight downward brace which is morticed and pegged into the side girt and the Principal Post C-C (**Plate 11**). The eastern wall of the stairwell is of wattle and daub construction with a lime mortar rendering. In the northern, southern and eastern walls of the stairwell the same timbers are apparent as noted in the exterior description of the building.

Plate 11: Brace in Eastern Wall of Stairwell

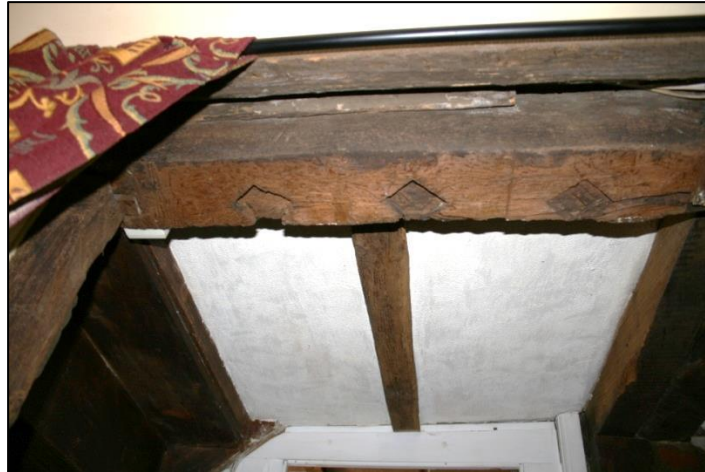
- 5.5** The Anteroom is located to the south of the Drawing Room. The timbers apparent on the south wall of the Drawing Room are also apparent in the north wall of the Anteroom, with the addition of the Principal Post in the north-western corner of the room. The eastern wall is of brick with the doorway to the 18th century extension at the southern end of it. The doorframe is constructed of the Principal Post A with a lintel above; the northern upright of the doorframe is a modern timber. This was originally a diamond mullioned window of most likely four lights (**Plate 11**). This is

evidenced by the three diamond shaped mortices in the soffit of the doorframes lintel, and the sawn off tenon located about half way up the principal post for the lower window rail.

Plate 11 Diamond Shape Mortices for Window Mullions

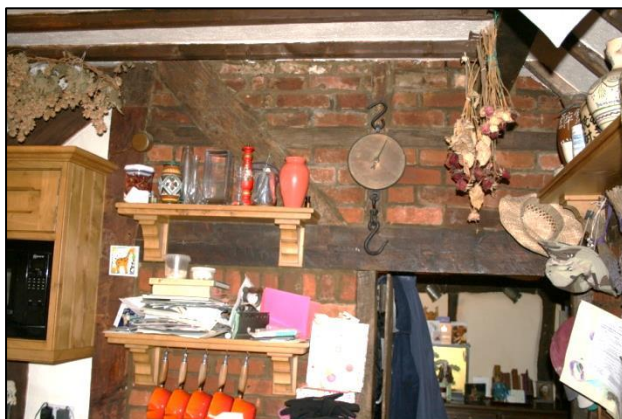
- 5.6** There is a brick built fireplace in the southern wall of the Anteroom, with a wall stud adjacent to the eastern side of it. Just below ceiling height the cross beam of the original north end of the cottage can be seen. The ceiling appears to comprise the original joists, these are on a north to south alignment. At the eastern end of the southern wall of this room is the entrance to the Modern Kitchen extension.
- 5.7** The kitchen is completely modern with plaster and bare brick wall with mock timber framing attached to the surface, this part of the building was constructed in 1993 (**Plate 12**). This is where the new extension is to be constructed, after the present extension is demolished. This building work will only impact on the 1993 extension with none of the earlier fabric of the building being affected.

Plate 12: The Timber framing in
The 1993 Kitchen Extension

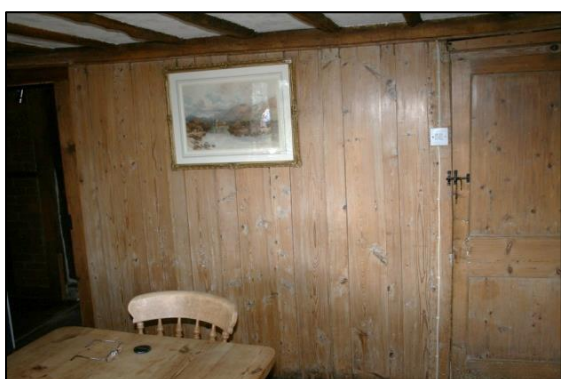
- 5.8** The Dining Room and Bedroom 4 are located in the two extensions on the eastern elevation of the original cottage. The Dining Room is the only ground floor room in the 18th century extension. There is a small amount of timber framing visible, consisting of a central ceiling girder on a north south alignment. The central girder has eight joists either side of it running in an east west direction. The walls are all plaster excepting the western wall which is of pine vertical planks with a moulded cornice at the junction of the panelling with the ceiling (**Plate 13**). The panelling was also noted on the western wall of Bedroom 3, which suggests that this was an original 18th century feature. In the centre of the southern wall there is a medium sized fireplace. The fire place is of cast iron with a wooden surround (**Plate 14**). Between the sides of the fireplace and the outer surround there is a column of five decorated tiles, and would appear to be Victorian.

Plate 13: Wooden Panelling in Dining Room

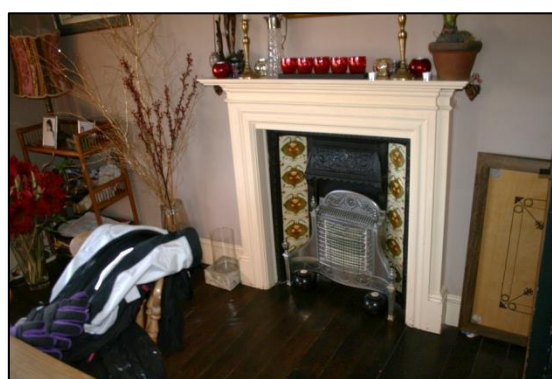
Plate 14: Fireplace in Dining Room

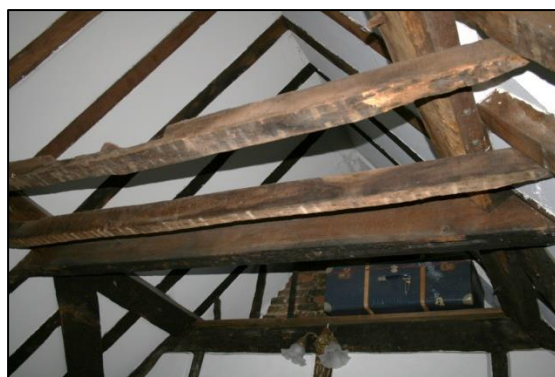
- 5.10** The first floor of the original 16th century cottage consists of the Master Bedroom and Bedroom 2; there is short corridor in the south-eastern corner of the original building giving access to the two bedrooms on this floor. The Master Bedroom is located at the northern end of the original building, and is open to the roof. The roof is of the common rafter type with side purlins. There are four collars with only the most northerly one clasping the purlins. This collar is also of much greater scantling than the other three, and has a row of six mortices (**Plate 15**). The end mortices both have empty peg holes; these end mortices are longer than the other four. Possibly the empty mortices suggest that the very north end of this room was partitioned off. The other three collars appear not to be original. The collar in the trusses in the northern wall of the Master Bedroom have three staves rising to the rafter above at the western end of it.

Plate 15: Collars in Roof Master Bedroom

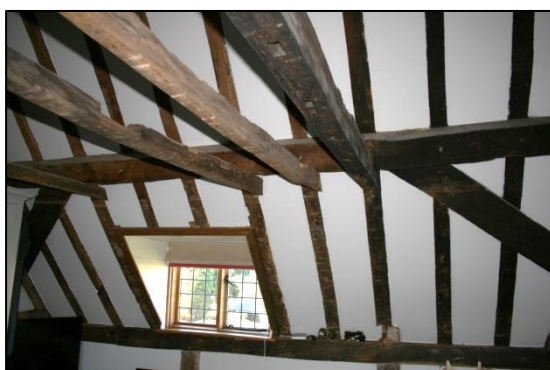
- 5.11** There are two wind braces at either end of the framing of the roof on both the western and eastern sides of the Master Bedroom (**Plate 16**). These have been set into the inner face of the rafters and the purlins. The wall plates on both sides of the Master Bedroom are original, as are the tie beams at the northern and southern end of the room; the southern wall tie is only visible for a short length at its western end before being obscured by a large cupboard at the southern end of the room. There is a change to narrower floorboards in the north eastern corner of this room, with the post in the western wall having a notch cut into the top of it.

Plate 16: Wind braces Western Side

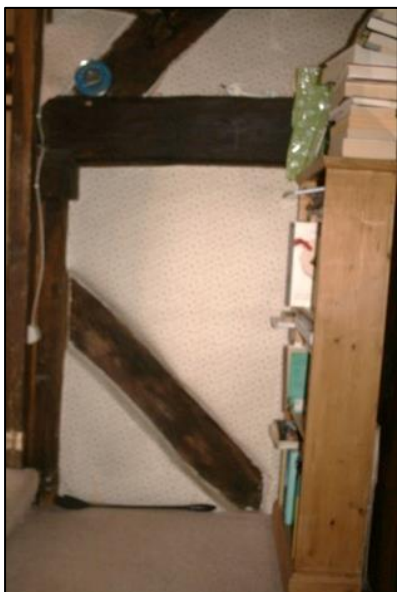
- 5.12** In Bedroom 2 the original timber framing consists of the western wall plate and the tie beams at both ends of the room. In the southern wall at the western end there is a straight downward brace wall plate, rising from the cross beam to the eastern face of principal post A-A. There is also a wind brace in the bottom south-western corner of the roof framing; this has a small shallow mortice cut into the eastern face near to its junction with the purlin. The eastern wall is of wooden vertical planking with window in its upper part, this appears to be a modern partition dividing Bedroom 4 the corridor to the east of it. In this corridor the timber framing of the original eastern wall of the cottage with its brick infill is visible. This consists of the eastern wall plate with the eastern end of the southern tie beam and the principal post A in the south-eastern corner of the corridor. At the eastern end of the southern wall joined to principal post A, there is a slightly curving downward brace (**Plate 17**). Just visible is the southern end of the downward brace on the northern side of principal post B. At the southern end of the framing of the eastern side of the roof there is a wind brace, this appears to be in its original position but has had a timber inserted behind it.

Plate 17: Downward Brace in Corridor

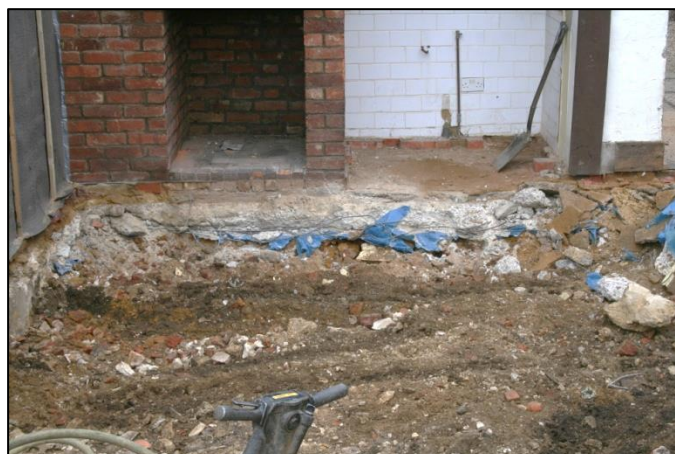
- 6.1 Context 1 was the concrete floor of the 1993 extension located at the eastern end of the footing trenches (**Plate 18**). This was of concrete construction with steel reinforcing rods and had a thickness of 500mm. The concrete floor was laid on a hardcore bed of red bricks, with a blue plastic membrane between the floor and the hardcore.

Plate 18: Concrete Floor of the 1993 Extension.

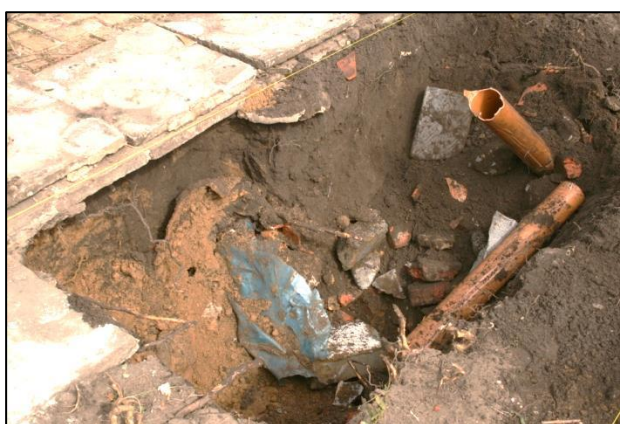
- 6.5** Context **3** (**Plate 19**) was a modern soak-away located in the projecting northern footing trench. The soak-away was roughly circular in plan, measuring 1.5m at the top, with a depth of 1.45m. The break of slope at the top was irregular. The sides were gently sloping with the break of slope at the base being gradual. The base of the soak-away was an irregularly dished shape. The fill of the soak-away was of the same dark brown sandy silty loam matrix as the topsoil, mixed with an orange coloured sand (25%). The fill was very loose in consistence. The inclusions in the fill were fragments of broken breeze blocks (5%), large pieces of mortar (5%) and ceramic building material (5%). The ceramic building material consisted of modern broken roofing tiles, with the fill of the soak-away also included some plastic sheeting. A modern orange plastic pipe was running from the soak-away towards the house to the east. The cut of the soak-away cut Contexts **2**, **4** and **5**.

Plate 19: The Soak-away

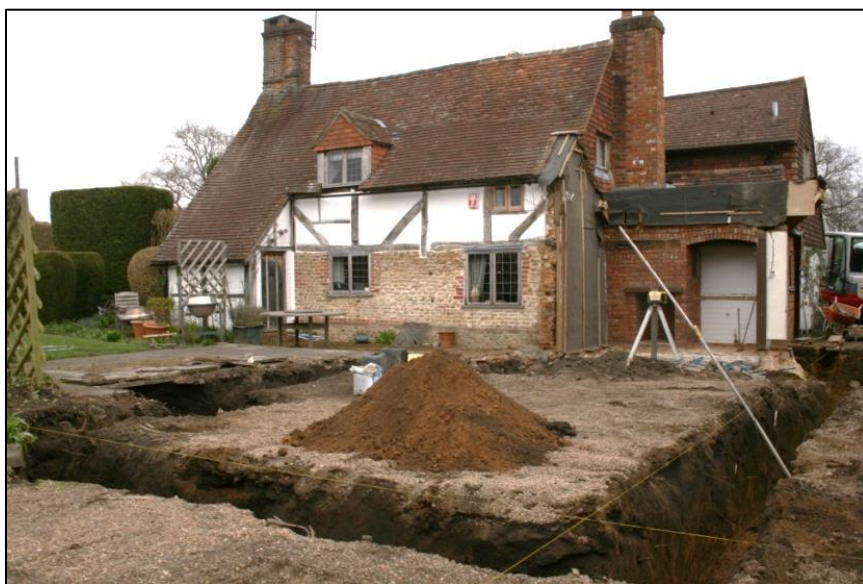
- 6.6** Context **6** was a concentration of large pottery sherds and glass bottles, located 7.1m from the western wall of the house in the southern footing trench. This appeared to cover a circular area of approximately 600mm within the topsoil (Context **2**) but there was no cut apparent.
- 6.7** Context **7** was a drain run running on an east to west alignment to the house, located 2.1m from the northern side of the footings trenches. The drain run was 1m in width and cut both the topsoil (Context **2**) and the subsoil (Context **4**). At the base of the drain run there was a reddish-orange ceramic drain pipe with an external diameter of 120mm.
- 6.8** No archaeological features were noted during the excavations of the footing trenches (**Plate 20**).

Plate 20: The Completed Footing Trenches

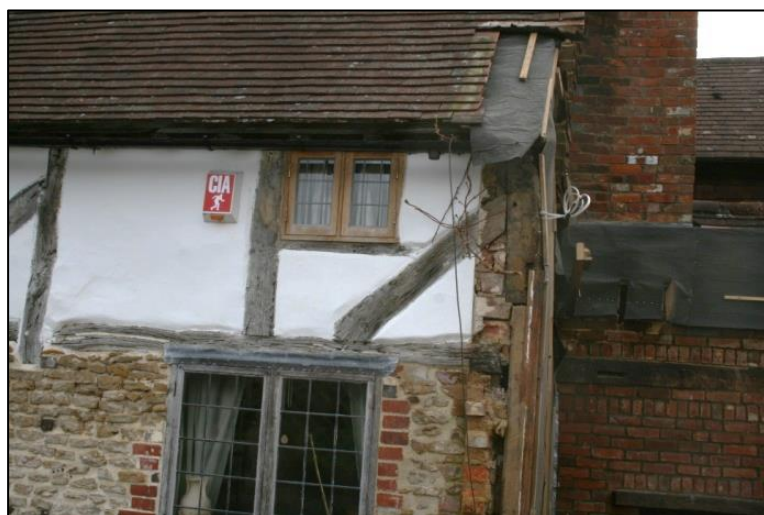
- 8.1 The brief walk through survey confirmed that there is still a large part of the original 16th century timber framing belonging to the earliest phase of the building surviving. It was noted during the course of the survey that the downward braces on the eastern side of the building were curved, whereas the braces on the western side of the building were straight.
- 8.2 The building of the replacement extension has not impacted on the original fabric of the cottage as it is attached to the same area as the original extension which was built in 1993. The only part of the original framing exposed by the building works was the principal post of the south-western corner of the cottage. The principal post had been largely replaced by a replacement post that had been scarf jointed to a remnant of the original timber (**Plate 21**).

Plate 21: The South-western Principal Post

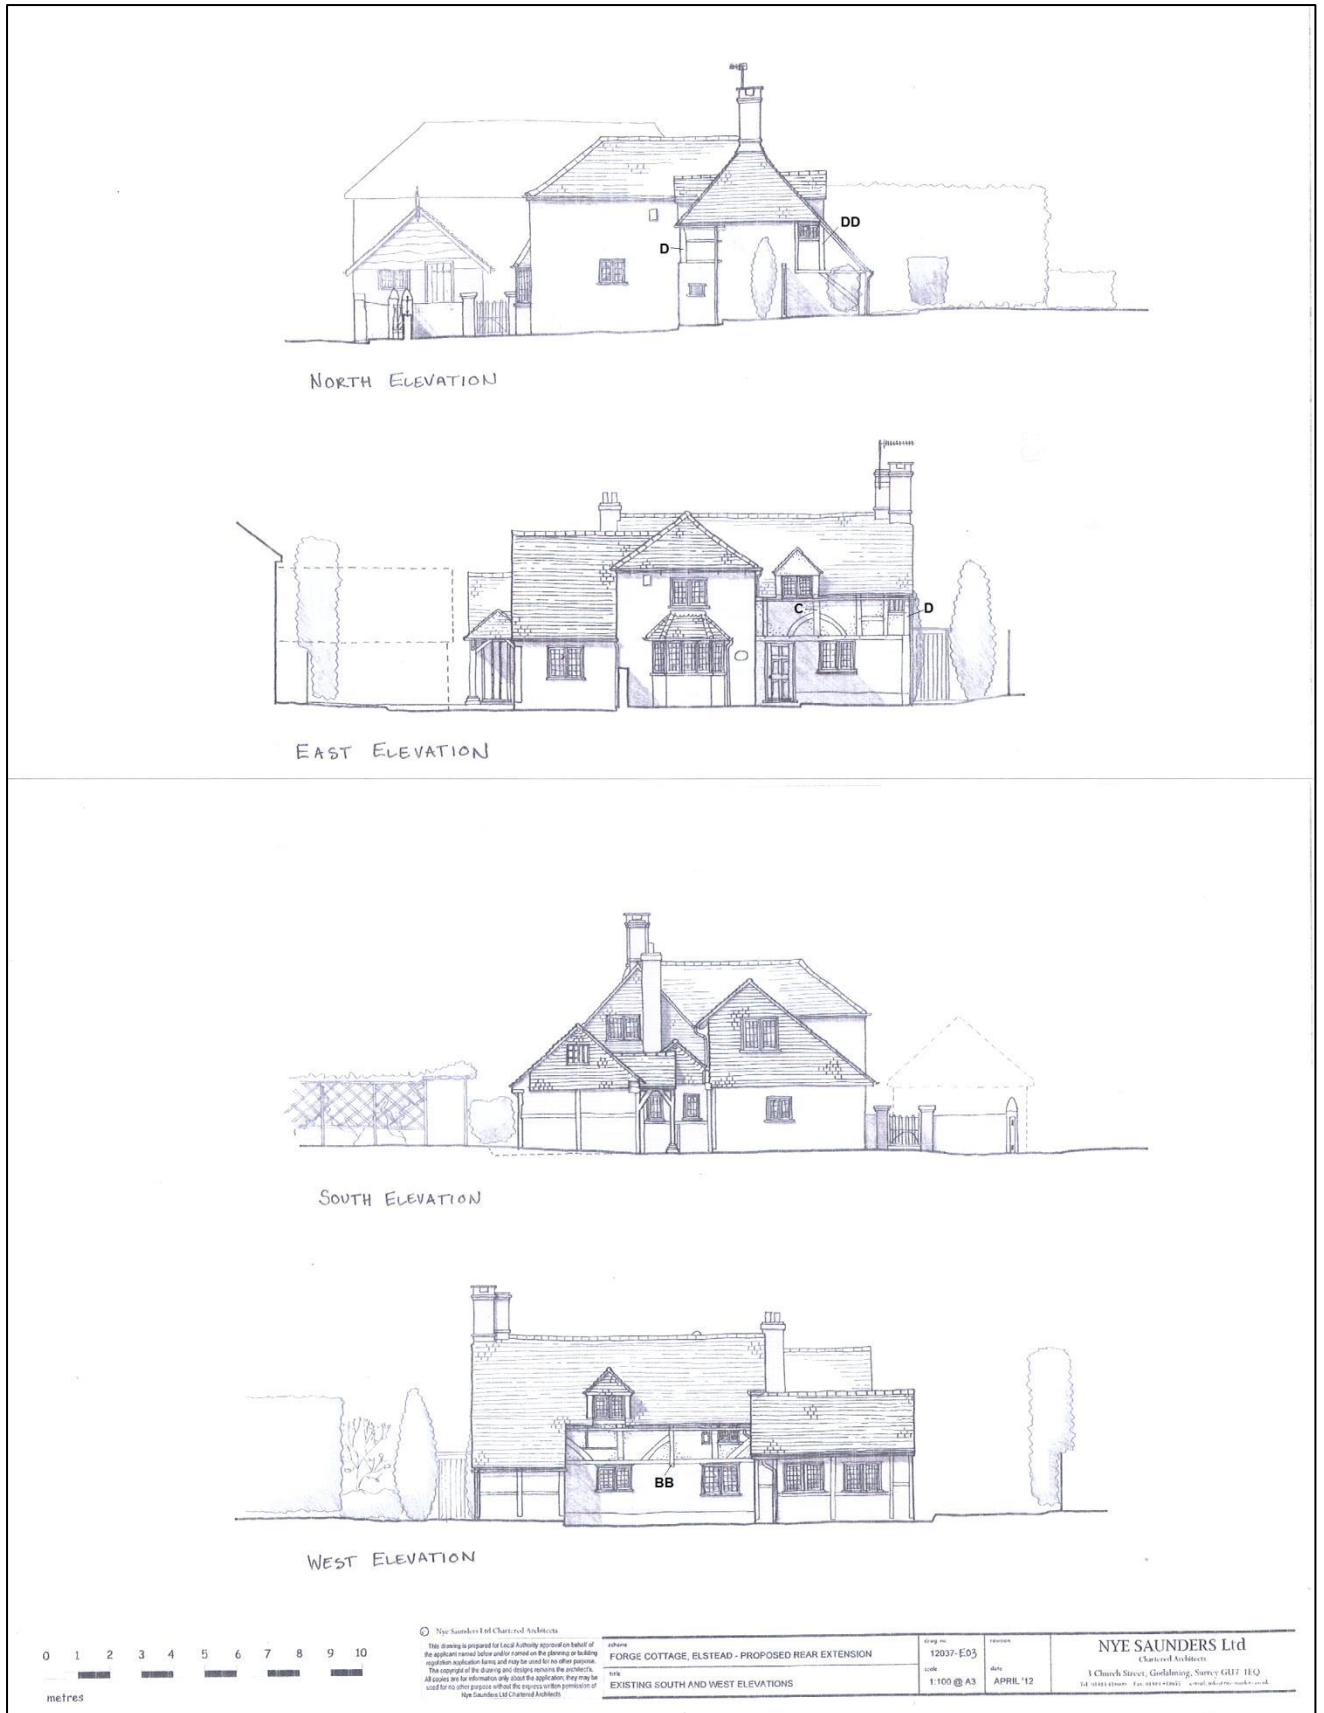
Fig. 7: Forge Cottage, Elstead: House elevations
(Adapted from Architects drawings)

4.0 Building Survey: General External Description (Fig. 7)
