**A Statement of Significance  
for  
Shoreham Town Hall, High Street,  
Shoreham by Sea, West Sussex**

by  
Keith Butler PIfA

June 2013

*Shoreham Town Hall was built in 1830 as a Custom House, and subsequently converted to the Town Hall in 1886. The building is a Grade II Listed Building, and has been modified inside for use as a restaurant and offices, and has an annex added to its south side in the 1920's.*

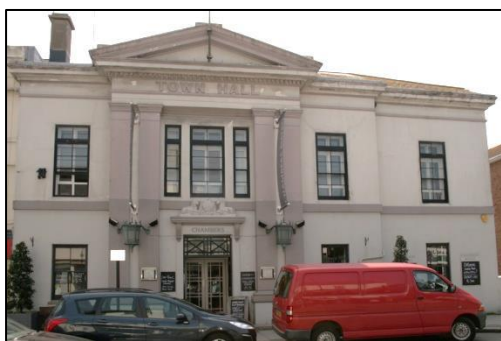
**Plate 1:** Northern Elevation

- 4.1 The northern elevation of Shoreham Town Hall faces onto the High Street (**Plate 1**), and is of two storeys externally (Fig. 10). This elevation is of four bays, with the western bay, which was a later addition to the building, being slightly recessed. The northern elevation has a rendered finish and is painted white with details such as the pilasters and surround to the pediment being painted grey.

- 4.2 The central bay of the original building has the original main entrance on the ground floor which is now the entrance to the Chambers Bistro which occupies the northern part of the ground floor. Above the entrance is a projecting plinth supported at the east and west ends by a corbel. Surmounting the plinth is a coat of arms which is supported by a lion on the eastern side and a unicorn on the west representing the royal arms (**Plate 2**). Below the plinth there is the word 'CHAMBERS' in modern raised lettering. Above the doorway is a window consisting of a centre sash window which is divided into ten panes of glass by narrow glazing bars. To the east and west of the central window there is a narrow sash window consisting of a column of five panes of glass. At the eastern and western ends of the central bay there are plain double pilasters, with a moulded capital. The base of the pilasters has a moulded frieze around its upper edge. The double pilasters support a lintel which has a raised horizontal moulded band which is apparent on all of the bays of this elevation. Above this band and below the slightly projecting pediment are the words 'TOWN HALL' in raised lettering. A band of dentil detail was noted at the base of the pediment and also the shallow returns to the centre original bay, this was not apparent on the other bays of the building.

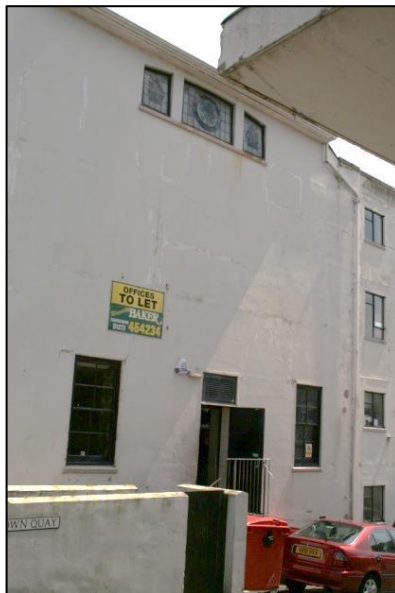
**Plate 5:** Western Elevation of the Town Hall

**4.4** The western elevation consists of the Town Hall at the northern end (**Plate 5**) with the building known as the Annex (**Plate 6**) to the south of this. There is a further element of this elevation at the southern end which is development of flats, built in the 1980's and was not included in this survey. As with the northern elevation, the western is of a rendered finish painted white. The ground floor of the Town Hall western elevation is the western exterior of Chambers Bistro, which consists of a doorway in the centre with a modern sash window on the north and south side of it. The only other features are three windows just below the western edge of the hipped roof. The three windows have a curved head and although separate form a single unit (**Plate 7**).

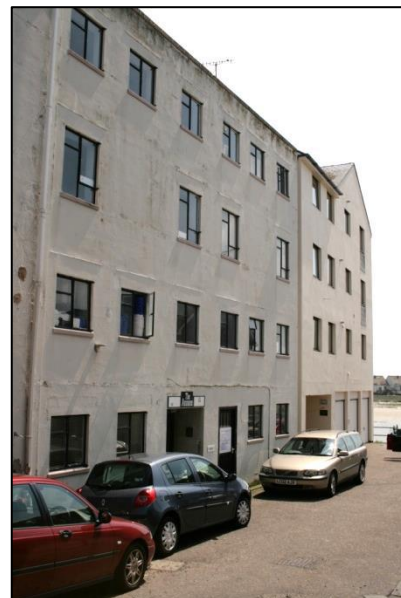
**Plate 6:** Western Elevation of The Annex

**4.5** The western elevation of The Annex is on four floors, and has the same white painted finish as the elevations of the Town Hall. The entrance to The Annex is the northern doorway of two located in the centre of the lower ground floor. The southern doorway is the entrance to an office on the southern side of the lower ground floor. To the north and south of the two doorways are two Crittall type metal framed casement windows. The same type of windows also occurs on both the upper ground floor and second floor level, with those on the first floor being slightly longer in height and having an extra glazing bar in the lower part of the northern side of the window (**Plate 6**). The upper ground floor and second floor have a row of six windows, whereas the first floor only has a row of four.

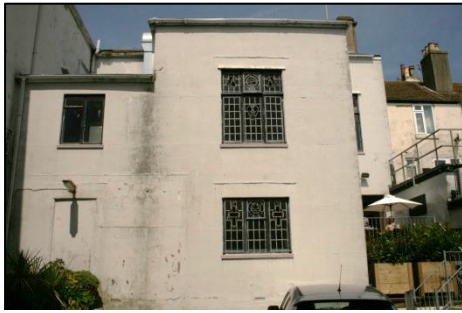
**Plate 8:** Southern Elevation of Town Hall

**4.6** Access to the southern elevation of the Town Hall and the eastern elevation of The Annex is via a short subway under the northern end of the 1980's building at the southern end of the complex of buildings. Both the eastern elevation of The Annex and southern elevation of the Town Hall are of a white painted render. In the centre of this elevation the block holding the staircase projects from the main body of the Town Hall (**Plate 8**), and has a small infill building between its western side and the eastern wall of The Annex. The only features visible on the exterior of the eastern wall of The Annex is a circular stained glass window in the centre of the first floor level and two small metal framed windows at the northern end of the upper ground floor. The small infill building has a single metal framed Crittall type casement window on the first floor level, with a blocked entrance in the centre of the upper ground floor. The projecting centre section of this elevation has two metal framed window frames with some of the panes being of stained glass on both the upper ground floor and the first floor. The eastern return wall of the staircase projection has the same sort of window as seen in the southern wall located in the centre of the first floor level and a circular window at the northern end of this part of the elevation. The eastern side of the projecting staircase range has a raised outdoor dining area belonging to Chambers Bistro.

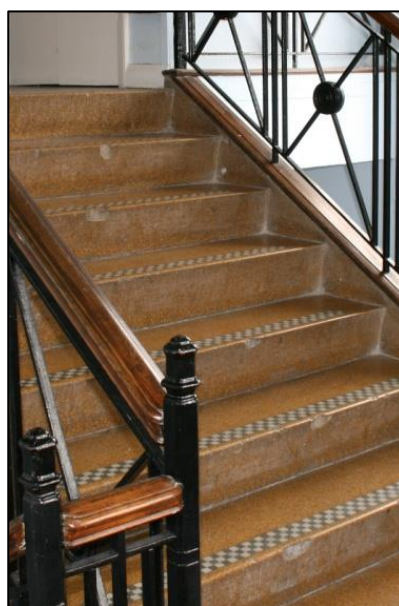
- 5.2** Chambers Bistro occupies the whole of the northern half of the building on the upper ground floor and was not included in the survey. The projecting part of the building houses the staircase **B1**. The staircase on the upper ground floor consists of three flights; the first has four steps up to a landing with a split staircase second flight of eleven steps on both the western and eastern sides to a landing, with a third flight central staircase of nine steps to the first floor landing (**Plate 11**). The landings and stairs appear to be polished concrete which is brown in colour. Where the outer finish of the concrete has been chipped the concrete is a light grey in colour (**Plate 12**). The landings have a geometrical design in black, with the stairs all having a panel of black and white small tiles inserted close to the front edge of the treads, laid in a checked design. The staircase has a square sectioned metal continuous balustrade, which is painted black. The balustrades consist of an outer rectangle frame with a diagonal bar from each corner meeting in the centre at a roundel, which has a raised centre dome in the middle. The newel posts are of larger square sectioned metal surmounted with a decorative finial. The hand rail is of moulded wood with a varnished finish.

**Plate 12:** Chips in Polished Concrete finish on Stair Treads

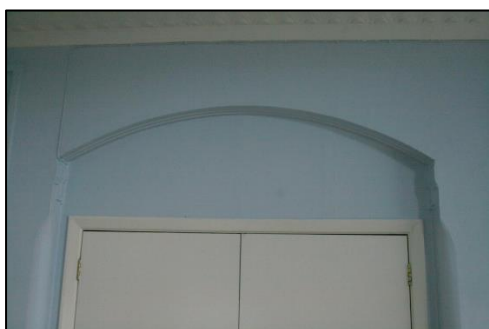
- 5.3** In the northern wall of the intermediate landing there is a blocked double doorway which leads into Chambers Bistro (**Plate 13**). This has a moulded wooden frame with a curved head and a geometrical design located at the springing point on both sides of the head. The ceiling of the first floor of the staircase has moulded coving and two bands of the same on an east to west alignment forming three rectangular panels. All of the ceiling mouldings have a triangular design moulded into their outer faces (**Plate 14**).

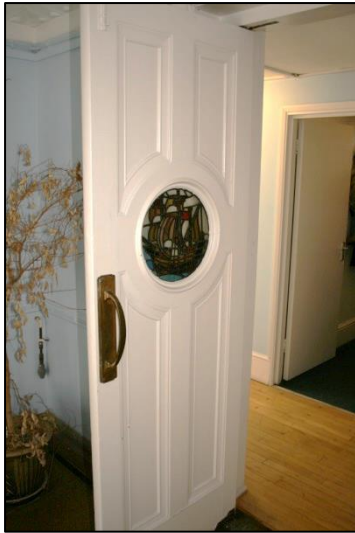
**Plate 15:** First Floor Landing Doors

- 5.4** In the north wall of the first floor landing there are a set of double doors leading to the first floor of the main body of the building. These appear to be Victorian in date, and have four panels with a circular stained glass window inserted in the centre of the door just above mid height. The stained glass window in each of the doors depicts a sailing galleon (**Plate 15**). The intermediate landing is lit by two circular windows located at the ends of both the eastern and western walls. The window in the western wall is a stained glass window depicting the Shoreham coat of arms (**Plate 16**). This window has a metal frame. The circular window at the northern end of the eastern wall is a modern replica of perplex, with no frame visible (**Plate 17**). There is also a metal framed casement window lighting the lower part of the staircase in the southern wall. This consists of three frames divided into three columns of five rows with the upper panes of the eastern and western frames having a design of a fasces, with a wreath behind. Across this design is a plaque with 'PORTUS ADVRNI' on it. The opening part at the top of the frame of the centre window has a long ship within a wreath (**Plate 18**).

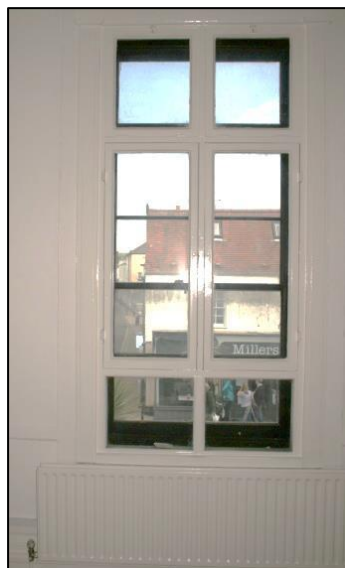
**Plate 21:** Example of Window in North Wall of C1

- 5.8** **C1** is located at the western side of the Town Hall building and its northern side is full height to the original ceiling. The room is lit by two windows which appear to be original; the original windows are flush with the southern face of the wall with a later window inserted into the northern end of the window reveal. The original windows are wooden framed casement windows, with the centre section opening. The lower and upper windows do not open (**Plate 21**). At the southern end of the western wall there is a high set metal framed window which is glazed with stained glass depicting a galleon (**Plate 22**). This window is the northern element of the three windows noted at the top of the western elevation in the general external description. The other two elements of this window are located at the top of the western wall in **D1** on the second floor. There are two sets of paired pilasters on the northern wall of this room, with a fluted wide band below the capital. The pilasters support a projecting coving which is situated at the base of the ceiling. The eastern pilaster of the pair at the eastern end of the room is cut by the dividing wall between this room and **C4**. It was noted that this eastern wall of **C1** also had high skirting

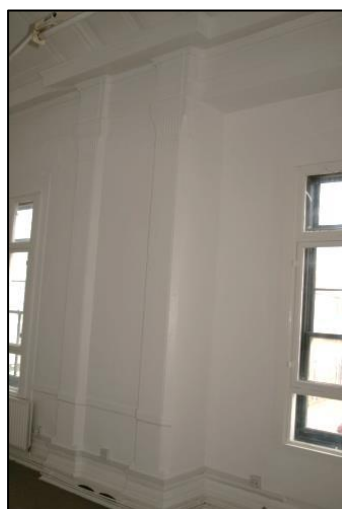
**Plate 23:** Example of Pilasters C1

boards with a moulded top and was a different type to that on the northern and western walls which looked to be the original Georgian type. This would imply that this wall is a later insertion. There is a single pilaster on the western wall, with a moulded capital and a recessed panel in the centre of the column.

- 6.3** The pilasters and the ceiling mouldings are of a classical design and would suggest that they belong to the original Customs House, and are Georgian in date. The windows in the northern elevation of the Town Hall have had modern windows inserted in the outer face of the window reveals, with the earlier wooden casement window being retained on the inner face of the reveal. These are either Georgian or Victorian in date. The wider width of the glazing bars would suggest they most likely have a Victorian date.

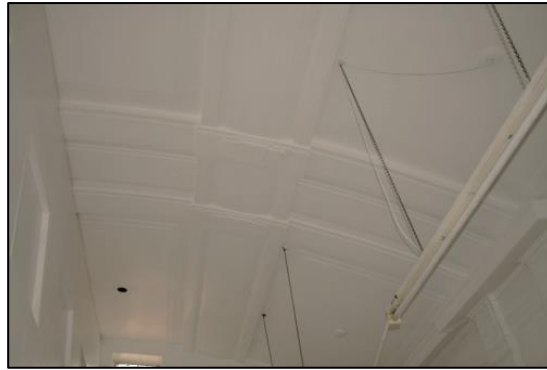
**Plate 24: Ceiling Mouldings C1**

**5.9** The ceiling is half arched in shape and has a wide moulding on an east to west alignment; this has a fluted design on it. There are two mouldings on a north to south alignment, comprising of three bands separated by a small gap. These run from the top of the pilasters on the northern wall, and are cut by the east-west moulding. Over this moulding two outer bands are apparent, with each of these having a circular pattern moulding at their centre (**Plate 24**).

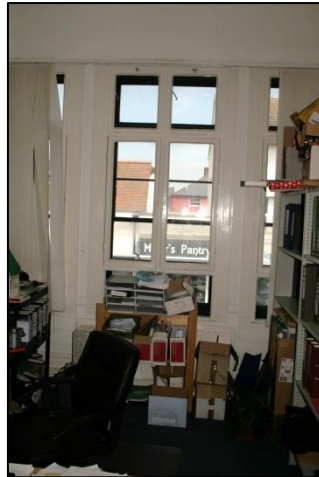
**Plate 26:** Inner Windows **C4**

- 5.11** C4 is the office to the east of C1. The northern end of this room is of the same full height as seen in C1, with the southern end being reduced by the mezzanine floor of D2. The ceiling of the northern end of the room has the same mouldings as seen in C1. The only other early feature noted in the survey where the other half of the eastern pilaster, seen at the eastern end of the eastern wall of C1 and the three original inner windows on the centre bay. These had moulded wooden sides to the frame with a roundel design at their base (Plate 26).

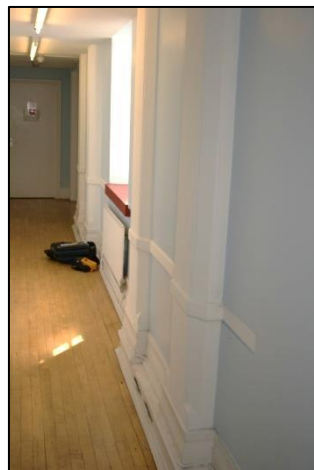
**Plate 27:** Lower parts of  
Paired Pilasters in  
Corridor **C5**

- 5.12** **C5** is the corridor at the south of **C2**, **C3** and **C4**. The only original features are on the southern wall consisting of the lower part of two paired pilasters (**Plate 27**), the upper part being cut by the floors of **D1** and the western end of the floor in **D2**.

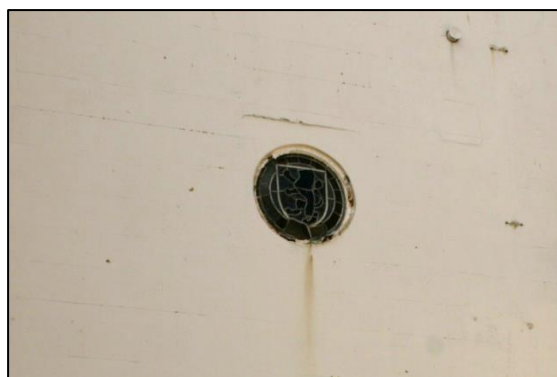
**Plate 28:** Stained Glass Window taken from  
Exterior **C9**

- 5.13** **C6** and **C7** are located at the northern end of The Annex, and are modern WC's with plastered walls and ceiling, no features noted.
- 5.14** **C8** was a modern staircase located to the south of **C7** in The Annex. The staircase had thin square sectioned metal balustrades supporting a metal handrail.
- 5.15** **C9** is located at the southern end of The Annex. This room has plastered walls and ceiling with the only earlier feature being a circular stained glass window located in the centre of the eastern wall. The stained glass window depicts a lion within a shield (**Plate 28**).

southern end of The Annex. All the windows have metal frames which would suggest that they are of a Victorian or later date, with the stained glass window in The Annex possibly being relocated from main body of the Town Hall. However, if this window is in its original position, it would suggest that the windows date from the 1920's when The Annex was built.

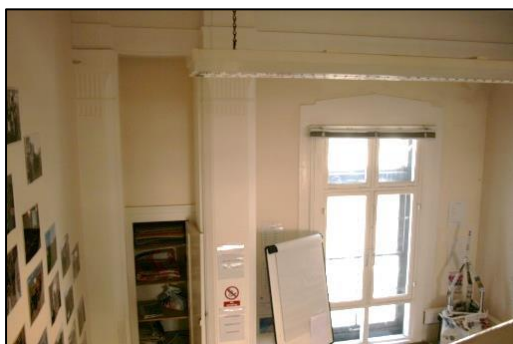
**Plate 29:** Paired Pilasters on North  
Wall of **C10**

- 5.16** **C10** is located at the eastern end of the Town Hall building. The room is of full height at the northern end, and is reduced in height at the southern end by the mezzanine floor of **D2**. This room has a paired pilaster on the northern wall with the western one being directed by the western wall of **C4**. This implies that, as with the eastern wall in **C1**, this wall is also a later insertion (**Plate 29**). Also in this wall is the original casement window with a shallow arched head to the wooden frame. There are two pilasters on the western wall with the top part of both being concealed by the floor of **D2**. The bottom part of a paired pilaster is visible on the southern wall (**Plate 30**). The ceiling mouldings and coving are a continuation of those seen in **C1** and **C4**.

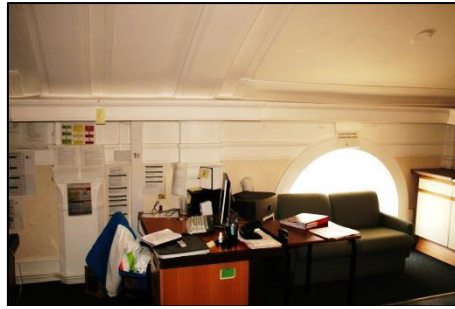
**Plate 31: Top of Pilasters D2**

- 5.17** On the second floor Room **D2** is a mezzanine floor above the southern end of **C10**, and is reached by a modern wooden staircase at the north-west corner. The southern side of the arched ceiling of the Town Hall building is apparent in this room and has the same mouldings and coving as noted before. The top of the pilasters seen on the southern wall of **C10** are apparent on the southern wall of this room. These consist of the capitals and the fluted band below. To the west of the pilasters there is the arched head of a metal framed window. The top of the two pilasters on the eastern wall of **C10** are also visible in this room. The north-western corner has been partitioned off to accommodate a small office **D3**, which has no early features. The walls and ceiling are plastered.

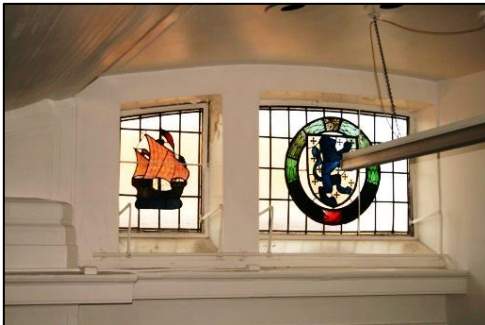
**Plate 32: Stain Glass Windows D1**

**5.18** **D1** is located above the two inserted offices at the southern side of **C1**, and is reached by a modern wooden staircase at the eastern end of the room. In the western wall the other two elements of the window set high in the western wall of **C1** are apparent. These have an arched head, with the same design of a galleon on the southern window seen in **C1**. The northern window has a lion within a shield, which is surrounded by a laurel wreath (**Plate 32**). The ceiling mouldings are a continuation of those seen in **C1** to the north and **D2** in the east, and are of the same design. The top of two paired pilasters are apparent on the southern wall, consisting of the capitals and a fluted band below (**Plate 33**). The eastern pilaster of the eastern pair is dissected by the eastern wall of the room. The top part of a single pilaster is located on the western wall and also consists of the capital with a fluted band below, but having a roundel in the centre of the fluted band (**Plate 34**).
