**An Archaeological Watching Brief
at 1, Whitefriars,
Conduit Hill, Rye, East Sussex**

RR/2012/1606 & RR/2012/1607

Project No. CBAS0339
TQ 92131 20497

August 2015

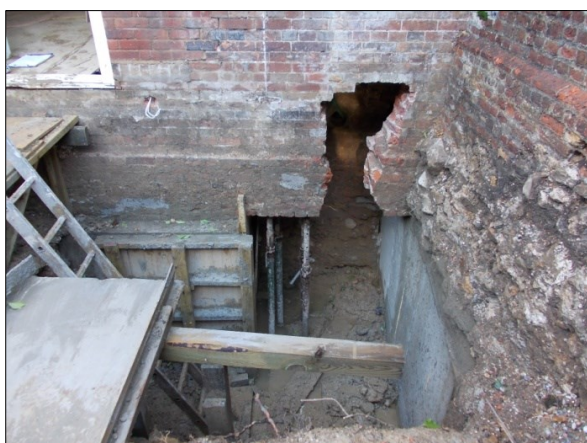
Plate 1: External excavations for the stairwell **Plate 2:** Internal excavations for the stairwell

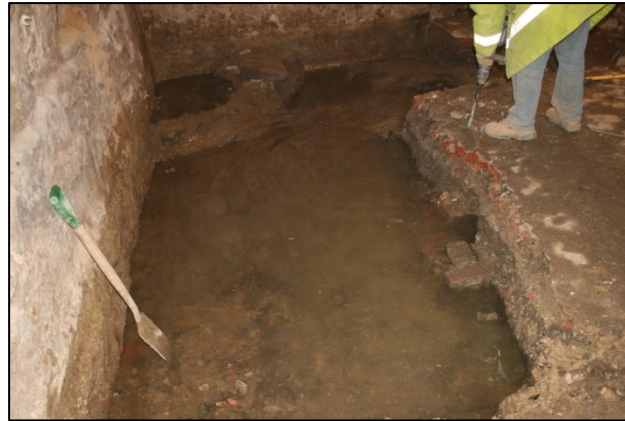
Plate 3: Ingress of water in cellar

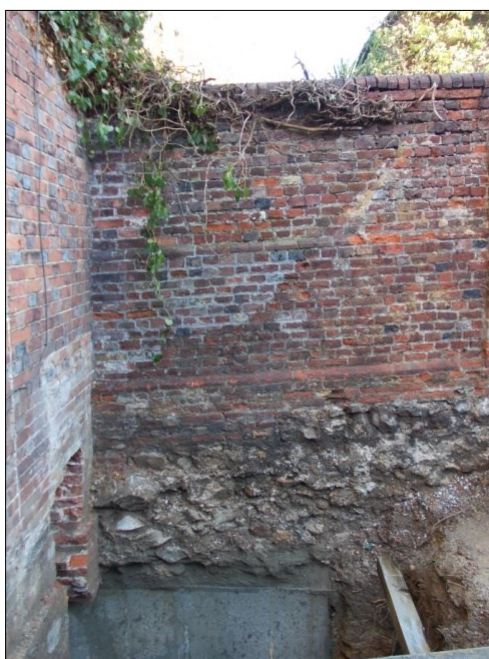
Plate 4: Garden wall with brick rubble footing

- 4.4 The garden wall (**Plate 4**) beside the trench was built of handmade red bricks, of varying size and butts against the house, with no bonding. It is of probable 18th century date. The trench revealed that the bricks were laid over a stone rubble footing, 1.05m deep. Ground reduction in the garden showed this wall footing to extend outside the trench. The red bricks of the house, in the area of the trench, looked less worn and of better quality than those used in the garden wall, but are also of 18th century date.

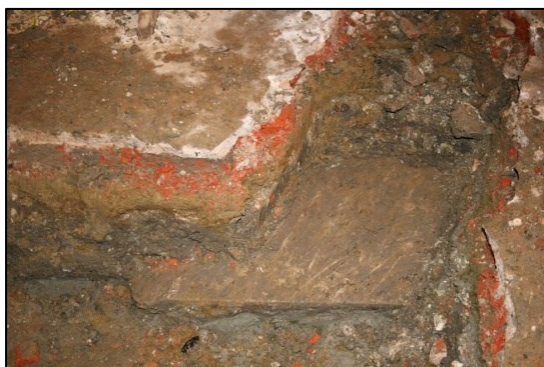
- 4.9** Below Context **104** was Context **105**, which was a deposit of dark bluish grey clayey sand with a loose consistence. This deposit had a variable thickness of between 60mm and 90mm. No artefacts were recovered from this deposit, but in a few places at the interface with the deposit above (Context **104**), were a few sandstone slabs which although broken appeared to be *in-situ* (**Plate 5**). These were interpreted as an earlier floor layer with an associated levelling layer of the blue grey silty clayey sand. A sample of one of the sandstone slabs was taken (**Plate 6**).

Plate 5: *In-situ* Sandstone Slab
(Context **105**)

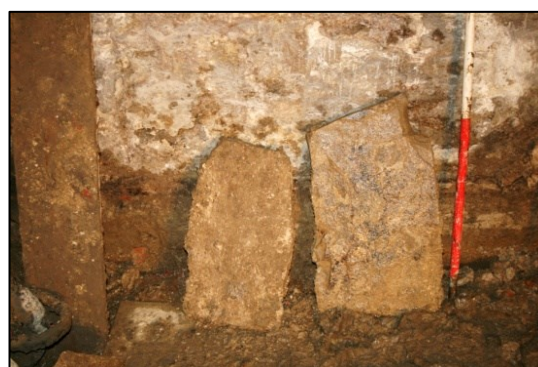
Plate 6: Sandstone Slabs from Context **105**

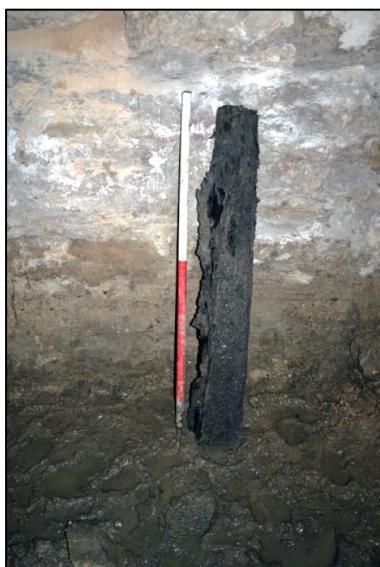
- 4.10** Below Context **105** was Context **106**, which was a deposit of dark brown silty clay with a very similar matrix to Context **104**. This deposit had a loose consistence and a thickness of up to 150mm, and was interpreted as a deposit of made ground evidenced by the inclusions of ceramic building material (<1%) and pieces of wood (<1%). The pieces of wood appeared to be wall or ceiling lathes. A larger piece of wood was recovered and photographed but not retained (**Plate 7**). The piece of wood had a length of 1.08m, and was square in section measuring 130mm. The end of the wood was heavily rotted. Artefacts recovered from this deposit consisted of c. 1550-1750AD pottery, bone, ceramic building material and wood (pieces of the possible ceiling or wall lathes).

Plate 7: Length of Wood (Context **106**)

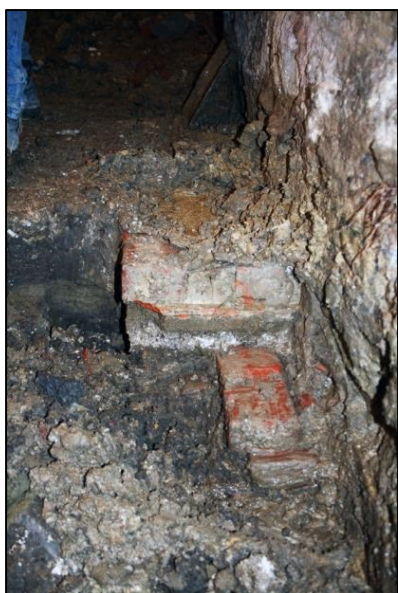
- 4.12** Three archaeological features were noted during the course of the excavation (**Fig. 4**), Context **102** was a drain or conduit (**Plate 8**). The drain or conduit cut Contexts **103** and **104**, and consisted of a floor of clay tiles with a single course of bricks either side. The bricks supported a sandstone slab, which has possibly been re-used from the floor at the interface between Contexts **104** and **105**. There were two courses of bricks under the clay tiled floor of the drain, on its outer edge. The frogless bricks had the dimensions of 220mm for the stretchers, 110mm for the headers and a thickness of 60mm. There was no bonding material apparent in the brick work. This drain or conduit followed the same course as the modern gully in the concrete floor (Context **100**) around the perimeter of the cellar including the run across the cellar on a north to south alignment to the east of centre. A sample of brick was taken from this feature, which was dated to between the late 17th to 18th centuries.

Plate 8: Drain or Conduit (Context 102)

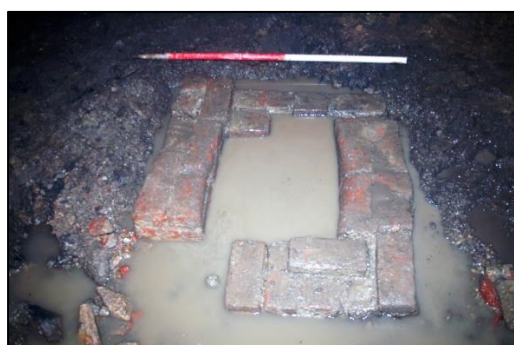
Plate 9: Context 109 Before being Pumped Out

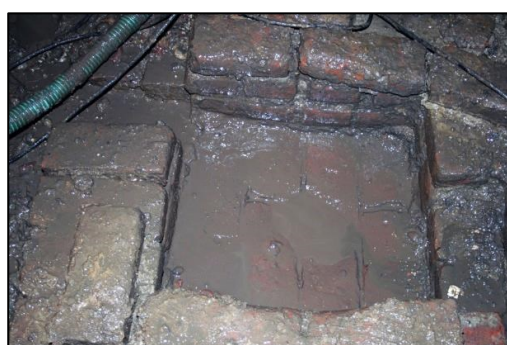
- 4.13** The second feature (Context 109) was located in the centre of the cellar. This consisted of a square brick built structure which measured 900mm north south by 840mm east west (**Plates 9 and 10**). The bricks used in the construction of this structure measured 225mm (stretchers) by 102mm (headers) and had a thickness of 55mm. The bricks were laid in stretcher bond except for those in the southern side of the feature which were laid in header bond. There was no bonding material apparent in the construction of the feature. The base of the structure is also of brick construction. The structure stood to a height of three courses of brick, with those bricks in the third course showing heavy wear on the inner top edge. A sample brick was taken, and when analysed was dated to the late 16th to the 17th century. The structure appears to have been some sort of sump possible associated with a light industrial use. The wear on the internal faces of the bricks on the eastern and western sides, suggest fairly heavy use.

Plate 10: Brick Built Structure (Context 109)

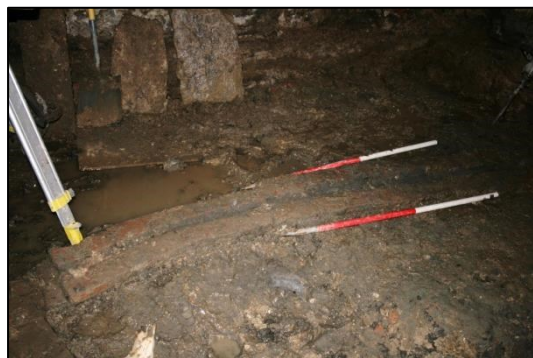
- 4.14** The third feature (Context 108) is the remains of a second drain (**Plates 11 and 12**) or conduit located to the east of the sump (Context 109), and between 1.1m and 1.5m from the eastern wall of the cellar. This drain was on a north to south alignment, with the northern end slightly curving to the west. The base of the drain

Plate 11: Drain or Conduit Context 108

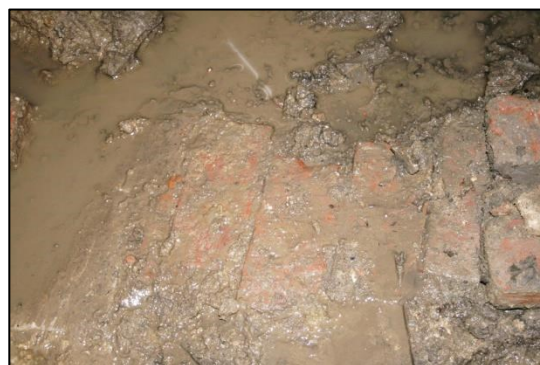
was constructed of bricks laid flat on an east to west alignment forming the base of the drain, with a single course of bricks to the side laid lengthways either side of the brick base. There was a gap of between 60mm and 130mm between the bricks making up the sides of the drain. A sample brick was taken and this returned a date of between the late 16th to 17th centuries, making the drain contemporary with the sump like feature in the middle of the cellar (Context 109).

Plate 12: Construction of Context 108

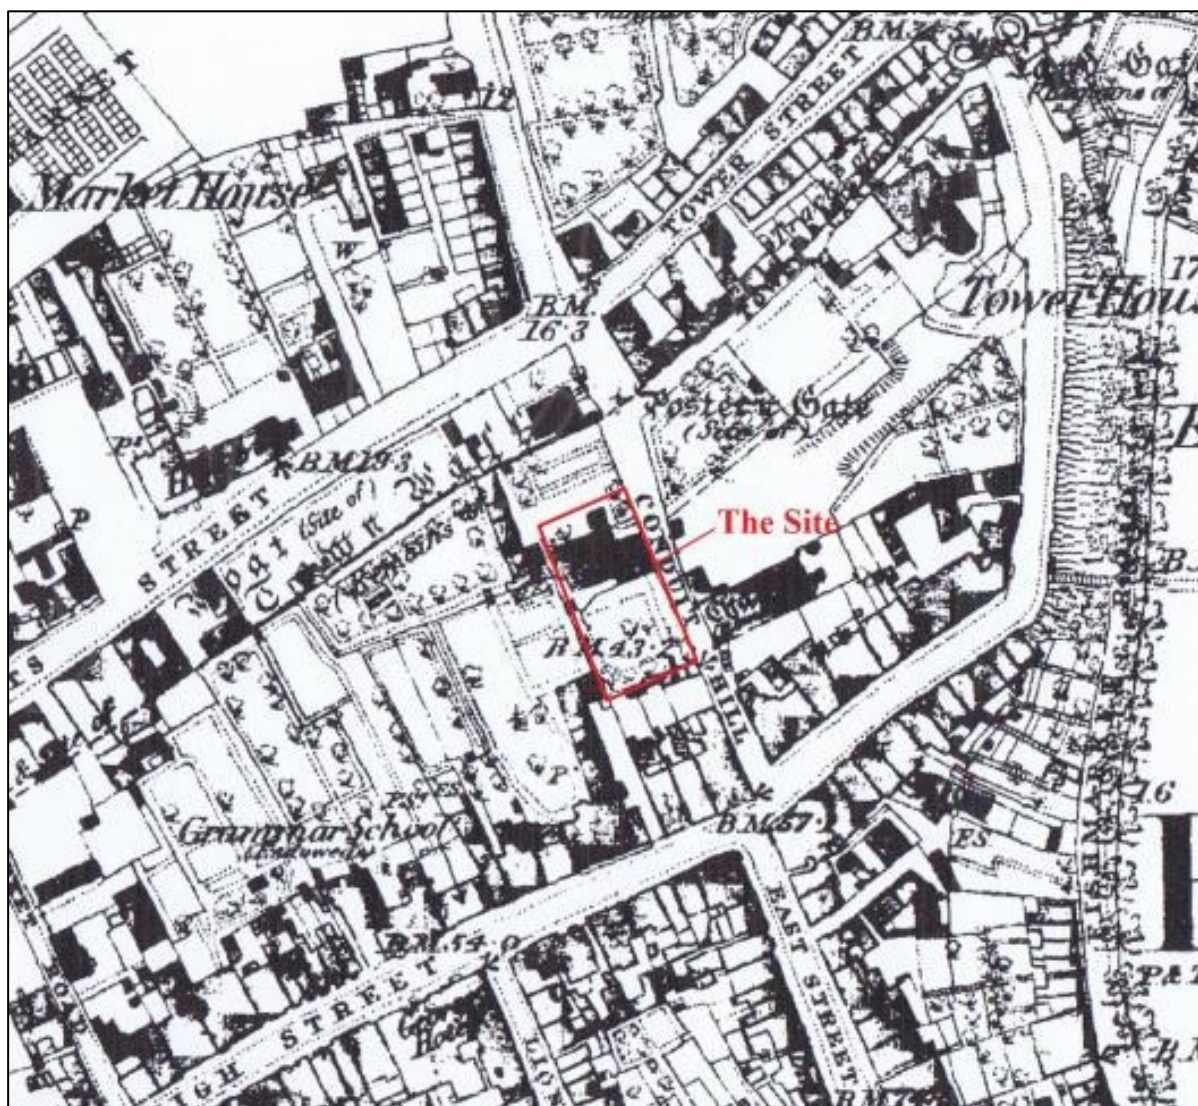
Fig. 2: 1 Whitefriars, Rye: 1st Edition OS map 1872

- 2.6 Whitefriars is shown on the 1st Edition OS map of 1872 (Fig. 2). The outline of the building is similar to that surviving today, although there is a projection from the north centre of the building which lines up with the hall, and presumably indicates that there was a large porch entrance to the house at this location. The Town Wall is shown running along the north side of the site, and there are formal gardens at the front and back of the house.
