**A Desk-based Assessment at
Edgmond Chapel,
Church Street, Old Town,
Eastbourne, East Sussex**

By
Dr Caroline Russell
with a contribution by
Keith Butler

March 2012

This Desk-based Assessment has been prepared for a site at Edgmond Chapel, Church Street in Old Town, Eastbourne in order to establish the likely presence and importance of any archaeological remains and original features of the building that may be affected by the proposed redevelopment of the site into a Supported Living Centre for people with a learning disability.

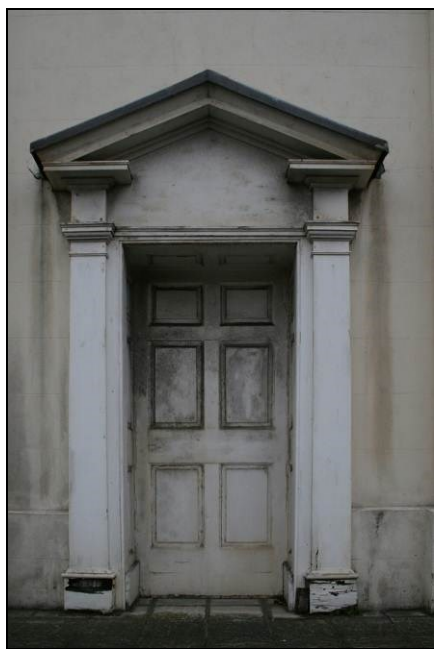
Plate 1: Edmond Chapel: Porch

- 5.2** The northern elevation has four plain pilasters. The original entrance is located between the two inner pilasters, and is sheltered by a shallow porch (**Plate 1**), this is reached by a flight of five steps. The porch comprises an open pediment ended roof, which is supported by a half pillar at either end. This structure is completely of wooden construction, with the shallow roof of the porch being covered in ashfelt sheets. Although, now sealed, the access to the chapel was through a Georgian six-panelled door, a type which became the standard design during that period⁵³.

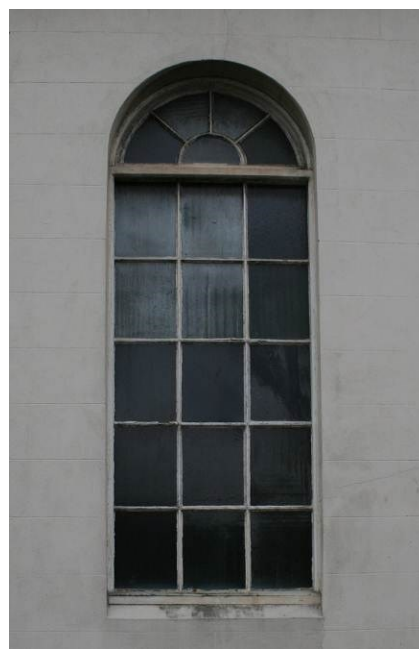
Plate 2: Edmond Chapel: Example of window

- 5.3** Either side of the central entrance there is a window. These are metal framed with three columns of five panes. The head of the window is arched, and forms a fan light. This has a design of a plain semi-circular pane of glass with three angled ribs radiating from it (**Plate 2**).

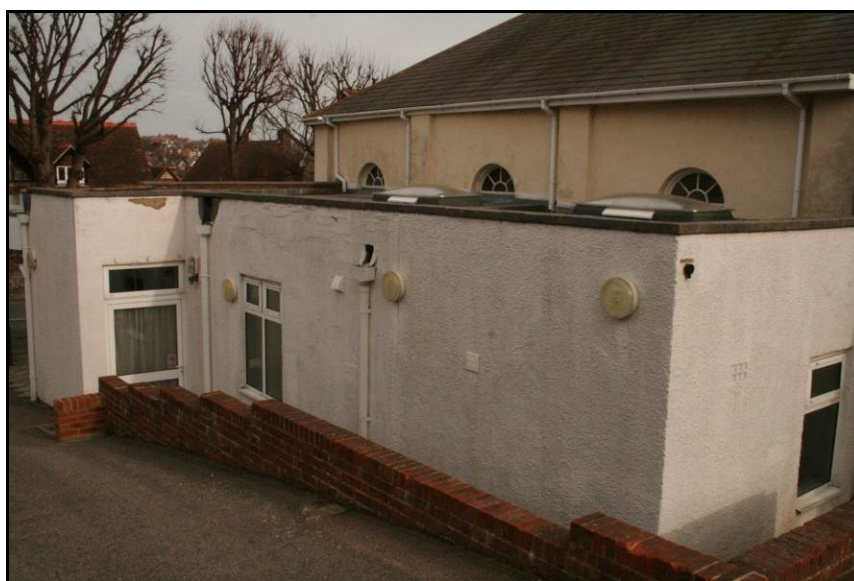
Plate 3: Edgmond Chapel: Western Elevation

- 5.5 At the southern end of the original chapel there is a modern two storey extension, with a single storey extension running along both the original chapel and the later southern extension. The top of the western wall of the chapel is visible above the flat roof of foyer extension, where the three fan lights of the windows and the top of four pilasters can be seen, implying that this wall was a mirror image of the eastern wall (**Plate 3**). The whole building looks to have been re-roofed, probably in 1924 (see 4.9.14 above). The roof over the original chapel at the northern end is hipped, with the southern end being gabled at the southern end over the two storey extension. The northern part of the foyer extension on the western side of the chapel has a flat roof. On the ridge approximately above the southern wall of the chapel is a small decorative bell tower, of wooden construction. This dates to the time of the re-roofing of the building.

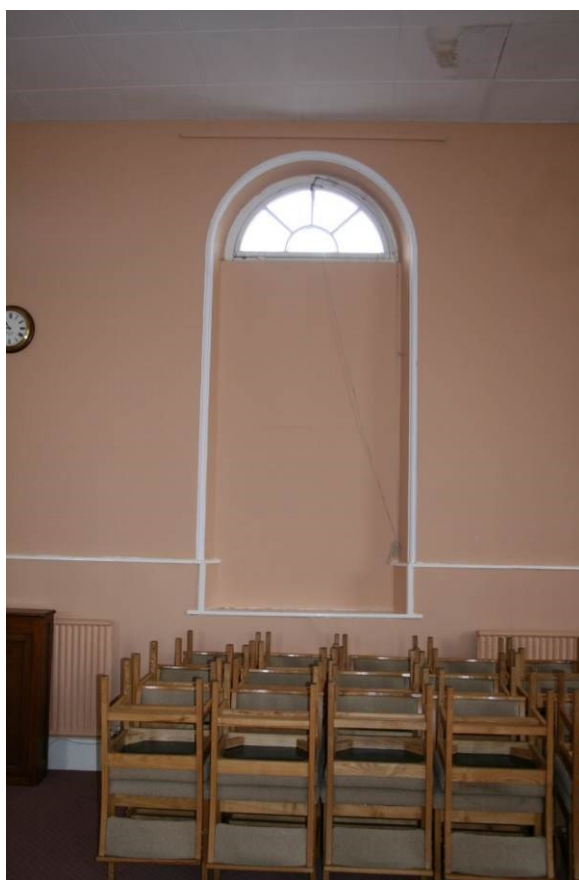
Plate 4: Edgmond Chapel: Moulding around windows and rail

- 5.7** The three windows (already described) are regularly positioned in the eastern wall, and have a narrow band of moulded wooden beading around the window recesses. It is apparent that the western wall had the same layout of windows as in the eastern wall. However, due to the insertion of the later entrances in both the northern and southern end of this wall, and the blocking in of the centre window, only the fan lights to these windows remain. The window in the centre is described by the wooden moulding beading surround still *in-situ*. There is also a wooden rail forming a narrow shelf, running around the northern, eastern and western walls, at 1.35m above floor level. This is possibly an original feature as it is incorporated into the wooden surround of the window recesses (**Plate 4**).

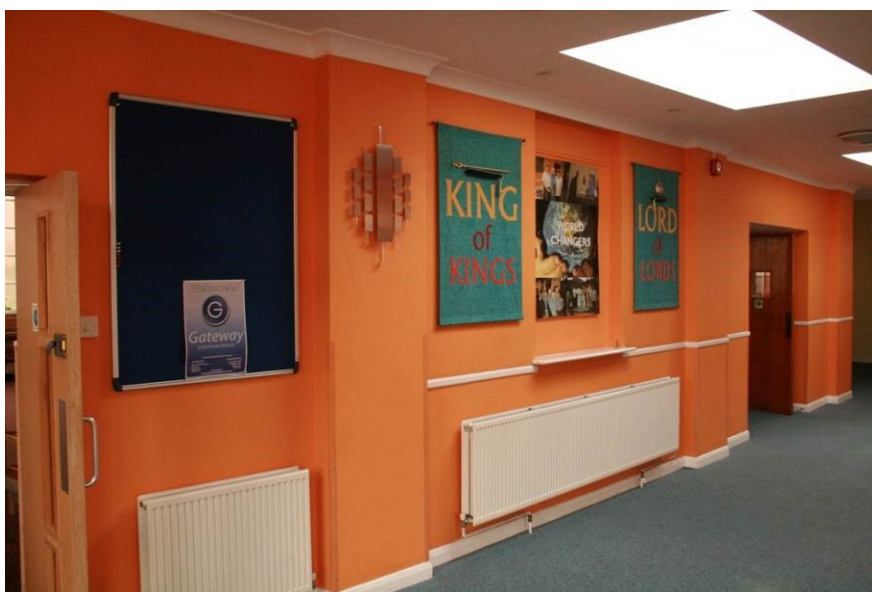
Plate 5: Edgmond Chapel: West wall of Foyer showing Pilasters

- 5.9** The eastern wall of the single storey foyer extension is the western exterior wall of the chapel, with the three southern pilasters being apparent on the wall (**Plate 5**). This appears to be the earlier of the two extensions, with a plaque on the north wall giving the date of 29th November 1982 for the refurbishment and extended foyer. On the western side of the foyer there are three WC's and a prayer room. In the north-western corner of the foyer is the current main entrance, which consists of UVPC double doors. There are two full height UVPC windows to the east of the entrance. At the southern end of the foyer is a modern staircase to the first floor of the southern extension, constructed of metal balustrades with a wooden hand rail.

- 5.12** The western wall of the chapel is preserved as the eastern wall of the foyer. The remaining features on this wall consist of only the lower part of three southern pilasters. Viewed externally above the flat roof of the foyer extension the top of all four of the pilasters are visible, as are the three fan lights of the blocked windows of the western wall (**Plate 6**). Enough evidence remains to say that the western wall was a mirror reflection of the eastern.

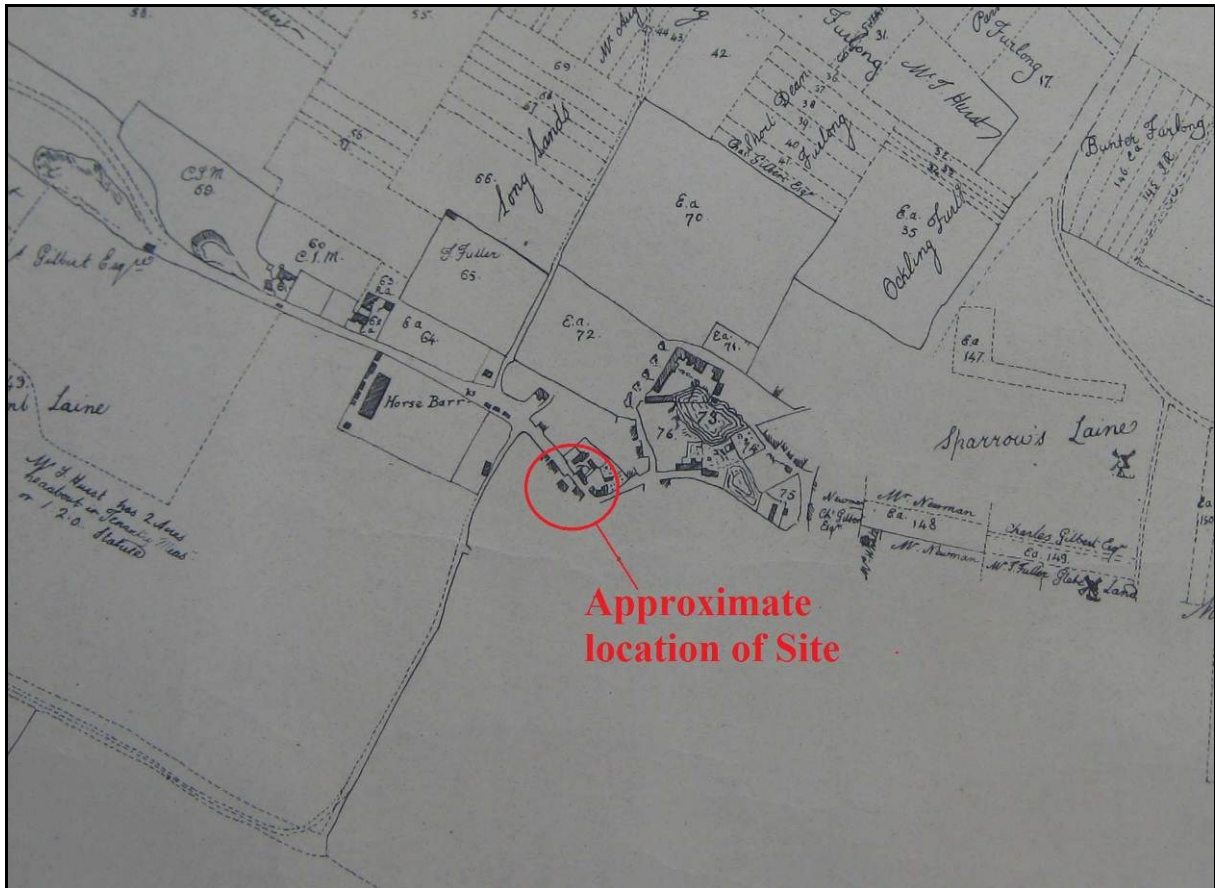
Fig. 5: Edgmond Chapel, Eastbourne: Duke of Cavendish Map of 1801
(reproduced with permission Eastbourne Museum Services)

- 4.9.4 The Yeakell and Gardner map of 1778-1783⁴⁴ shows the full size of 'East Bourn'. The site may yet again have had a building standing within it.
- 4.9.5 An 1801 map produced for the Duke of Cavendish (Fig. 5) only shows properties owned by the Duke. At least three buildings appear to have been built within the site, with one standing slightly back from Church Street. Figg's map of 1816 (Fig. 6) seems to show the site as having an additional building beside the road. Due to its small scale, the 1819 map of Eastbourne and its environs does not provide any further information on the site.

- 4.9.6 The 1841 tithe map (Fig. 7) shows the site to comprise three plots. Most of Plot 86 lies within the site boundary, and is occupied by a house, school, coach house and one other building, probably a stable. On the basis of the more detailed 1801 map (Fig. 5), the school looks to have been the additional building, in which instance it has been misplaced on the Figg map (Fig. 6).

- 4.9.7 The other plot in the site that fronts Church Street is not numbered, which may suggest that the sole building within it is owned by the government. This is the building set back from the road, as seen on the 1801 map (Fig. 5), and which can be identified as Edgmond Chapel. The third plot in the site is also not apparently numbered, and is possibly a garden at the back of Plot 86.

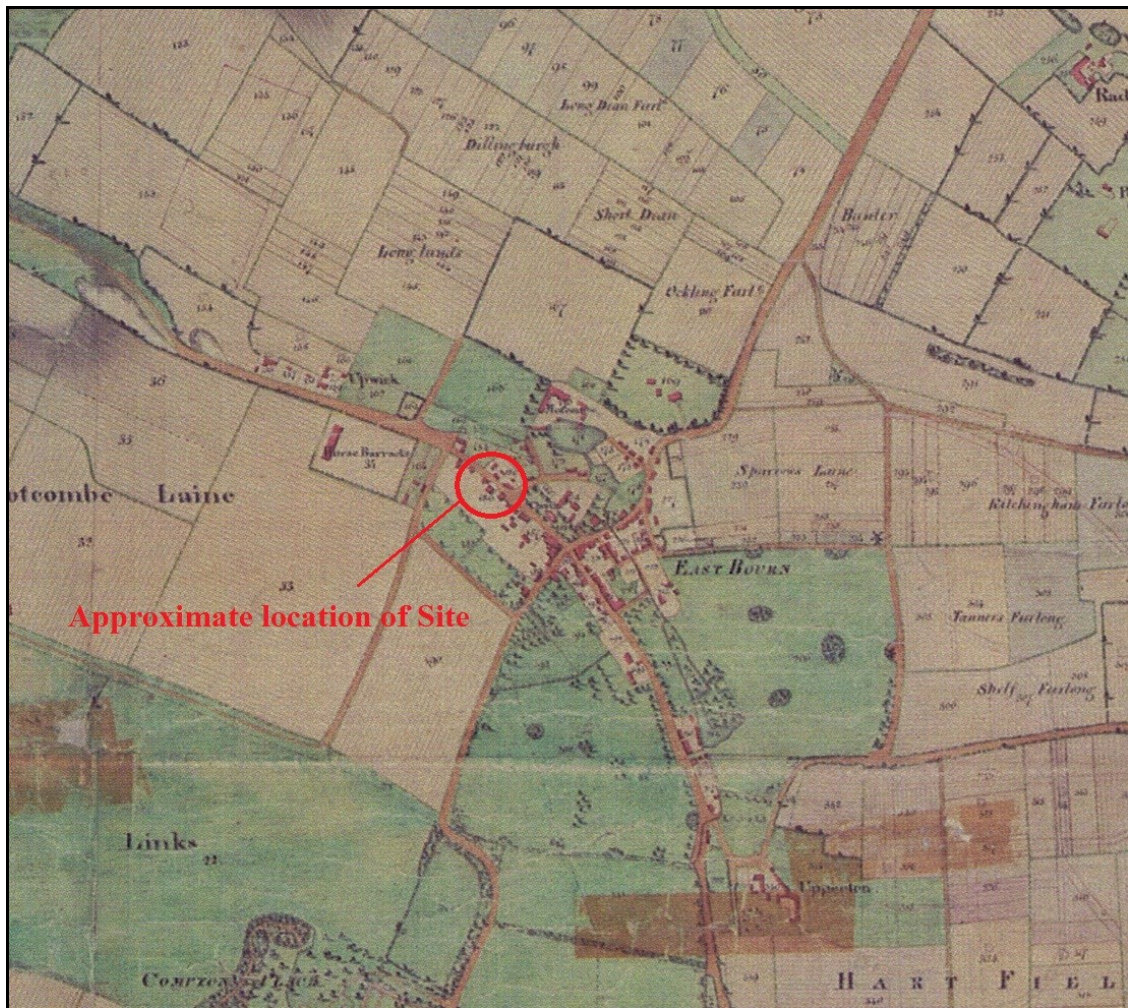
Fig. 6: Edmond Chapel, Eastbourne: Figg Map of 1816
(Copyright ESRO GIL/3/17/1)

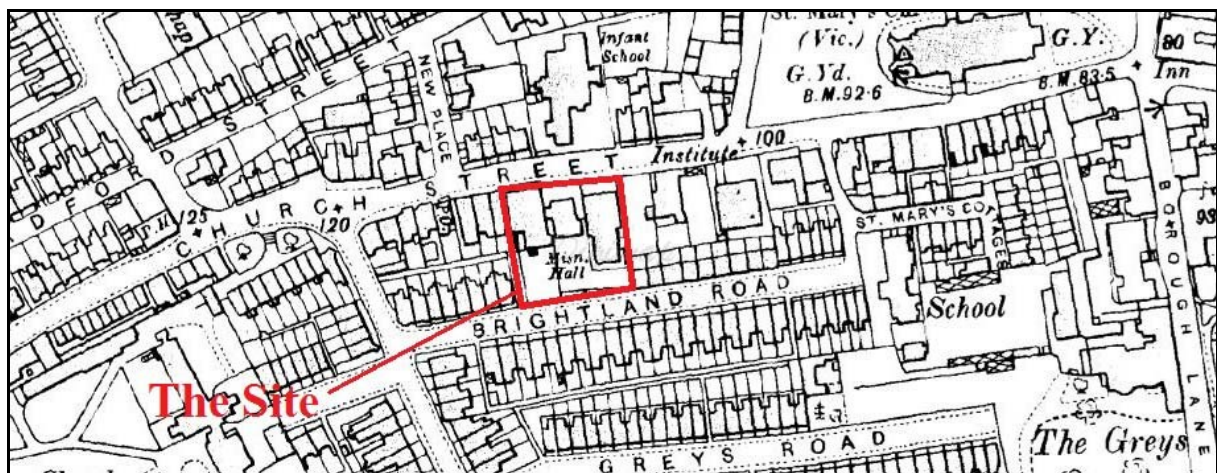
Fig. 9: Edmond Chapel, Eastbourne: 3rd Edition OS Map, 1910

- 4.9.11 The site changed little between 1899 and 1930, as revealed by the 3rd and 4th Edition OS maps of 1910 and 1930 (only the 3rd Edition has been reproduced, Fig. 9). A building had been built between 1899 and 1910 to the rear of the site, alongside Brightland Road. By 1959 (Fig. 10), the Mission Hall had become known as Edgmond Hall and two new buildings had been built behind Edgmond Hall and Edgmond Lodge (No. 41 Church Street).

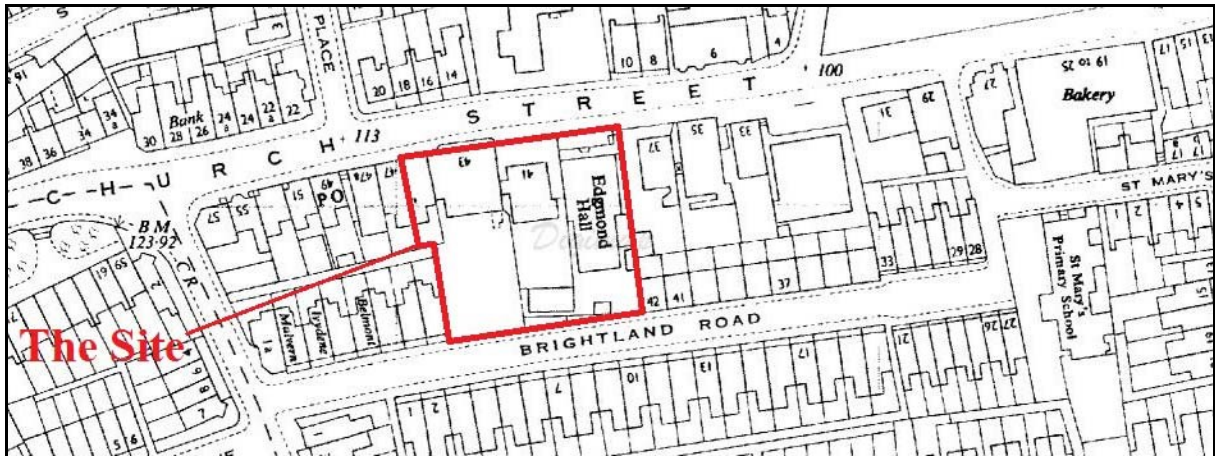
Fig. 10: Edmond Chapel, Eastbourne: 1959 OS Map
Ordnance Survey © Crown copyright 1959 All rights reserved. Licence number 100037471

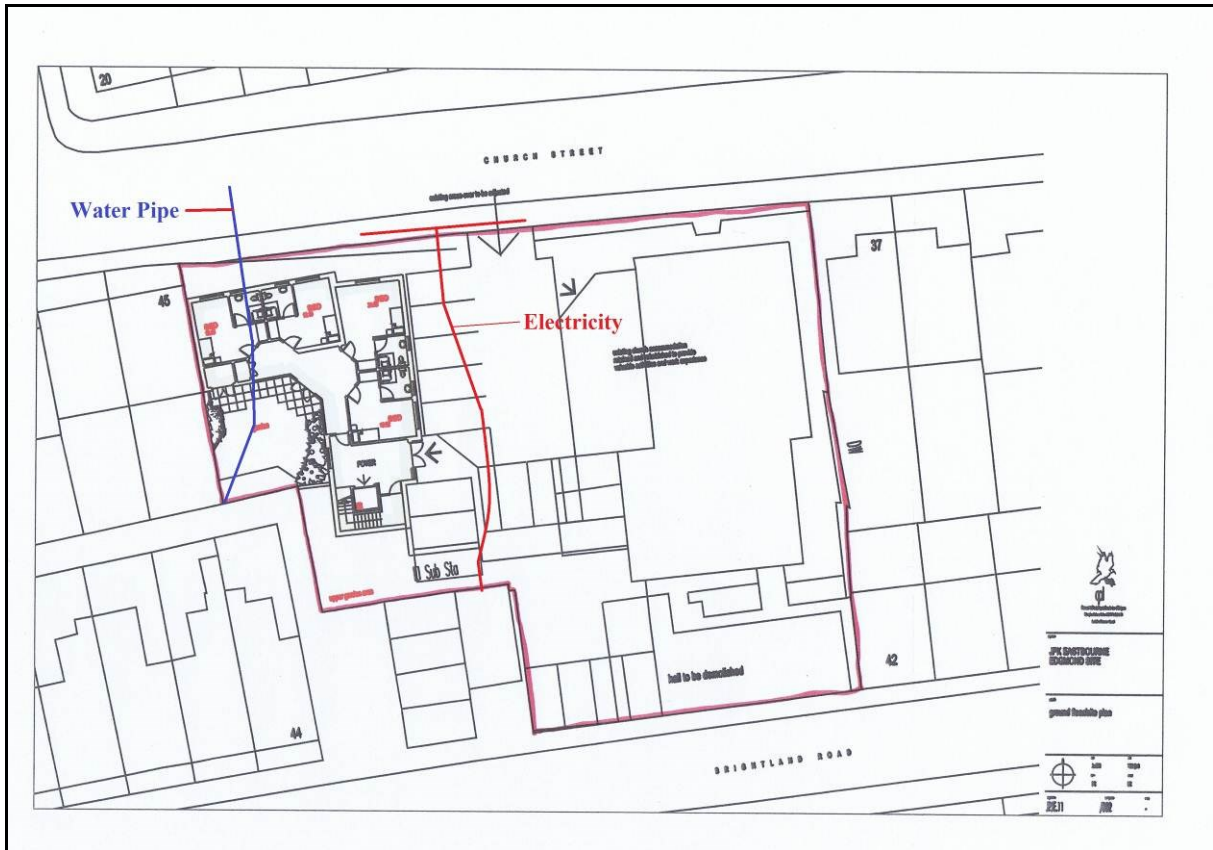
Fig. 15: Edgmond Chapel, Eastbourne: Development Plan, also showing services.
(Adapted from architects drawing)

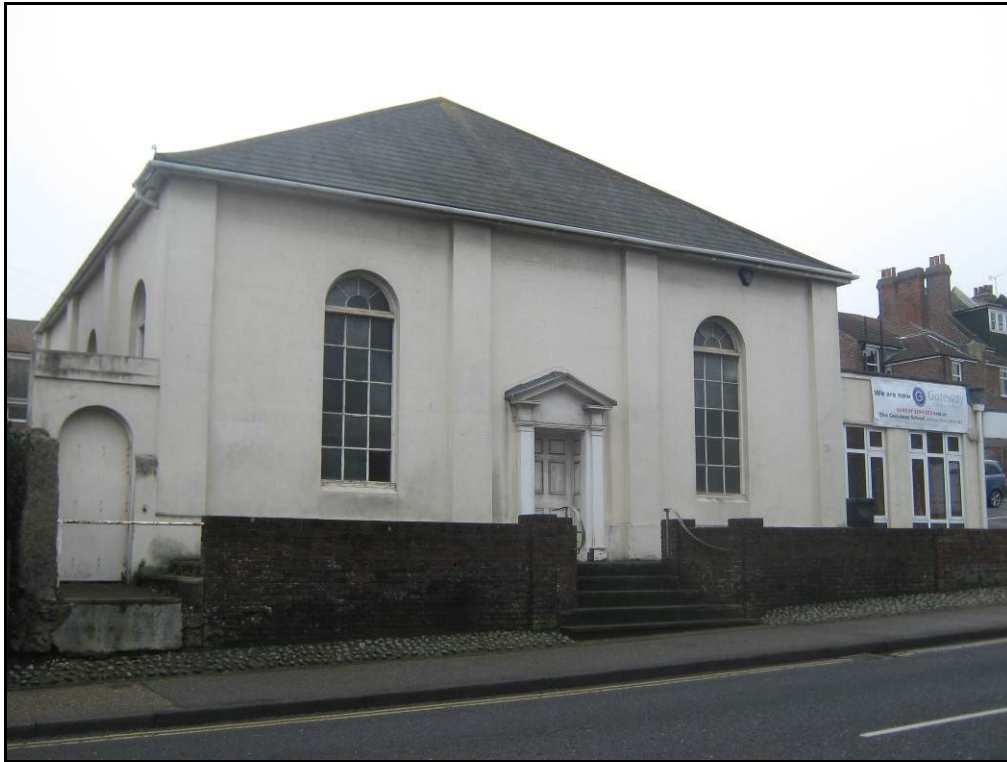
Plate 7: Edmond Chapel, Eastbourne: North facade
