**An Archaeological Watching Brief and
Historic Building Survey at
Hayreed Barn, Hayreed Lane,
Wilmington, East Sussex
(Final Report)**

WD/2015/2690/F

Project No. CBAS0501

September 2016

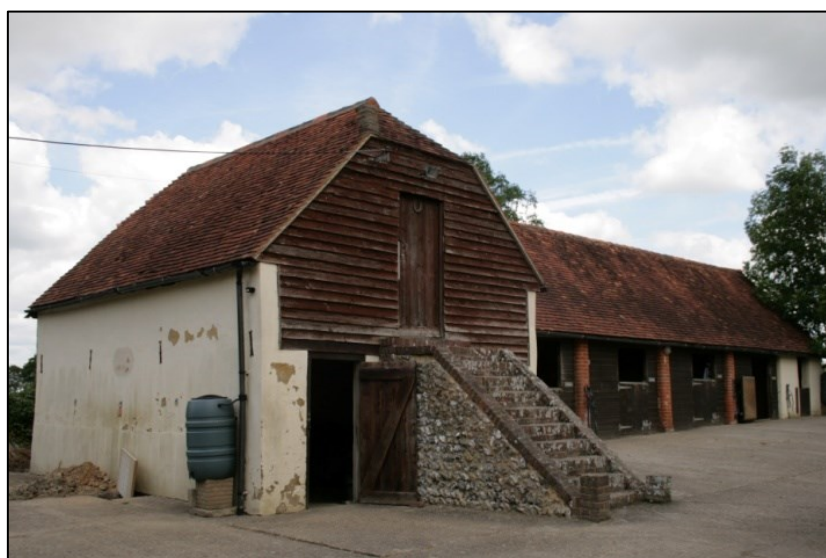
Plate 1: The Store/barn and Stables from the South-East

- 4.1 The surveyed building consists of two elements; the store is on two storeys and on an east-west alignment. The stable block is made up of four stalls with a small tack room at the northern end of this part of the building, and on a north-south alignment (**Plate 1**).

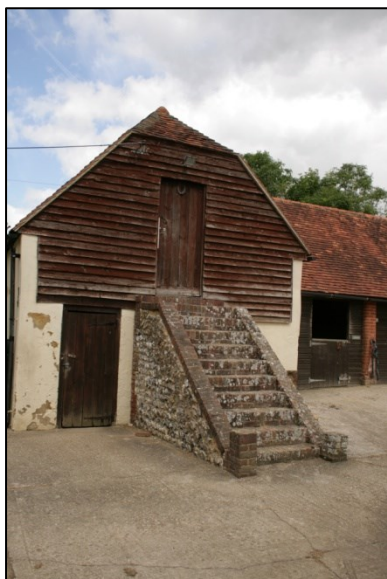
Plate 2: Eastern Elevation of Barn/Store

- 4.2 The store/barn has a painted cement rendered finish on both the north and south walls, with the centre part of the northern wall being the interior southern wall of the stable block. The gabled eastern and western walls have a painted cement rendered finish on the ground floor, while the upper part of both these elevations is of horizontal weatherboarding. Both the entrances to the interior of this part of the building are located in the eastern elevation (**Plate 2**). The entrance to the first floor is via a staircase located in the centre of the eastern elevation, which consists of ten brick built steps. The sides of the staircase are of coursed un-worked flint nodules bonded with a yellowish grey sandy mortar. The top of the walls of the staircase have a single course of capping red bricks. The northern side wall of the staircase has an arched recessed feature at the western end of it (**Plate 3**). The sides of the recessed arch feature are of brick construction, with the southern end wall being of the flint nodule construction. The western end of the southern side of the staircase has a brick built quoin between it and the eastern wall of the building, while on the northern side the brick built quoin is only apparent in the upper part of the staircase wall. The lower part is made up of the brickwork of the northern side of the arched feature. At the eastern end of the staircase there are two small brick built plinths (the one on the northern side is damaged and reduced in height). The doorway to the first floor is located in the centre of the elevation, and is fitted with a door of six vertical wooden planks. The entrance to the ground floor of the store/barn is located to the south of the staircase to the first floor of the building. This is fitted with a door of five vertical wooden planks.

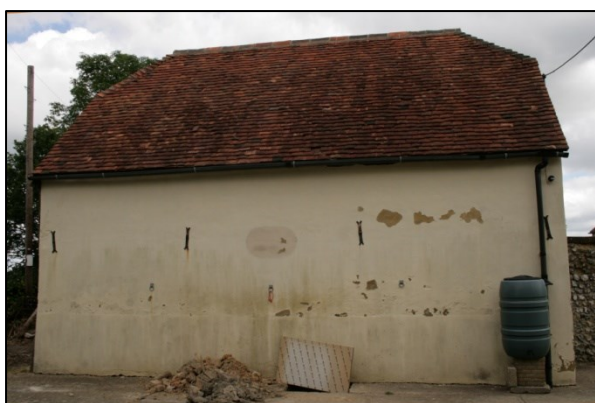
Plate 4: Southern Elevation of Store/Barn

- 4.3 The southern elevation (**Plate 4**) of the store/barn is of a painted cement render finish, with the render having a smoother finish in the lower 870mm, suggesting that this part of the wall had been re-rendered. There are no openings in the southern wall; with the only feature being a row of four wall tie plates. These were of a plain vertical metal strap with a decorative end at the top and bottom (**Plate 5**).

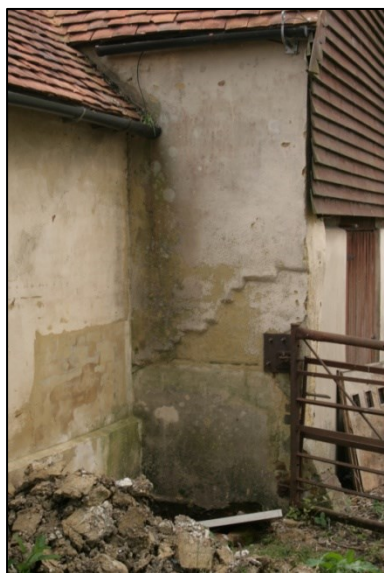
Plate 6: Possible Repair Western Side of North Wall

- 4.4 The northern elevation of the store/barn is only visible from the exterior for a short length at the eastern and western sides, the rest being concealed from view by the stable block. The part of the north wall to the east of the stable block has the painted cement render finish with a single wall tie plate of the same design as seen on the southern wall of the building. The short length of the north wall at the western side of the stable block appears to have been repaired before being rendered as can be seen

by the raised stepped brickwork in the upper part of this wall (**Plate 6**). The central part of the north wall of the store/barn serves as the southern end wall to the stable

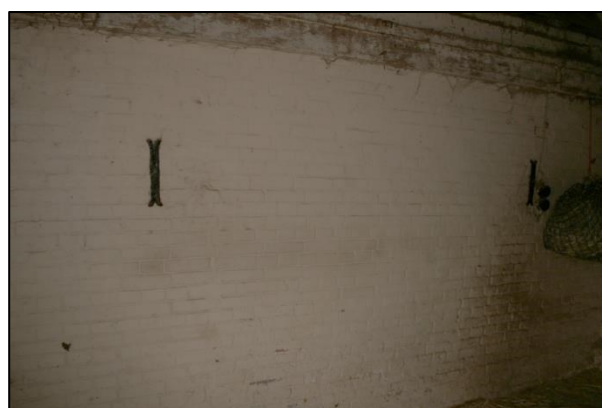
Plate 7: Wall Tie Plates in Southern Interior Wall of Stable Block

block. The evidence for this is that the interior wall of the stables has two of the same design wall tie plates as seen on the southern exterior wall of the store/barn (**Plate 7**). This is also suggested from the evidence in Test Pit **3** where the western wall of the stable block only butts up to the northern wall of the store/barn.

- 7.2 The constructional details of the two buildings would suggest that they were built in the later 19th century. The evidence from the short survey would also hint at the stable block being constructed after the store/barn. This is evidenced by the northern wall of the store/barn serving as the southern end interior wall to the southernmost stall of the stable, and also the butt joint between the western wall of the stable block and the northern wall of the store/barn. This butt joint is also apparent at foundation level in the side of Test Pit 3. The northern slope of the roof of the store/barn is also apparent above this wall when viewed from the interior of the stable block, although, this part of the roof is covered with horizontal wooden planks, with the bottom of the rafters still being visible below the lower planks.

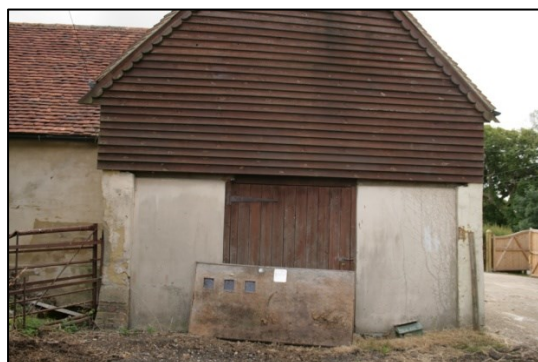
Plate 8: Western Elevation of Store/Barn

4.5 The western elevation (**Plate 8**) of the store/barn has the same painted cement render finish on the ground floor as seen on the other elevations, with the upper part being of horizontal weatherboarding. There is a doorway in the centre of the ground floor which is fitted with a door of eleven vertical wooden planks. It was noted during the survey that the western ends of the northern and southern wall projected out from the main body of the wall by 40mm. This possibly suggests that the building originally had a wider entrance in the western wall, but was later modified with a narrower doorway with the wall being re-built at this time. There is a small brick built buttress at the base of the stub of the northern wall (**Plate 9**), which also appears to be a later addition.

- 7.4 There is also a possibility that the western wall of the store/barn is a later addition as suggested by the western ends of the southern and northern walls slightly projecting from the current western wall of the building. Perhaps, this end of the building was originally open or had wider doors. The modern brick built piers of the eastern elevation of the stable block could hint at the original use of the stables as a cart shed with this side of the building being open. The modern brick built piers respect the position of earlier supports for the roof of the building.

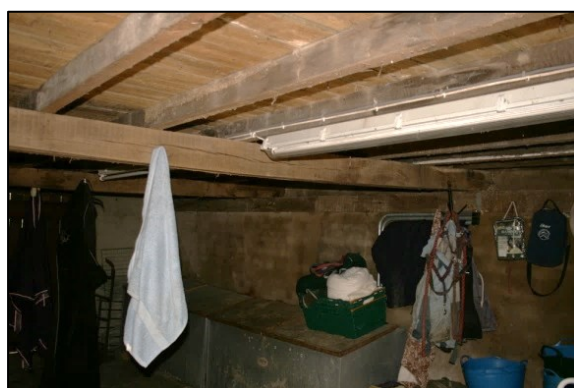
Plate 10: Ceiling of Ground Floor of Store/Barn

4.7 The interior walls of the ground floor are all of un-painted cement render. The walls of the ground floor part of the store/stable are wider than those of the first floor. This creates a ledge at the top of the wall on which rests the square sectioned timbers which act as wall plates. These in turn support two timber girders on a north south alignment on which the floor joists of the first floor rest; these are on an east-west alignment. The joists support the floor boards of the first floor which act as the ceiling to the ground floor. The floor is of concrete construction.

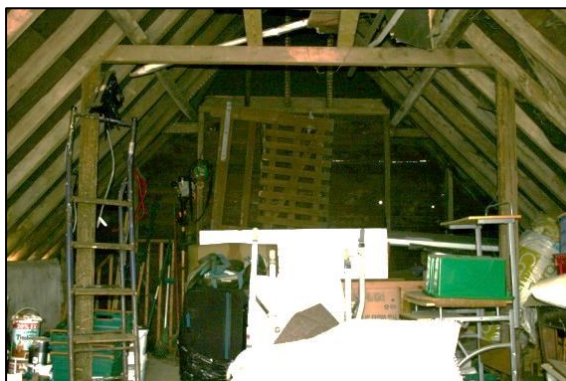
Plate 11: Construction of the
Roof of the Store/Barn

4.8 The first floor room consists of the upper part of the north and south walls, which have a cement rendered finish, with the rest of the side walls being the slope of the roof. The eastern and western ends of the first floor are constructed of a simple studwork with the weatherboarding attached to its outer surface. The roof structure is common rafters with a side purlin and a centre ridge plate. There are two beams supporting the purlins which have an upright timber supporting either end of the beam; these rise from the floor (**Plate 11**). The lower end of the rafters is cut round the wall plate, located at the top of the northern and southern walls. The floor is of bare floor boards.

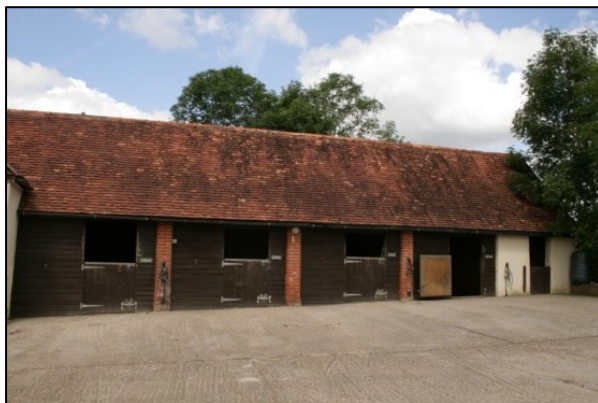
Plate 12: The Eastern Elevation
of the Stable Block

- 4.9** The stable block consists of four stalls at the southern end with a small tack room at the northern end. The entrances to the stalls and the tack room are all located in the eastern elevation (**Plate 12**). This elevation has three brick built piers with their outer corners rounded off; these appear to be recent from the un-weathered appearance of the bricks used in their construction. Between the brick piers the wall is of horizontal tongue and groove wooden planks, with a half height door to each of the stables. The tack room at the northern end of the building has a painted cement rendered finish over brick, with a half height door which is narrower than those to the stalls.

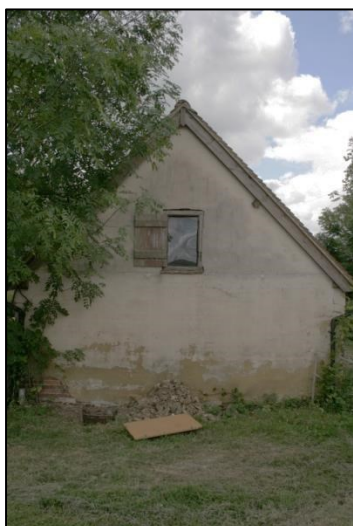
Plate 13: Northern Elevation of
the Stable Block

- 4.11** The northern gabled elevation of the stable block has a painted cement rendered finish, over brick. A small area of the render had broken away at the base of the eastern end, where the bricks had the dimensions of stretchers 220mm, headers 110mm, and a thickness of 55mm; these appeared to be laid in English Garden Wall bond. There is a wooden framed window located in the centre of the lower part of the gable. The window is of a single light, with an external shutter attached to the eastern side of the window frame. The gabled end of the roof has a plain wooden barge board, with a decorative plate at its apex.

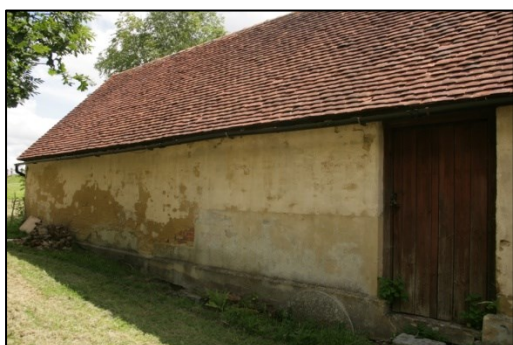
Plate 14: Western Elevation of Stable
Block

- 4.12** The western elevation (**Plate 14**) is of a painted cement render over brick, the render was missing in places allowing the dimensions of the bricks to be measured. The bricks used in the construction of this wall had stretchers measuring 220mm with a thickness of 55mm and in the small area exposed appeared to be laid in English Garden Wall bond (**Plate 15**). The lower part of this wall steps out by 60mm to a height of 250mm above ground level. There is a single doorway to the interior of the building located at the southern end of this elevation, fitted with a door of seven vertical wooden planks.

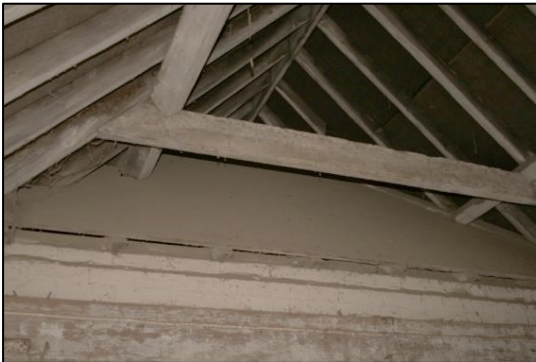
Plate 16: Roof of Store/Barn Visible
in Southernmost Stall

- 4.13** The interior of the stable block consists of four stalls separated from each other by a partition wall of sheets of block board. The southern wall of the southernmost stall is the exterior wall of the store/barn, and is of brick construction. The bricks have the dimensions of stretchers 220mm, headers 110mm and have a thickness of 60mm, these are laid in English Garden Wall bond with alternative courses of stretchers and headers (**Plate 7**). Above this wall the northern slope of the store/barn roof is visible, and is covered with horizontal wooden planks, with the end of the rafters being visible at its lower edge of the planking (**Plate 16**). It was also noted that the western wall of the stable block only appeared to be butted up to the northern wall of the store/barn when viewed from the interior of the stable block. The stalls have concrete floors with the exception of the northernmost stall and the tack room where the floors

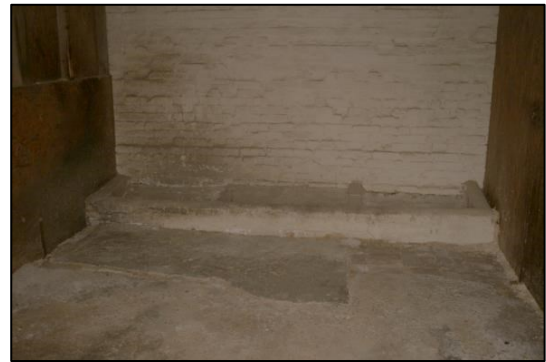
Plate 17: Feeding Trough in Northern Stall

are a mixture of concrete and bricks. There is a concrete feeding trough adjacent to the western wall in the northernmost stall (**Plate 17**).

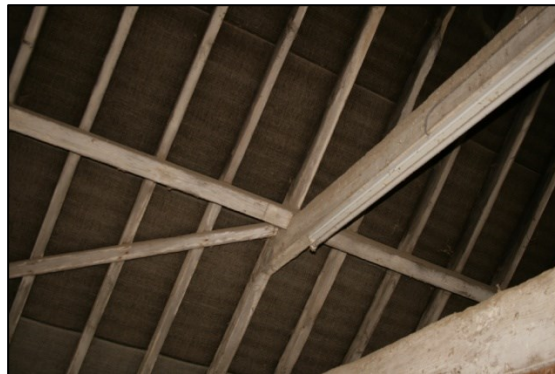
Plate 18: Roof Structure of Stable Block

4.14 The roof construction of the Stable Block is of common rafters with side purlins and centre ridge plate. There are five collars at mid roof height, which support the purlins. There is a wind brace on both side above the southernmost stall and a second pair in the roof above the third stall from the south (**Plate 18**).

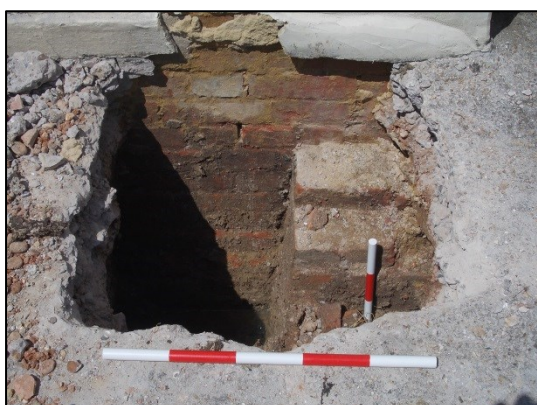
Plate 19: Test Pit 1

5.1.2 Test Pit 1 was excavated adjacent to the northern end of the eastern wall of the store/barn, and measured 580mm in length by 800mm which narrowed to 450mm, and had a depth of 680mm (**Plate 19**). There were five deposits apparent.

1. The concrete yard surface which had a depth of 90mm.
2. A deposit of orange sandy clay with inclusions of frequent small pebbles, with a thickness of 100mm.
3. A deposit of orange sandy clay with inclusions of brick, breeze blocks and shingle, with a thickness of 260mm.
4. A deposit of mid brown sandy clay with no inclusions, and a thickness of 200mm, with no inclusions.
5. The foundations of the eastern wall of store/barn. Nine courses of bricks were revealed, with the upper three courses possibly being a repair. Also revealed was a small brick built buttress on the north-eastern corner of the building.
6. The natural which was a buff-coloured silty clay, and was apparent to the limit of the excavation.

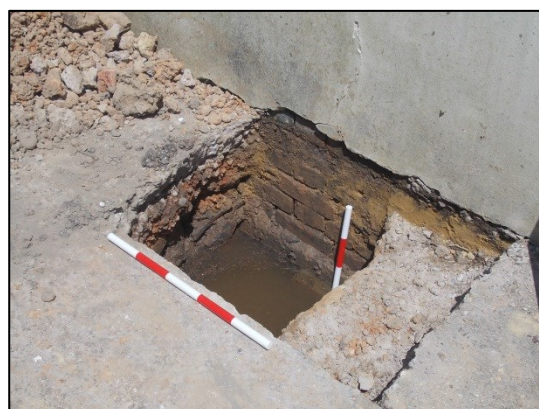
Plate 20: Test Pit 2

5.1.3 Test Pit 2 was located adjacent to the centre of the southern wall of the store/barn (**Plate 20**). This test pit measured 580mm in length by 800mm wide which narrowed to 450mm. In this test pit there were four deposits apparent.

1. The concrete yard surface with a depth of 90mm.
2. Below this was a deposit of orange sandy clay, with frequent inclusions of small pebbles. This deposit was 100mm thick.
3. Below this was a deposit of orange sandy clay with inclusions of brick, tile and shingle. This deposit was 210mm thick to the water level.
4. Below this was a mid brown sandy clay which was recorded from the spoil from the excavations, due to the bottom 260mm of the test pit filling with water.

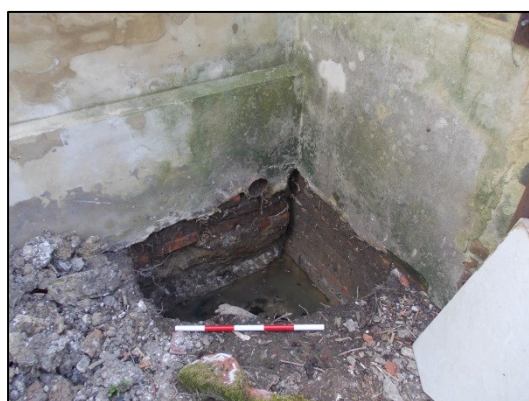
Plate 21: Test Pit 3

5.1.4 Test Pit 3 was located in the corner of the junction of the western wall of the stable block and the short length of northern wall of the store/barn (**Plate 21**). The test pit measured 800mm in length by 600mm wide, with a depth of 630mm. In this test pit there were three deposits apparent.

1. The upper deposit was a 250mm thick deposit of topsoil, which was a dark brown sandy clay loam with inclusions of fragments of ceramic building material (2%) and rooting (3%).
2. Below this was a deposit of mid brown sandy clay with inclusions of frequent chalk block fragments of various sizes and ceramic building material (<1%). This deposit was 120mm thick.
3. This was the assumed natural; a buff coloured silty clay, which was apparent to the limit of the excavation. The bottom of the test pit filled with water to a depth of 100mm.
4. The foundations of the western wall of the stable block consisted of seven courses of bricks which sat on a base of chalk blocks. This wall could be seen to butt up against the wall of the barn.

- 7.3 The different dates for the buildings is also suggested by the bricks of the foundations of the stable block which, in Test Pits 3 and 5, were laid on chalk block foundations. In contrast, no chalk blocks were noted in the test pits adjacent to the store/barn.

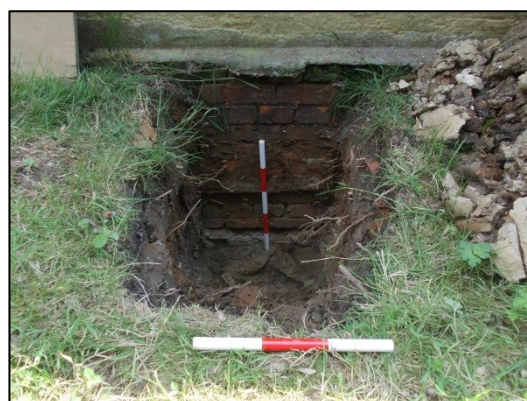
Plate 22: Test Pit 4

5.1.5 Test Pit 4 was located adjacent to the western wall of the stable and measured 500mm in length by 800mm in width with a depth of 800mm at the wall (**Plate 22**). There were three deposits apparent in this test pit.

1. A 120mm thick deposit of the topsoil which was a dark brown sandy clay loam with inclusions of rooting (3%).
2. Below this was a mid brown coloured sandy clay with a thickness of 280mm with inclusions of rooting (2%) and minimal chalk pieces. This deposit produced some pottery.
3. Below this was the assumed natural which was apparent to the limit of excavation. This was a buff coloured silty clay.
4. The foundations of the western wall of the stable block, comprising ten courses of brick, of which the bottom three courses stepped in slightly.

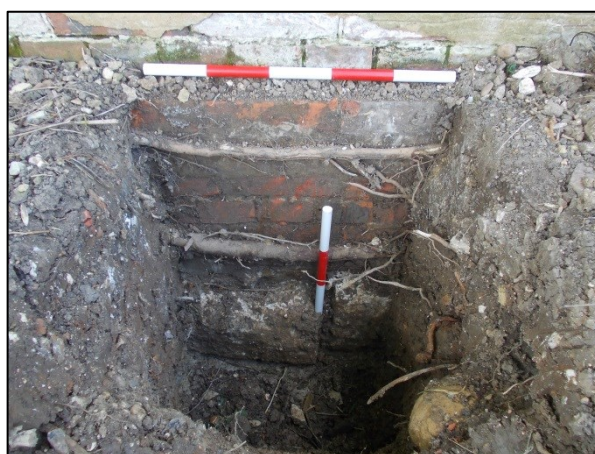
Plate 23: Test Pit 5

5.1.6 Test Pit 5 was located at the eastern end of the northern wall of the stable block and measured 500mm in length by 400mm in width (**Plate 23**). There was a plastic drain pipe at the northern end which restricted the length of the test pit.

1. This was a 550mm thick deposit of the topsoil, which was a mid greyish brown sandy clay loam with inclusions of chalk pieces (2%), ceramic building material (1%) and rooting (3%).
2. Below this was the assumed natural, which was a buff coloured silty clay which was apparent to the limit of the excavation of the test pit.
3. The foundations of the northern wall of the stable block consisted of six courses of brick sitting on a base of large chalk blocks.

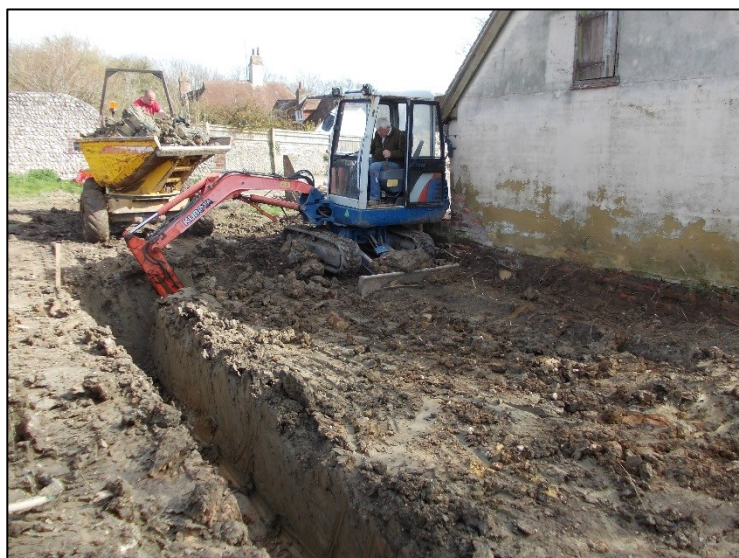
Plate 24: Excavation of the foundation trenches

5.2.1 The initial ground reduction over the footprint of the new extension on the north side of the stable block was carried out to a depth of c. 500mm. This revealed a topsoil (Context **001**), which was a soft dark greyish-brown sandy clay loam. This varied in depth from 100mm to 250mm and contained roots, and occasional chalk (20mm sized) and CBM (100mm sized).

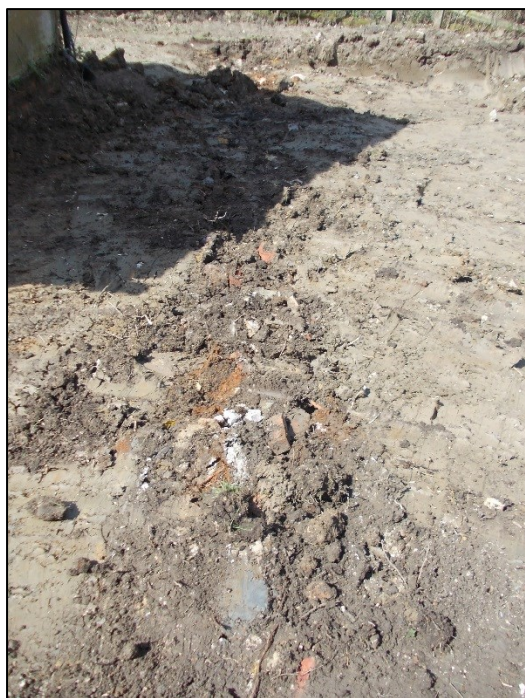
Plate 25: Cut feature 004

- 5.2.3** Cut into Contexts **002** & **003**, was a U-shaped linear feature (Context **004**) orientated east to west, measuring 7.8m long, 1.1m wide and 0.45m deep (**Plate 25**). This was filled with a soft sandy clay (Context **005**), dark grey-brown in colour, and including frequent CBM fragments (<200mm), metal pieces, mortar fragments, chalk pieces (c. 50mm), flint pieces (<10mm) and glass fragments. The artefacts recovered from this feature are all of a late 19th or 20th century date, and the feature appears to have been a soakaway, perhaps associated with the manure heap.

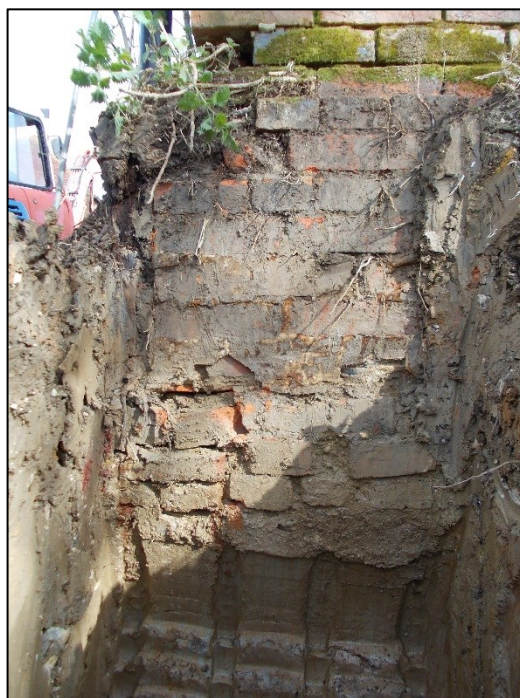
Plate 26: Brick foundation on NW corner of the
Stable block

- 5.2.4** The foundations of the stable block (Context **006**) were exposed on the north-east side of the building in the footing trench. Four courses of bricks were visible here, but on the north-west corner of the barn a foundation of 10 courses of bricks were seen (**Plate 26**), which step-out 50mm from the wall. Below the 7th course there is a single row of tile. The bricks are bonded with a light yellow-brown sandy mortar, and the individual bricks are 240mm x 100mm x 65mm in size.

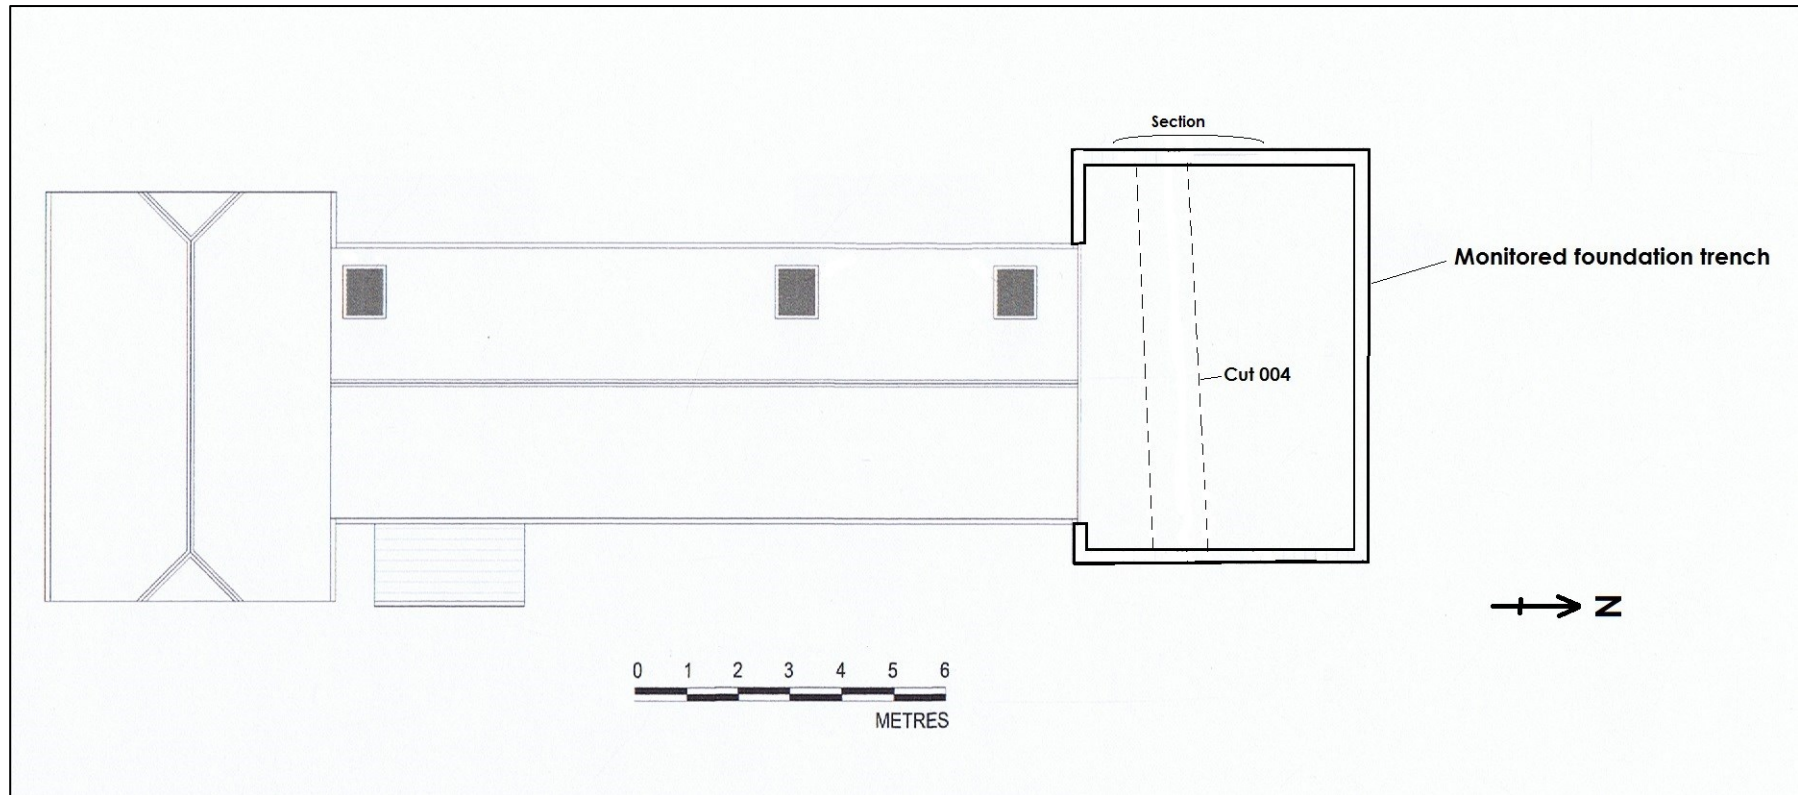
Fig. 5: Hayreed Barn, Wilmington: Plan showing monitored foundation trenches
(adapted from Abstract Plans drawing)

5.2 Ground reduction & footing trenches (Fig. 5)
