**Archaeological Watching Brief
at
Grain Cottage,
Hempstead Lane,
Hailsham, East Sussex**

Planning Ref. WD/2015/2239/F

Project No. CBAS0705

July 2017

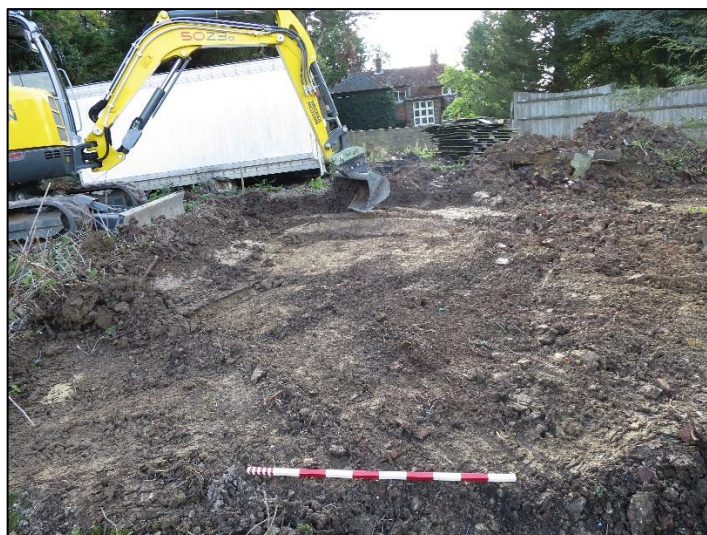
Plate 1: General site reduction

4.2 Work had begun with the demolition and removal of the 20th century barn and associated hard standings and was not subject to archaeological monitoring. General ground reduction was monitored, which was predominantly through the demolition rubble and remaining topsoil to a depth of c200mm (Plate 1). This left a thin deposit of mixed modern demolition material (c40mm to 100mm deep) in places over the footprint of the new build which in turn overlaid the natural.

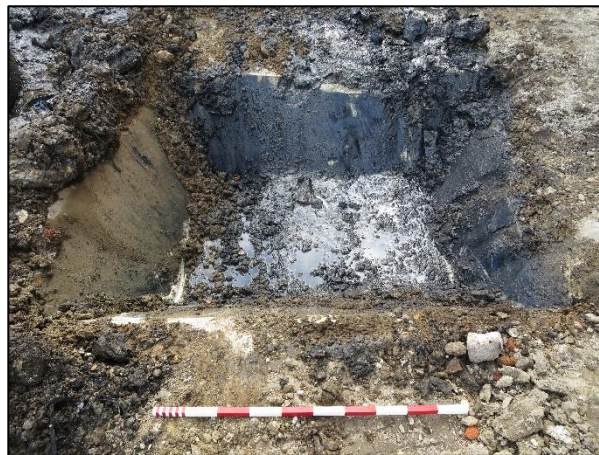
Plate 2: Excavated 20th century slurry pit

- 5.1** Context 1 was a loose, modern deposit derived from the demolition of the barn and removal of the hardstanding which lay across the footprint of the new build, mixed with the topsoil/subsoil overlying the natural. As a result of this, it was a mix of greys, blacks and browns in colour and a mix of various silts with a small amount of clay within the matrix. There was ceramic building material (hereafter CBM) throughout and the deposit was up to 300mm thick.
- 5.2** During the ground reduction a filled-in 20th century slurry pit was located and removed (Plate 2). A pitch fibre drainage pipe dating to the 1950-60's running east-west in the southern corner of the site, and just cut into the top of the natural, was noted.

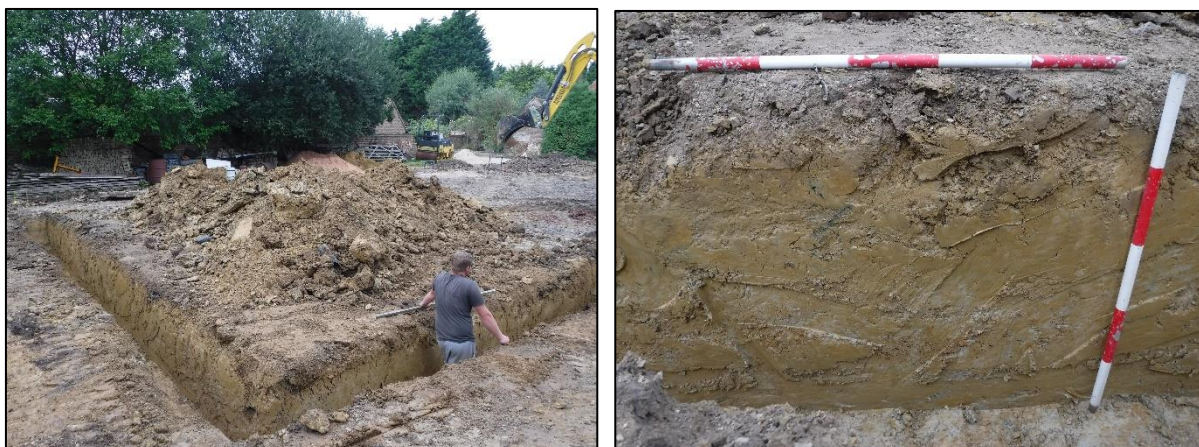
Plate 3: Excavating foundation trenches and section of foundation trench

- 5.3** Context 2 was assigned to the natural clay that lay directly below the demolition deposit of Context 1 (Plate 3). There were no inclusions and it was a mix of mid-yellow and light grey in colour and was 950mm deep to the limit of excavation (LOE).

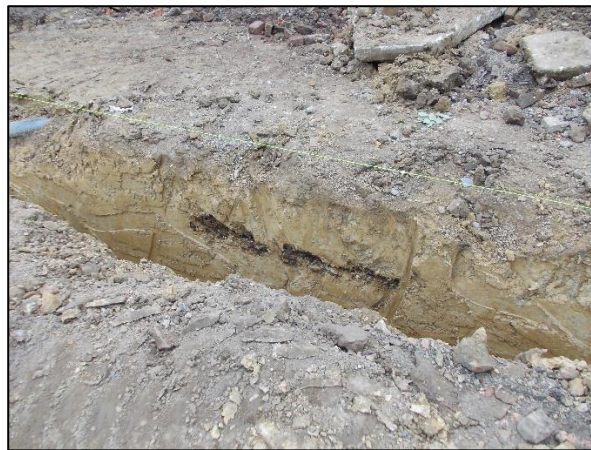
Plate 4: Natural stone deposit (Context **4**)

- 5.4** Context **3** was a straight sided cut 0.75m wide and 1m deep, with a flat base, that was part of the demolished 20th century barn and was filled with modern debris (CBM & Concrete) from the barn.
- 5.5** Context **4** was assigned to a natural loose, dark brown, iron rich stone horizon, c1.5m wide and 200mm deep, present in the south-west section of the footings (Plate 4), within the clay natural (Context **2**).
