**An Historic Building Survey
of the Former Cart Lodge,
96, High Street,
Westham, East Sussex**

Project No. CBAS0736

November 2016

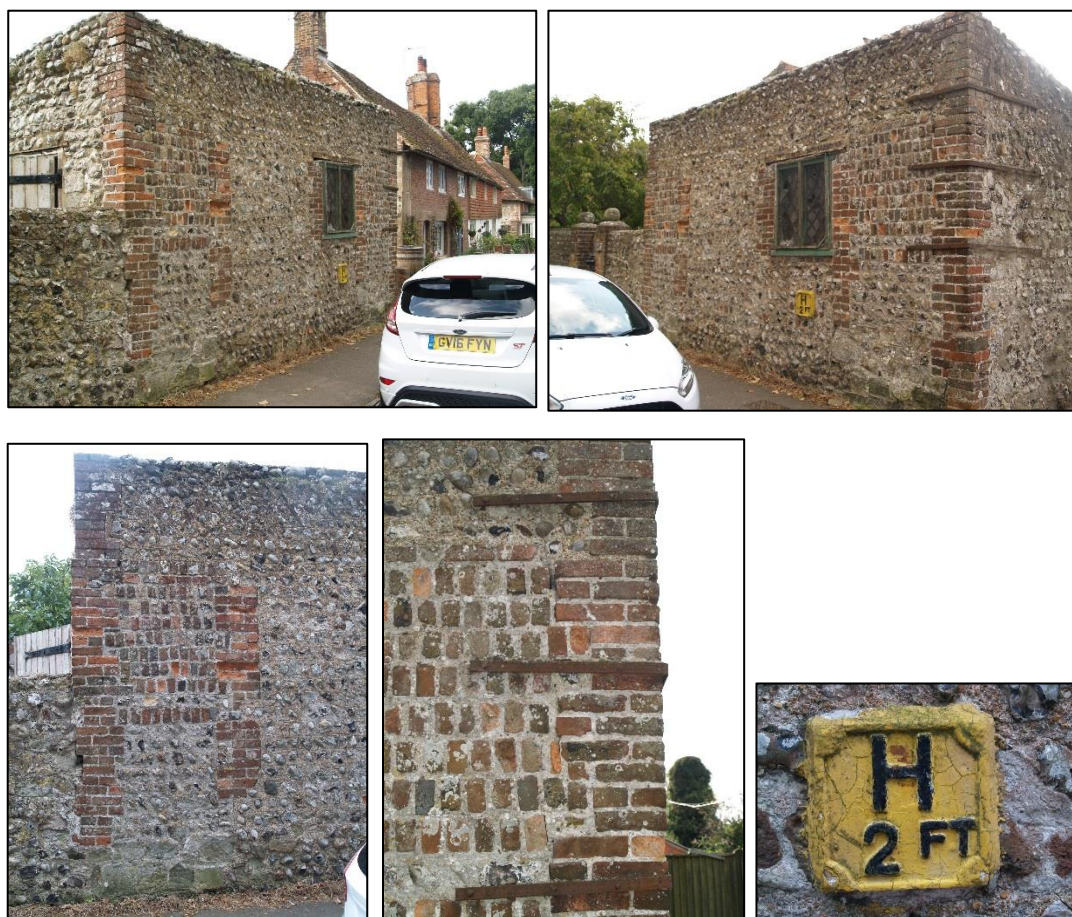
4.1.2 The North Elevation (Plate 1) – is constructed in two phases, an upper phase of 11 – 12 courses of coursed flints (11 courses at the east end and 12 courses at the west end) and a lower phase of circa 24 courses of flints. There are two columns of long & short brickwork on the eastern and western corners with a further two infill columns in the wall structure itself at 1.06m and 1.20m in from the east and west corner columns respectively. Between these columns, forming the main part of the elevation, there are circa 21 courses of flints up to the upper phase.

Plate 1 – The north elevation viewed from the east (top left) and west (top right). Note the long & short brickwork at each corner with the adjacent infill columns (detail bottom left) the NW corner metal strapping (bottom middle) and detail of the 'Hydrant' sign (bottom right).

- 4.1.3** Between the corner columns and their adjacent infill columns there is a lower infill of green Sandstone with coursed flint above and circa 9 courses of rowlock brick infill, laid in no particular bond stretching down from the upper phase, with coursed flints below. This foundation course of sandstone was not visible across the central section of the elevation, again indicating that this was probably open at some point.

- 4.1.4** Adjacent to the western infill column there is an inserted diamond leaded window of two panes with a decayed wooden lintel above, long & short brick work to the east and a single course of bricks beneath. Directly below is a pre-1938 'Hydrant' sign indicating that the wall between the two infill columns was certainly in situ before that date and so any former doorway was blocked before this time.

- 4.1.5** The eastern end of this elevation is linked to the northern boundary wall which runs east from the buildings NE corner. The level and style of infill on the elevation appears to indicate that there was originally a pair of doors in the centre of this elevation allowing direct access to the road.

- 4.1.6** The two corner, long & short, brick columns have at some point had 11 to 12 courses of brick added to the top, the east series being noticeably out of line, presumably to raise the height to create the slope of the flat roof. The flat roof, which slopes to the south is not contemporary with the building it is more likely that it had a pitched roof, possibly with a ridge running east to west from the plan shape as shown on the OS maps, Figs. 8 – 11.

- 5.6 The principal areas of interest that still remain are the north wall of G1 which retains indications that there was direct access to the High Street, now blocked in favour of access through the eastern elevation to the front of No. 96; possibly at the time of No. 96 being constructed during the 1930’s. Also the western elevation, which illustrates the original access from the adjacent property when they both formed a single holding and the current one which was used as a coal yard.¹⁰ *Features on both of these elevations should be retained as far as possible.*

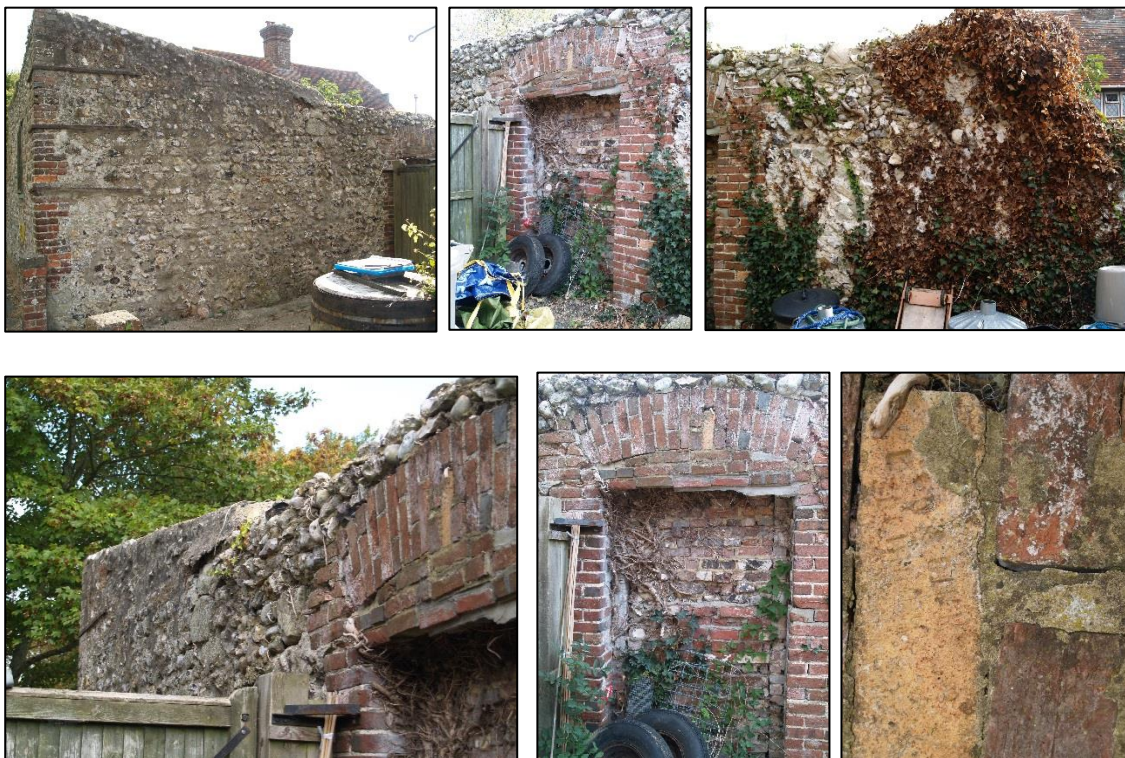
- 4.1.7** **The West Elevation (Plate 2)** – extends southward along the western boundary of the property, it is immediately adjacent to No. 94 the High Street and forms a continuation of the boundary wall. The NW corner of this and the northern elevation have been reinforced with three metal straps.

- 4.1.8** The elevation is largely constructed in rough coursed flint up to a height of 1.7m at its southern end; generally these flints are larger than those noted on the northern elevation with some brick inclusions. The lower part is of roughly coursed flints with inclusions of brick laid in herringbone style, the upper part of the elevation is constructed in a more random '*Rubble*' style of bond. The wall eventually drops down to the lower level beyond the south elevation of the building, indicating that the upper, '*Rubble*' construction was possibly added to an existing boundary wall to form the elevation of the building.

- 4.1.9** The construction of this southern section of the elevation ends, adjacent to the gateway into No. 94's drive, at an infilled doorway; this probably gave access from No. 94 to the former 'Coalyard' when they existed as a single property. Doorway is 1.11m wide with two, short & long, brick columns and a soldier and rowlock arch above. The arch has been reinforced with three courses of random brick beneath and the doorway itself roughly infilled with brick, between two remaining brick jambs; indicating that the door most probably opened into No. 94.

- 4.1.10** Above the archway are two courses of '*Rubble*' laid flints which extend, at an upper level, slightly beyond the arch itself.

Plate. 2 – The Western Elevation viewed from No. 94, High Street, The NW corner showing the coursed flint construction with the added upper phase supporting the flat roof of G1 (top right). The infilled doorway with its brick supporting columns and arch (top centre) and the southern end of the elevation constructed in larger flints (top right). Detail of the '*Rubble*' flint work above the arch (bottom right), detail of the blocked doorway showing the brick jams (bottom centre) and detail of Marker mark on one of the arch bricks (bottom right).

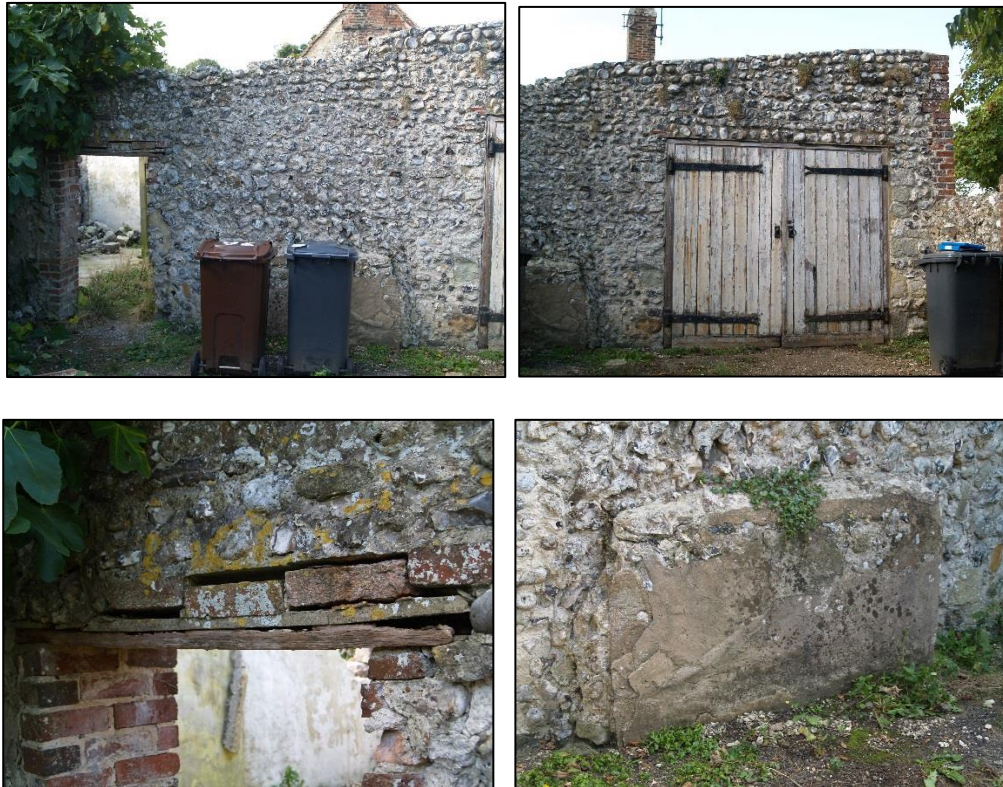
- 4.1.10 The East Elevation (Plate 3)** – is dominated, at the northern end, by a set of wooden garage doors mounted on '*Tee*' hinges slightly to the south of the boundary wall. Between the boundary wall and the door frame is a column of rough-hewn sandstone blocks with inclusions of flints, extending up to just below the height of the doors. Above the doors are 8 – 10 courses of medium to small flints reaching up to the flat roof which slopes down to the south.

- 4.1.11** At the southern side of the doors there is an infill of '*Rubble*' coursed flints, with some inclusions of rough-hewn sandstone blocks against the door frame itself, above the height of the doors sits the coursed flints of the type described above.

- 4.1.12** It is interesting to note that the upstands each side of the doors and extending south to an approximate alignment with the internal dividing wall between G1 & G2 appear to be bonded with a lighter coloured mortar than the elevation further to the south. It is possible that extensive repairs have taken place to this part of the elevation, possibly when the properties were divided and the access changed.

Plate 3 – The Eastern Elevation showing the doorway into G2 and wall to the south (top left) and double garage doors adjacent to the boundary wall, to the north (top right); note the change in mortar colour between G1 & G2. Detail of the lintel over the doorway into G2 (bottom left) and the small plinth (bottom left)

- 4.1.13** Southward from the change in mortar colour the flint wall continues in a more randomly coursed bonding to the single doorway leading into G2. At the base of the elevation, immediately adjacent to the change in mortar, is a small partly rendered plinth extending 1.6m, 0.84m in height and protruding out from the wall by 0.08m; constructed of flint and brick. The purpose of the plinth is unclear as there appears to be no need for such a local reinforcement at this point in the wall.

- 4.1.14** The single doorway into G2 has a brick column on the south side supporting a decayed wooden lintel with a single course of narrow brick above; the brick course has fallen away from the main wall construction leaving the above flintwork largely unsupported. On the north side of the doorway the lintel is supported directly in the flint wall, possibly a corresponding brick column has historically been lost here.

- 5.8** The eastern elevation of G1 has been extensively rebuilt, possibly to accommodate the modern Garage doors, see plate 3 and para 4.1.12, and *so any loss of fabric here would not constitute a significant loss.*

- 5.9** Southward of the dividing wall between G1 and G2 the eastern elevation the wall is most probably of original flint construction, similar to other elevations on the building. While of interest it does not appear to show significant evidence of the buildings development, or unique details of the construction; this type flint walling is a common and widespread technique across the local area, hence *some minimal loss here would not be considered significant.*

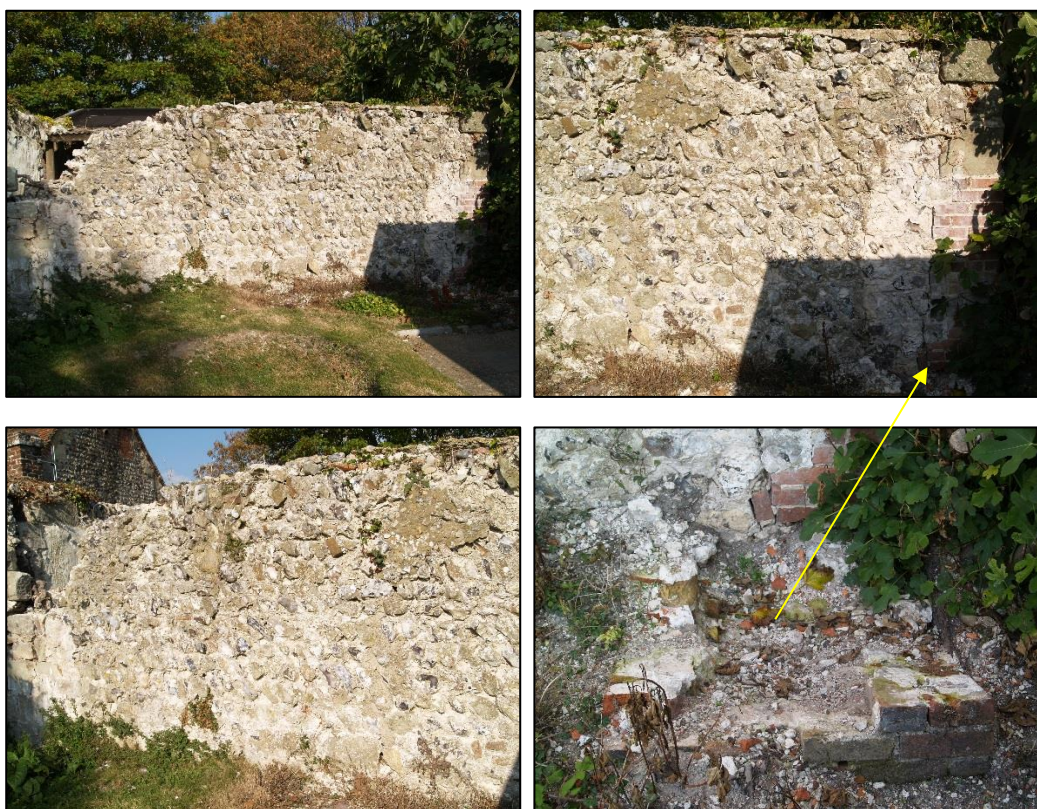
4.1.16 The Southern Elevation (Plate 4) – has a brick column on its eastern corner consisting of sixteen courses with three sandstone blocks above. The wall itself is constructed in a similar way to the southern section of the western elevation, see para 4.7, of coursed flints below giving way to ‘Rubble’ construction above with occasional inclusions of brick set in herringbone fashion. The base of the wall has several sandstone blocks set into the base at mid-elevation, at the far western end of the elevation the wall has collapsed leaving only the lower part, but appears to have been constructed in sandstone blocks at the extreme end of the elevation. Several areas of repair and re-mortaring are evident across the elevation, presumably in an attempt to maintain the wall.

4.1.17 At the base of the eastern end of the wall are the remains of a square brick feature extending out from the elevation by 1.04m and 0.93m in width, with three courses of brick remaining. Directly behind it there appears to be a witness mark on the wall, extending three quarters of the height of the wall indicating where some has been removed. The purpose of the feature is unclear but it may be the remains of a reinforcing buttress.

Plate 4 – The southern elevation, showing a general overview (top left), detail of the eastern end (top right), note the brick feature at the base and the mark on the wall directly behind. The western end (bottom left) and detail of the brick feature at the eastern end (bottom right).

- 5.10** The southern elevation, again, shows features of the buildings development with the use of Sandstone blocks and the square feature, a possible buttress, at its eastern end. *As far as possible the original materials and form of this elevation should be retained while at the same time stabilising and preserving it within the proposed development.*

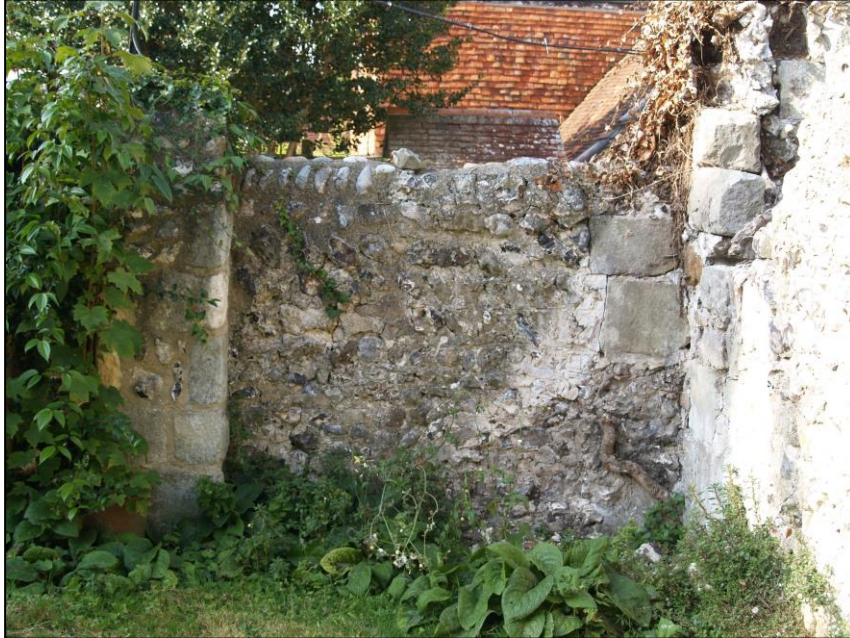
4.1.18 In the western boundary wall immediately adjacent to the southern Elevation there appears to be an infilled gateway (Plate 4A), this may possibly be the entrance to the pathway shown crossing the site from east to west on the 1st Edition OS Map, Fig. 8.

Fig. 4a – The blocked gateway in the western boundary wall immediately adjacent to the southern elevation.

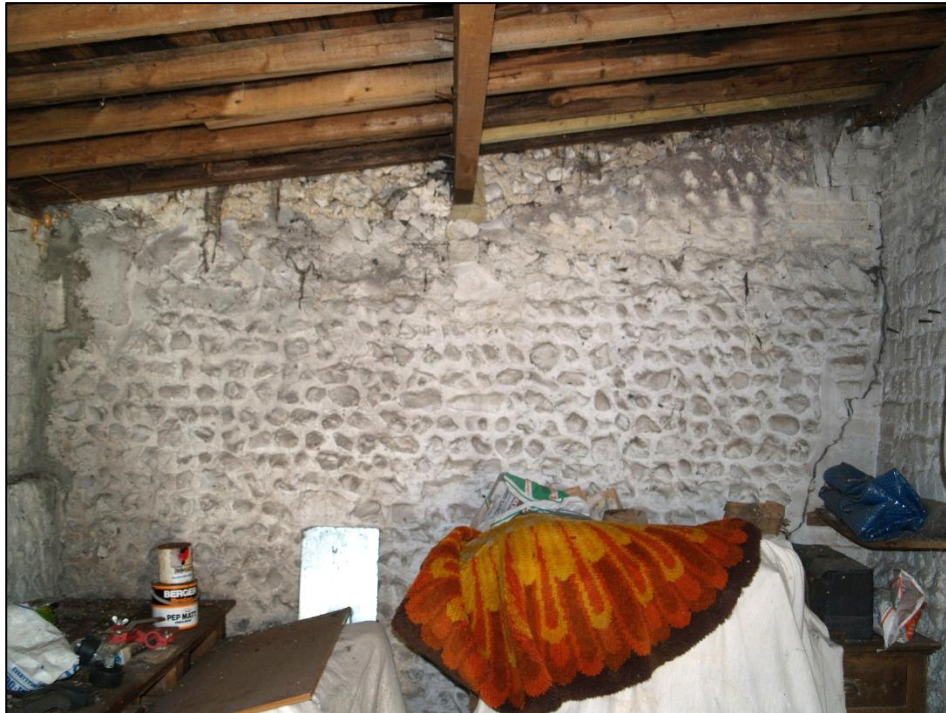
4.2.1 Garage, G1 (Plates 5-8) – has a western elevation constructed in 23 courses of flint with rough randomly coursed flints above, as noted on the external description of this elevation; indicating that the wall has been raised to accommodate the new roof.

Plate 5 – The internal western elevation showing the coursed flint on the lower part of the wall with more randomly coursed flints above, the brick column in the NW corner and the modern roof timbers.

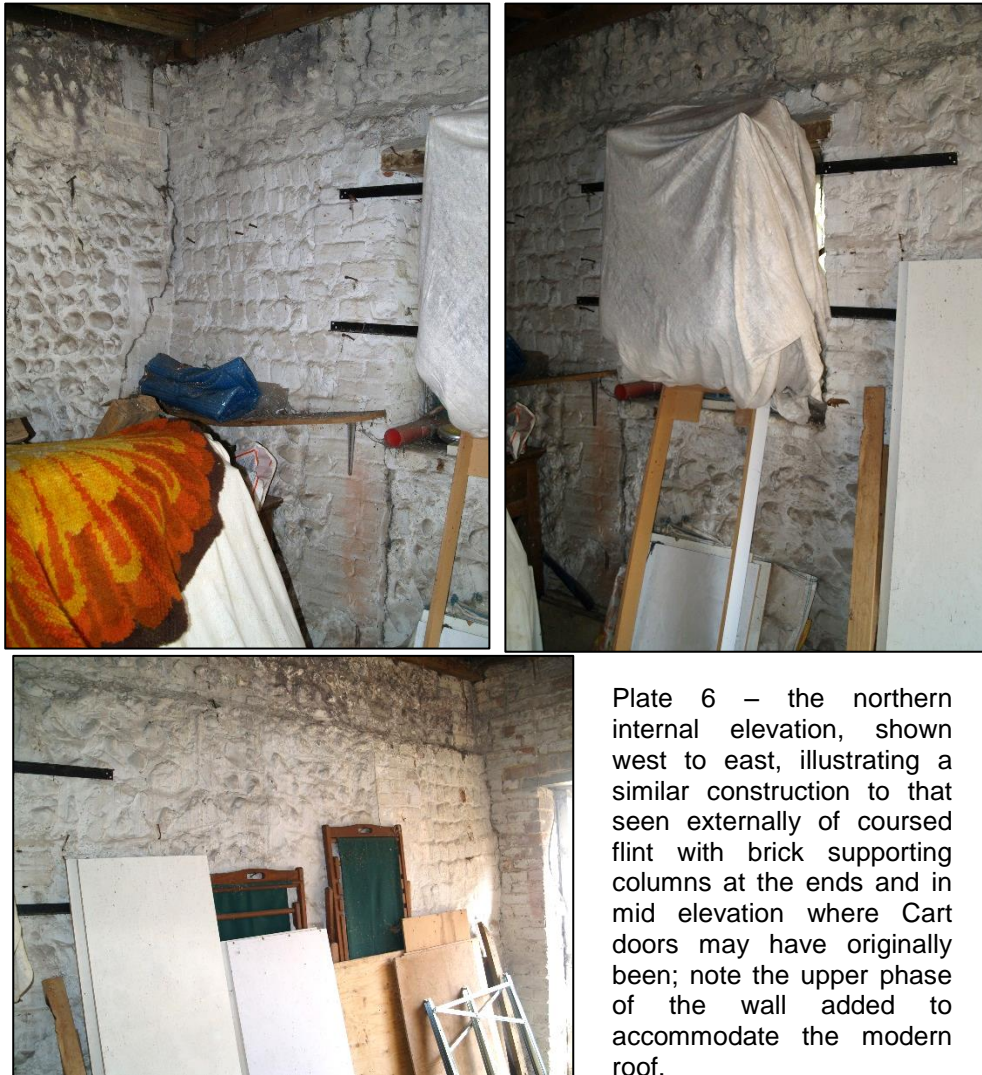
4.2.2 The northern elevation (**Plate 6**) has a construction which mirrors that of the external description, of coursed flint in two phases with supporting brick columns at each end and at mid-elevation where Cart doors were possibly originally sited. The upper phase of the wall is a distinct addition, again, presumably to create the slope of the modern flat roof.

4.2.3 The flat roof is supported along this elevation on a Beam secured to the wall by iron brackets rather than on a wallplate or by beams let into the wall, indicating that the neither this phase of the wall and the current roof are contemporary.

Plate 6 – the northern internal elevation, shown west to east, illustrating a similar construction to that seen externally of coursed flint with brick supporting columns at the ends and in mid elevation where Cart doors may have originally been; note the upper phase of the wall added to accommodate the modern roof.

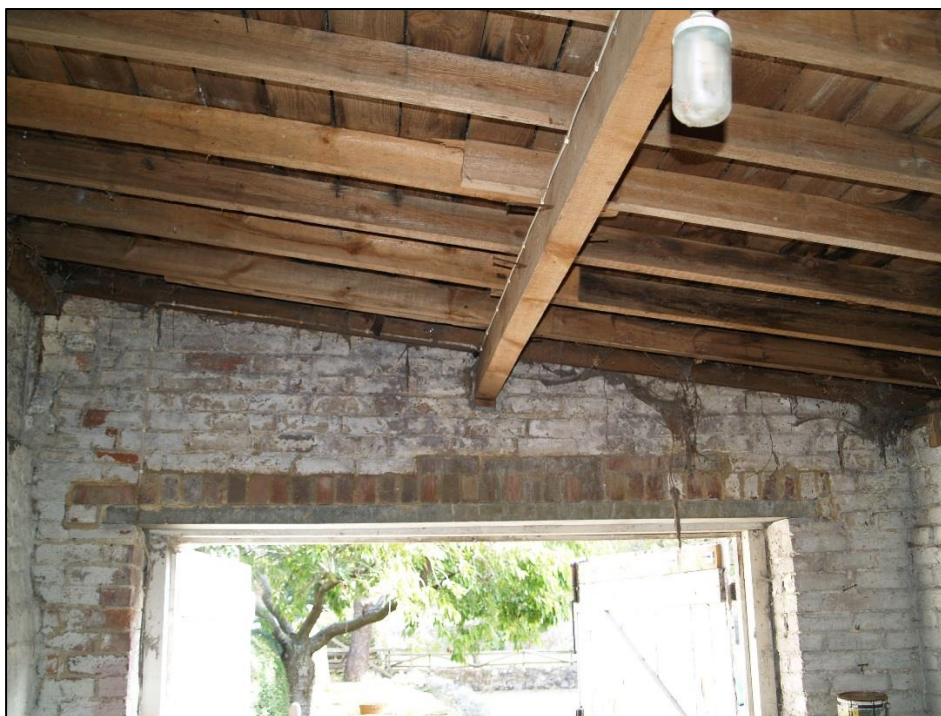
- 4.2.4** The eastern elevation of G1 (**Plate 7**) has an internal structure of brick, laid in Stretcher bond except directly over the Garage doors where there is a modern concrete lintel with a single course in vertical Header bond. The roof beam on the northern elevation is let into the brickwork whereas the central beam is supported on a galvanised steel bracket. The brickwork on this elevation appears to be butted to the north and south elevations rather than keyed into them.
- 4.2.5** The door frame is of modern timber as are the doors and their fittings, this and the modern brickwork which appears to match the area of lighter mortar noted on the outside elevation, see para 4.1.12, appearing to indicate that this part of the elevation has been extensively reconstructed to possibly to accommodate the current doors and to preserve this elevation.

Plate 7 – The eastern internal elevation of G1 showing the Stretcher bond brick construction, modern door lintel and bracket holding the roof beam.

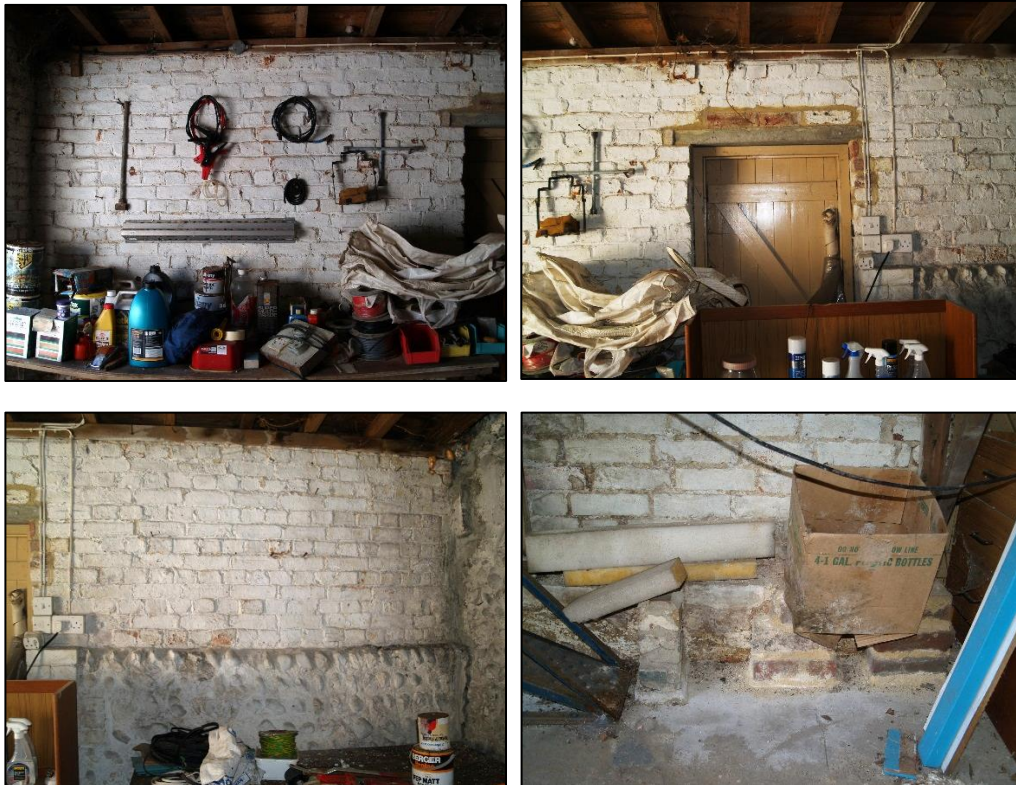
4.2.6 The southern elevation (**Plate 8**) appears to have several phases of construction. At the western end there is a low coursed flint wall of 15 courses, extending eastwards to a brick column which forms the western side of a single doorway at mid-elevation. The low flint wall has been raised, to the west of the door by the addition of thirteen courses of brick, laid in English bond, which extend to the roof. Above the door is a modern concrete lintel with a continuation of the English bond wall above. To the east of the door the English bond wall continues, but now extending down to an older low brick plinth at the base. The brickwork on this elevation appears to be keyed into the east wall, but butted up to the west wall, the roof along this elevation is supported on a modern wallplate on top of the wall.

4.2.7 It would appear that the southern elevation may originally been open to the Paddock behind, G2, with a low flint wall dividing the two areas; only the western part of this wall survives. Later the wall was extended, using English bond brickwork, with possibly the eastern low flint wall having been removed, if it actually existed. The doorway, but not the current door and frame and possibly only an opening, appears to be original as the surviving western low flint wall terminates in a brick column, which is either contemporary with the wall or its upper extension.

Plate 8 – The southern internal elevation of G1 shown from east to west (top left to bottom left) note the English bond brickwork and low flint wall at the western end (bottom left). Also detail of the earlier brick plinth at the base of the wall to the east of the door.

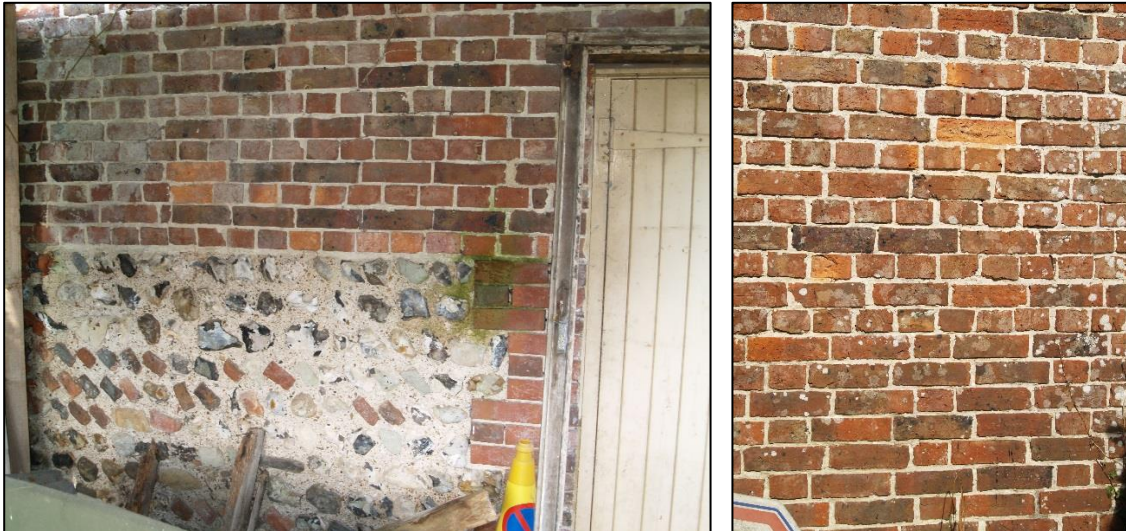
- 4.2.10** The northern internal elevation (**Plate 9**), which is the dividing wall with G1, is a low flint wall to the west, with an inclusion of five courses of Herringbone brick at the extreme western base, with a Header course of bricks on top of the flintwork, Above there is twelve courses of English bond brick work above. To the east of the central doorway the wall becomes exclusively brick with a lower half in Flemish Garden Wall (Sussex) bond and an upper half in English bond. Generally English bonding proceeds Flemish, but it was resurrected in the later Victorian period due to its strength and its popular appearance during the Gothic Revival.

Plate 9 – The northern elevation of G2, showing low level flint wall with English bond brick work above at the western end, and the wall to the east of the central doorway note the lower Flemish Garden Wall (Sussex) bond at the base and the change to English bond above.

- 5.7** The dividing wall between G1 and G2 also demonstrates the development of the building with its low flint wall to the west and variations in brickwork. The brickwork plinth that was noted at the base of the eastern part of this elevation indicates that there was an older wall separating G1 & G2, possibly of flint, as demonstrated by the western part of the elevation. The multiple types of bonding in this elevation are also of interest as English bond generally pre-dates Flemish Garden Wall (Sussex), but did make a reappearance in the Victorian period because of its style and strength. *There is potential to loose important features of the buildings architectural history with this elevation.*

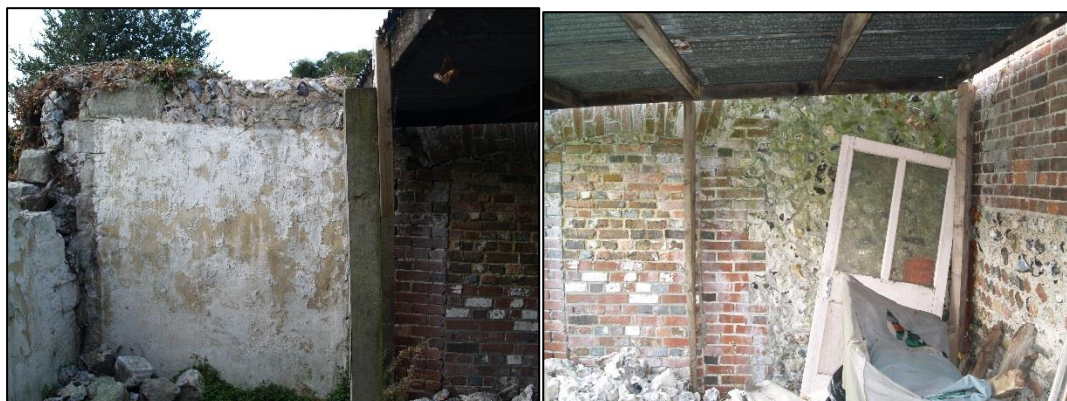
4.2.12 The western elevation (**Plate 10**) inside G2 has rough coursed flint construction to the north of the blocked doorway, see para 4.1.9, which has a brick column of long & short work. Above the doorway is a Soldier and Rowlock arch. To the south of the blocked doorway the wall is constructed in rendered rough coursed flint with sandstone blocks in SW corner. The render is painted and marks the location of a former lean-to. The wall is seriously deteriorating in the SW corner with two elevations actually separating at this point.

Plate 10 – Western internal elevation of G2 showing the plastered and painted wall to the south (left) and the blocked doorway and flint construction to the north (right).

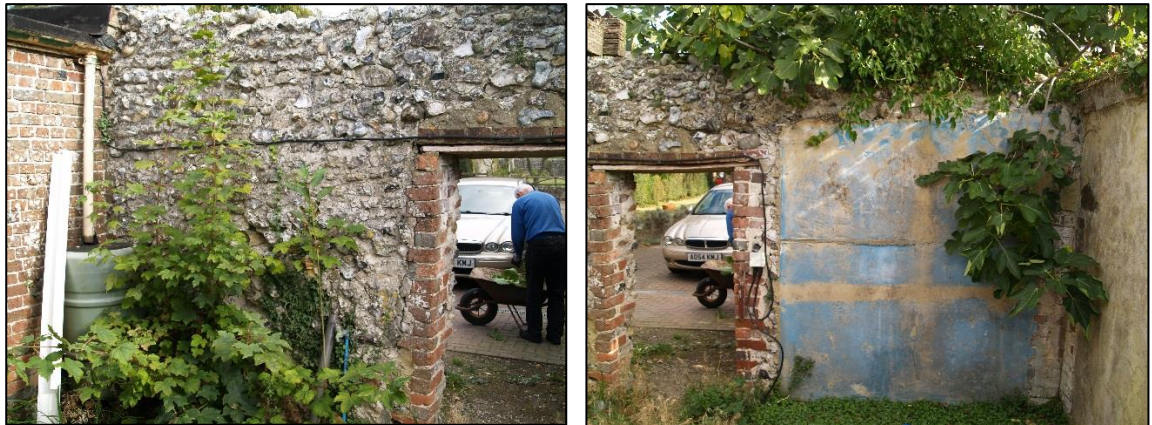
- 4.2.13** The eastern elevation, (**Plate 11**) is rendered to the single doorway, see para 4.1.14, from the SE corner and then continues in coursed flint as the external of this elevation, see para 4.1.13. The southern end of the elevation, from the single doorway is rendered and painted, corresponding to a similar area on the western elevation, indicating where a lean-to formally stood.

Plate 11 –East elevation of G2,north end (left) to south end (right), note the area of rendering on the south of the elevation which corresponds to similar on the west elevation, denoting where a lean-to formally stood.
