## **An Archaeological Landscape Survey of Gayles Farm, Friston, East Sussex**

Project Ref: CBAS0561

November 2015

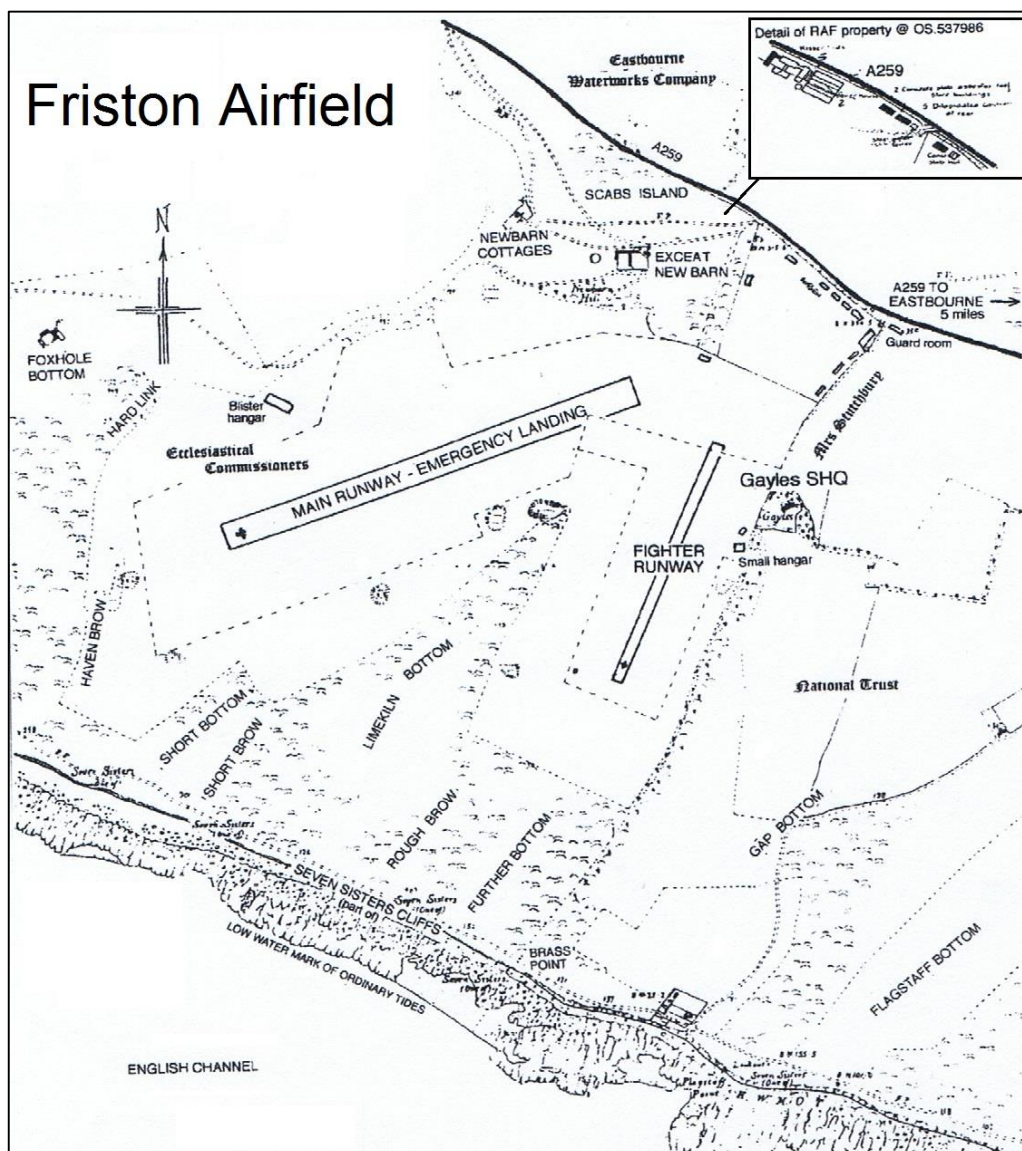
Fig. 2: Friston Airfield map  
(adapted from Operation Cuckmere Haven<sup>1</sup>)

A large portion of the property was given over during the Second World War as an airfield, RAF Friston, initially serving as an emergency landing strip and later as a fully operational airfield with a resident squadron of Spitfires (Fig. 2). Within the property boundary, the airfield complex included a number of anti-aircraft gun emplacements, a radar station, weapons pits and ancillary buildings scattered across the site many of which have been mapped from historic aerial photography as part of the Beachy Head-Peacehaven National Mapping Programme.

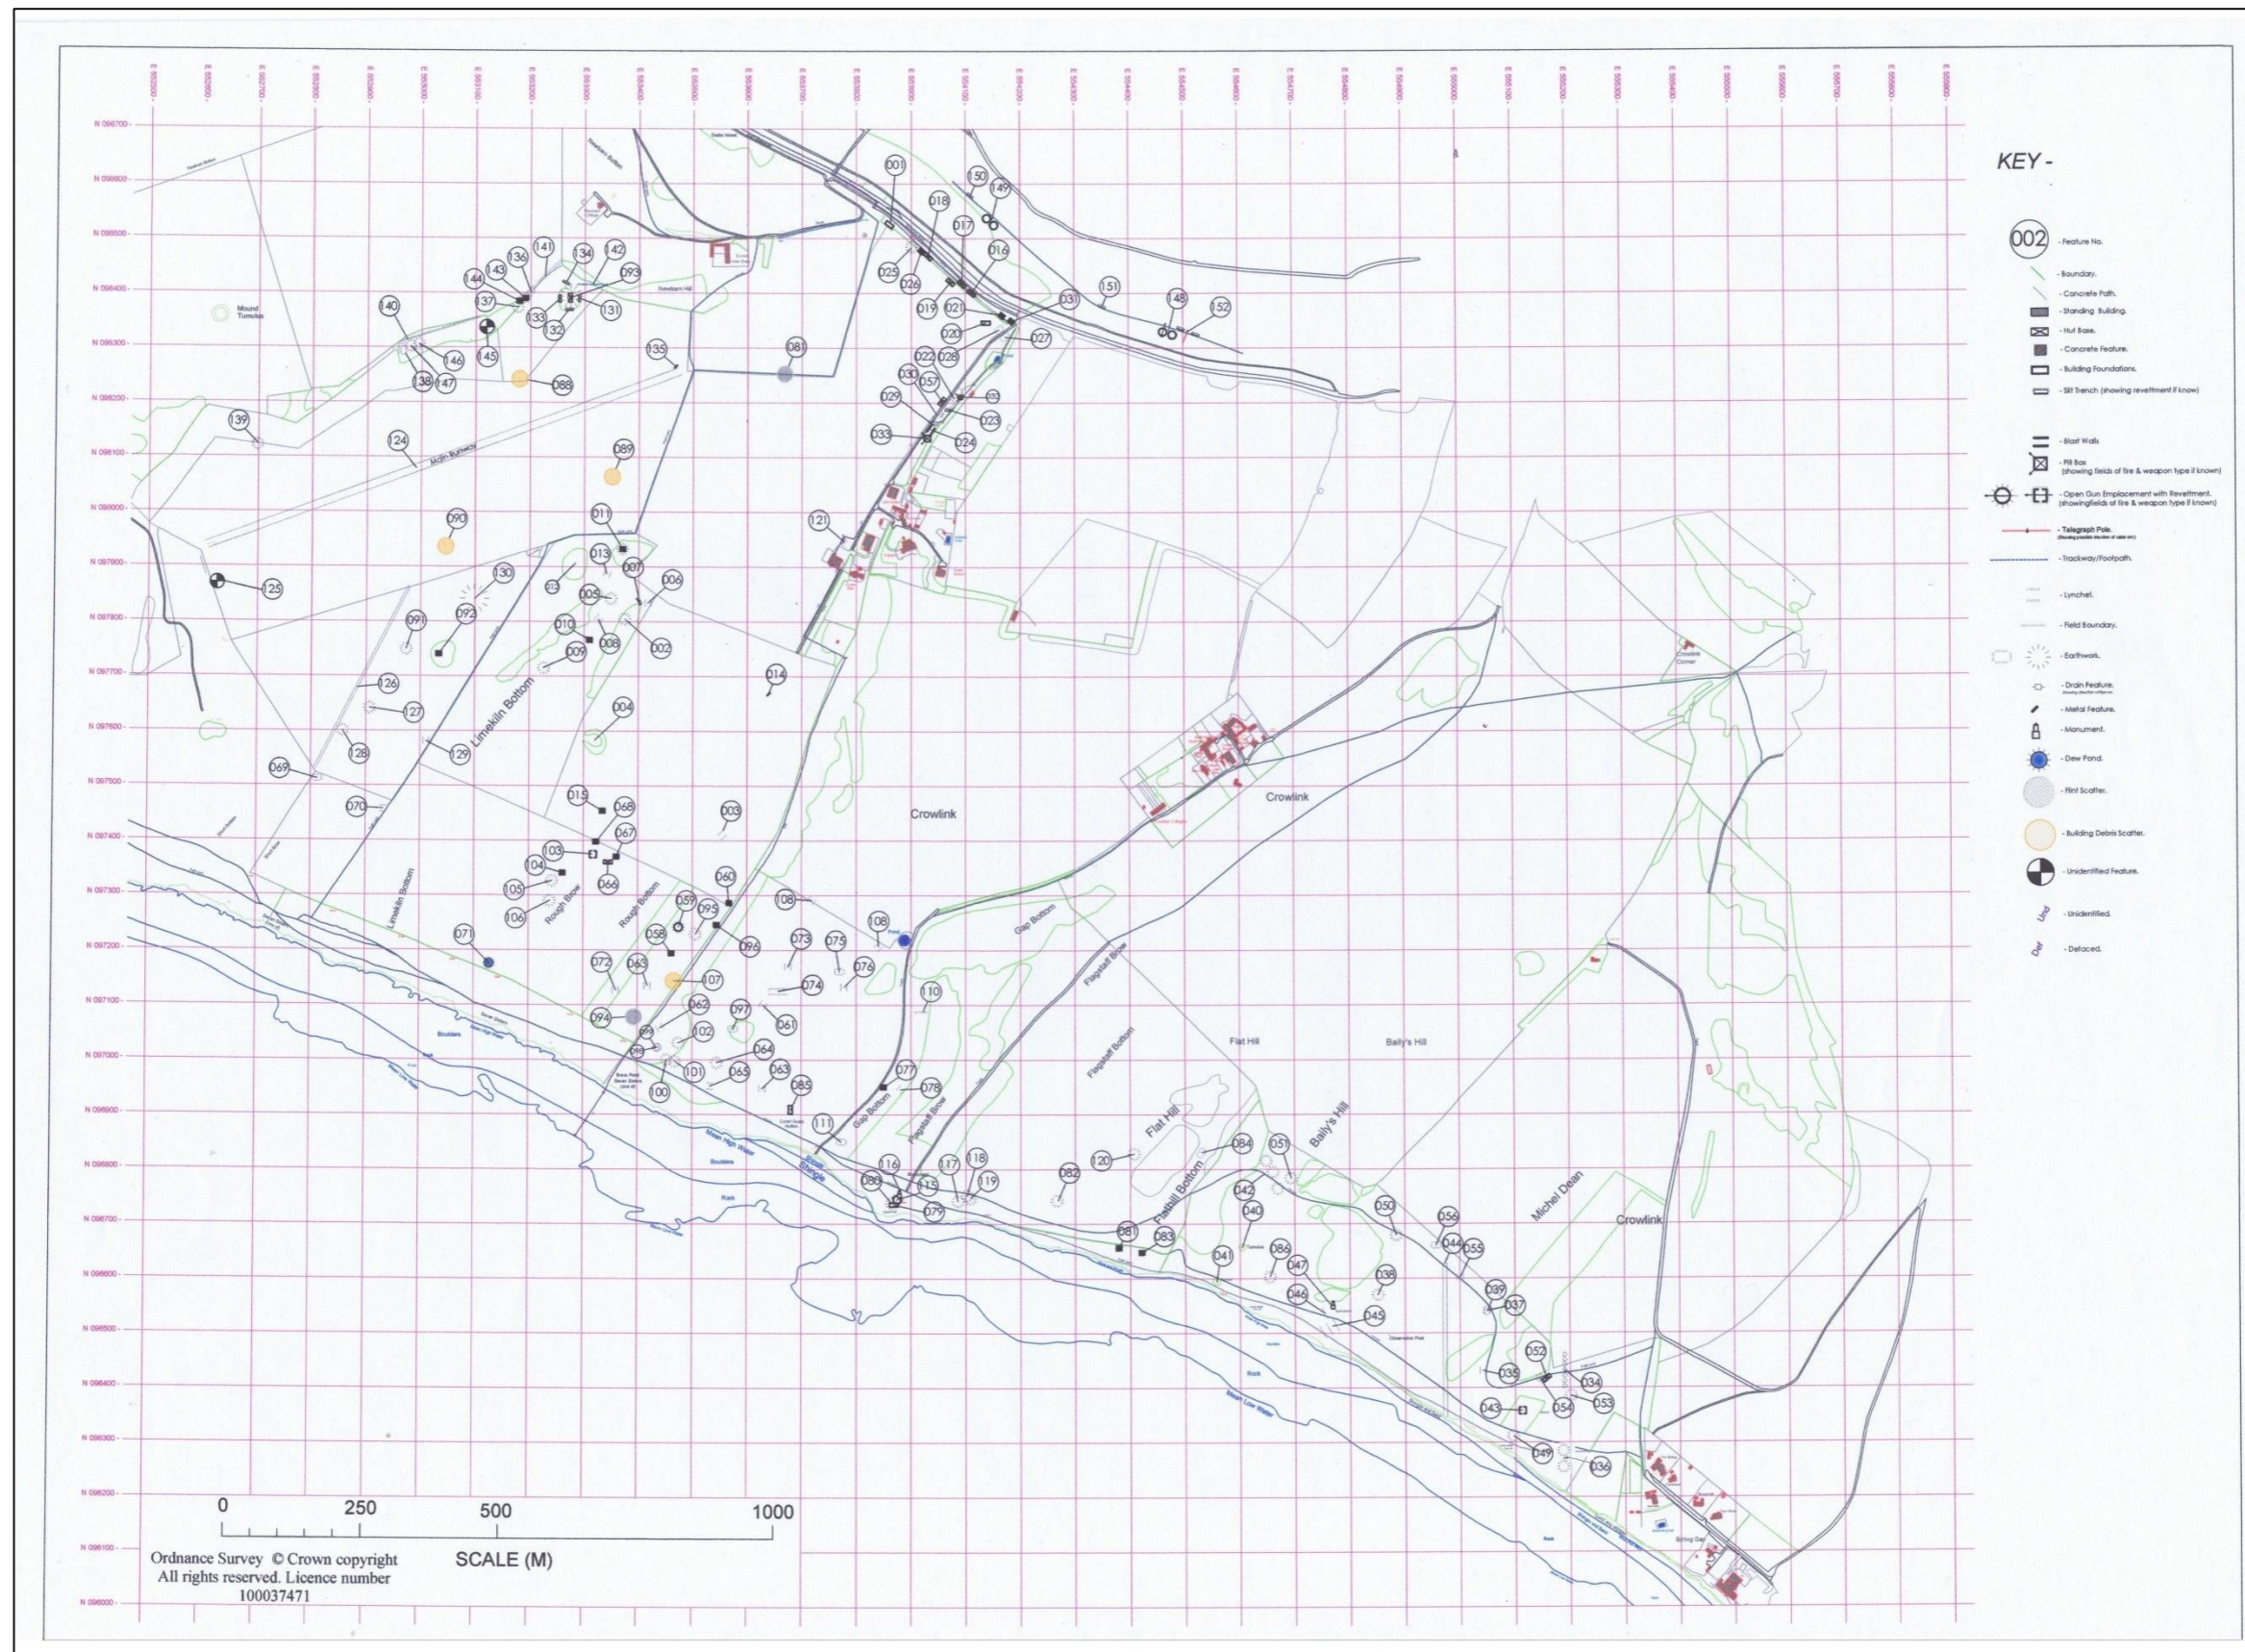
Fig. 6: Map showing all of the sites recorded during the survey

A total of 147 sites and find spots were recorded during the survey and are detailed in Appendix 2, and shown on Fig. 6. The main types of site found in the survey are listed and defined in Table 1 below, and are described in more detail in the report.

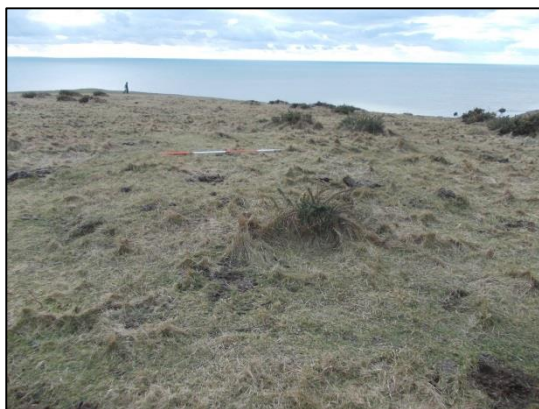
Plate 5: Barrow GAY040

The 15 barrow sites cover a total of 22 possible barrows. These are all circular mounds, which vary in size from 5m to 10m in diameter, and between 150mm and 0.5m in height (Plate 5). Some have a trace of a ditch up to 1m wide around part of the barrow circumference. The form of this group of monuments suggests that they could be Bronze Age burial mounds, however this cannot be certain for all of them, and some are covered in scrub or gorse which makes a full identification difficult (Plate 6), and therefore it is possible that some of these barrow-like mounds could be evidence of later activity, either military or perhaps quarrying.

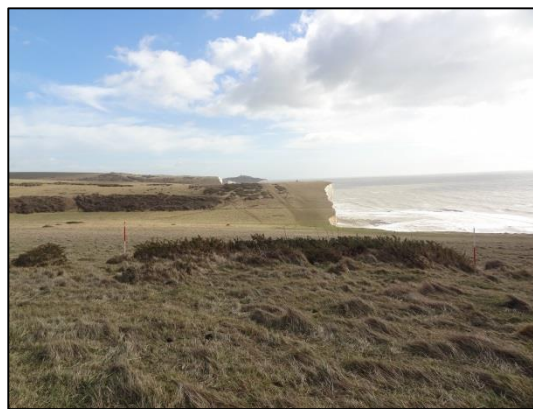
Plate 6: Possible Barrow GAY064

The barrows are generally located on the coastal strip, and are normally found on the higher ground, with concentrations on Baily's Hill and Rough Brow. Some of these barrows have been previously recorded but others are new discoveries. A few of the barrows appear to be directly associated with the lynchet field systems (eg. GAY064).

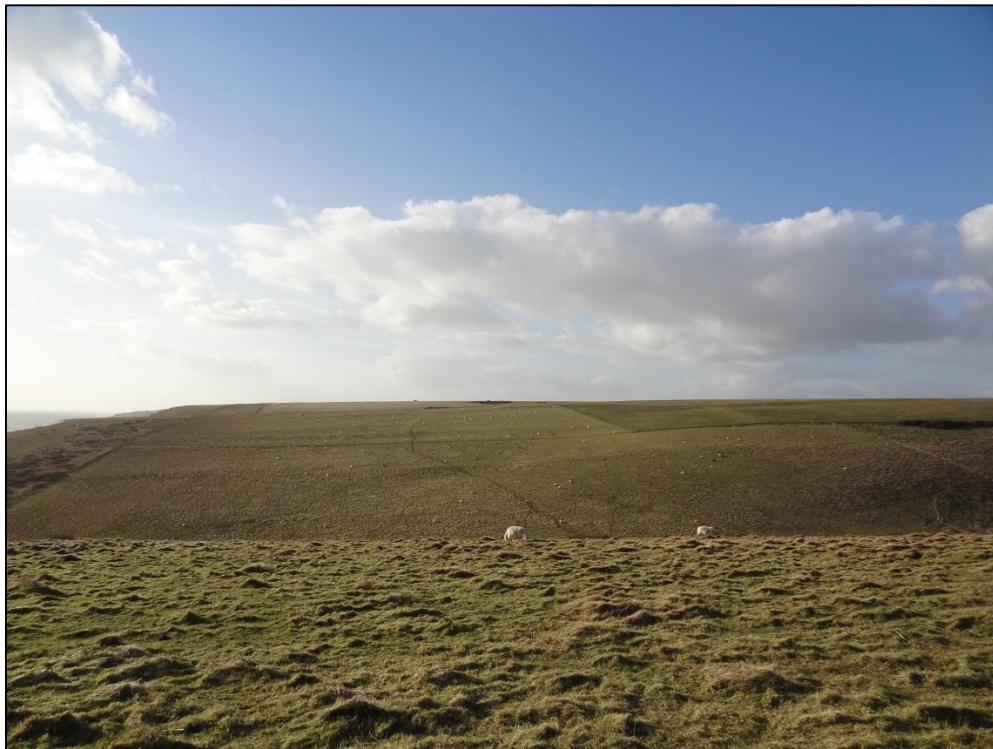
Plate 8: lynchets forming field system (GAY072)

The lynchets have been grouped under prehistoric sites as, although they are likely to have continued in use into the Romano-British period, it seems most likely that they originated in prehistory. The form of these field systems formed by sub-rectangular fields with linear lynchet boundaries, and including banked trackways, is typical of fields found associated with Bronze Age settlement sites, and which continued into the Iron Age (Plate 8).

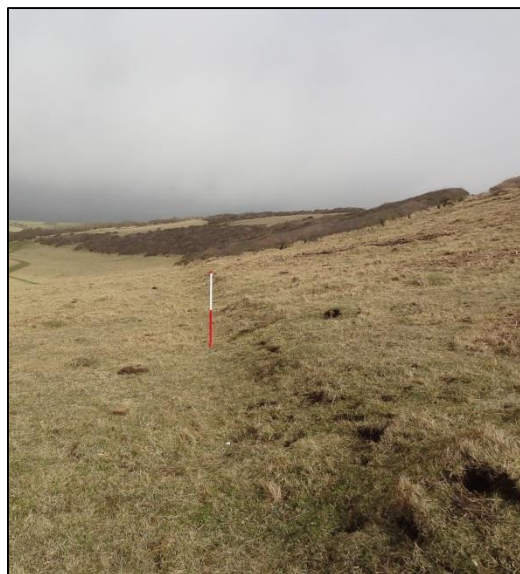
Plate 9: Lynchet GAY078

The field systems were known from aerial photographs, and had been largely plotted onto the HER records from those photographs and are recorded on the HER under two references (MES3005 & MES20076), however this is the first time anyone has attempted to record these particular field systems on the ground (Plate 9). It is clear that they have been badly denuded by the effect of ploughing, although some of the best preserved lynchets are those located on existing field boundaries.

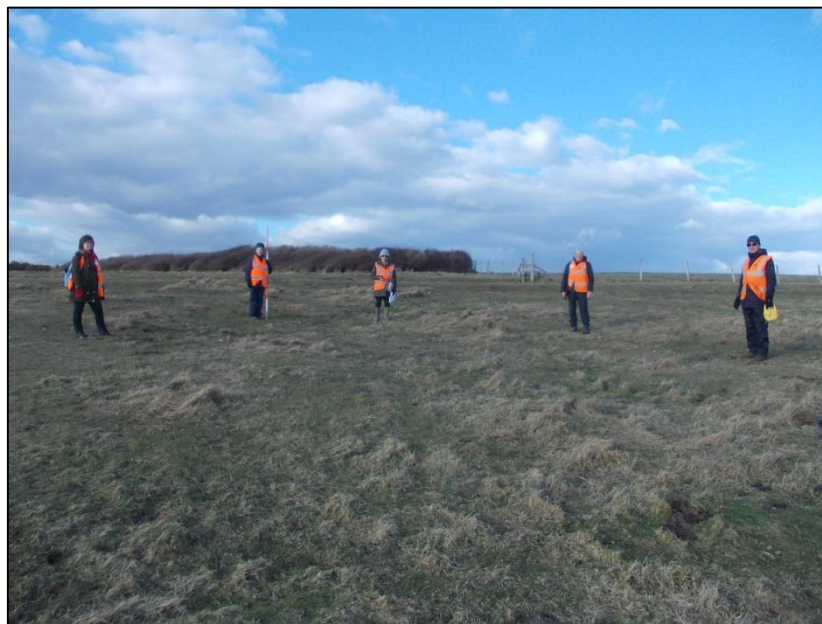
Plate 10: Possible prehistoric hut platform

A single possible Bronze Age hut platform was found during the survey (GAY052). It was located on the south-east facing slope of Went Hill overlooking Birling Cap, and comprised an area of 10m x 12m terraced into the upper slope (Plate 10). This would be of sufficient size to hold a single roundhouse, or associated pair of smaller roundhouses, and is typical of other Bronze Age hut platforms seen elsewhere on the South Downs. Only excavation will resolve whether this is a hut platform or whether it served some other purpose.

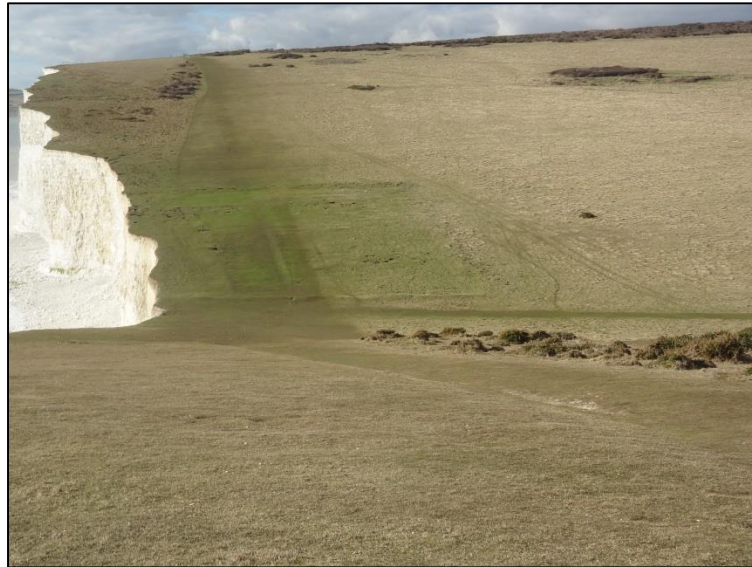
Plate 11: Coastguard Station (GAY085)

The confirmed 19<sup>th</sup> century sites include the Coastguard Station (Fig. 9 & Plate 11) at Crowlink (GAY085) and a scatter of 19<sup>th</sup> century building material near the entrance to Gayles Farm (GAY020). Other features likely to be 19<sup>th</sup> century are the Dew Ponds (GAY071 & 109), with GAY109 being shown on the 1<sup>st</sup> Edition OS map (Fig. 10).

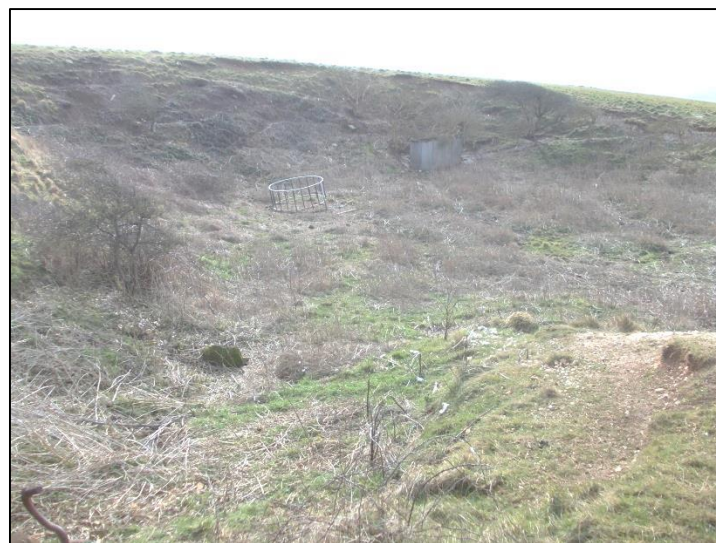
Plate 13: Quarry GAY004

These quarries are quite substantial, being 30-40m in diameter and c8m deep (Plates 13 & 14). They have a similar form being oval in shape with one side, generally the downslope side, open and used as the access into the quarry. Many of the quarries have then been used for other activities, with Quarry GAY004 having evidence for a building within it, a tank and machinery pieces, all probably associated with agricultural activities (Plate 13). Quarry GAY011 has the remains of a demolished pillbox from the Second World War dumped into it (Plate 20).

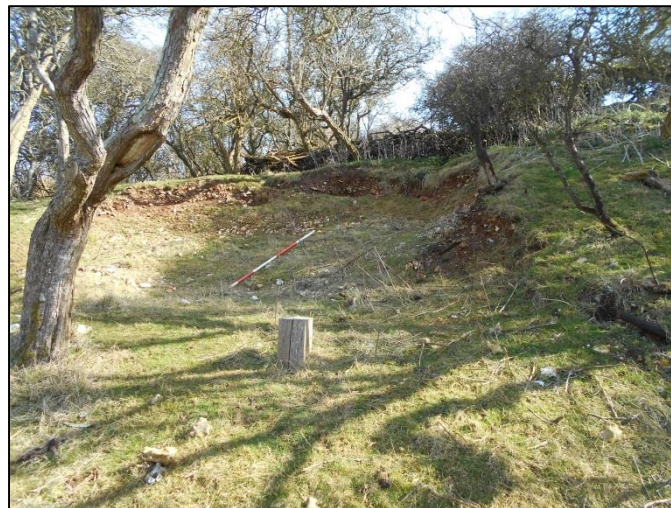
Plate 15: Quarry GAY146

The second group of quarries are much smaller, and can occur individually (e.g. GAY005, 009 & 146) or in groups (e.g. GAY034 & GAY050). They tend to be anywhere from 3m to 6m in diameter, and are usually shallow, usually less than 1m, although a few are deeper (Plate 15). They are difficult to date, but it is most likely that the majority will have dated from the 19<sup>th</sup> century, and they may be for quarrying either chalk or flint. It is possible that some may have been dug for other purposes and may not be quarries. The group GAY034 corresponds with an HER reference (MES24472) for Second World War activity.

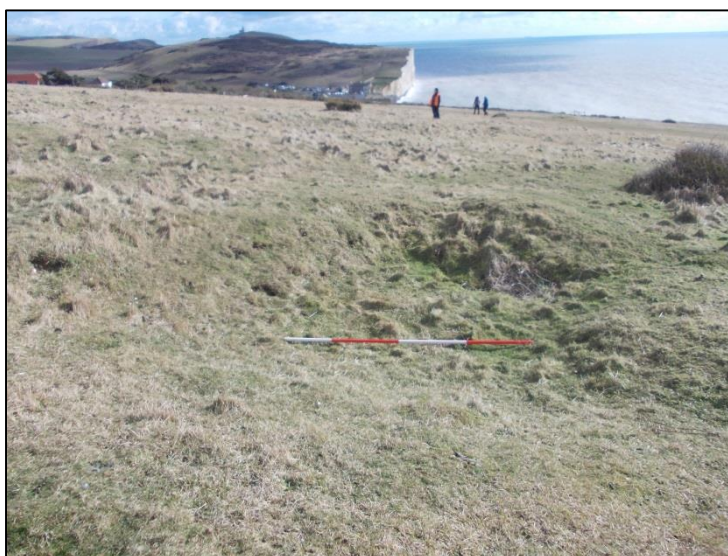
Plate 17: Possible weapons pit overlooking Birling Gap (GAY043)

The sites fall into two groups, firstly those which are defensive in nature, some of which directly relate to the airfield whilst others are part of the coastal defence sites prepared along the South Coast during the early part of the war. These include slit trenches, weapons pits (e.g. Plate 17) and gun emplacements, and pillboxes.

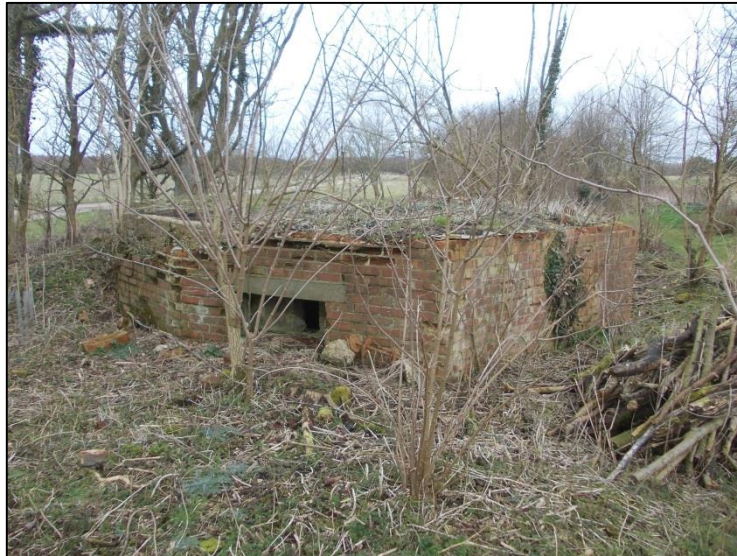
Plate 18: Pillbox GAY032 with concrete track beyond

Two extant pillboxes (GAY032 & GAY033) had been previously identified and recorded, and sit in a small copse to the north of Gayles Farm overlooking the runway (Fig. 11 & Plates 18 & 19). The pillboxes are identical (Fig. 12), and appear to be Modified Type DFW 3/24 (4f), similar concrete examples exist at Chiddingstone Causeway, Kent.<sup>13</sup> Pillbox GAY032 still has its metal door, and both have their metal fittings in their embrasures still in-situ.

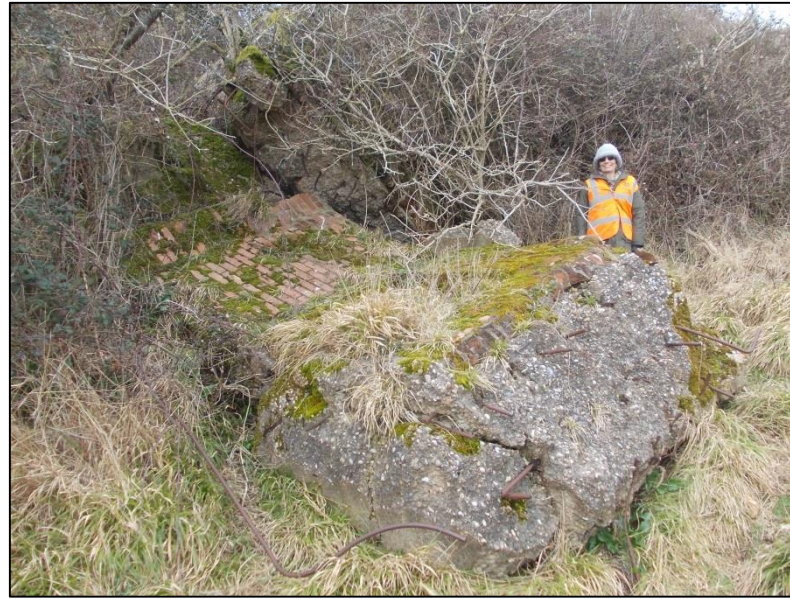
Plate 20: Demolished pillbox (GAY11a) in Quarry

The remains of a further pillbox (GAY011a) was identified in quarry GAY011 where it appeared to have been bulldozed after its demolition (Plate 20). It presumably had stood on the high ground beside the quarry where it could have covered both the runway and access from the coast. The NMR records a site comprising several small huts located in a chalk pit (Quarry GAY011) between the two runways, and is likely to be associated with anti-aircraft gun emplacements in the vicinity (NMR: 1529491).

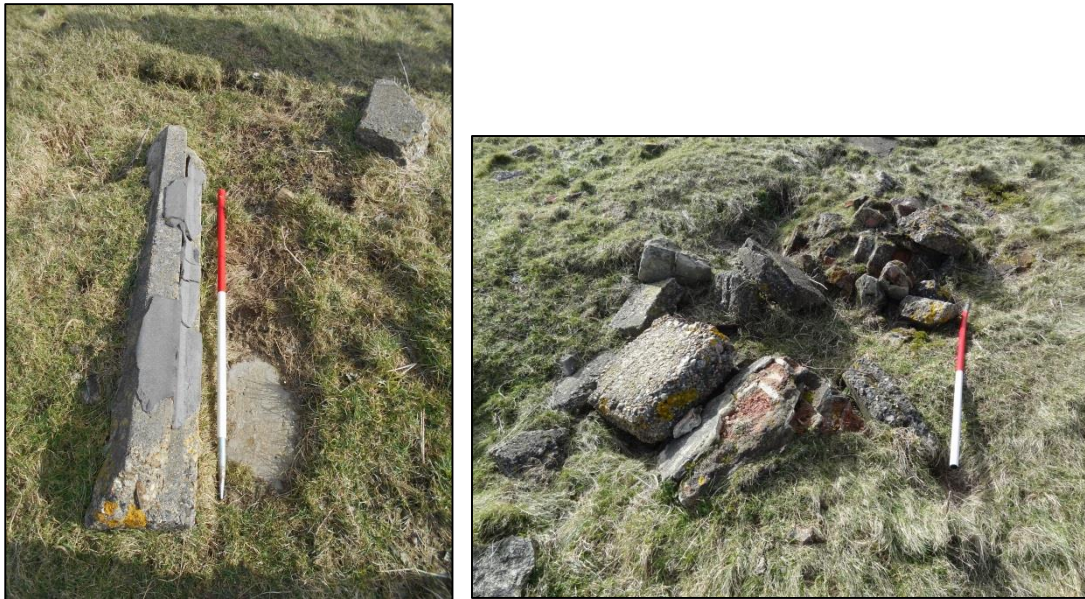
Plate 22: Concrete and other building debris relating to WW2 activity (GAY103 & 068)

Possible reinforced concrete remains of a fourth pillbox (GAY068) were also found, but these could be from another military building as no distinctive pillbox features were noted amongst the remains (Plate 22). This latter ‘pillbox’ was within an area identified on the NMR (1529500) from 1942 aerial photography as being an area of military activity, perhaps a defended locality or ammunition dump, comprising eighteen dispersed small huts within a double enclosure of barbed wire. The survey found in addition to GAY068, a number of other military features at this location, including GAY015, 058, 059, 060, 066, 067, 103, which all feature earthworks with pieces of concrete and bricks, all of which indicate the presence of military buildings at this location (Plates 21 & 22). Similarly features GAY104, 105 & 106 a little further south correspond to another possible ammunition dump comprising small huts (NMR record 1529501).

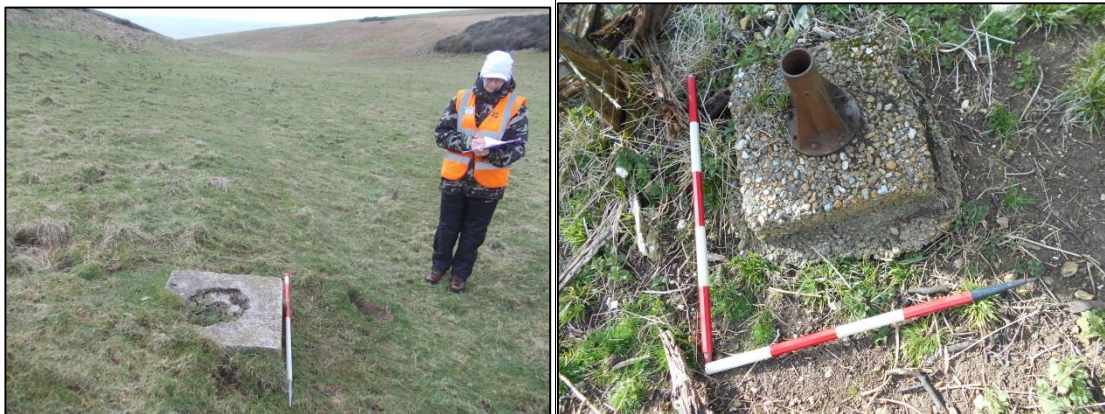
Plate 23: Holdfast in Limekiln Bottom    Plate 24: Pintle mount in Quarry GAY092

There are numerous slit trenches and weapons/gun emplacements, along both the Coastal Strip and around Friston airfield. The slit trenches could be defensive, but those around the airfield also probably served as air raid shelters. The weapons pits and gun emplacements could have held infantry support weapons such as Vickers machine guns or mortars, but some may have held anti-aircraft guns. Suggestions of weapons positions come from the concrete block with a nine-bolt holdfast (GAY010) in Limekiln Bottom (Plate 23), perhaps originally mounting a small anti-aircraft gun or searchlight, and the pintle in Quarry GAY092 (Plate 24), perhaps for a Stork Type mounting with twin anti-aircraft machine guns (Plate 34).

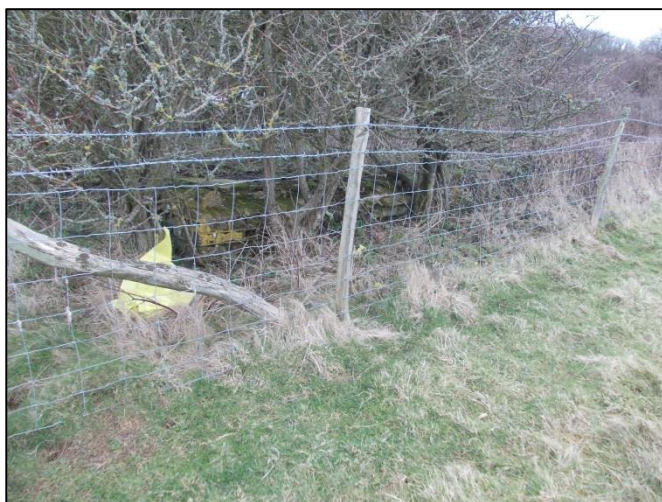
Plate 25: Nissen hut base (GAY001)

The survey did however locate the concrete bases of some 11 Nissen huts, and building debris perhaps from other buildings. The largest group of buildings is situated alongside the A259 road and around the entrance and concrete track to Gayles Farm. The concrete track from the A259 to Gayles Farm (GAY030) appears to have been built during the war and replaced the earlier metalled trackway (GAY029) which survives as a slight hollow way to the east side of the copse containing the pillboxes. The presence of Nissen huts was known from a map of the airfield (Fig. 2), and the remains of at least seven hut bases were noted here (Plate 25) along with evidence for a latrine building (Plate 26). The guard house, marked on the map, could not be located, however some pieces of concrete around the entrance way may have been parts of concrete blocks or posts. Further huts are shown on the airfield map extending along the road to the north-west outside the survey area (Fig. 2).

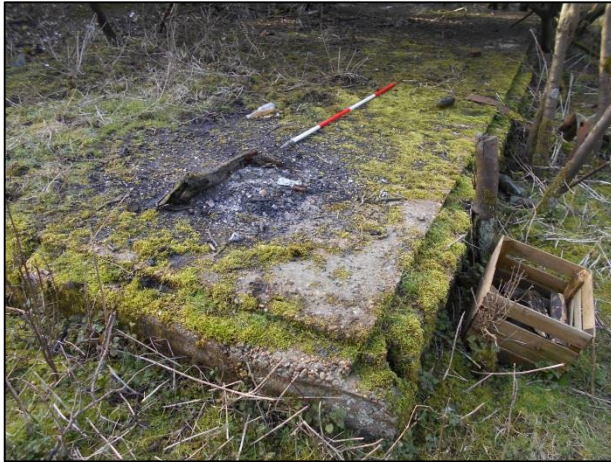
Plate 27: Nissen hut base (GAY093)

contained a concrete hut base (GAY093 – Plate 27), and on its upper edge were four slit trenches, covering all approaches. These all had pieces of timber in the fills, and there was barbed wire and chicken wire associated with them. One slit trench (GAY131a) still had some corrugated iron shuttering visible along one side (Plate 28).

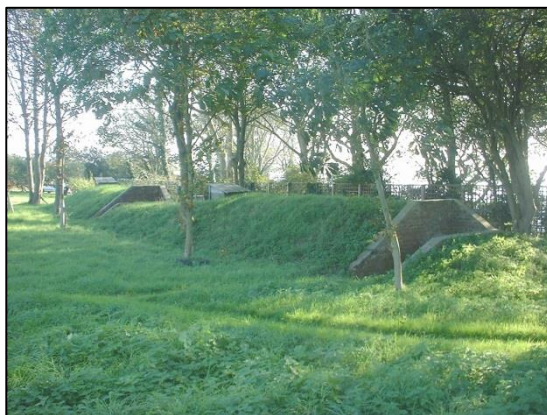
Plate 29: Gayles Farm air raid shelters (Copyright C. Butler)

Although outside the survey area, the previous survey at Gayles Farm had located a number of buildings and structures, including two large below ground air raid shelters (Plate 29), and a number of brick built bays which may have stored fuel or ammunition. The farm buildings were utilised for various purposes, one being used as the fire station, and to the east of the farm a maycrete pre-fabricated building apparently functioned as a hospital (Plates 30-33). A number of other buildings and blast walls survive and are being re-used today for other purposes.

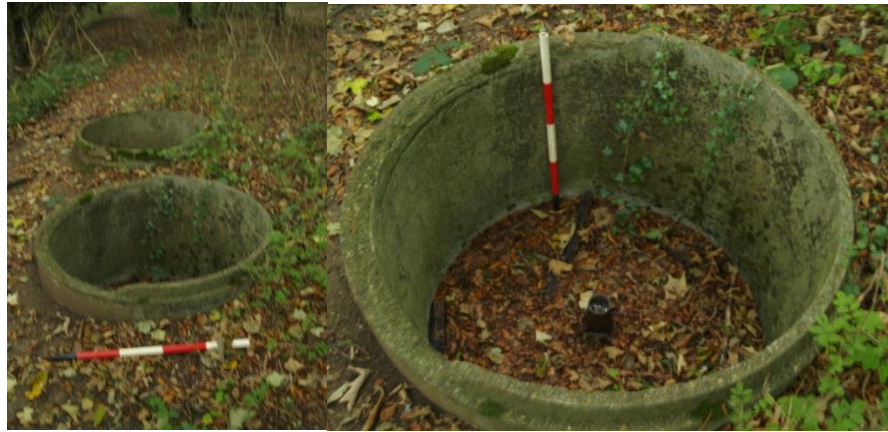
Plate 34: concrete pipe posts & Stork Mount illustration.<sup>15</sup>

Situated to the north of the entrance to Gayles Farm, and also outside the survey area, were some slit trenches and a number of concrete pipe posts, one of which had a metal pintle, possibly for a Stork Type mount, with twin anti-aircraft machine guns (Plate 34).

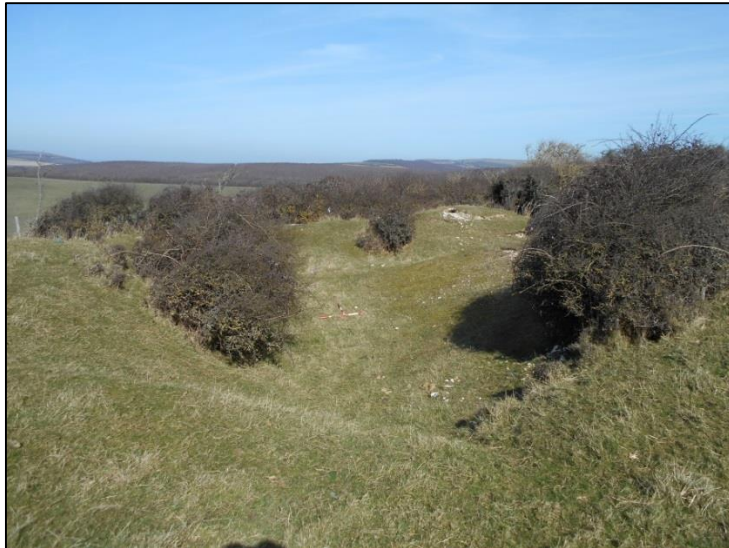
Plate 35: Possible anti-aircraft gun position GAY138.

Some features classified in the survey as earthworks, may also have served a military purpose. An example is GAY138 which was a quarry-like feature 17m x 11m and 4m deep, with the spoil embanked around its edges, except at south end which may be an entrance (Plate 35). As this feature has good views out to the north and west, it would make a good location for an anti-aircraft gun.
