An Archaeological Watching Brief at 8 The Street Berwick East Sussex

WD/2007/1826/F

**by
Chris Butler**

September 2008

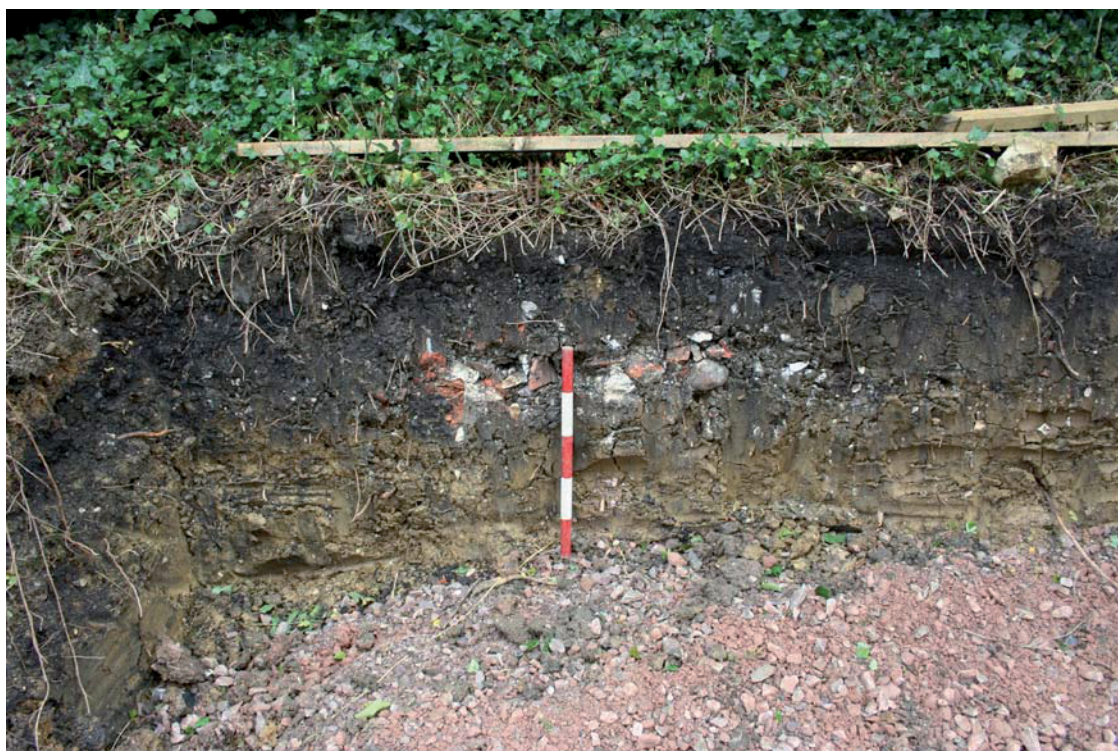
Fig. 5: The Street, Berwick: Contexts 10 and 11 in east bank section

- 4.7** A dark charcoal rich layer (Context **10**) was observed in the east bank during the creation of the ramp. This comprised a dark grey to black sandy clay loam, with charcoal pieces and flecks (20%), roots (2%) and chalk pieces and flecks (1%). This layer overlaid Context **1**, which tapers out at this point, and was above Context **5**.

- 4.8** At the base of Context **10**, and above Contexts **1** and **5**, was a horizon *c.* 150mm thick, of dark grey-brown sandy clay loam (Context **11**), which contained numerous chalk pieces to 35mm and flecks (20%), tile and brick fragments (15%), occasional flint nodules (2%) and charcoal pieces and flecks (5%). The brick and tile fragments in Context **11** are all of 19th/20th century date, and no other artefacts were found in this context.

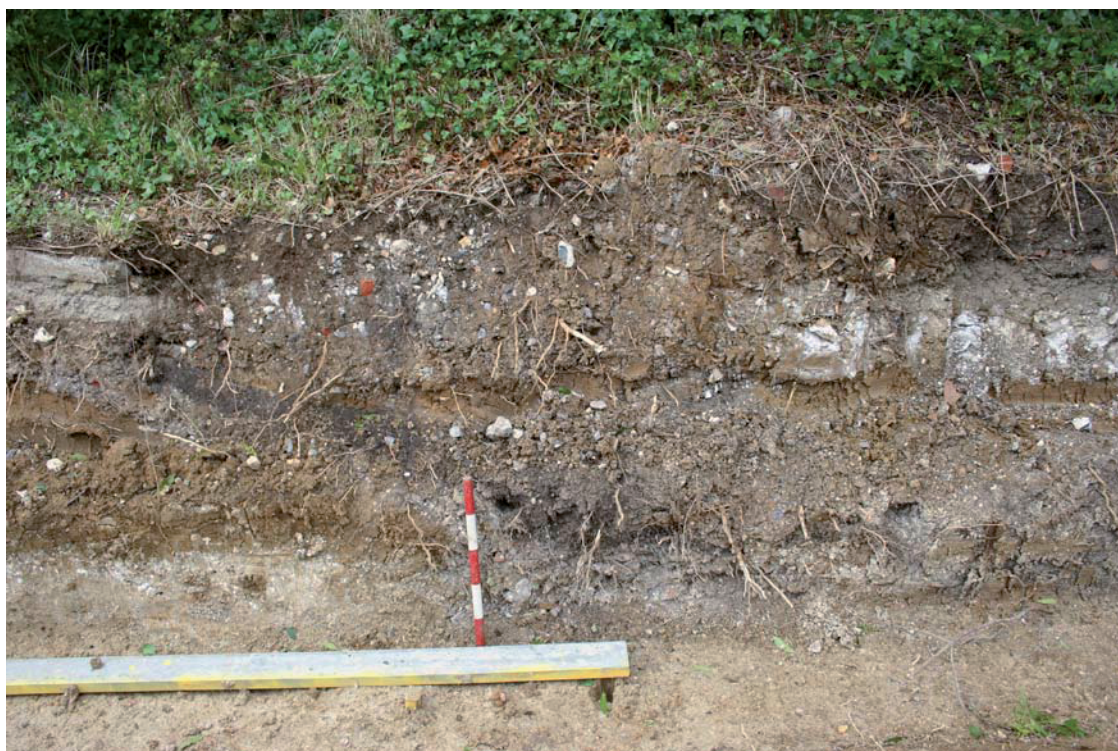
Fig. 6: The Street, Berwick: Cut 14 in west bank section

- 4.10** A large V-shaped cut 1.5m wide at the top and 800mm deep (Cut **14**) was also noted in the section, 1.5m from the south end of the west bank. It cut through Context **12**, and into Context **5**, and formed the southern edge of Context **13**. The primary fill (Fill **16**) was a loose mid grey-brown sandy clay loam containing roots (5%), charcoal pieces and flecks (3%) and chalk pieces to 50mm and flecks (2%).

- 4.11** The upper fill (Fill **15**) was a yellow-brown silty clay with roots (3%), shingle (3%), chalk pieces to 80mm (2%), irregular flint pieces to 60mm (2%) and charcoal flecks (<1%). The two fills appear to be similar to the topsoil and underlying Context **5**, except that they are in reverse order in the cut, with the 'topsoil' below the 'natural'. Both contexts contained 18th/19th century brick and tile fragments, and Context **15** produced a later 19th century stoneware sherd.
