JOHN MOORE HERITAGE SERVICES

AN ARCHAEOLOGICAL EVALUATION

6 COLLEGE OPE, PENRYN, CORNWALL

SEPTEMBER 2011

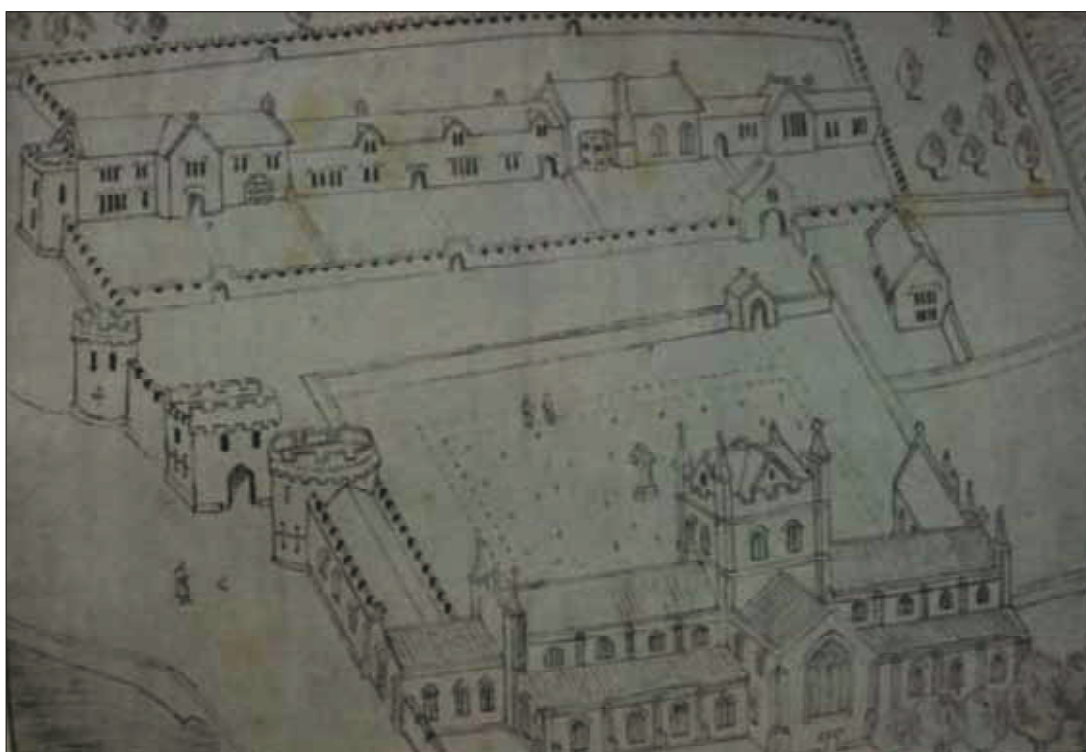
Figure 2. Part of the view of the College complex produced by Sir Ferdinand Georges in c. 1580, looking south (from Peter 1903). The Site lies just to the north of the Collegiate Church tower and transept in the foreground.

Over time a sizeable complex of buildings and enclosures developed at St Thomas College, including a church (MCO6320), an associated cemetery (MCO250330), a detached infirmary (MCO25034), a school (MCO25035), gardens and various other buildings, all protected by a fortified enclosure (MCO25032). These fortifications had an important wider role in the defence of Penryn and the tidal creek. They were described in John Leland's Itinerary of 1535-43 as being 'wel walled and dyked' and 'incastellid, having 3 strong towers and gunnes at the but of the creke' (Toulmin-Smith 1907, 197). Even in the mid-16th century, a survey during the reign of Edward VI noted the 'walls of the said Colledge on the Southe-syde well fortified w^t Towers and Ordinaunce in the same for the Defence of the said towne and the ryver' (quoted in Peter 1903, 101). A pictorial view of the College produced in *c.* 1580 by Sir Ferdinand Georges (Fig. 2), though not entirely accurate, nonetheless provides an impression of the scale of this complex that covered up to 4³/₄ acres or 1.92 hectares.

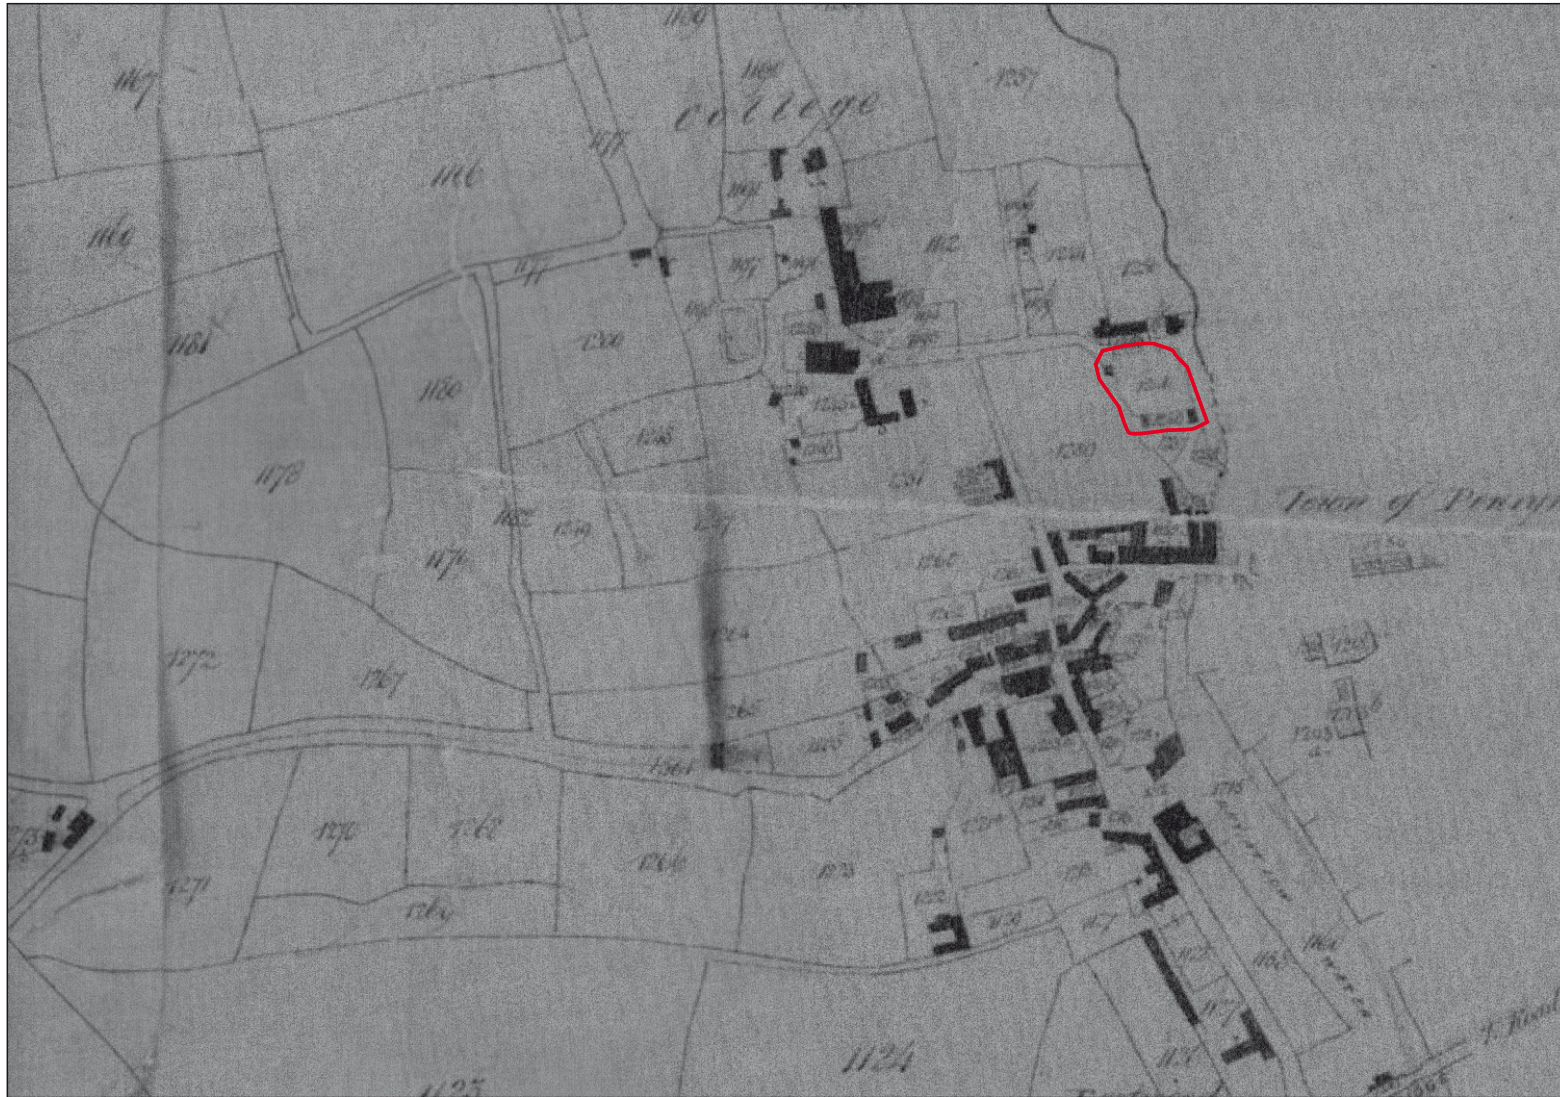
Figure 3. The Budock Tithe Map of 1843 (CRO)

The 1843 Budock Tithe Map (Fig. 3) clearly shows College Hill, and the lines of the lanes that became Glasney Terrace and Brook Place. The bulk of what is now Glasney Playing Field is numbered as 1239 and in the Apportionments is described as 'Orchard', owned and 'occupied' by John Austin. There is a small building and a sub-triangular yard space depicted at the western edge of Glasney Playing Field near where the modern entrance into the field is located.

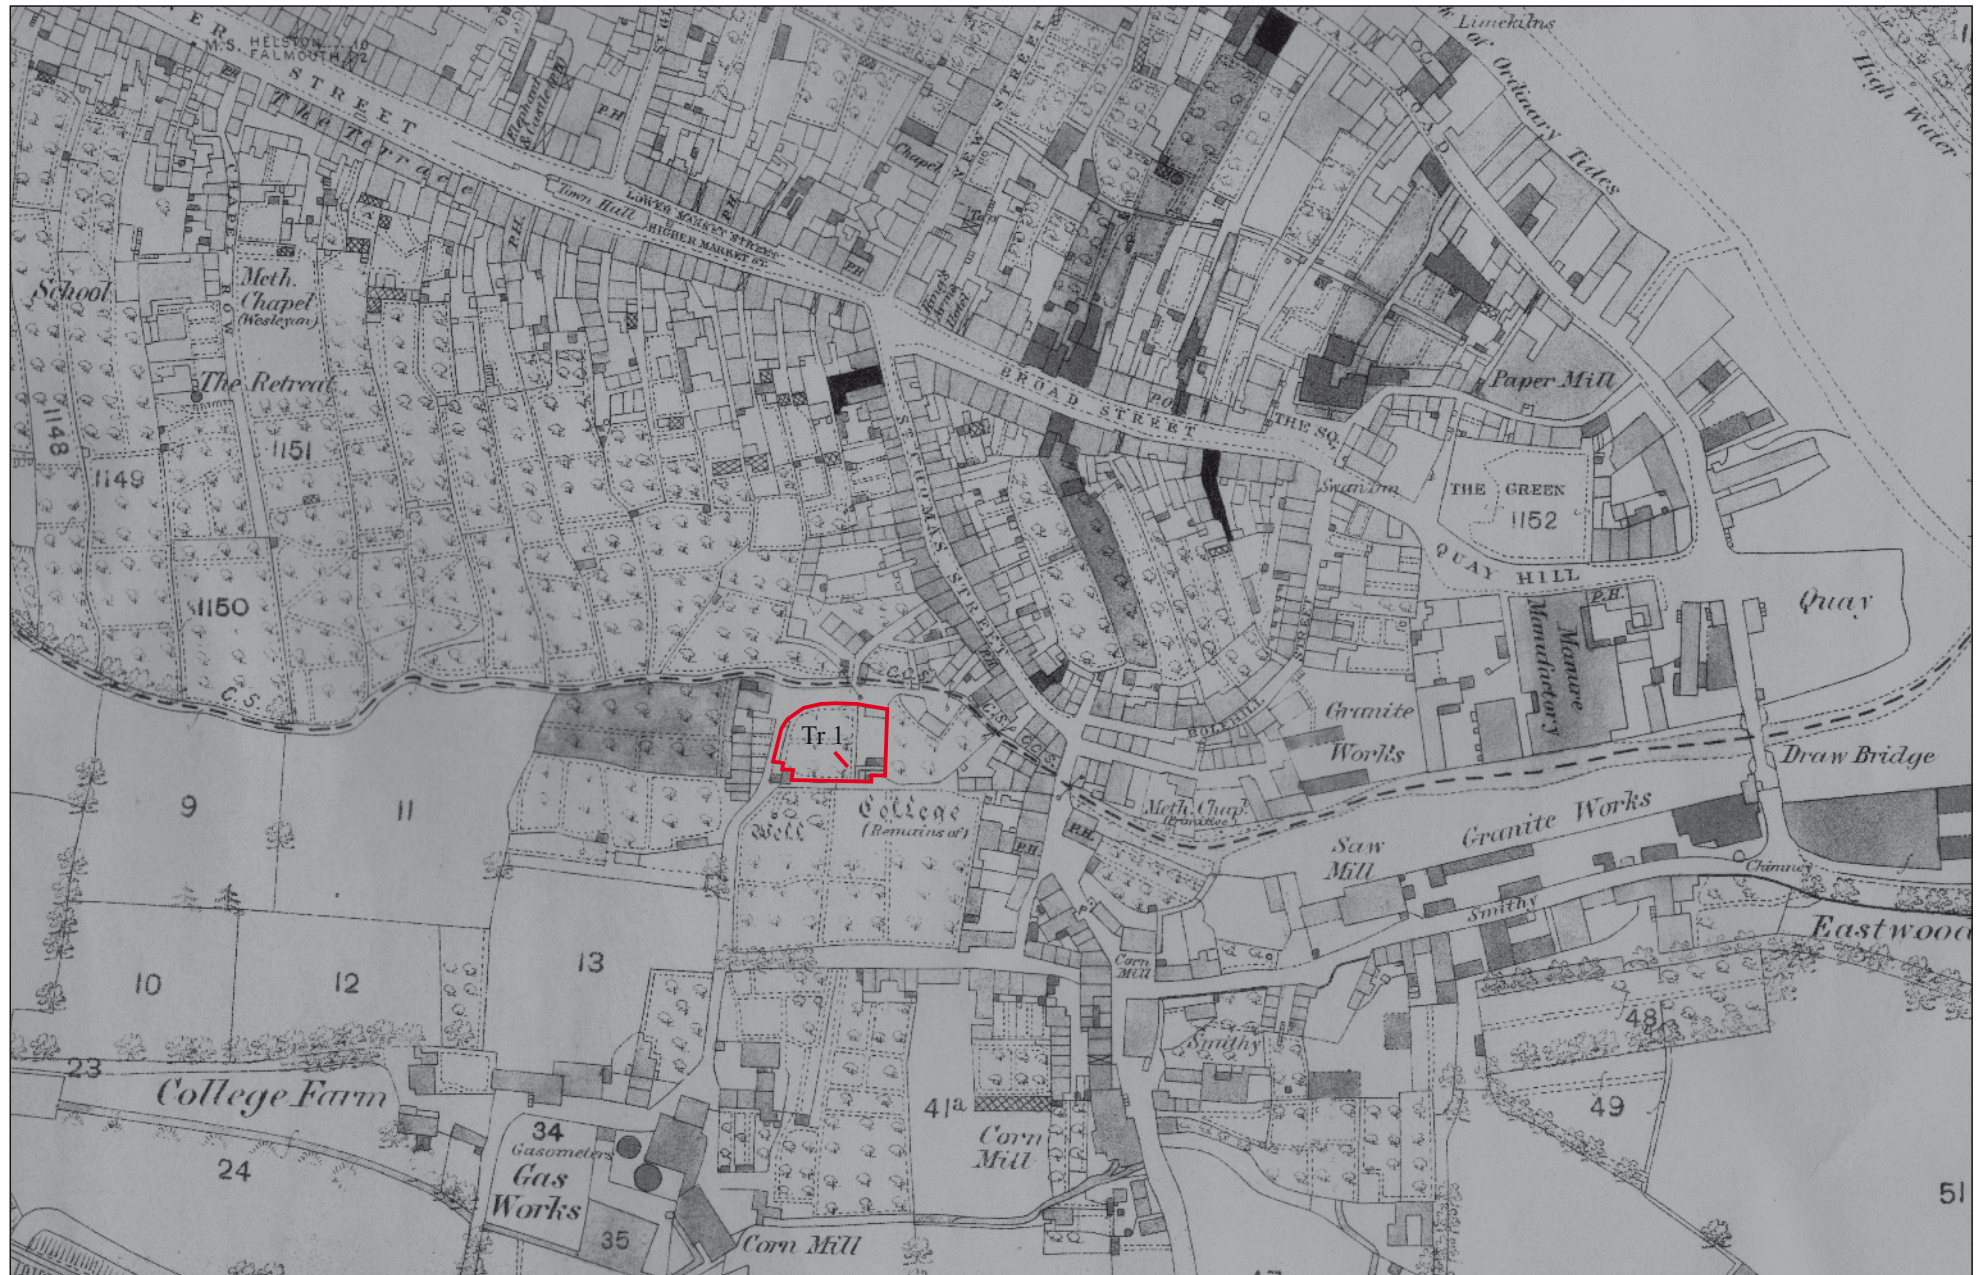
Figure 4. Part of the 1st Edition 25" OS map of 1888 (CRO WH/1/6505)

The 1st Edition 25" 1: 25000 Ordnance Survey map of 1888 (CRO WH/1/6505) shows much of the area of Glasney Playing Field as orchard, with two conjoined or abutting buildings near the location of the modern entrance (Fig. 4). A well is shown near the north-western corner of the field. The location of the College is marked and the larger western portion of the Site is depicted as gardens and/or orchard, but the map also provides more details of the buildings on the narrow eastern part of the Site. On the southern side of the Site, what was depicted as one building on the 1843 Tithe Map is clearly two conjoined or abutting structures, with one L-shaped structure and another smaller rectangular structure to the north of it. The L-shaped structure may well be the building mentioned in Polwhele's 1803-1808 description. The 1st Edition 6" 1: 10560 map of 1888 (CRO 055 71 NE/1) is much less detailed, but does depict the same buildings on and near the Site (Fig. 6).

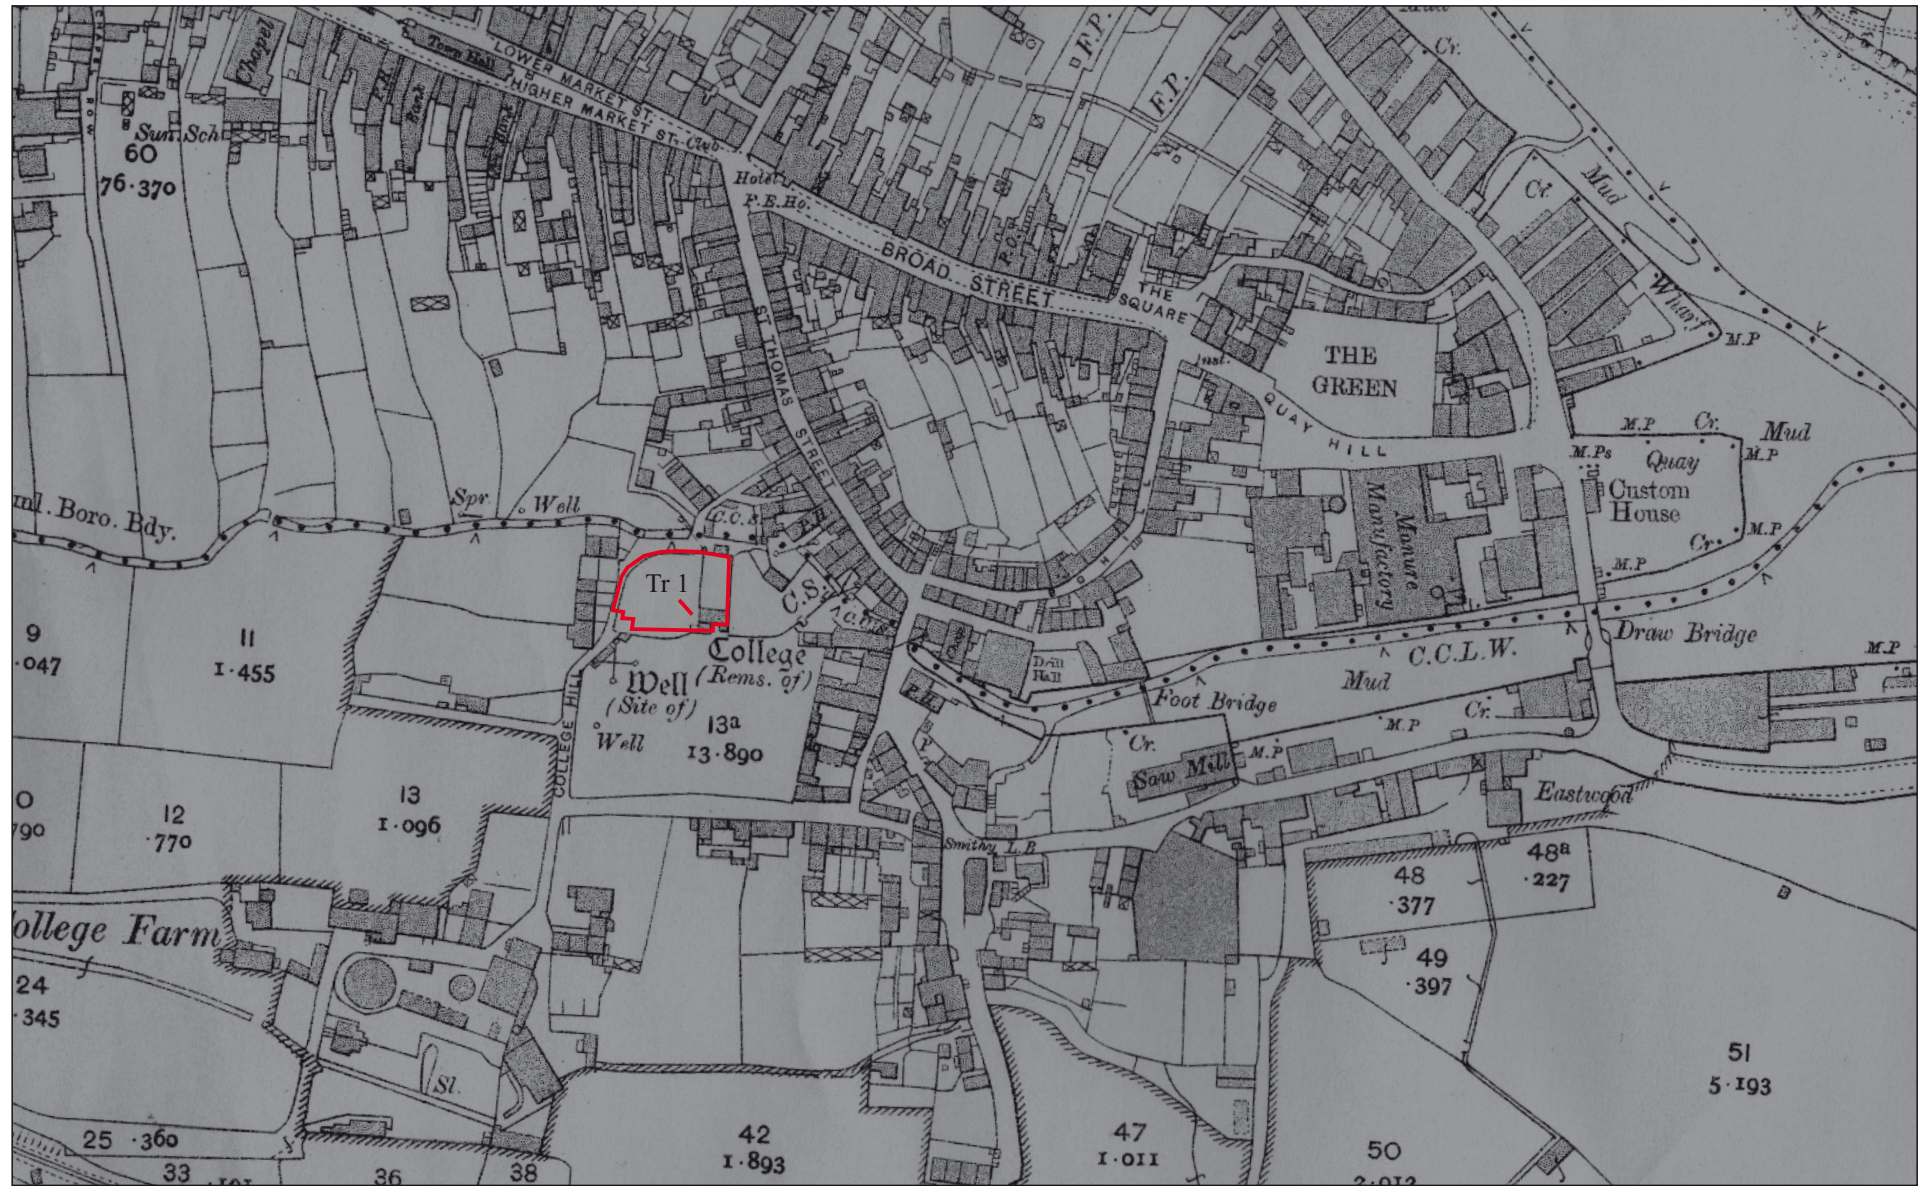
Figure 5. Part of the 2nd edition 25" OS map of 1888 (CRO OSP/1/406)

In some respects the 2nd Edition 1: 2500 Ordnance Survey map of 1903 (CRO OSP/1/406) is also less detailed, and does not depict the large numbers of orchards in the southern and western parts of Penryn for example. Some changes near the Site are evident – the original buildings in the extreme north-west corner of Glasney Playing Field at the south-west corner of the Site appear to have been demolished, whilst a new linear range of buildings orientated north-east to south-west has been constructed just to the south of the previous structures along the eastern side of College Hill. Two wells are now shown in Glasney Playing Field – one seemingly as the location of an earlier well, marked with a cross normally used to depict antiquities on early Ordnance Survey maps, with another second separate well to the south. On the 1908

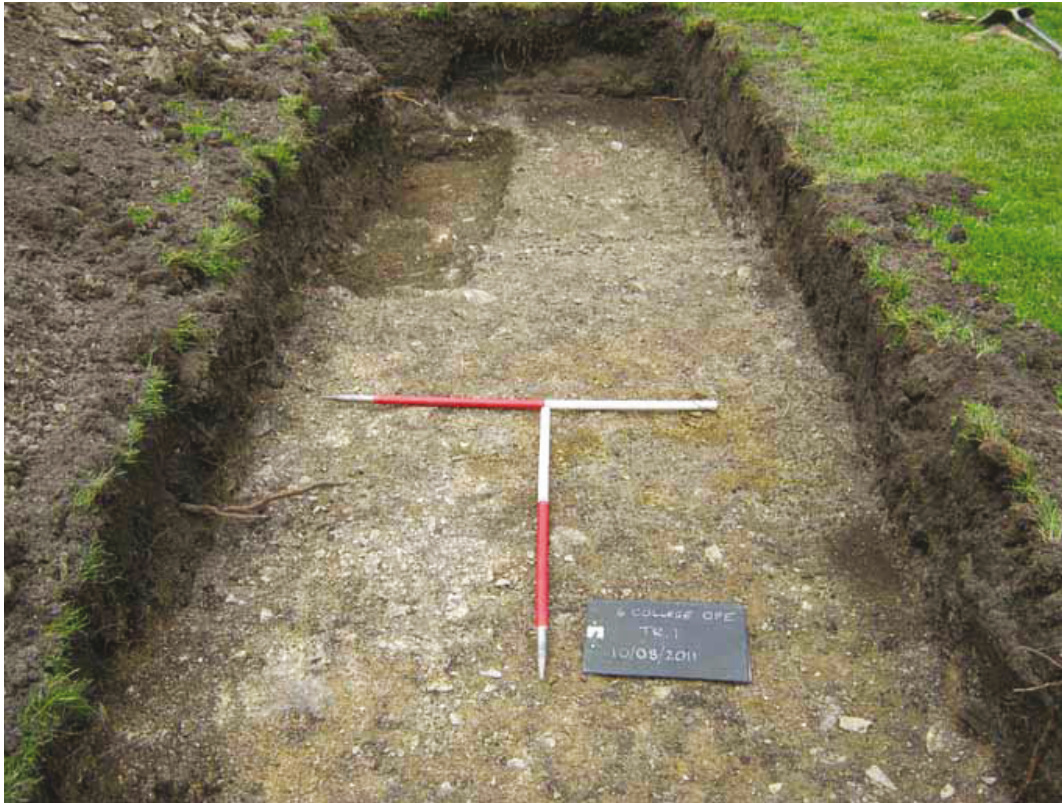
Figure 8. Trench 1 looking north-west, showing the extent of demolition layer (1/2) with cut 1/4 visible in the background

Underneath the topsoil was a mottled light yellow brown, orange brown and off-white silty sand deposit (1/2), with slate and stone fragments, and some pockets of topsoil remaining in shallow undulations within the surface caused by root disturbance. This deposit was initially thought to be a natural subsoil slightly disturbed by the roots of trees within the orchard, but subsequent investigation revealed that it was in fact a mixture of redeposited natural subsoil and demolition debris, the off-white material within layer (1/2) actually being degraded lime mortar. The top of this deposit was situated at a height of 3.30-3.41m OD, between 0.50m and 0.60m below the modern ground surface (Fig. 7). It was not excavated any further, so its depth and full extent could not be determined, though in places undisturbed natural subsoil was present just 0.002-0.05m below the surface of this layer.

At the north-western end of Trench 1, deposit (1/2) was cut by the edge of a broadly linear feature 1/4 that was at least 2.40m wide and 0.40m deep and continuing beyond the north-western end of the trench. Only one edge was exposed, and this was somewhat irregular and not very well defined, sloping at approximately 30 degrees. The fill of this cut was layer (1/3), consisting of mottled dark grey brown and mid-grey brown sandy silt with stone and roof slate fragments, medieval brick or tile fragments, several small fragments of painted wall plaster lumps and lenses of mortar, oyster shells and two corroded iron objects. In the base of the cut there were large irregular and sub-rounded red sandstone fragments exposed up to 0.20m long, 0.15m wide and 0.10m thick, bonded with off white mortar and grey brown clay. Portions of potentially large blocks of stone were visible in places beneath. The clay and mortar bonded stones were interpreted as wall footings (structure 1/5), and although exposed in the bottom of cut 1/4 they extended to the south-east beyond the cut edge. This suggested that 1/4 was the later robber cut of an earlier masonry structure, although the original orientation of the footings was not clear. The top of the wall footings was situated at approximately 3.08m OD, or 0.70m below the modern ground surface.

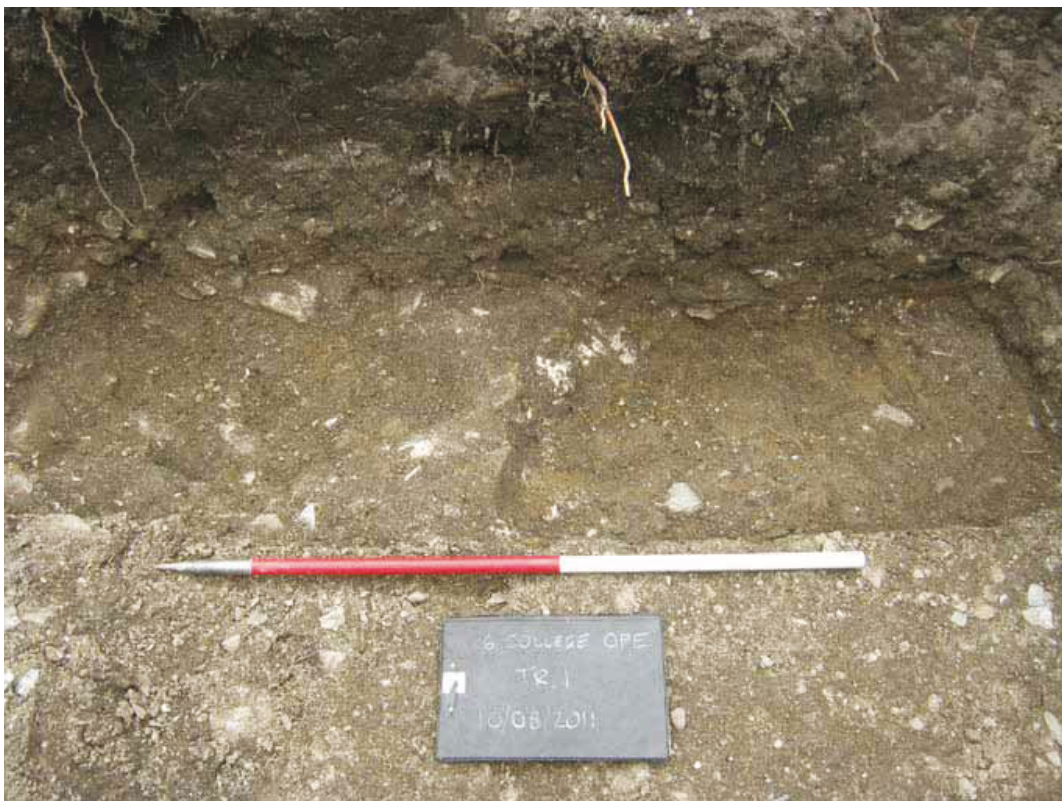
Figure 9. North-east facing section cut 1/4 showing fill 1/3 and the top of footings 1/5

The full width of the earlier wall footings 1/5 was not clear, though the possible edge of an earlier construction cut 1/7 was noted in plan as a darker stain just visible beneath part of the spread of demolition rubble. This would make the presumed footings very substantial and at least 3.00m wide, and the north-western edge of them was beyond the end of Trench 1. One fill of construction cut 1/7 was exposed in the base of later robber cut 1/4, and consisted of dark grey brown clayey silt with slate and stone fragments, and fragments of chalk and mortar (1/6). The top of this deposit was situated at 3.01m OD, or 0.86m below the modern ground surface.
