JOHN MOORE HERITAGE SERVICES

**A SUMMARY REPORT ON THE FIRST PHASE OF  
AN ARCHAEOLOGICAL EVALUATION**

**BRYAN HOUSE, CHAPEL STREET**

**BICESTER, OXFORDSHIRE**

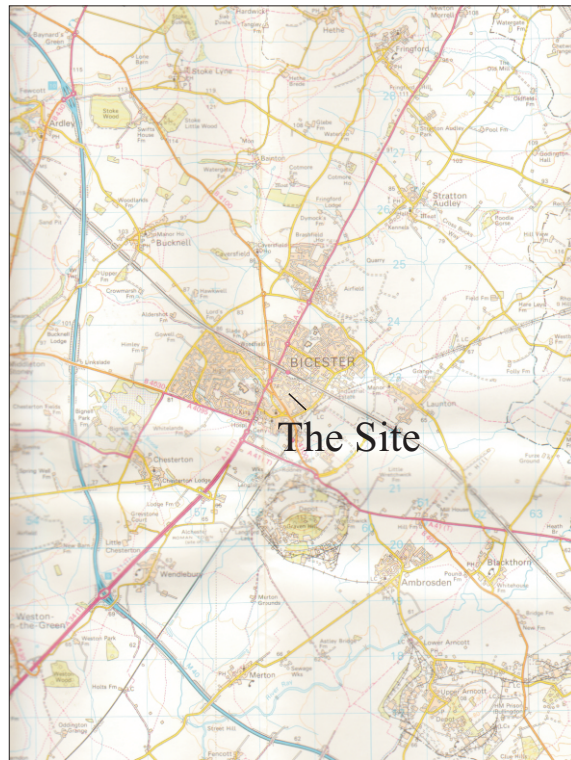
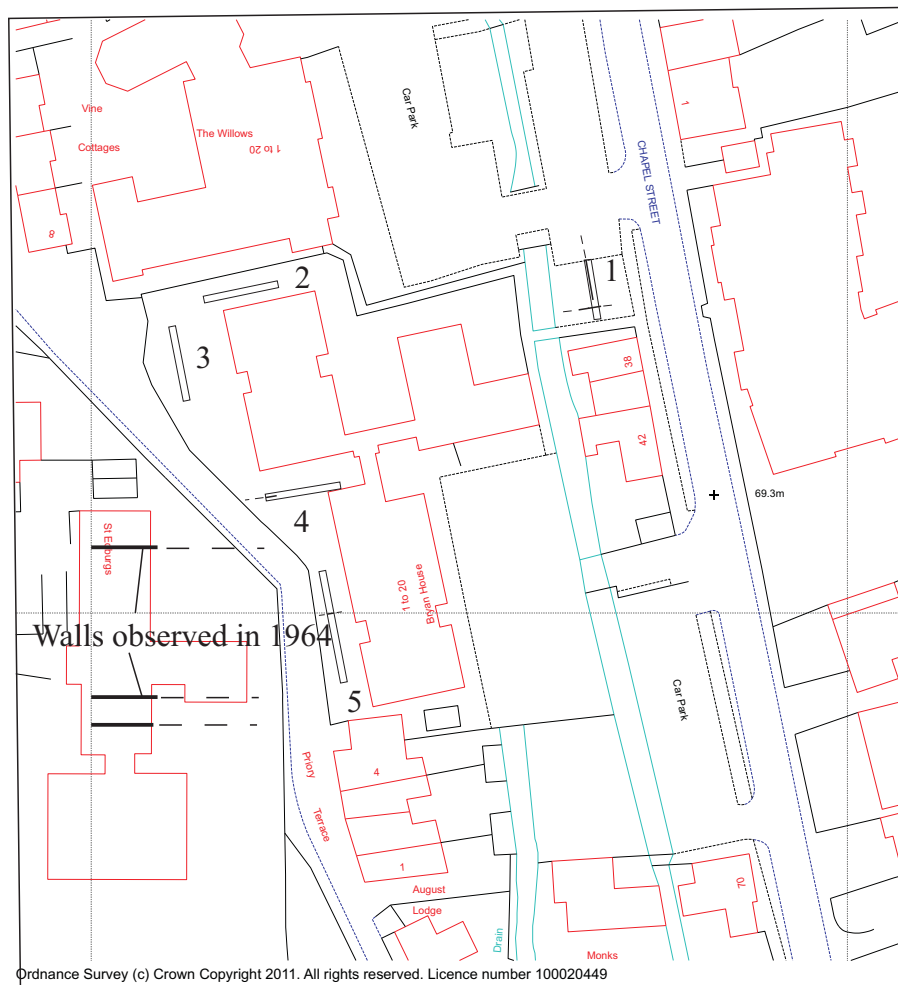
Figure 1: Site and Trench Location

The proposed development site is located in the centre of Bicester, on the western side of Chapel Street and south of the Causeway (SP 5843 2221). The site lies at approximately 69.3m above OD and the underlying geology is shown as Cornbrash. The site is currently a residential development.

The field evaluation comprised the mechanical excavation of five trenches. Four trenches were located to the rear of Bryan House; one trench was 15 in length and three were 10m in length excavated to the west of the site (Trenches 2-5 Fig. 1). A 5m trench was excavated in the area of the car park to the east of the site (Trench 1). All trenches were 1.6m wide.
