**MARLOW SPORTS CLUB, POUND LANE, MARLOW,  
BUCKINGHAMSHIRE**

**ARCHAEOLOGICAL RECORDING ACTION**

**July 2011**

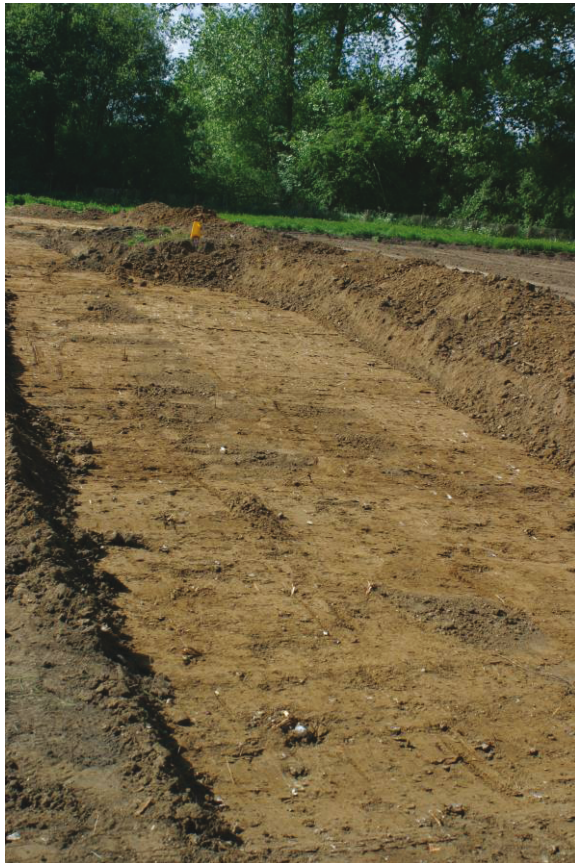
Plate 1: Stripped area on eastern side of site to surface of natural ground

Before any of the major ground work commenced it was decided that the depth of the archaeological horizon should be established beneath current ground level. A c. 5m wide corridor was excavated down to the surface of the natural along the eastern side of the new playing field (Plate 1). No archaeological features were observed but a good point of reference was made for impact levels of the playing field on potential archaeology.

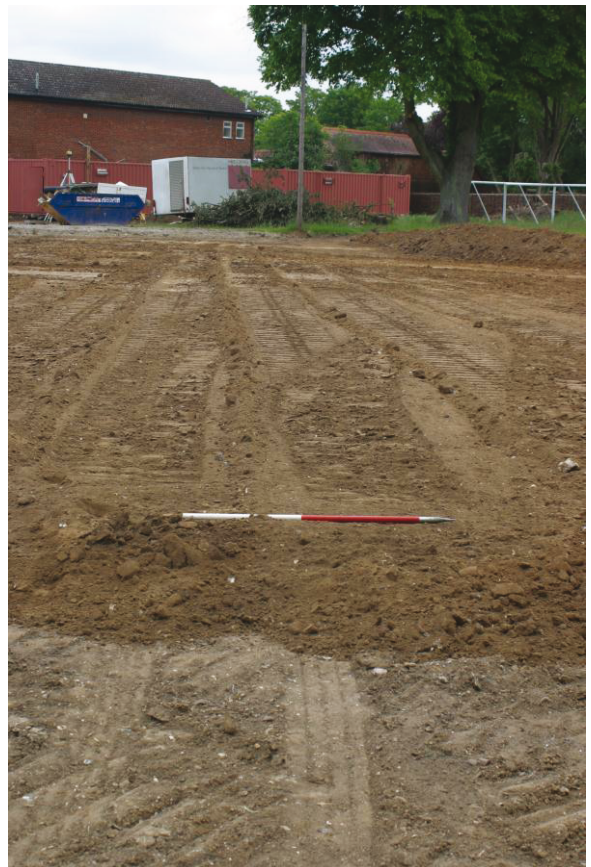
Plate 2: Showing height of raised ground

The actual level of needed ground reduction changed from day to day at the outset of the project but after consultations between McArdle and the on site contractor WPH Projects a higher level was agreed upon. This meant that the centre of the site was reduced to the uppermost surface of natural and the rest of the new playing field was raised in the lower lying areas to achieve a level finish (Plate 2).

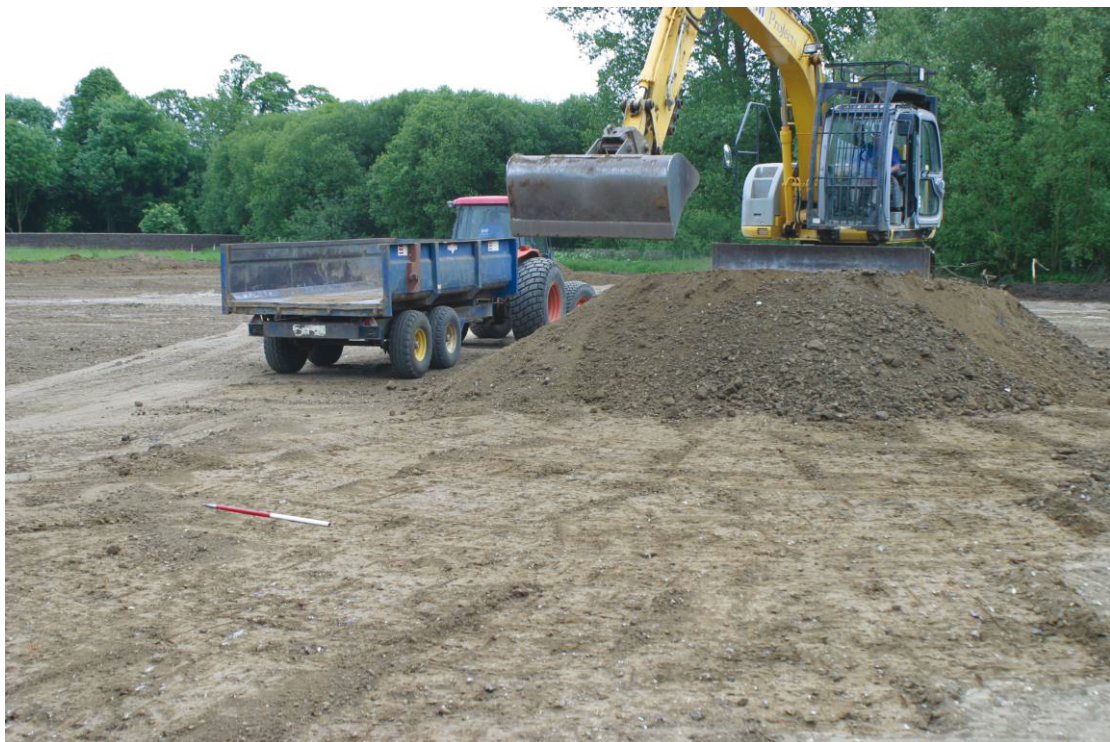
Plate 3: Showing centre of site reduced with ditching bucket

Any ground reduction over the centre of the site, which impacted the uppermost surface of the natural clay was undertaken with a tracked excavator with a ditching bucket (Plate 3). Other areas where levels were being raised were achieved with the bulldozer (Plate 4)

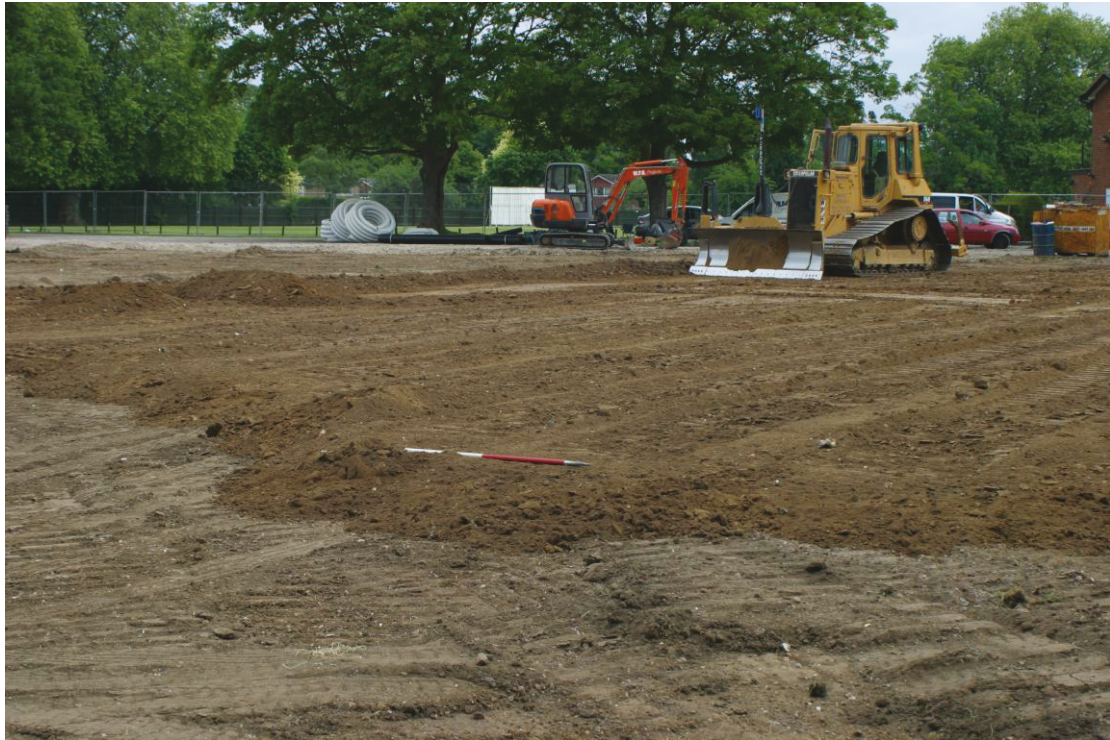
Plate 4: Showing bulldozer raising the ground level across the low lying area.

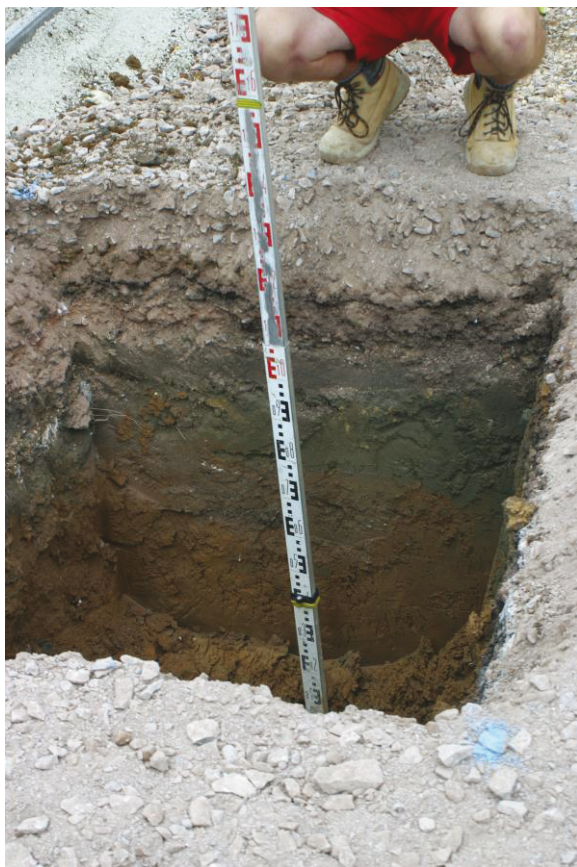
Plate 5: FLB 4; showing clay

The other flood light base excavations revealed thick clay deposits thought to be alluvium deposited between the gravel islands. These areas would have been marshy and not good for settlement.

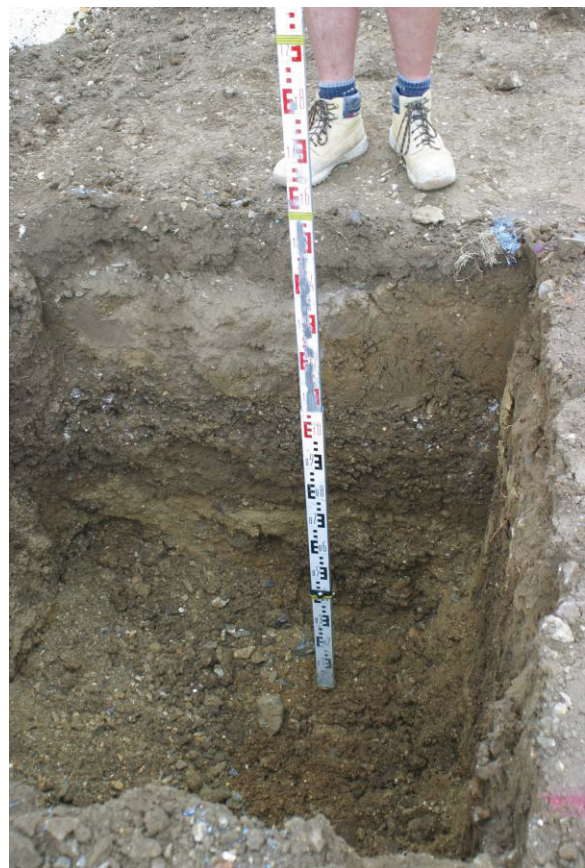
Plate 6: FLB 5 showing gravels and sands

On the northern side of the Sports Pitch in FLB 5 beneath a layer of clay were further gravels interspersed with layers of sand indicating successive periods of flooding during prehistory (Plates 5 & 6).
