AN ARCHAEOLOGICAL WATCHING BRIEF

ROSEMARY COTTAGE, MAIN STREET,

FRINGFORD

FEBRUARY 2012

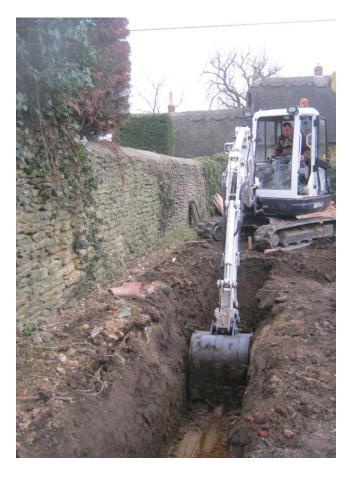
Figure 2. The machine excavation of one of the new footing trenches along the eastern side of the Site.

The footing trenches were 0.50m wide and up to 1.10m deep. Below the topsoil was a natural subsoil layer of dark orange brown to dark brown sand up to 0.40m thick. This did not produce any finds. It lay above natural subsoil consisting of a mixture of compact orange brown and brown sands and gravels with iron panning and

manganese staining and occasionally interspersed with irregular, natural fissures that were probably the result of periglacial activity, filled with sterile grey clay. No artefacts were observed.
