**AN ARCHAEOLOGICAL WATCHING BRIEF**

**BRIARWOOD, PLECK LANE,**

**KINGSTON BLOUNT**

**FEBRUARY 2012**

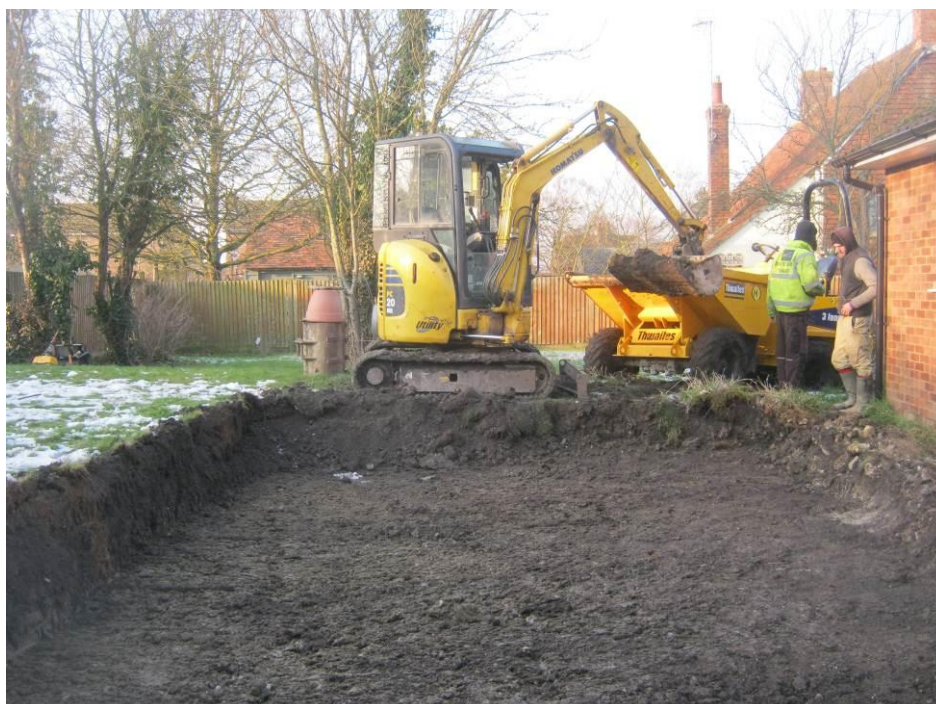
Figure 2. Machine excavation of the western area of the Site.

On the west side of the bungalow, ground reduction took place immediately west of a 0.5m wide area of paving and flint rubble walling alongside the west-facing wall of the house. An area approximately 9m long and 4.5m wide was excavated. Beneath the turf there was a layer of redeposited soil (1/100) consisting of dark grey-brown sandy silty loam topsoil mixed with yellow-orange and light grey sand up to 0.40m thick. This spoil contained modern brick and tile fragments along with lengths of angle iron, and had been used to build up the level of the garden behind the house. The ground reduction was 0.70-0.80m in depth at the west of this excavated area, and up to 0.20m in depth on its eastern side nearest the bungalow.

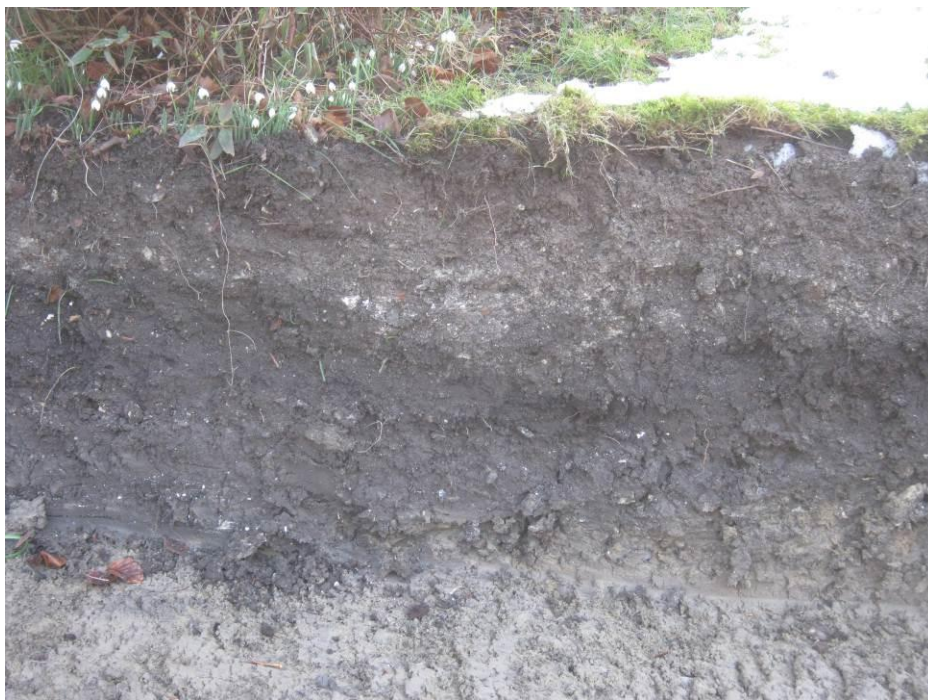
Figure 3. East-facing section of the western area of Site, with redeposited mixed material above the original topsoil. The natural subsoil is visible at the bottom of the section.

The redeposited material was situated above the buried topsoil, a layer of very dark grey-brown silty loam up to 0.35m thick (1/101). This too contained modern brick and tile fragments, some subangular limestone fragments, charcoal, and several sherds of late 19<sup>th</sup> century and early 20<sup>th</sup> century porcelain, in addition to just one sherd of probable 16<sup>th</sup> century Rhenish Stoneware. None of this unstratified material was retained. The natural subsoil (1/102) consisted of mottled greenish grey sandy clay with limestone fragments. It was truncated by several cut features or areas of disturbance, but these contained very dark grey-brown loamy fills similar to the buried topsoil, as well as modern brick and tile. The additional footing trenches that were to be dug along the edges of the reduced area were not observed, but would not have disturbed any archaeological remains.

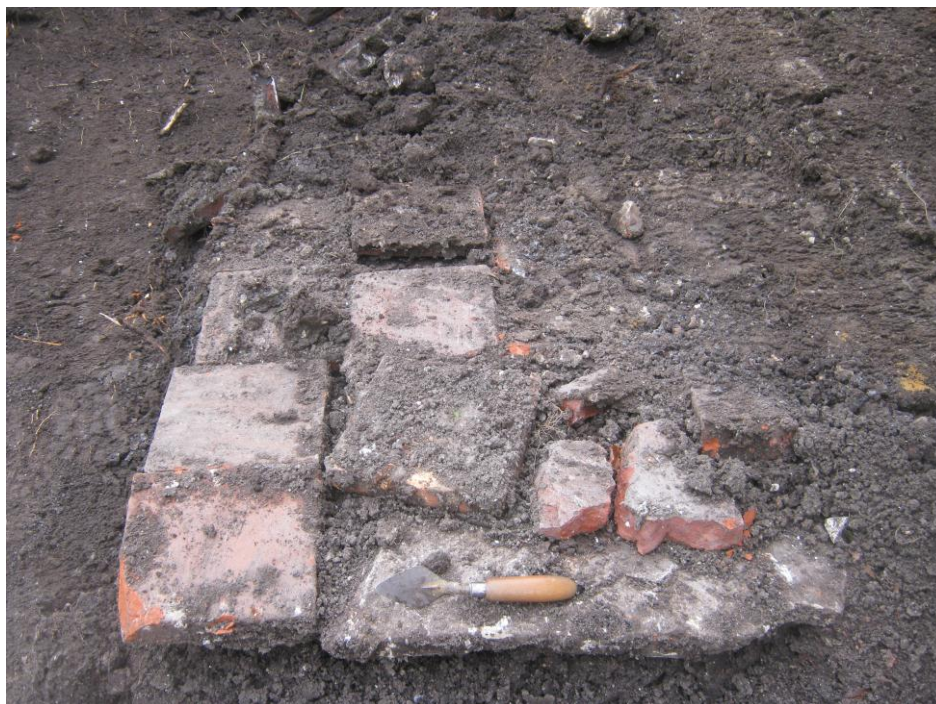
Figure 4. Modern external surface 1/104, showing re-used ceramic tiles, bricks and tabular limestone fragments built directly onto topsoil.

In addition to root action, the area to the north of the bungalow also featured extensive early modern or modern disturbance, and very little undisturbed natural subsoil was visible. Immediately adjacent to the concrete rubble covered drainage culvert, the remains of a rough external surface (1/104) were identified, at least 3m long and 0.80m wide. It was formed from tabular limestone fragments up to 0.45m long,

0.30m wide and 0.08m thick, and re-used late 19<sup>th</sup> or early 20<sup>th</sup> century bricks and floor tiles. The latter were approximately 0.18m square and 0.05m thick, and some of their surfaces still retained traces of the original mortar. Many of the tiles were worn and had evidence of past damage. In places two layers of tiles had been laid on top of one another. This crude surface was not bonded, and had actually been built directly onto 0.10m depth of topsoil. The tile, brick and stone was clearly re-used building material, probably from a 19<sup>th</sup> century structure on the Site that pre-dated the bungalow. The function of this small external surface was unclear, but may have formed a small extension to the paved path extending along the north-facing wall of the bungalow. The tile and brick was not retained.
