JOHN MOORE HERITAGE SERVICES

ARCHAEOLOGICAL INTERVENTION

THE MANOR, HIGH STREET,

YELVERTOFT,

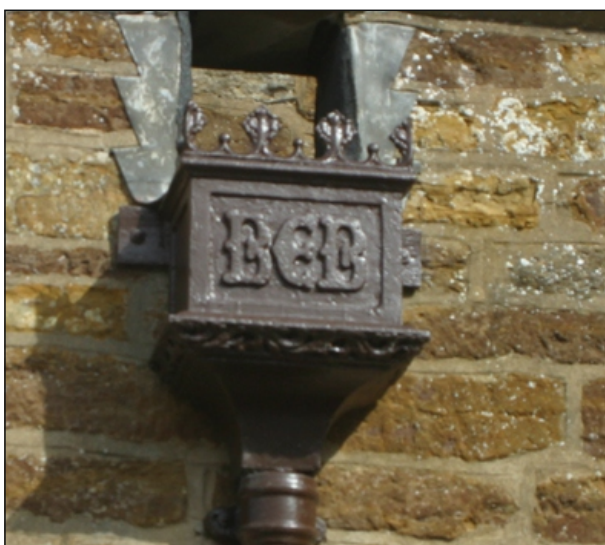
Figure 5. Cast-iron down-pipe with BEB initials.

The stable block located immediately to the west of the main house has a ceramic date plaque of 1893 (not illustrated), which provides the sole available date for the structure, at present. A cast-iron down-pipe on the front of the house is undated, but has the monogram BEB (Fig. 5), which would appear to probably refer to the Burges family, which owned the house at the time. The plans for the demolition of the extension were drawn up in 1955, and the client is named as L. Burges, who is undoubtedly Leslie Ravensdale Burges, father of Brian Ravensdale Burges who died in Calvados and is buried at Banneville-La-Campagne (War Graves Photographic Project). It is more than likely that the BEB letters on the down-pipe (Fig. 5) refer to his father. The 'faux-Gothic' style of calligraphy is very much in keeping with the Arts and Crafts style, and is believed to be part of that phase of works.
