JOHN MOORE HERITAGE SERVICES

**AN ARCHAEOLOGICAL
WATCHING BRIEF AT CROOKED CHIMNEY
COTTAGE, SHOGMOOR LANE, SKIRMETT,
BUCKINGHAMSHIRE RG9 6TB**

April 2012

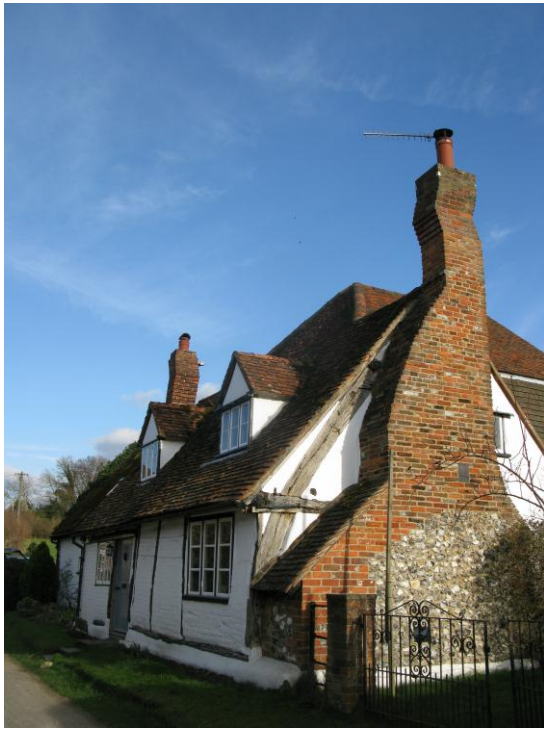
Figure 3; Crooked Chimney Cottage

Crooked Chimney Cottage is a grade II listed building of 16th century origins with 20th century additions (DBC5959). The timber frames of the building are exposed and the rare cruck trusses at the gables can be seen. The infill is of whitewashed brick, flint and plaster and there is an old board door to the front (Fig. 3). The old tiled roof has flanking chimneys with crooked shafts. The chimney top to the right was rebuilt to replace the original in 1990 (WDC 1997).

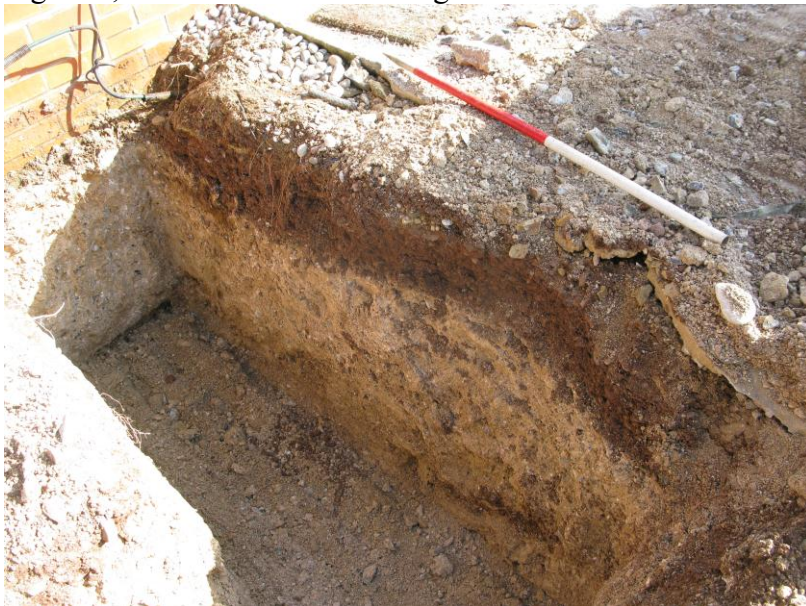
Figure 5; General View of Footing Trench excavation

The stratigraphic sequence (Fig. 5) seen in the footing trenches was very shallow consisting of the following contexts (earliest to latest). The natural chalk was the earliest deposit encountered (03). Overlying the natural was 0.20m thick grade 1 material (02) covered by paving slabs (01).
