JOHN MOORE HERITAGE SERVICES

**A SECOND PHASE OF ARCHAEOLOGICAL
EVALUATION AT HAM COURT, BAMPTON,
OXFORDSHIRE**

February 2012

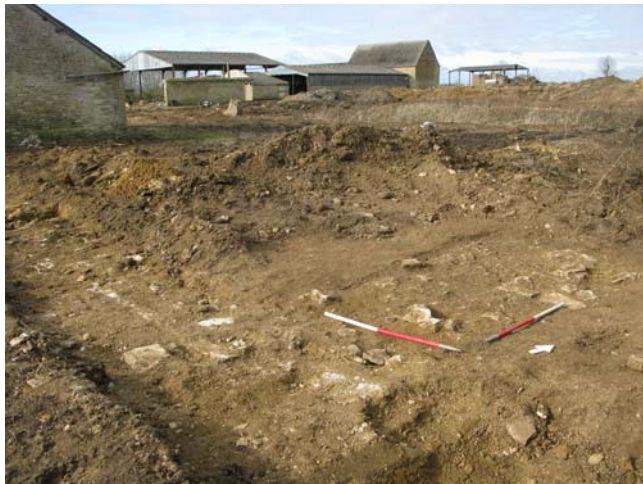
Figure 7; Showing medieval building T1

Trench 1 revealed the structural remains of a medieval building, possibly a barn or horse stable. The east-west wall was substantial in width but did not have deep footings. A total of four sherds of early medieval pottery (11th century and later) were recovered from the wall footing, providing good dating evidence. The wall returned north-south with a doorway on the eastern side. Frequent animal bones, considered to be goat, sheep and horse, were discovered from this area leading to the tentative suggestion that this structure was a barn or used as a horse stable. This building was potentially the earliest structure discovered within the castle complex. The earliest possible date for the building was 11th century but the early pottery sherds from (105) & (106) may have been residual. Having said that, the building may also prove that the settlement of Bampton, known to exist from Saxon times, could have extended this far west of the central nucleus of the settlement. Documentary evidence suggests the Castle was at least 13th century in origin. The royal manor of Bampton was given to William de Valence in 1249 and a survey undertaken on William's death in 1296 records a court. William's son Aymer obtained a royal licence to crenellate his house in 1315 (Blair 1988). The discovered building may indicate an earlier barn was absorbed into the castle estate by William de Valence and survived as a working barn/stable until the 16th century. A demolition layer recorded on the inside of the structure was dated by pottery sherds to the early post-medieval period (16th century), indicating this was when the building was demolished. If the curtain wall existed in this area then the building would have butted up against it. This would be unusual as the nature of a curtain wall was traditionally defensive and a barn on the outside of the wall would have been a defensive weakness; a problem unless the wall was used primarily for show purposes. Another explanation is that there was no curtain wall on this side of the castle and the river acted as a natural defensive barrier. A subsequent building probably replaced this barn, which is the building shown on the earliest historic map of 1789.

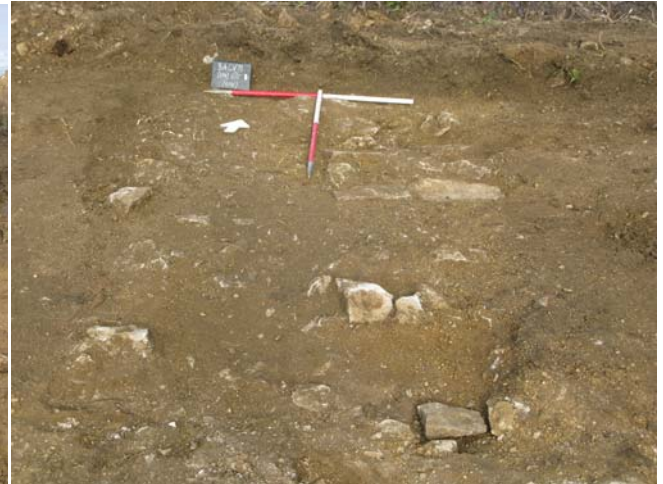
Figure 8; Showing wall 1/16 of medieval building and entrance.

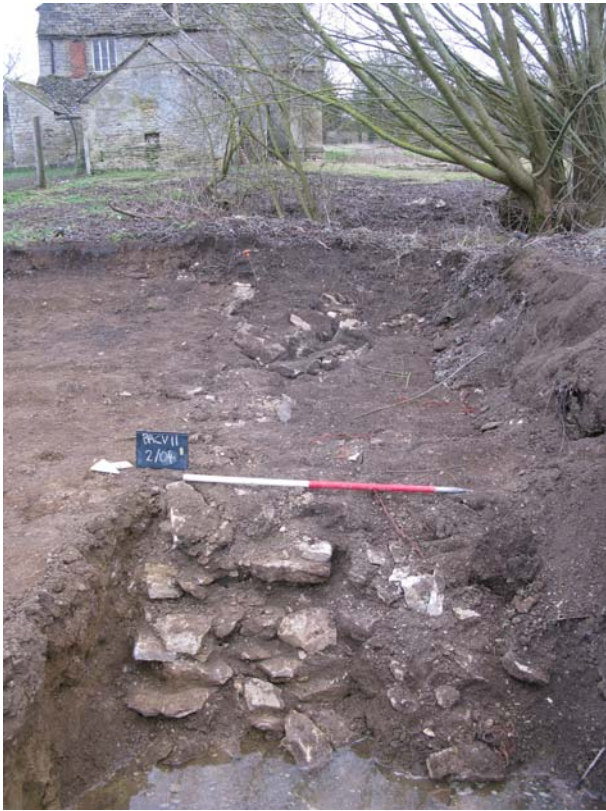
Figure 9; Showing wall 2/04 with existing with house in rear
