JOHN MOORE HERITAGE SERVICES

**AN ARCHAEOLOGICAL
EVALUATION ON LAND ADJACENT AND WEST OF
17-19 FREEHOLD STREET, LOWER HEYFORD,
OXFORDSHIRE**

**By
PAUL RICCOBONI BA AIFA**

May 2012

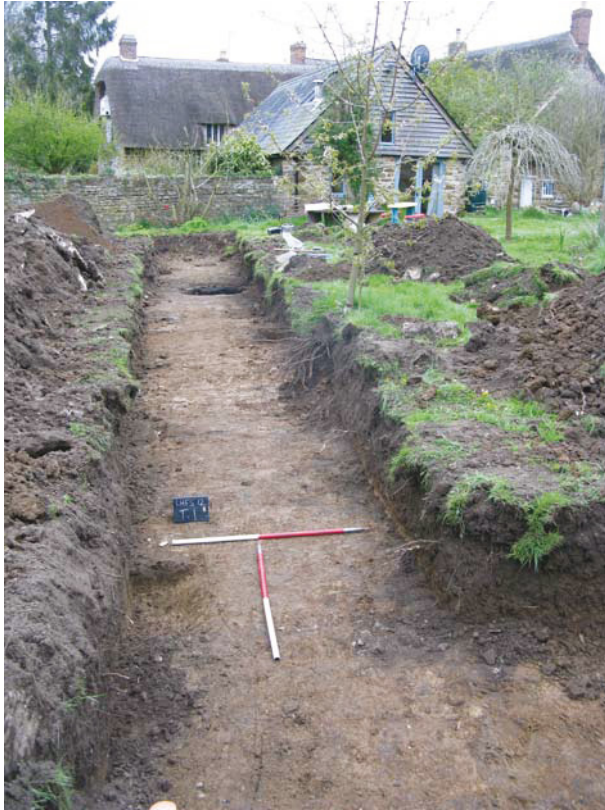
Figure 3; General shot looking East (1m scales)

The stratigraphy within the trench consisted of the following layers (earliest to latest). The natural yellow-orange clay was seen at the base of the trench (1/03). Overlying this was *c.* 0.10-0.15m thick mid greyish brown silty clay subsoil (1/02) overlain by *c.* 0.40-0.50m thick dark black-brown silty clay topsoil (1/01). The subsoil was only apparent at the eastern end of the trench.

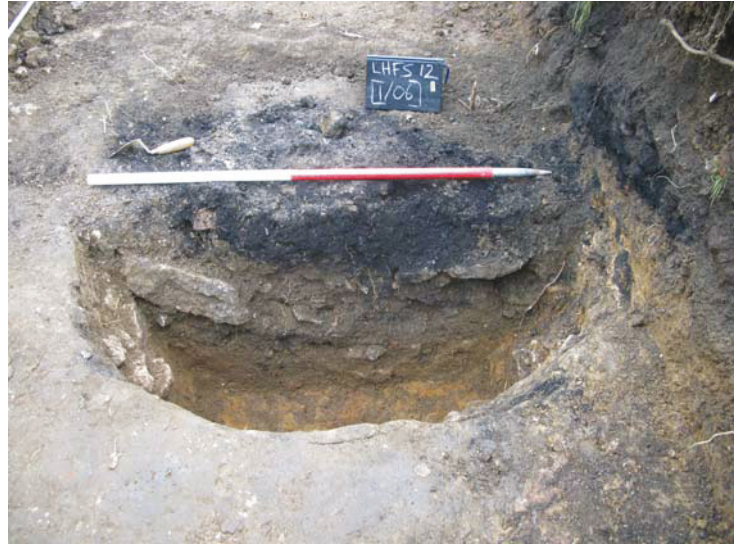
Figure 4; Pit 1/06 looking east (1m scale)

Pit 1/06 (top 80.99m AOD) (Figure 2; Section 1.3) was discovered 1.2m wide and 0.52m in depth with sharp concave sides and a flattish base possibly lined with limestone. The pit was filled by 0.40m thick mid greyish brown silty sand with limestone inclusions, slag, tile and one nail (1/05), overlain by a final filling of 0.20m thick black ash and soot (1/04) with tile, brick, iron objects and slag (see finds quantification table). The pit was sealed by topsoil (1/01).

The archaeological evaluation on land adjacent to 17-19 Freehold Street, Lower Heyford was successful in establishing that no medieval remains (or earlier) exist at the site. The presence of a nearby forge was evidenced by pit 1/06, which contained industrial metalworking waste of the late post-medieval period.
