JOHN MOORE HERITAGE SERVICES

**AN ARCHAEOLOGICAL
WATCHING BRIEF AT TRINITY RESTAURANT,
CHAPEL STREET, OXFORDSHIRE OX26 6BD**

June 2012

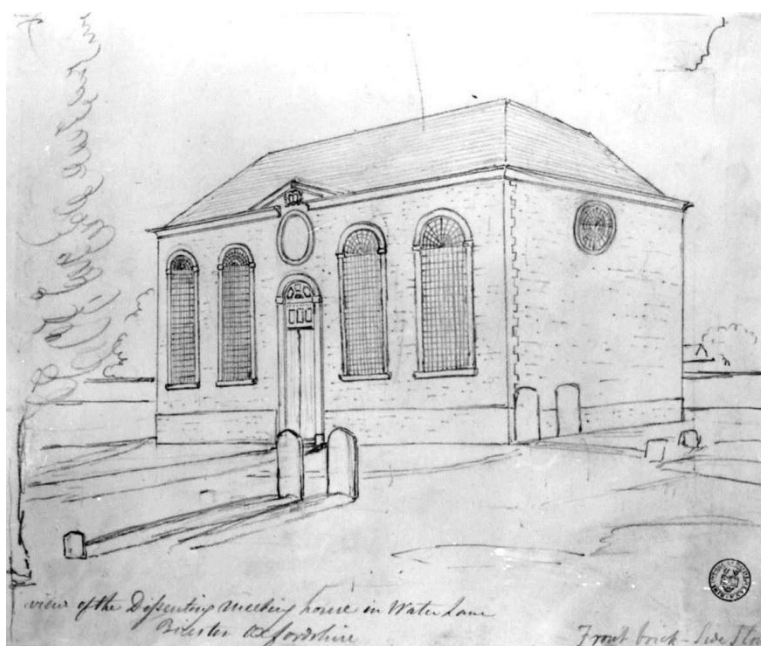
Figure 3; the congregational chapel before the later additions in its original form 1830

The grave headstones were tight against the southern boundary wall of the site with the head at the southern end. Shown on the drawing of 1830 (Fig 3) are two gravestones tight against the southern wall of the church (with a footstone). These headstones suggest two further crypts against this wall of the church also aligned north-south but presumably with the head at the northern end of the grave. The north-south alignment of burial is common when the east-west position is not practicable. This would have probably been the case here as more burials facing north-south could fit in the limited space available around the southern side of the chapel. It seems unusual that the headstones against the church wall on the drawing are the northern end and the discovered crypts have headstones at the southern end. This may be an inaccuracy in the drawing of 1830 or more likely as the church was non-conformist, alignment of burial was not considered to be important. From the drawing (Fig. 3) we can see that the graves in the front of the church building (western side) are orientated on a more standard east-west direction, as were the grave cuts tentatively seen during the excavations on the eastern side of the church (Fig. 2; Cuts 106; 115 & 117).

Although within a very narrow trench the grave cuts could be seen but excavations were not deep enough to locate the feet, which were presumably at this end of the grave, although the drawing from 1830 shows the headstone at the eastern end, again perhaps an act of non-conformity.

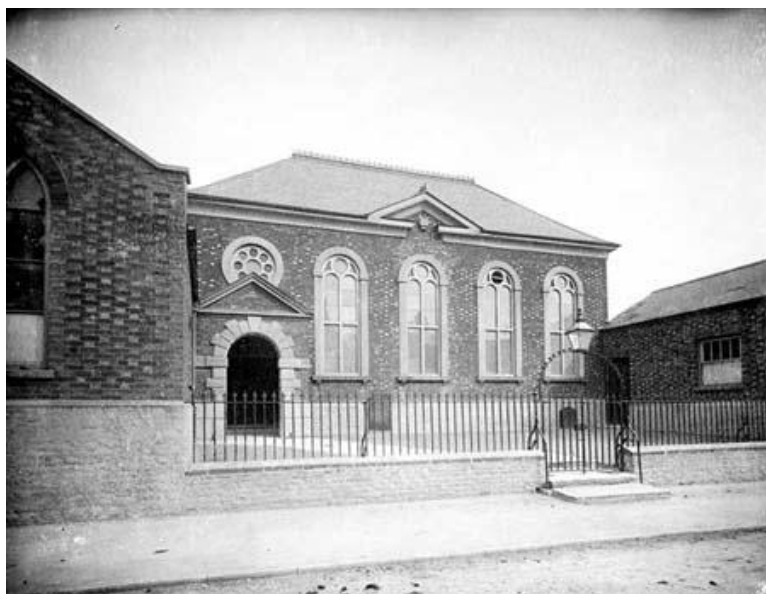
Fig 5; an early photograph of the congregational church from 1880 showing the addition of the two later wings and altered frontage

The later photograph (Fig 5) shows the building in its present day form with the altered frontage. It would seem that the circular window above the previous central doorway was swapped with the window where the porch is now located.

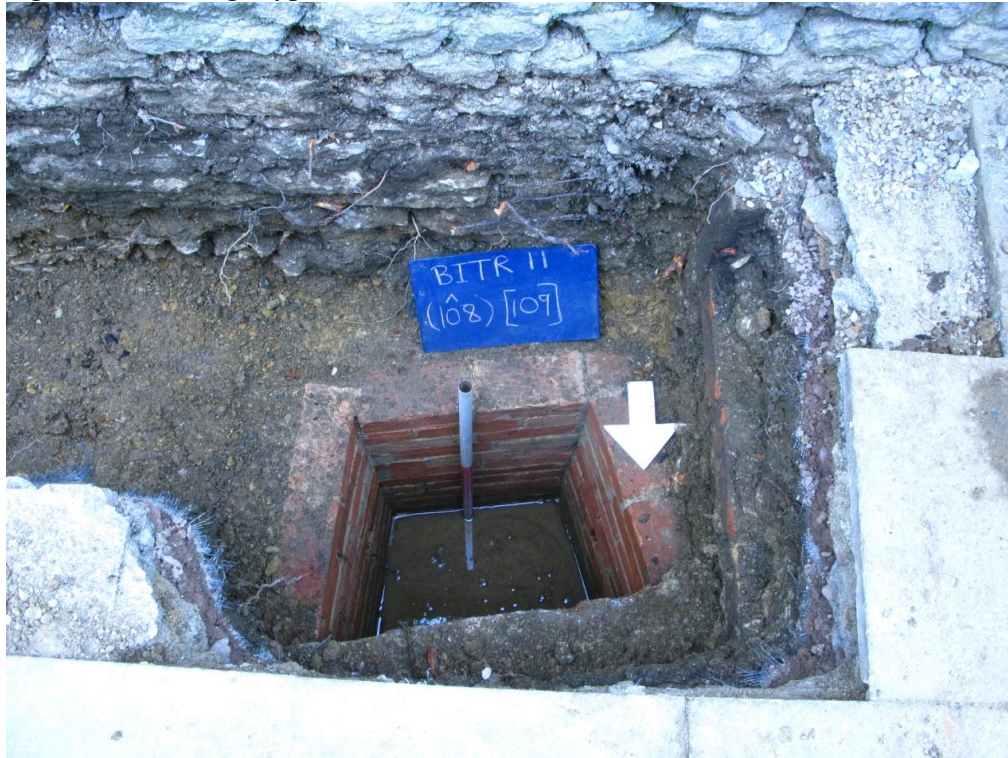
Figure 6; Showing crypt 108

At the south-western end of the new extension was a red brick crypt 108 in construction cut [109] was encountered measuring *c.* 2.2m in length and *c.* 1m wide on a north-south orientation (Fig 6). Within the crypt was a skeleton (SK1) in supine position, but had been disturbed after internment probably by rodents. The skeleton was contained in a highly decorated wooden coffin with large iron handles (110). The crypt was sealed by a large thick cut stone slab in good condition except for part of the centre of the stone slab that had collapsed into the void of the crypt on top of the skeleton.

The bricks used in the construction of crypt 108 correspond closely to the size of bricks generally produced in the latter half of the 18th & 19th centuries. The bricks used in the second later crypt 112 were frogged suggesting they were factory made and of late 19th or 20th century date. We know the chapel was used for burials during the first eighty years of its use after which the cemetery presumably became full and people were buried at the town cemetery. The brick crypts would certainly prove that burial for some important wealthy worshipers or more likely the pastors was still taking place into the early 20th century. As crypt 112 was later and immediately adjacent to crypt 108 it would be likely that this is the married partner of the deceased.
