JOHN MOORE HERITAGE SERVICES

AN ARCHAEOLOGICAL WATCHING BRIEF

ON LAND AT THE GRANARY,

LONG WITTENHAM

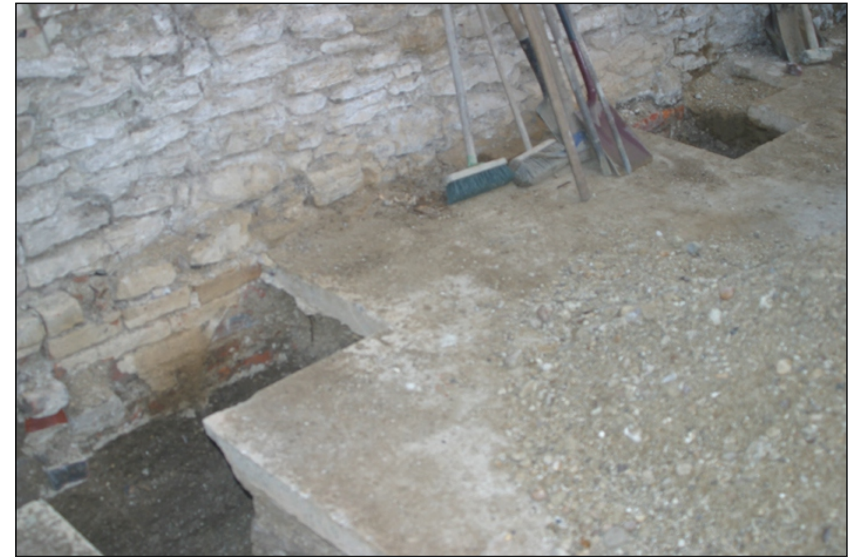
Figure 4. Photograph of footings trench showing walls 2 (located on extreme left of photo) & 3 (within footings trench).

Wall 3 appeared to consist of a double skin of brick (Fig. 4), although this was not absolutely clear and could not be clarified without invasive work, beyond the remit of the watching brief. The base of wall 3, which was a single course deeper than wall 2, appeared to form part of the same build. The brick walls were bonded with the same white grey lime mortar. The roughly-coursed stone wall 1, which was the present boundary wall to the yard in front of The Granary, appeared to be built on top of walls 2 and 3, although as wall 3, which extended beyond the edge of the footings trench, was not present in either the footings pit or in the footings trench to the north its precise relationship with the apparently later wall 1 remains ambiguous.

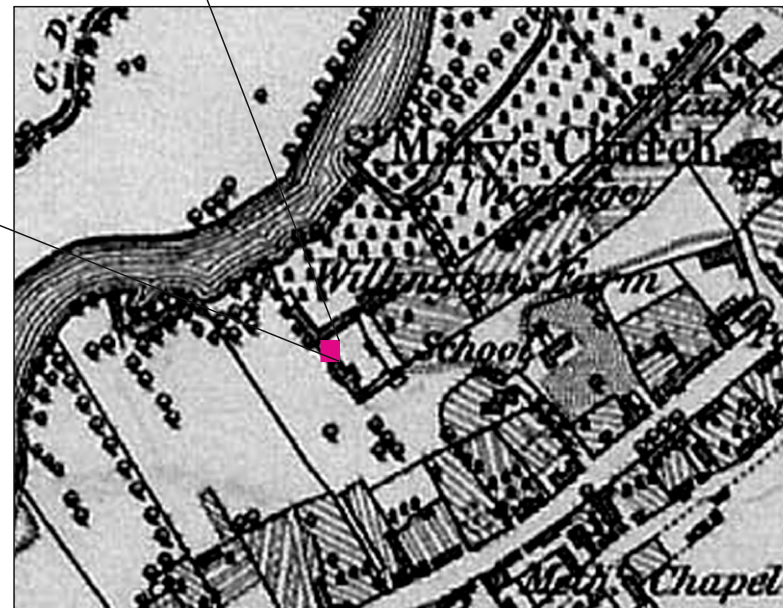
Figure 5. Historic map extract (OS 1st Ed. 1883)

Ordnance Survey mapping from 1875 (1st Edition; 1:2500) (Fig. 4) does not clearly indicate any structure commensurate with the remains found. This and later versions indicate that there were small structures along much of the west side of the yard. Only at the north end would there appear to have been just a wall separating the yard from the field to the west of the farmyard complex. While there does not appear to have been significant rebuilding between 1875 and 1912, it is clearly the case that internal work or even replacement *in situ* would not be evident from OS mapping. However, the light nature of the remains – a single skin of brick – are indicative either of a structure which was in use for perhaps only a short period of time, or of an internal division within an outbuilding. No internal surfaces were identified, nor were any earlier structures present.
