JOHN MOORE HERITAGE SERVICES

ARCHAEOLOGICAL WATCHING BRIEF
ON FOLLY BRIDGE, OXFORD
(SECTION OF GRANDPONT CAUSEWAY)
NGR SP 51425 05595 to SP 51405 05629 (linear)

SEPTEMBER 2012

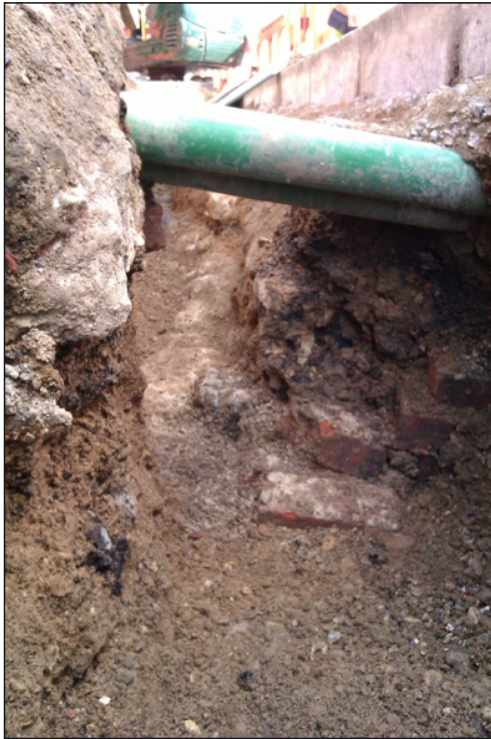
Figure 2. Photograph to left showing line of wall 103 and single skin brick wall extending east under Folly Bridge observed during watching brief.

There was only a single location in the service trench where previous impacts were excavated to expose remains. This was located 10m north of the former tollbooth where part of a north/south stone wall 103 (Figs 2-4), in line with the front wall of the toll house, was present at the depth of the base of the service trench; this was rapidly cleaned and exposed archaeologically to permit a record to be made. This wall had previously been extensively impacted upon by other services; the fill of these was assigned (102). The top of the wall was exposed during cleaning. It comprised at least two courses. The stones – measuring an observed maximum of 650 × 40 × 20mm – were limestone, and extended beyond the northern and eastern edges of trench. At the north end it appeared to return to the west. At the south end of the exposed wall was the top of an east/west oriented single skin brick wall 104. South of this brick wall had been extensively impacted upon by a BT access chamber. The levelling and slab were assigned (101).

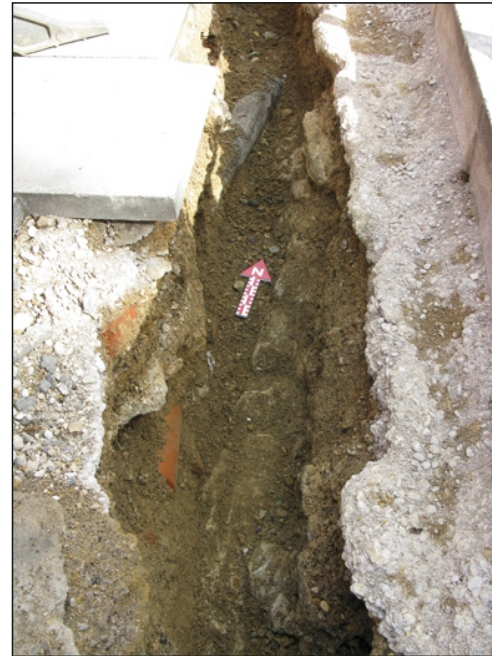
Figure 3. Photograph above showing extent of wall 103.

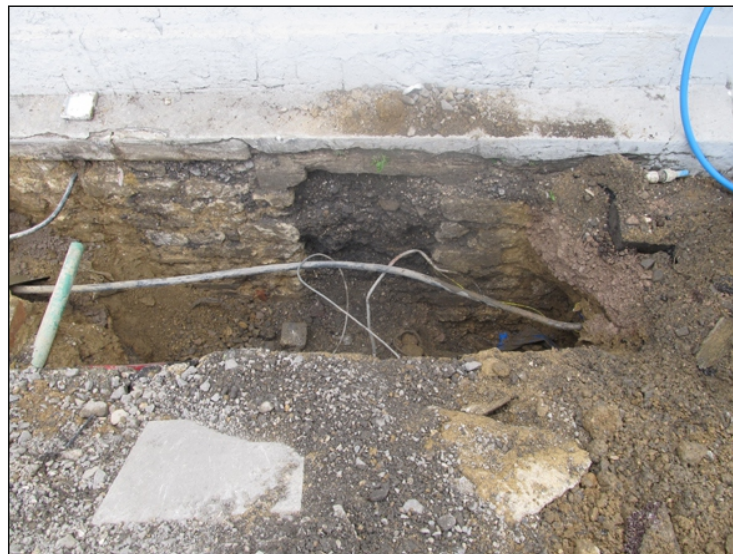
Figure 5. Photograph to right showing line of wall-footings 105 of toll booth and location of access observed during watching brief.

To the south, a trench measuring *c.* 3m × 1m was excavated the length of the north side of the former toll booth at the north end of Folly Bridge (Figs 1, 5 & 6). The trench was within the footprint of previous excavations for services, which were revealed during the investigation.

Located beneath the north wall of the former toll booth, stone footings 105 were exposed. The full depth of the footings was not revealed as they were below the impact depth of the service trench, a depth of *c.* 1m below current ground level.. The limestone blocks were roughly shaped stone measuring approximately 650 × 40 × 20mm laid in rough coursing, similar to the north/south-oriented wall observed to the north. The footings included an access blocked with soil (Figs 4 & 6). This was not further investigated.

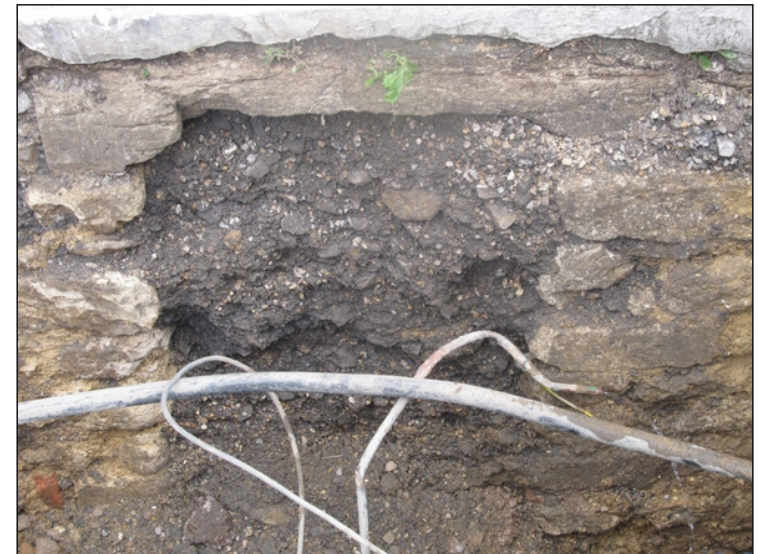
Figure 6. Photograph above showing close-up of access in wall 105.

The opening in the wall footings of the toll booth are not easily explained, unless the toll booth was perhaps larger originally. However, there is no such indication of this on the building. It is possible that there was a small access under the toll house; although as the extensive demolition and associated groundworks for the construction of Folly Bridge Court was not archaeologically monitored, it is not possible to assert the precise function of this access.

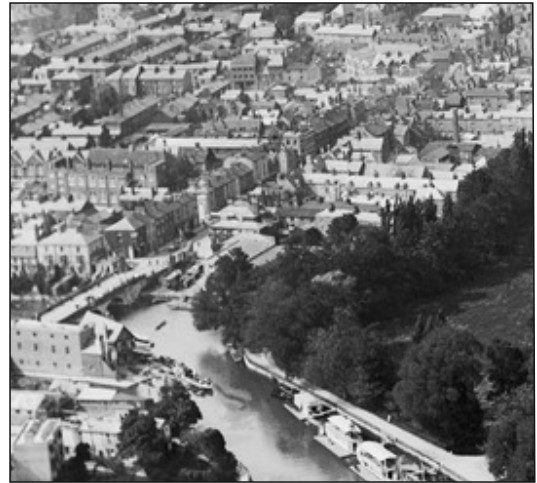
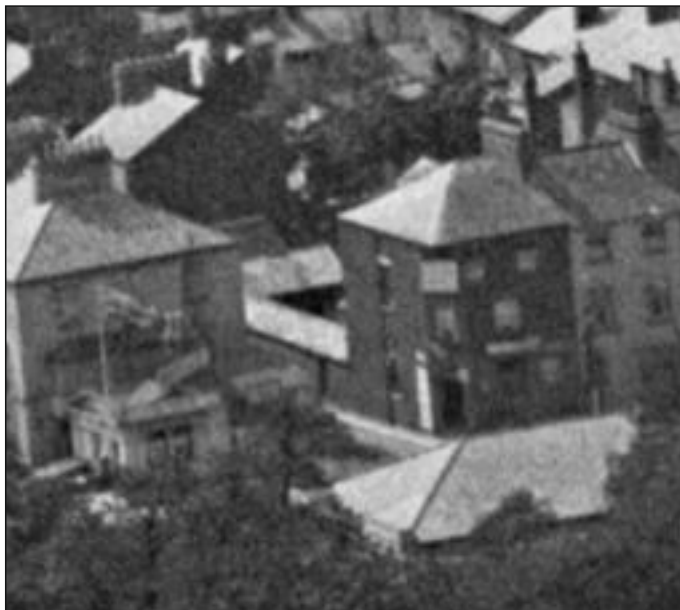
Figures 7 & 8. Grandpont, Oxford, from the south-east, 1920. (Aerofilms Ltd EPW000836) The image below is a close-up of that to the right showing the building line on Folly Bridge. This building appears to be behind the line of that identified.
© English Heritage

The wall observed was approximately 10m north of the toll booth and is possibly the house visible on the air photographs from 1920 (Figs 7 & 8). The 1st Edition OS 1:2500 (1878) and 6" Berkshire Sheet VI (1886) (Fig. 9) show the location of the former toll booth on the corner of Isis Street and Folly Bridge, as well as the location of the house on the opposite side of Isis Street (*ibid*). It would appear unlikely that the houses represented then are the houses represented on the prints of 1862 (Fig. 10) or 1785 (Fig. 11), although whether these are the remains identified during the watching brief is uncertain, as it is apparent that the area has been built up since the

late 18th century at least. The air photograph from 1920 (Figs 7 & 8) seems to show the house on the north side of Isis Street in line with house to the rear of the toll booth; the map (Fig. 9) shows it forward of the house. Furthermore, the map seems to indicate the toll house at the very corner of Isis Street, whereas the photograph seems to show it set back some small distance from the corner.

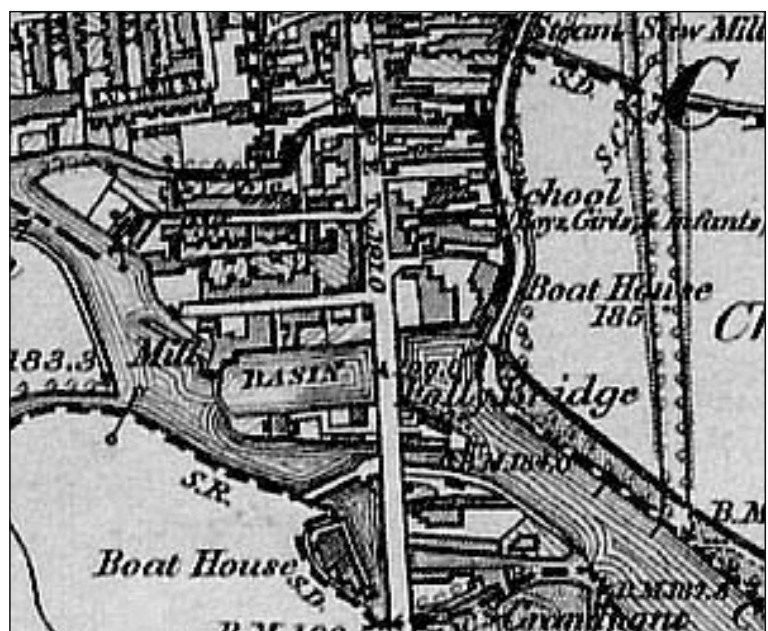
Figure 9. 1st Ed. OS Berkshire Sheet VI. (1886). Site north of basin

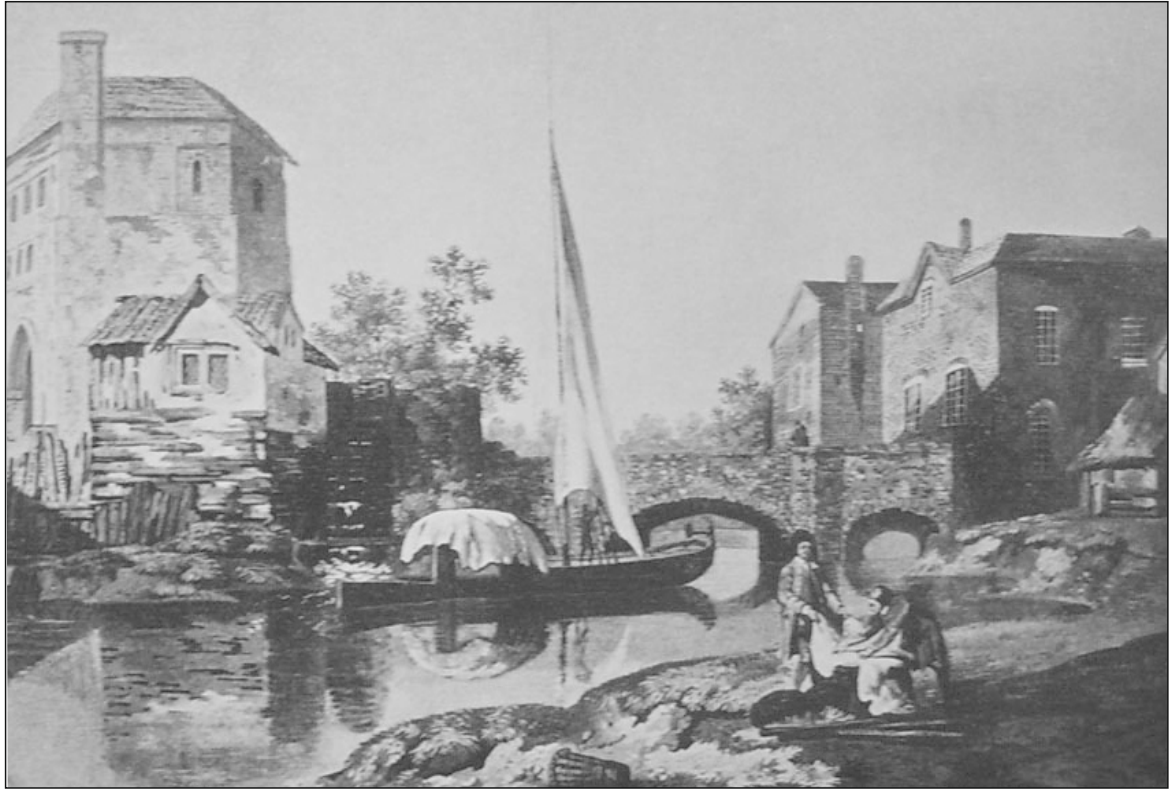
Figure 10. Friar Bacon's Study, S H Grimm, 1862, copied by J E Vincent, 1909;
building identified is possibly on the right-hand side of the picture

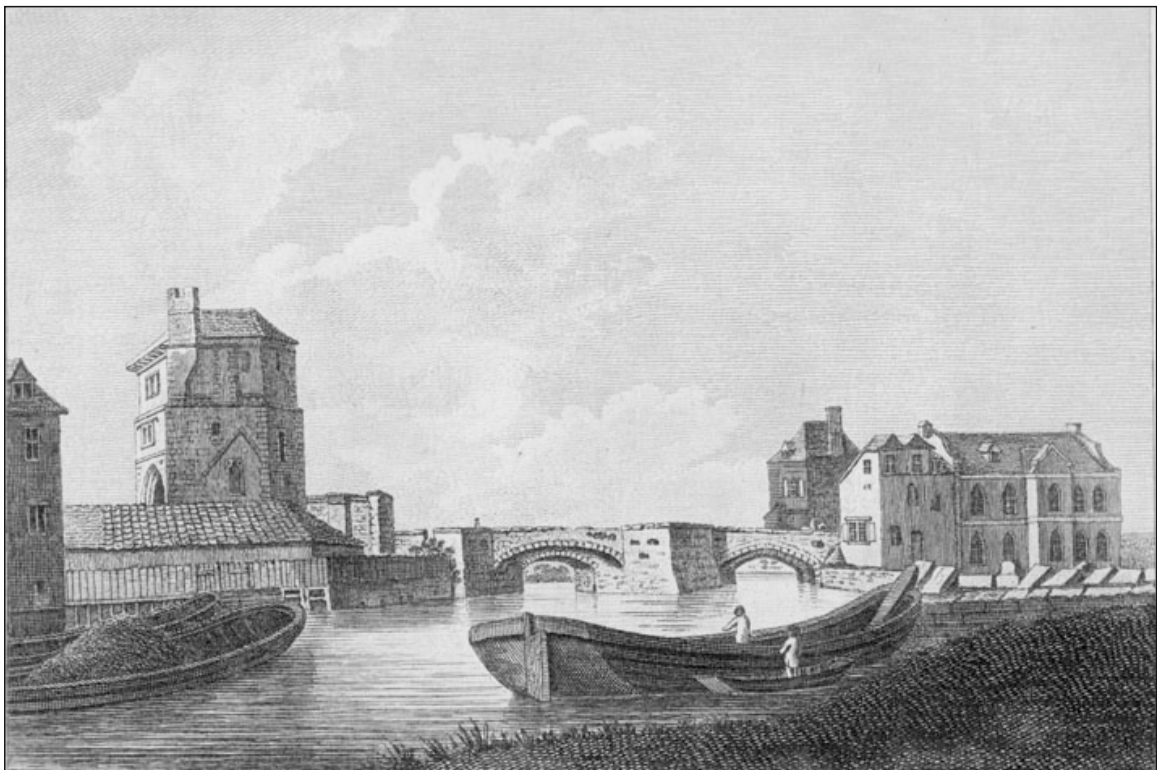
Figure 11. Folly Bridge and Bacon's Tower, S Hooper 1785;
building identified is possibly on the right-hand side of the picture
