**GLEND A SPOONER FARM,
BRINCIL HILL LANE, KINGSDON,
SOMERSET**

ARCHAEOLOGICAL EXCAVATION

DECEMBER 2012

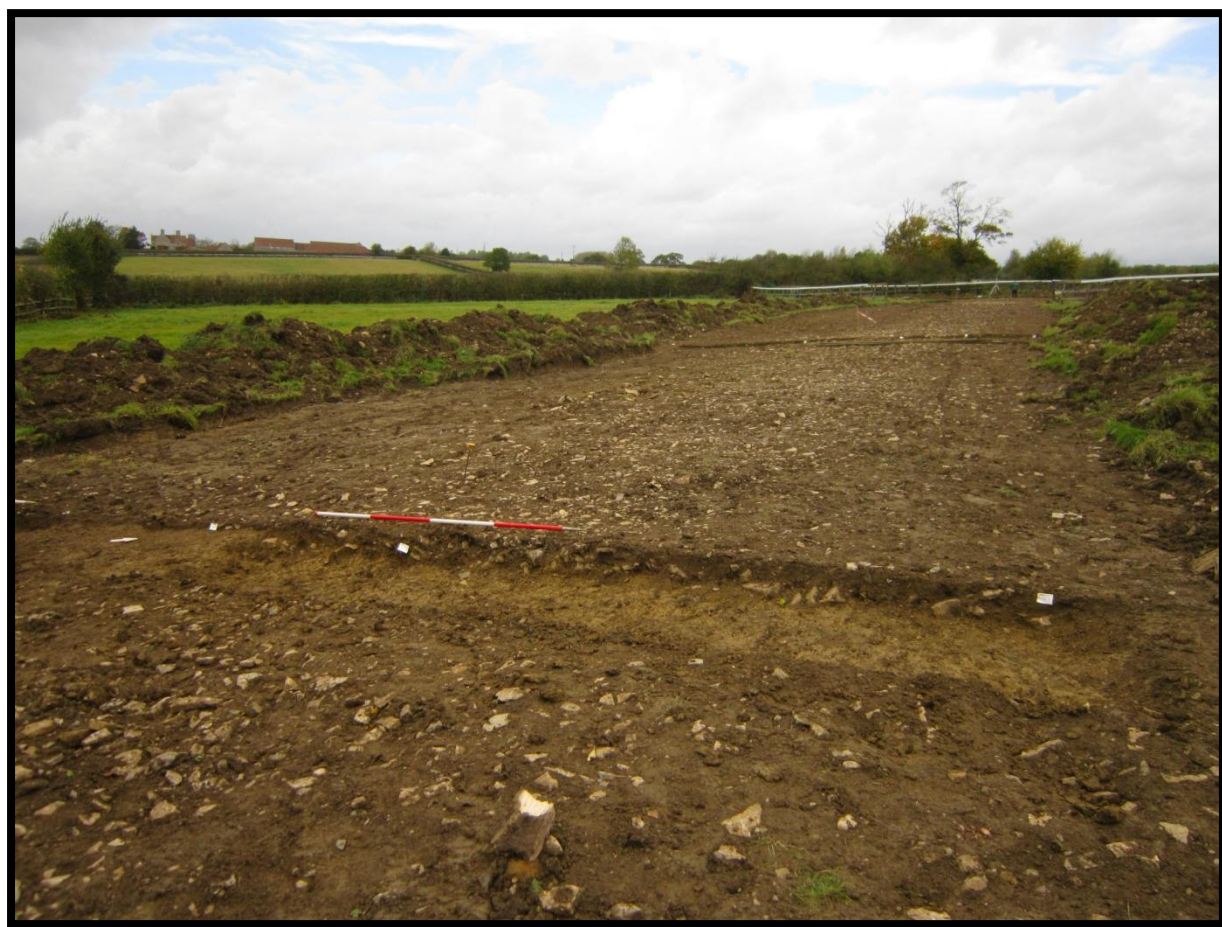
Plate 1; General view of the road looking north-west (2m scale)

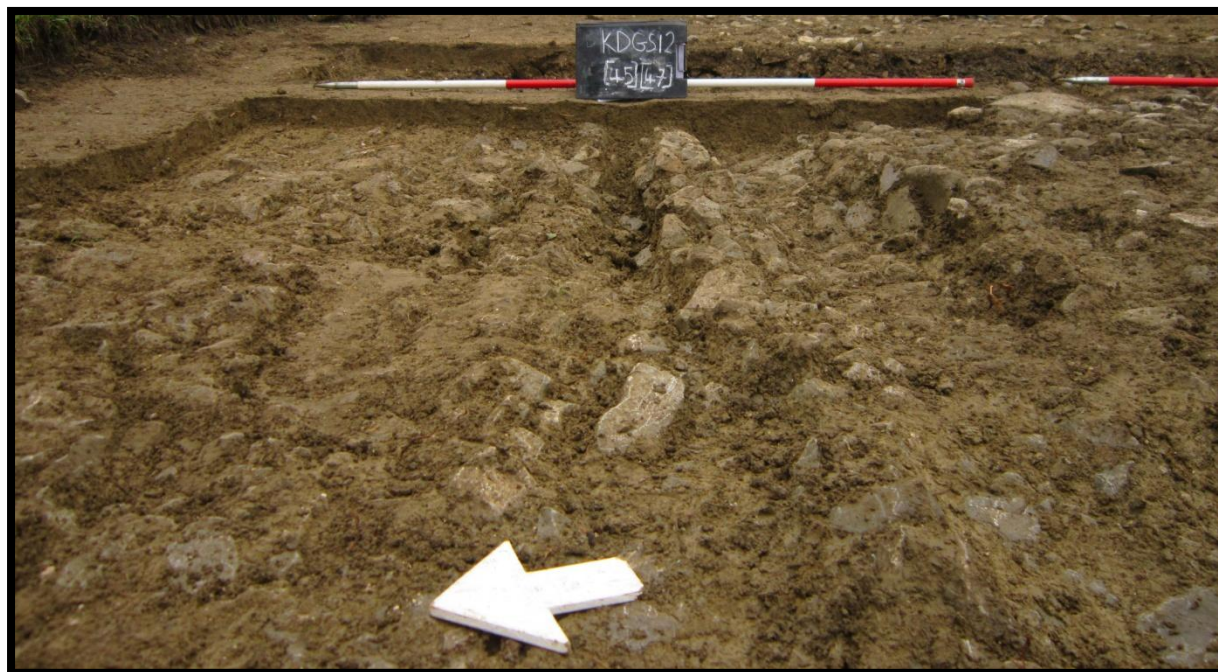
Plate 2; detailed view of cart rutting looking east (2m scales)

Where the road changed course with an obvious bend there was clear evidence of a possible gutter and cart rutting [45] & [47] (Fig. 5, Section 5, Plate 2). The possible gutter [45] was 0.30m wide and 0.10-0.15m deep with concave sides and a rounded base (Plate 2).

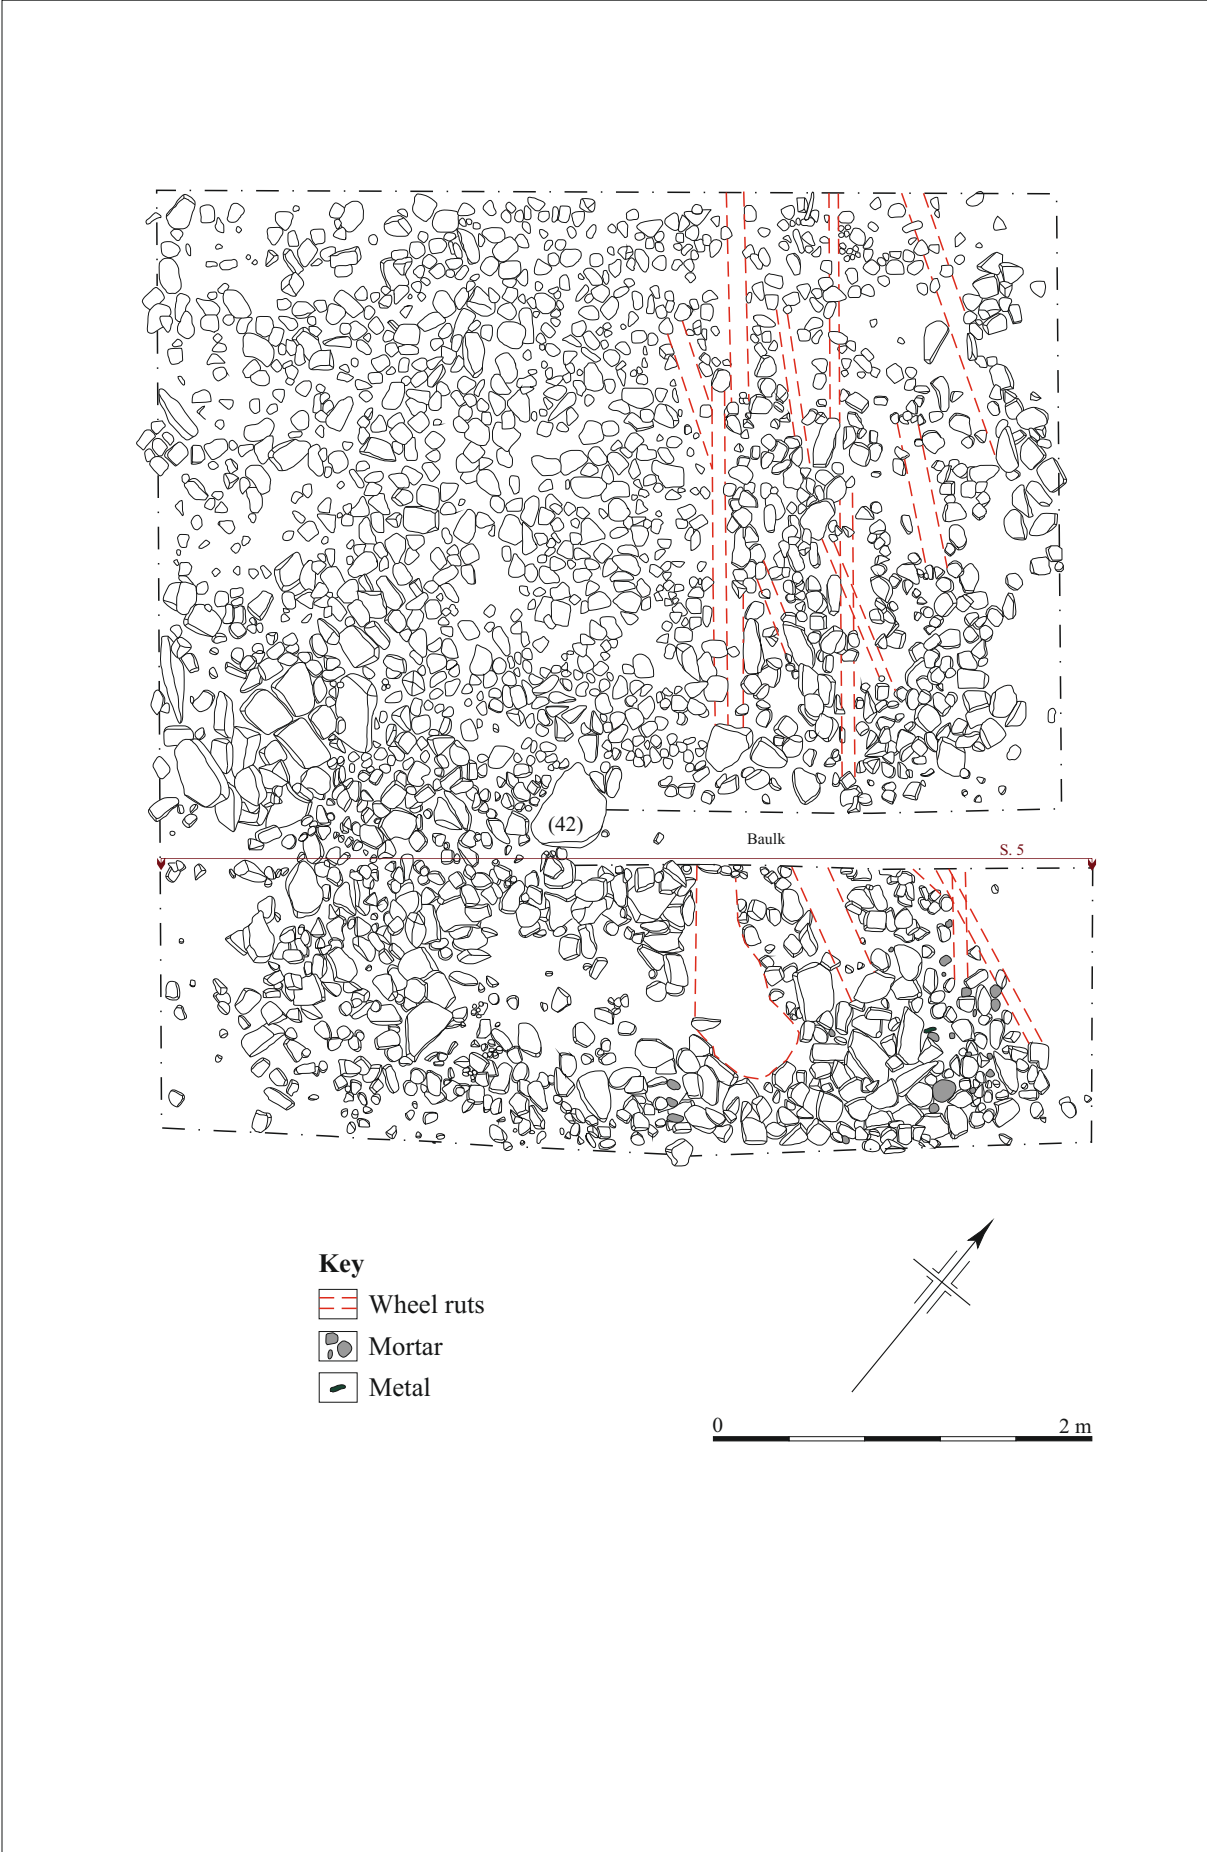
Figure 3. Detail plan of road showing wheel ruts

compact with cart rutting apparent on the eastern side [45] & [47] (Fig. 3; Fig. 5; Section 5). The road here was well preserved and an apparent cream coloured mortar was seen amongst the stones, used as a bonding agent. This may suggest a post-medieval addition across this area, although cream mortar was also recorded as a Roman bonding agent on the Fosse Way at Ilchester (Leach 1982).

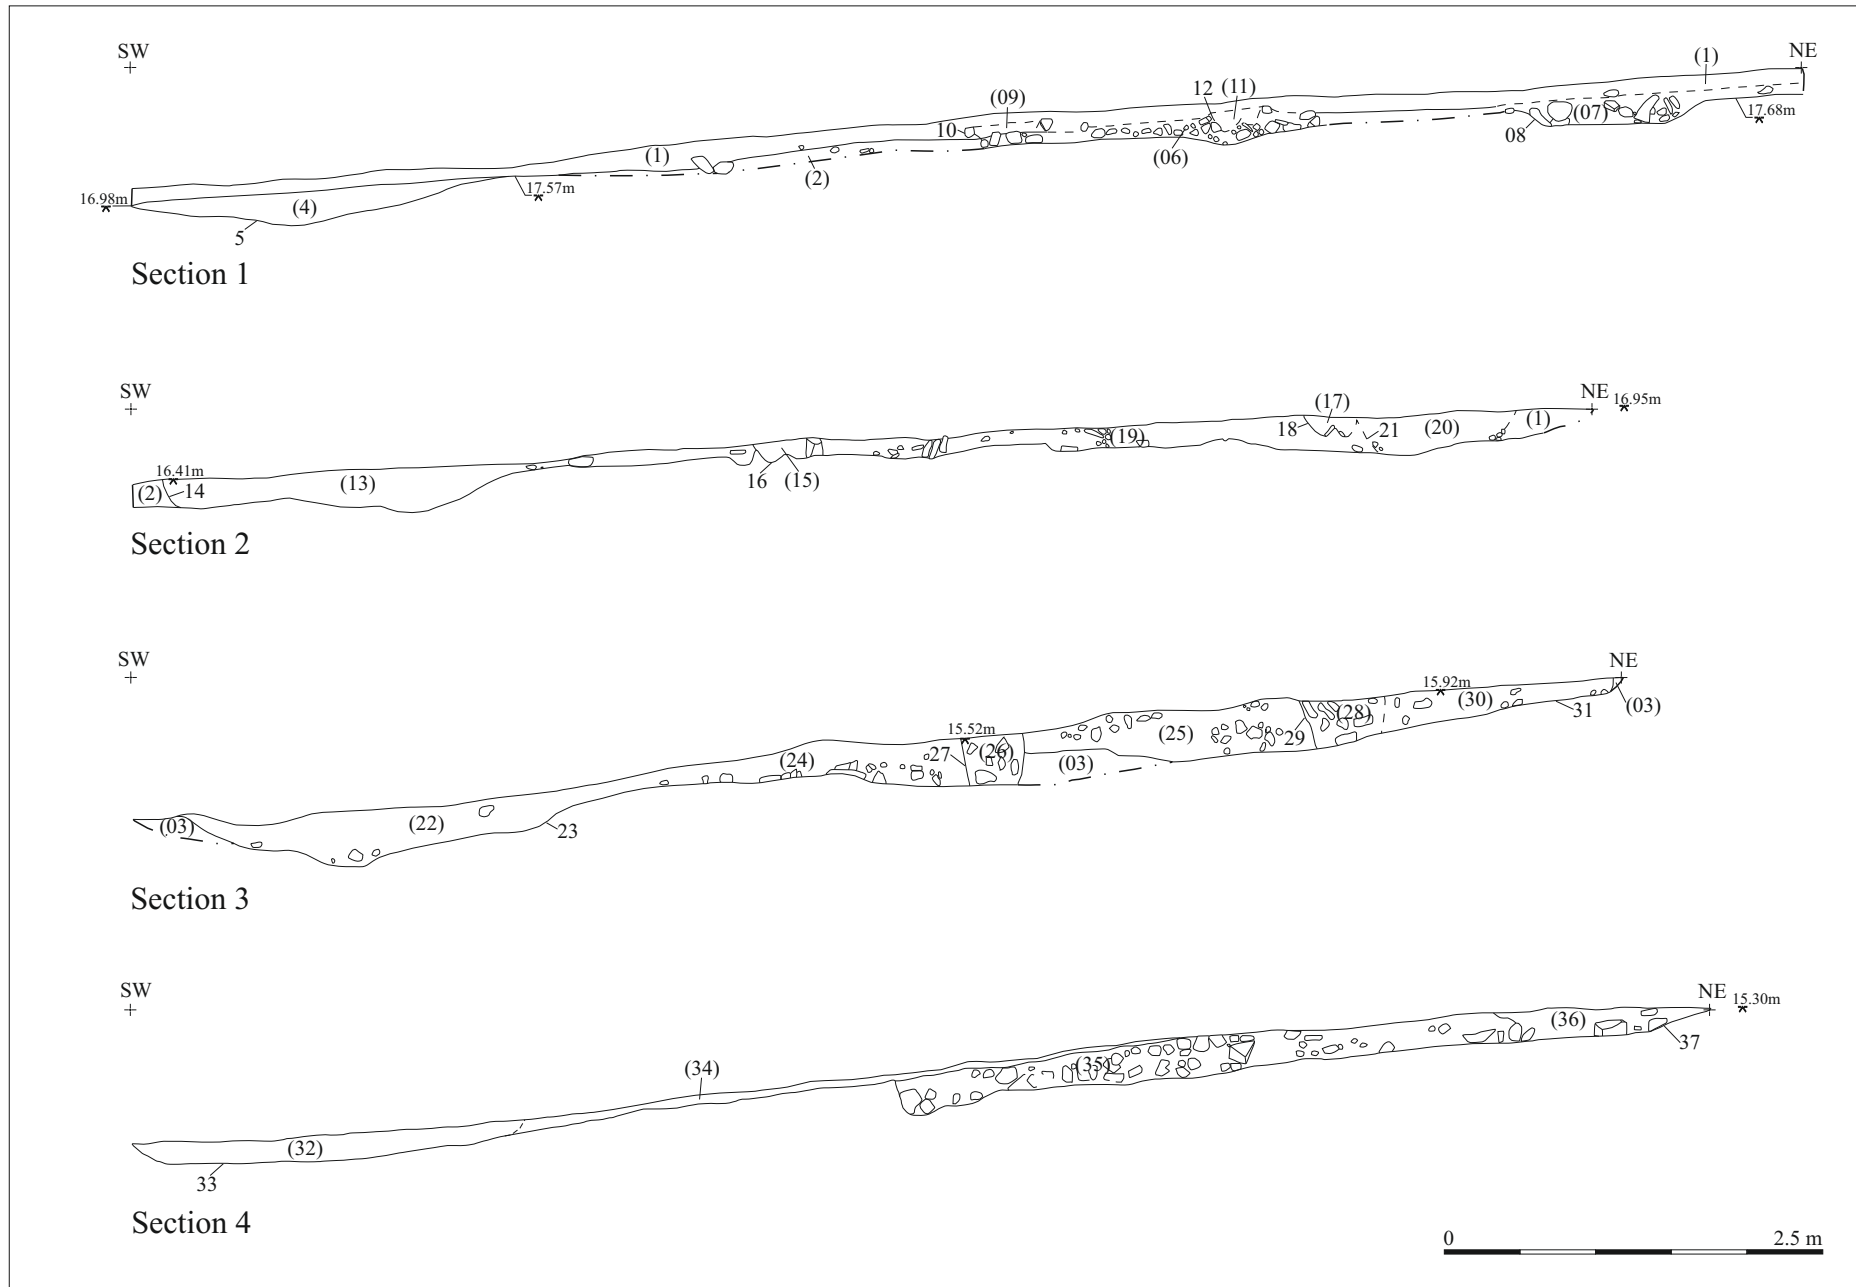
Figure 4. Sections 1, 2, 3 and 4

The southern kerb and construction cut had three sections placed across it; [10], [16] & [27] (Fig. 4). The construction cut dimensions ranged from 0.20-0.40m wide and 0.10-0.20m deep. The kerb was distinguishable from the rest of the road surface as the stones were denser and more compact along the edges. This cut was filled by compacted lias stone (<50-250mm) placed in an irregular order (09)=(15)=(26).

The northern kerb construction cut also had three sections placed across it; [12], [18] & [29] (Fig. 4). Again, the kerb was distinguished from the rest of the road surface by denser and more compacted stones. The dimensions of the kerb ranged from 0.20-0.25m wide to 0.10-0.30m deep. This cut was filled by irregular shaped compact lias stone (<50-250mm) (11)=(17)=(28).

The possible north roadside ditch (Fig. 4, Sections 1, 2 & 3) was less obvious than the south side ditch and had a shallow profile in all sections across it; [08], [21], [31] & [37]. The width of the ditch was generally *c.* 1.5m wide and 0.20m deep. It had shallow concave sides and a generally flat base. The ditch was filled by dark greyish brown silty clay with frequent stone inclusions (07)=(20)=(30)=(36). The north side ditch was tentatively seen during the evaluation within Trench 11. The ditch fades away in a similar location to the south side ditch, but was not seen again.

A layer of topsoil containing loose stones was recorded adjacent to the road on its south eastern side between the road surface and the south side roadside ditch; (24)=(34) (Figure 4; Section's 3 & 4). This deposit was probably created as a result of water erosion across the surface of the road, spreading some of the cobbled surface into this area between the road and the south roadside ditch.

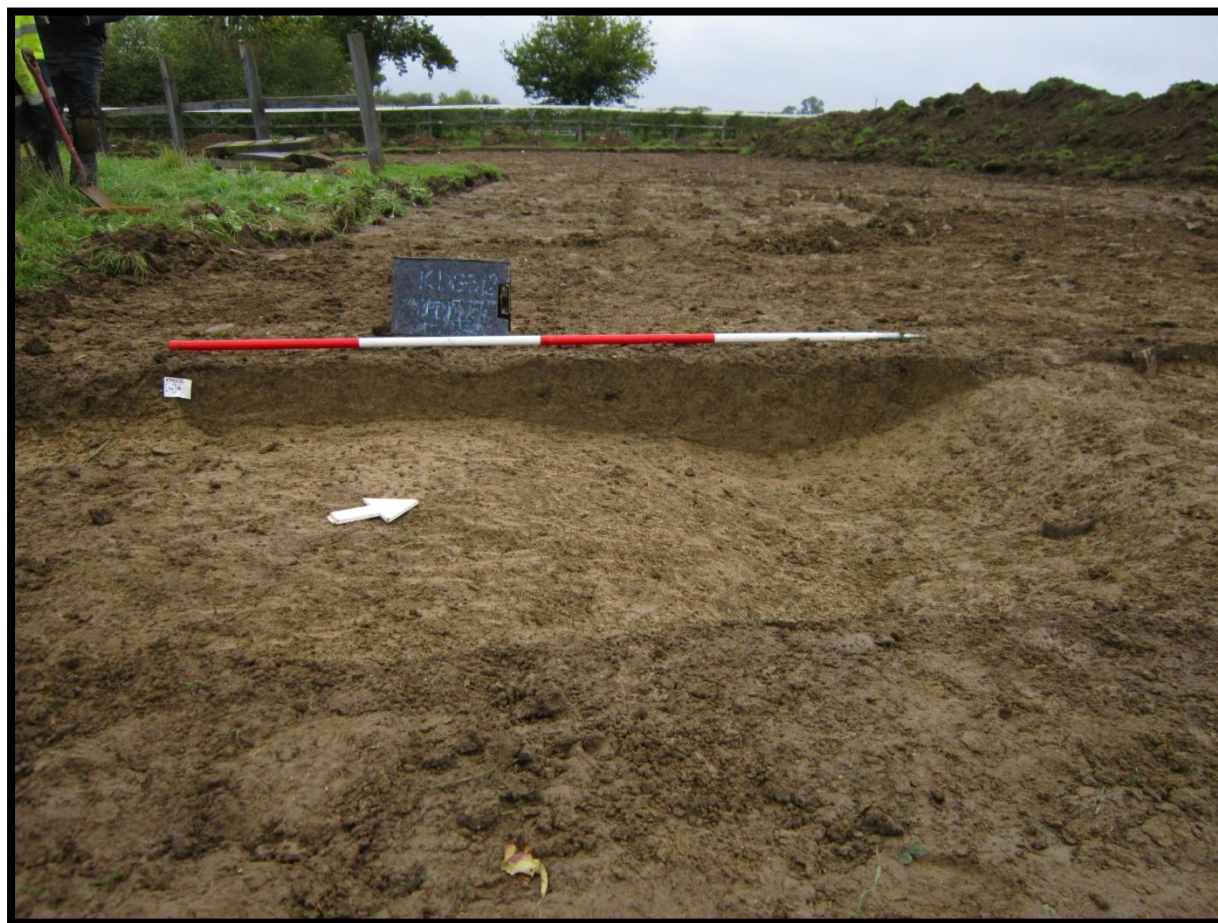
Plate 3; Southside ditch [14] looking north-west (2m scale)

The south roadside ditch was the more substantial of the two roadside ditches, but was still generally shallow. The ditch was sectioned across five locations [05], [14], [23], [33] & [49] (Figs. 4 & 5) and had a generally similar profile recorded, except in the far south eastern end of the site (see below). Section [06] was at the north-western end of the excavation (Fig. 4, Section 1; Plate 3), the ditch was 0.27m deep and 1.5m wide with gradually concave side and a gently rounded base. The profile remained similar until section [33] (Fig. 4, Section 4) where the ditch was 0.18m deep and 2.60m wide, it had gradual concave sides and an almost flat base. To the south of this section the ditch seemed to fade out with no obvious terminal end. It was seen again at the south-eastern end of the excavations [49] (Fig. 5, Section 7) and had a shallow depth of 0.05m and width of 1.5m. The ditch was filled by firm mid grey brown loamy clay (04)=(13)=(22)=(32)=(48). The geophysical survey showed the ditch curving away from the road surface on the southern side, but this was not visible during the excavation.

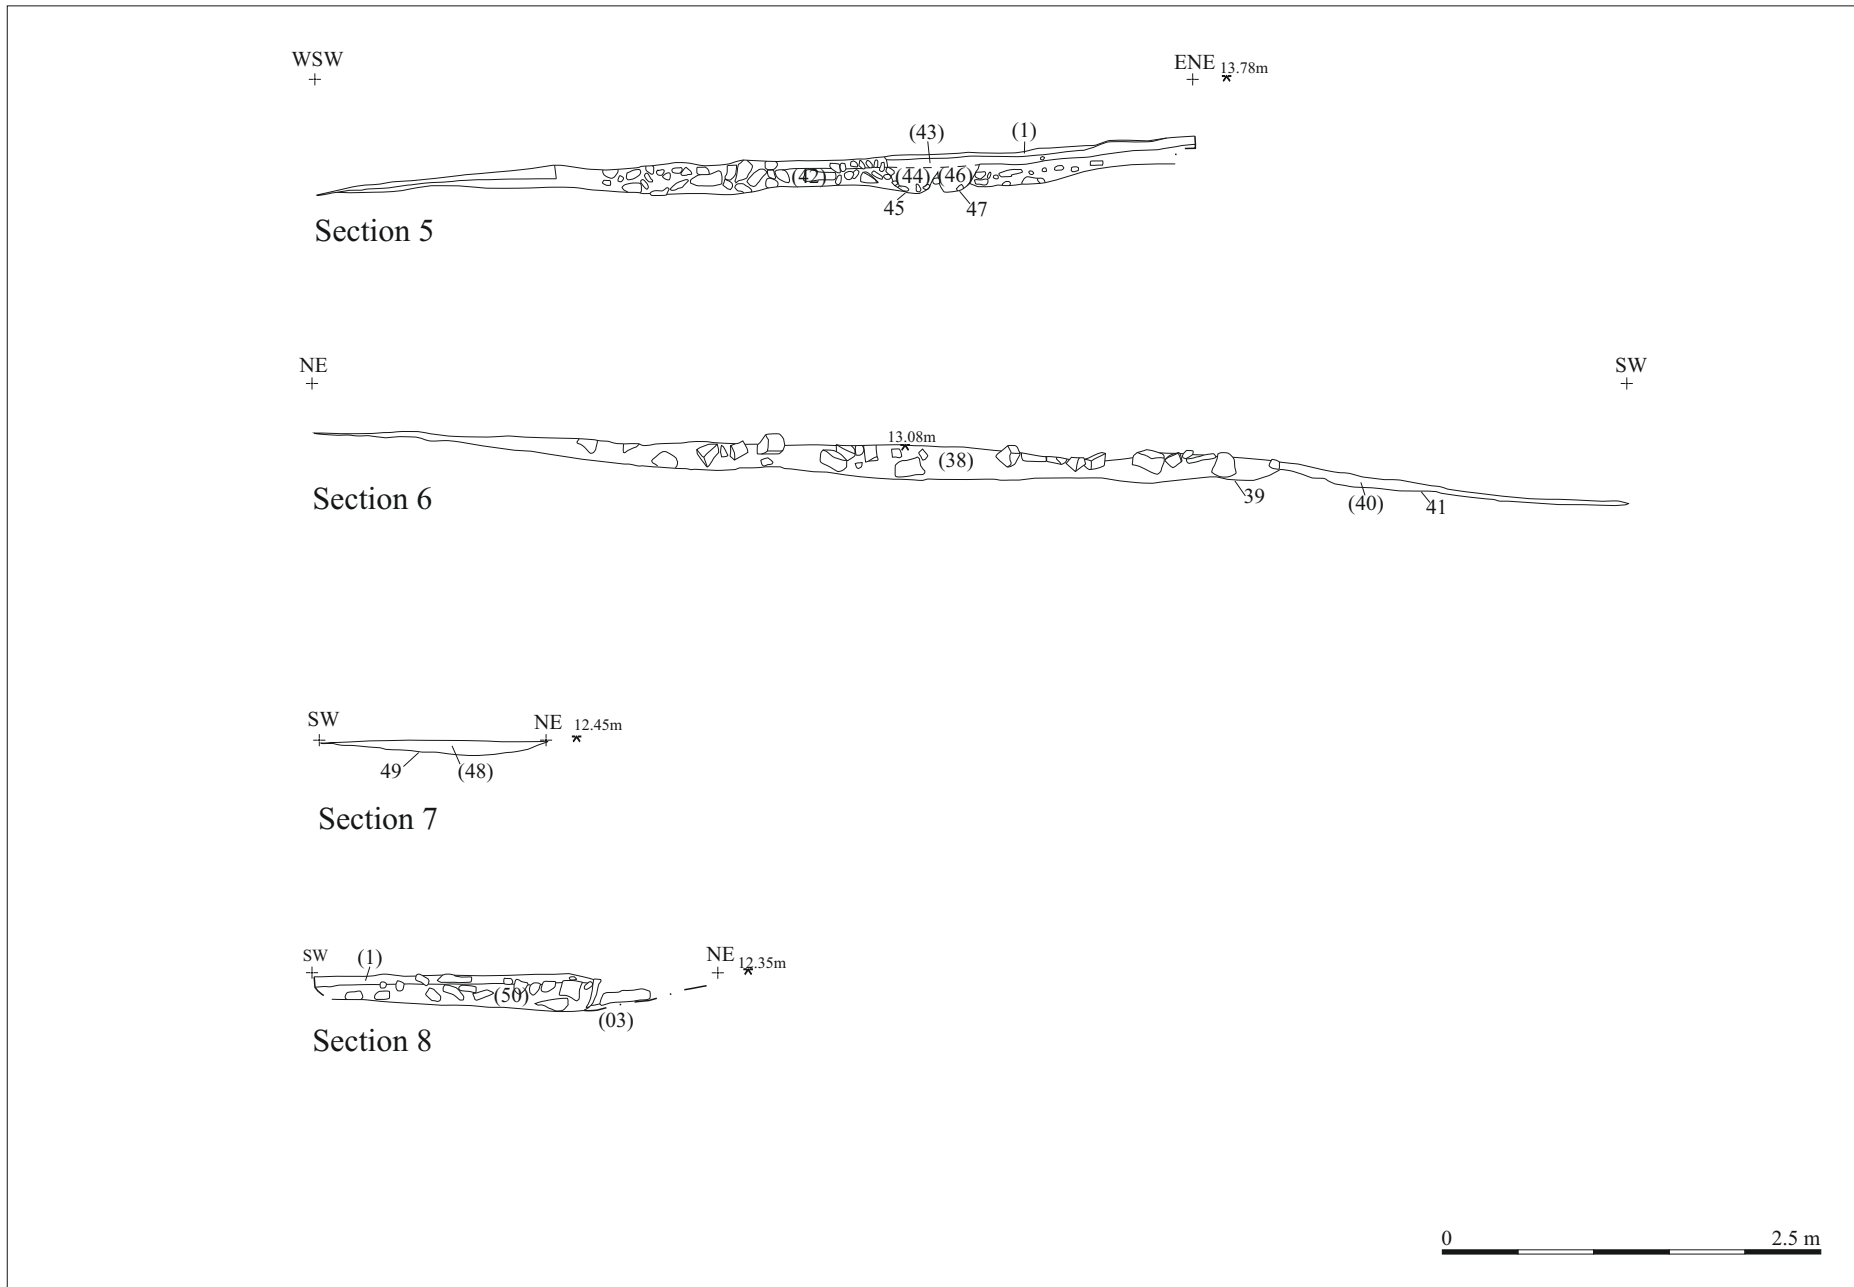
Figure 5. Sections 5, 6, 7 and 8

Towards the south-eastern end of the excavation an irregular area of stones (50) (Fig. 2; Fig. 5, Section 8) measuring 5m in length and 3m wide was investigated. This was considered to be a dump of material moved to this location perhaps from the surface of the road. Between the stones were fragments of post-medieval brick and pottery sherds.

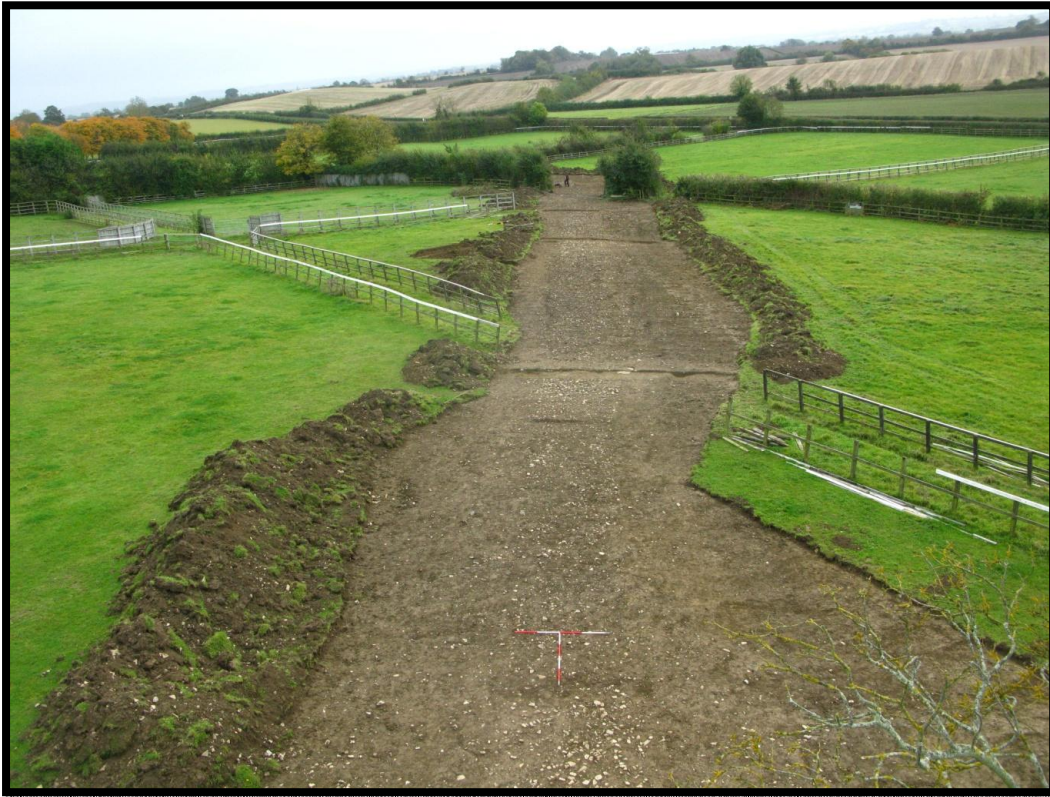
Plate 4; View of Road looking south-east (2m scales x2)
