**AN ARCHAEOLOGICAL WATCHING BRIEF**

**1 CHURCH STREET, SOMERTON, OXFORDSHIRE**

**JANUARY 2013**

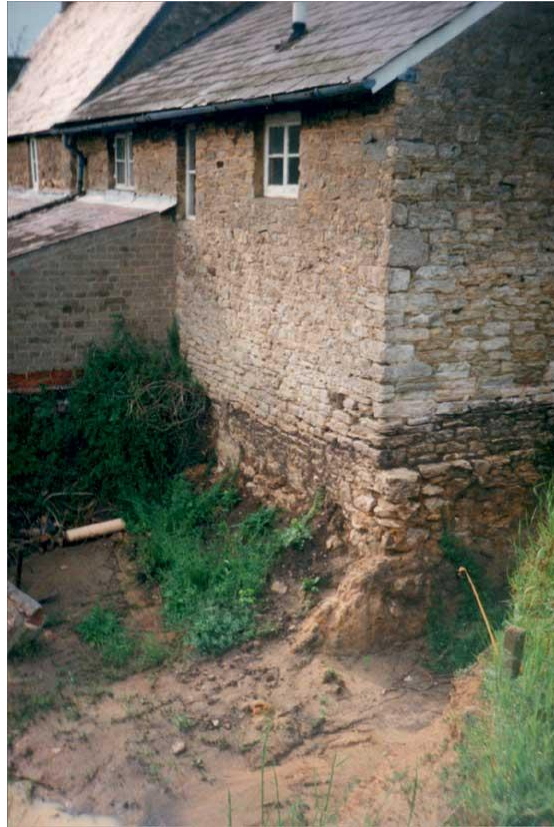
Plate 1; Showing corner of 1 Church Street previous ground reduction

Some areas of the new extension had previously been reduced to clear the site of vegetation and make an access road (See Plates 1 & 2). As the ground had been already been significantly reduced it was decided not important to monitor any foundation trenches for the new extension as they were excavated, across the eastern side of the site, but an inspection was made of the open trenches during a site visit.

The one large pit which was recorded in the footing trench was of possible early post-medieval date and probably associated with the early inhabitants of the cottage. The feature was most likely an organic waste pit located to the immediate rear of the property. There has been much ground reduction in the past over the general area around the cottage (Plates 1 & 2) which may have truncated any archaeological remains had they been present.

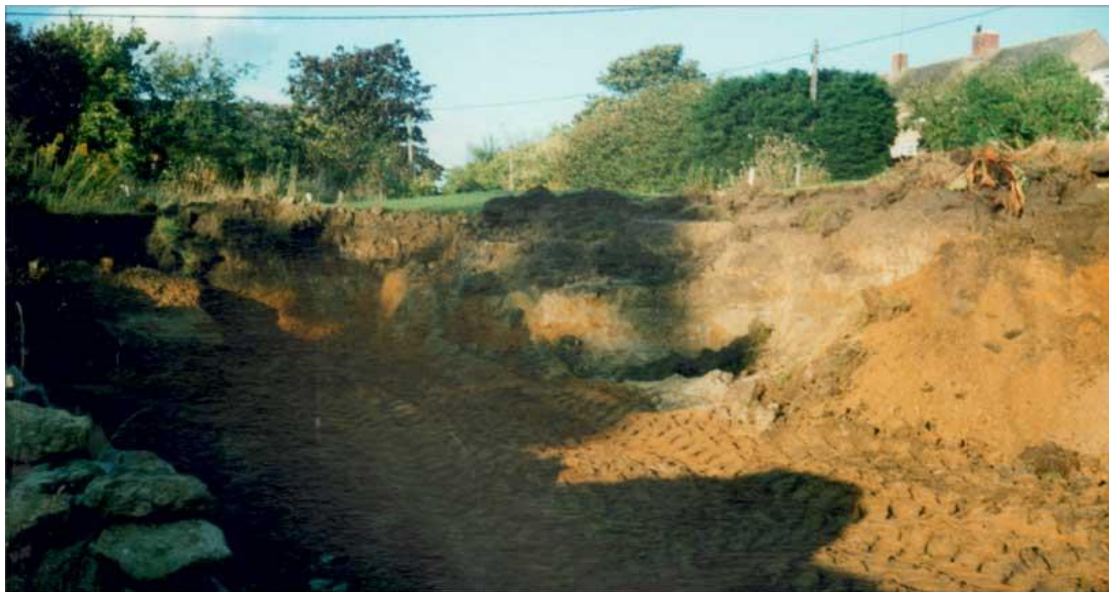
Plate 2; Showing extent of some of the previous groundworks in the garden

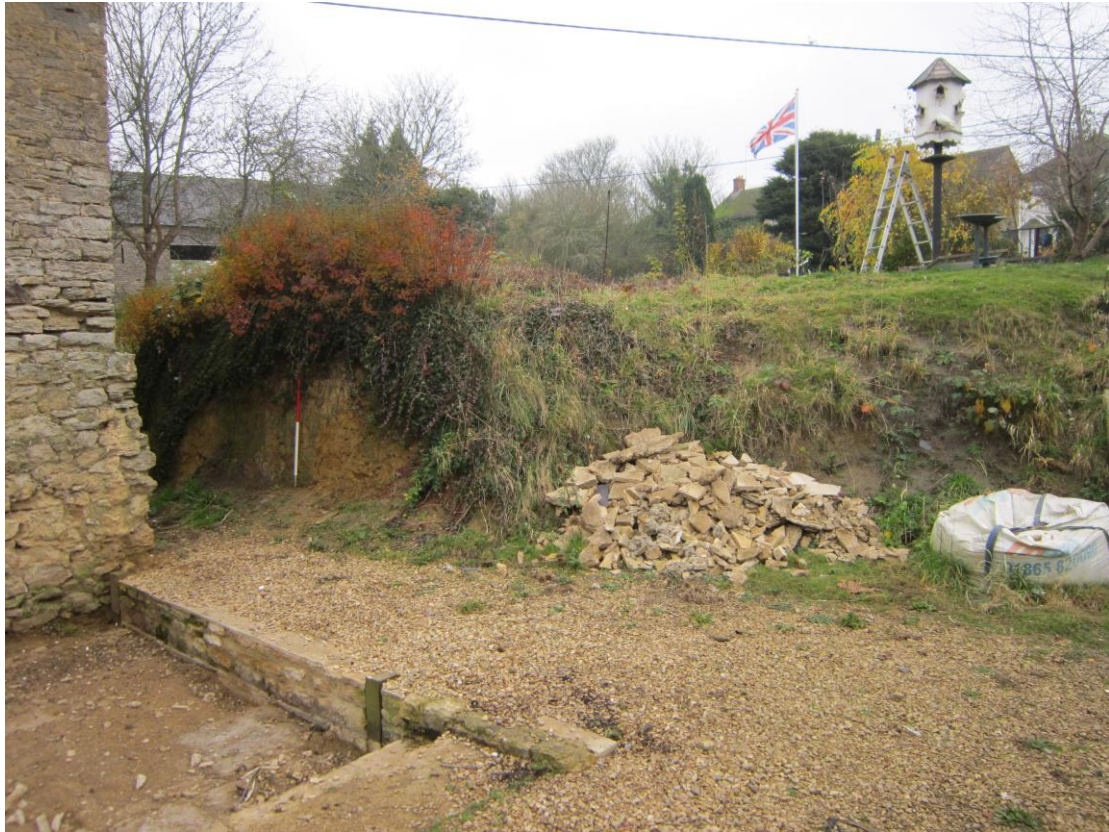
Ground reduction across part of 'the mound' was observed which revealed the natural clays and sands (02) overlain by 0.30m thick dark greyish brown silty clay topsoil (01). The 'mound' was clearly natural ground and no archaeological features were observed cut into its uppermost surface.

Plate 3; Showing an exposed section of 'the mound'

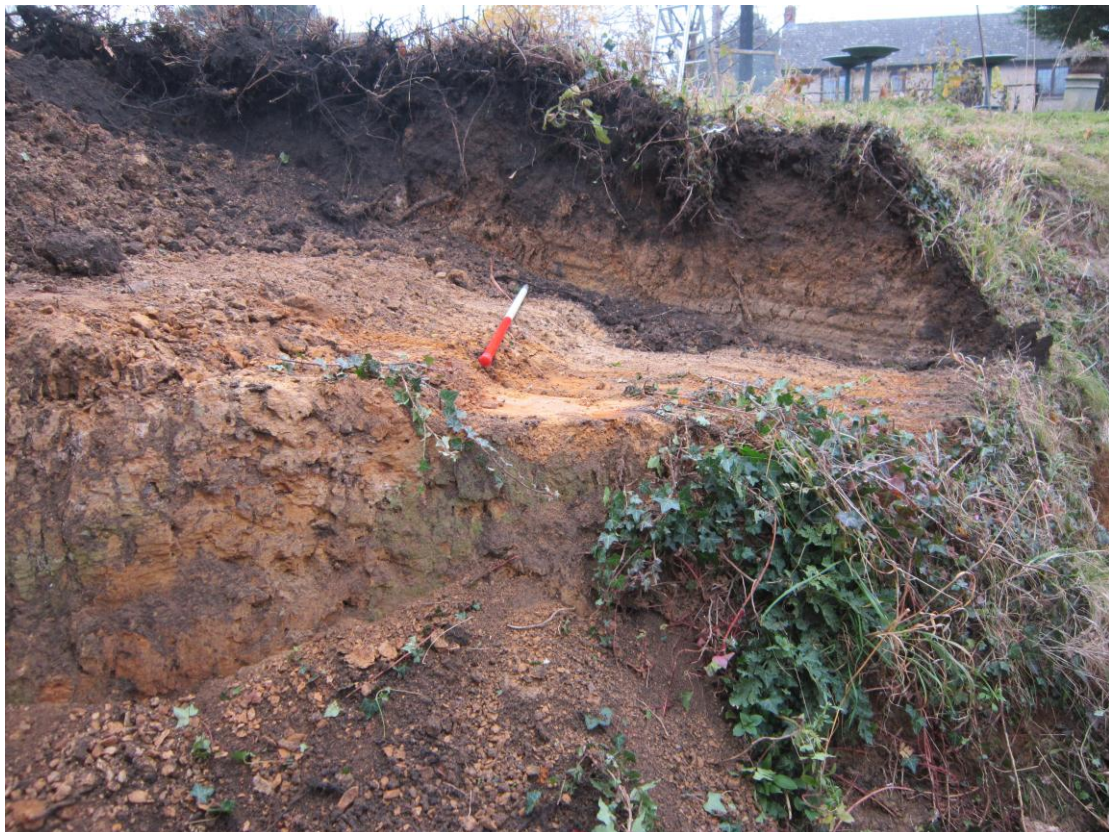
Plate 4; Ground reduction across the top of 'the mound' showing natural sands
