JOHN MOORE HERITAGE SERVICES

ARCHAEOLOGICAL WATCHING BRIEF

SAINT PETER'S CHURCH,

HOOK NORTON,

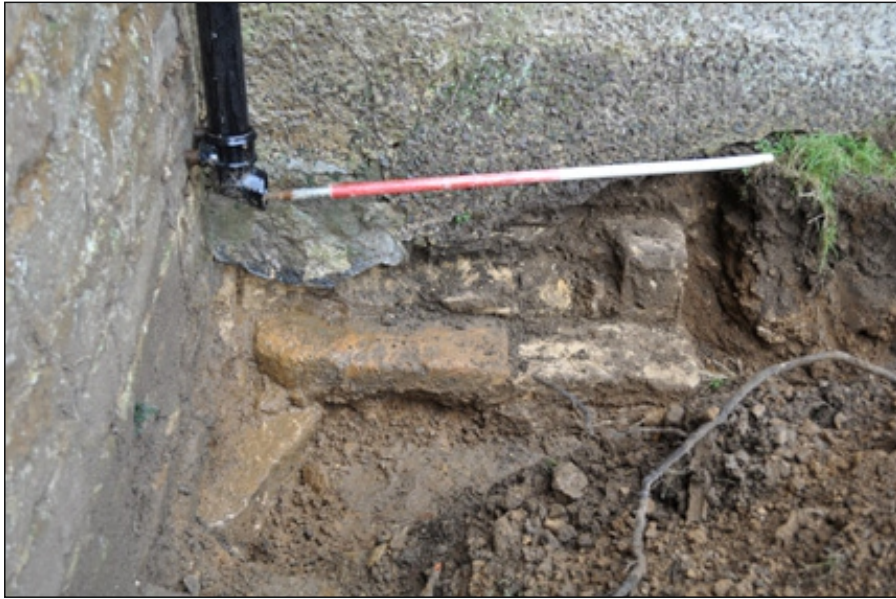
Foundation cut 20 was only partially visible but must originally have consisted of four linear cuts forming a rectangle (Figures 2, 5, Plates 1-2). The remaining visible section was over 1.16m in length with steep sides. The fill masonry 019 was the remains of limestone foundations and part of a wall. The feature contained ashlar blocks at the top of the foundation with more irregularly cut stones below. Set on the foundation was the remains of a quoin stone from what has to be an earlier building phase. Alongside the quoin was evidence of a rubble wall. The wall was mortared.

Plate 1. The remains of wall 19, 8th-9th centuries

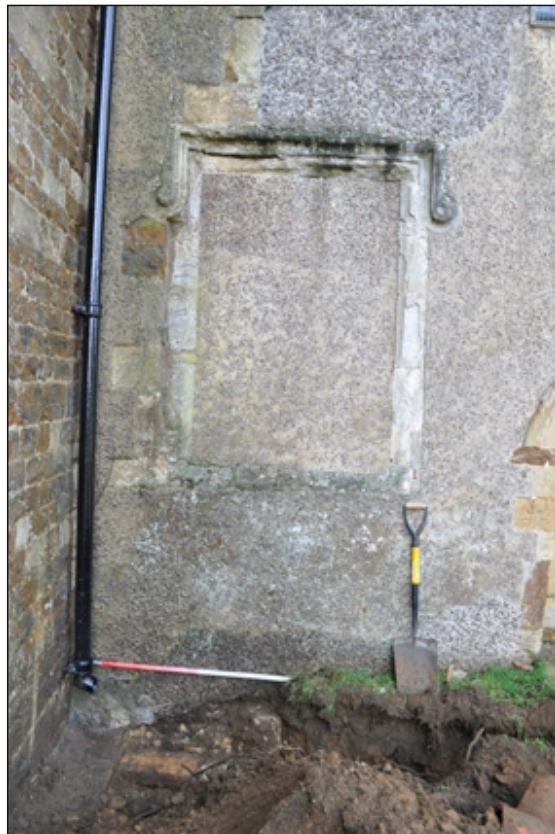
Plate 2. Wall 19 in context to the rest of the elevation

Foundation cut 32 contained three linear lengths forming a rectangular shape attached to the nave (Figures 2, 5, Plates 2). Masonry 22 was a rough limestone wall with carved ashlar masonry inserted. This included the Norman Romanesque round headed windows of the south chancel door, the round headed windows, new quoins above wall 21, and typical 11th or 12th century buttresses. Earlier features associated with this build were identified by Chambers (1981; 1987; 1988). Chambers suggested that this phase of construction should be associated with the granting of the church to Osney Abbey in c.1129, there is no reason to doubt this and it is possible to envisage the construction work being carried out after this date c.1130 and afterwards.

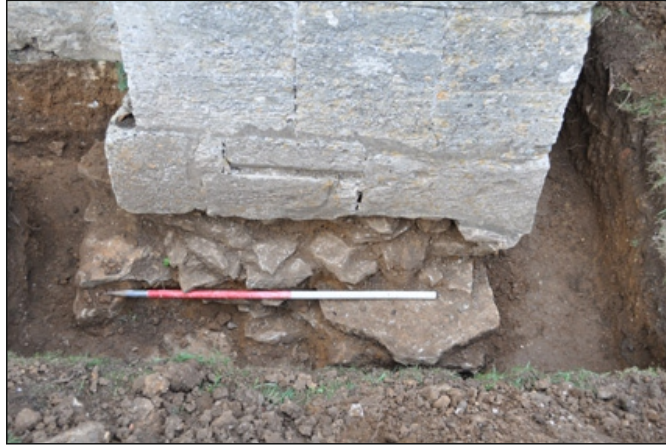
Foundation cut 24 survived as a T-shaped feature although it was probably part of something far larger (Figure 3, 6, Plates 3-5). The surviving part covered an area of over 2m by 1.7m and was uncovered to a depth of about 0.40. The fill was masonry 23 which was built of roughly squared limestone blocks of which the majority were laid flat, but some on the northern edge may have been pitched. The foundation was bonded by brown yellow clay. The later decorated period buttress, part of wall 25, sat on top of this foundation. The structure was considered to be unsafe and the buttress in danger of collapse. The early wall was left in situ and covered in terram, a soft concrete was then placed around this feature but with no aggregate in, so if it ever has to be removed in the future it is possible for it to be revealed (see engineer's report).

Plate 3. Wall 23 under buttress, from south

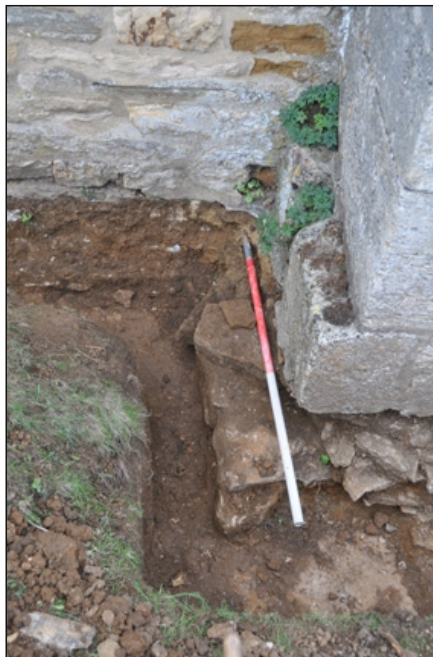
Plate 4. Wall 23, west side

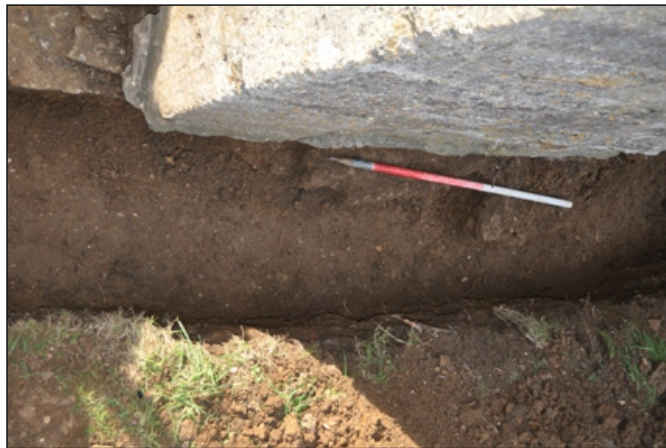
Plate 5. Wall 23, east side

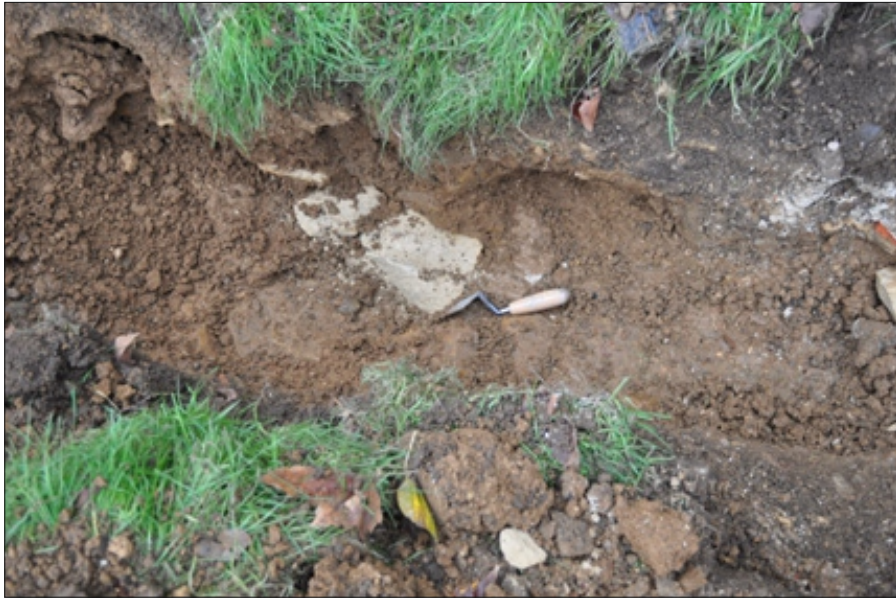
Plate 6. Wall 08, part of the 12th century chapel wall

Foundation cut 09 was a linear feature measuring 0.9m wide with presumably vertical sides and a flat base, although the profile was not observed (Figures 2, Plates 6-7). The fill masonry 08 was a limestone wall built of rubble bounded with a mortar clay. The wall was orientated north to south.

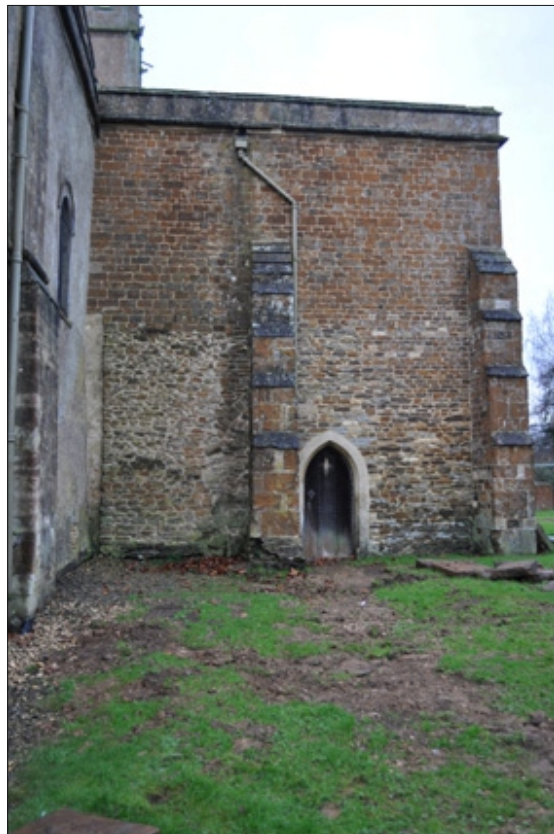
Plate 7. North wall of transept containing part of the Norman arch into the chapel

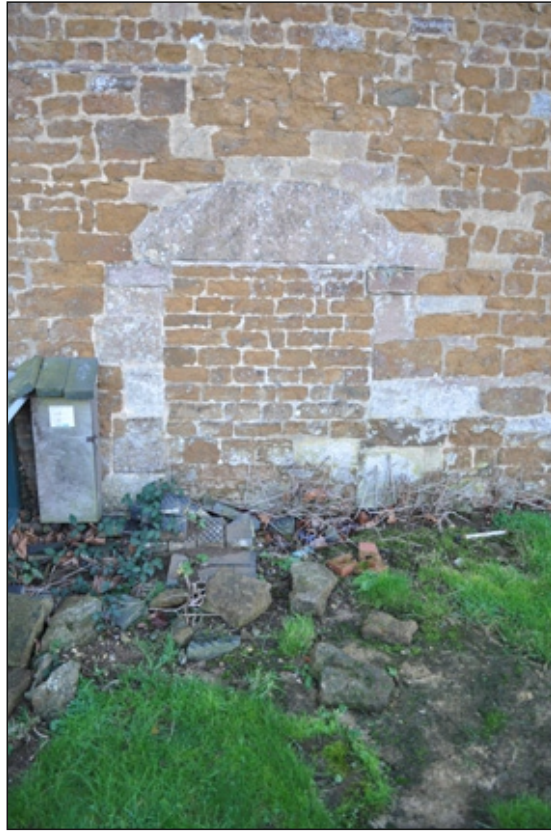
Plate 8. Blocked Norman, 12th century doorway

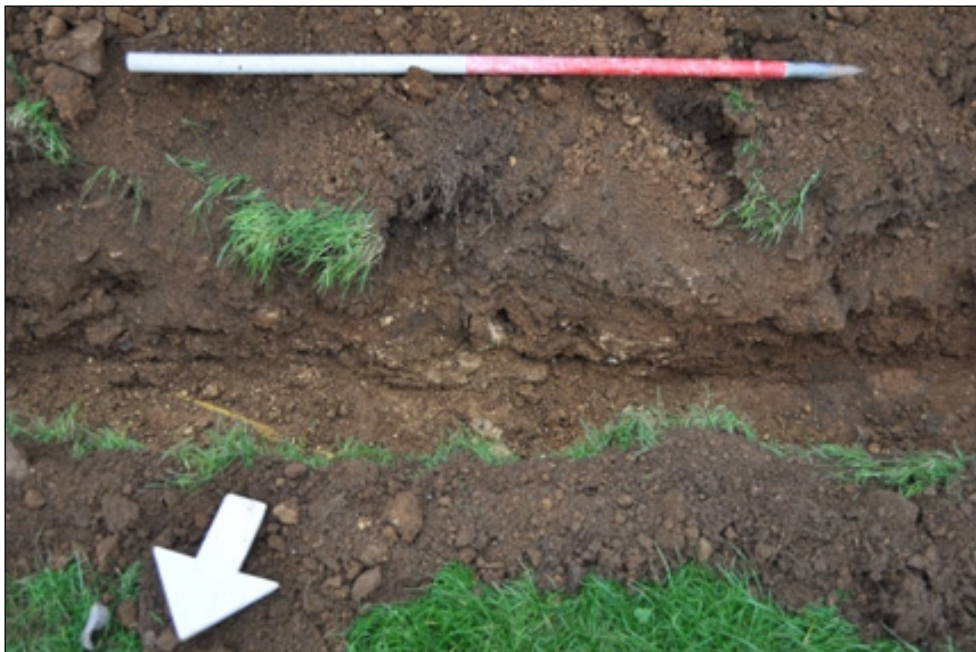
Foundation cut 05 was a linear feature for which the dimensions were not fully known, but which probably had steep sides and a flat base (Figure 4, Plate 9). The fill was masonry 04 the remains of a limestone wall built with rubble, bonded with white lime mortar and orientated east to west. The wall was probably 0.55m wide at least, it was sealed by deposit (02).

Plate 9. Wall 04, an undated wall to the north of the north aisle
