AN ARCHAEOLOGICAL WATCHING BRIEF

IN THE CHURCHYARD OF

THE PARISH CHURCH OF ST. MARY THE VIRGIN,

CHURCH ROAD, GREAT MILTON,

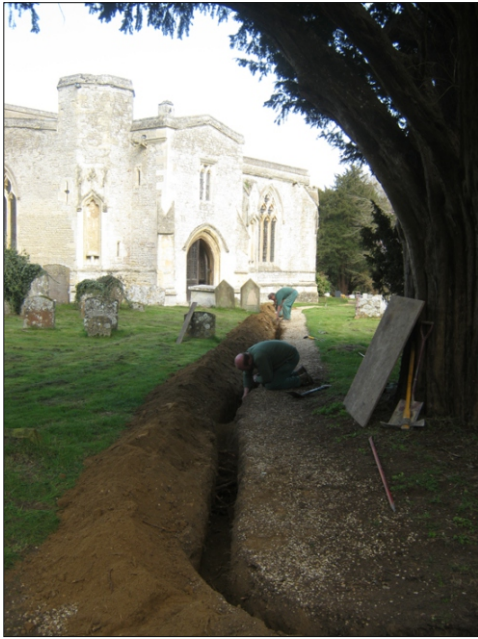
Plate 1. Hand excavation of trench, looking Southwest.

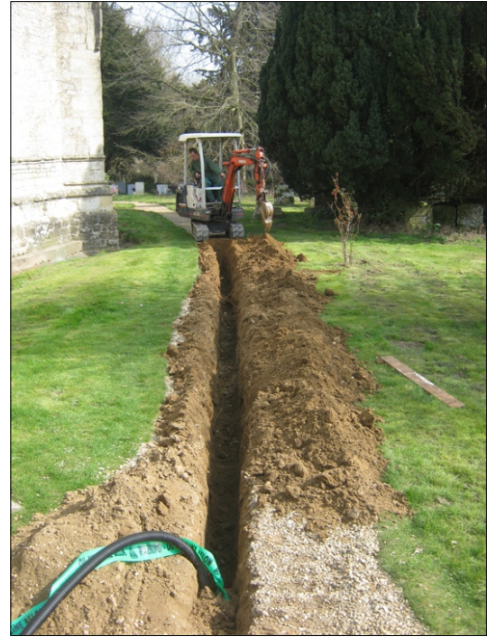
Plate 2. Machine excavation of trench, looking Southwest.

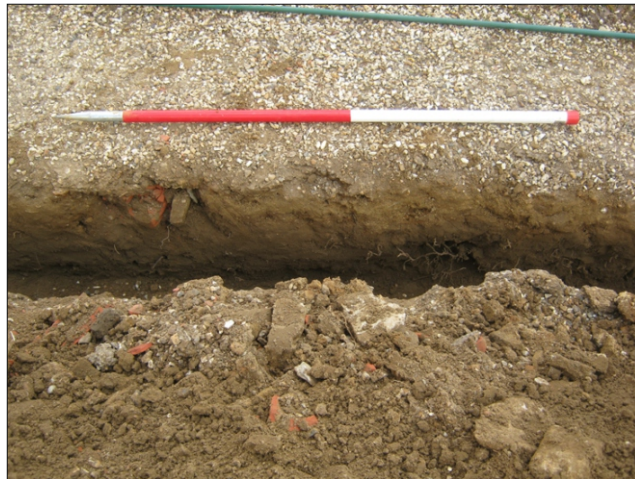
Overlying the deposit (102) was *c.* 0.03m thick greyish white fine gravel (101) this formed the present surface of the footpath (Plate 3).

Plate 3. Representative section of trench, looking Northwest.

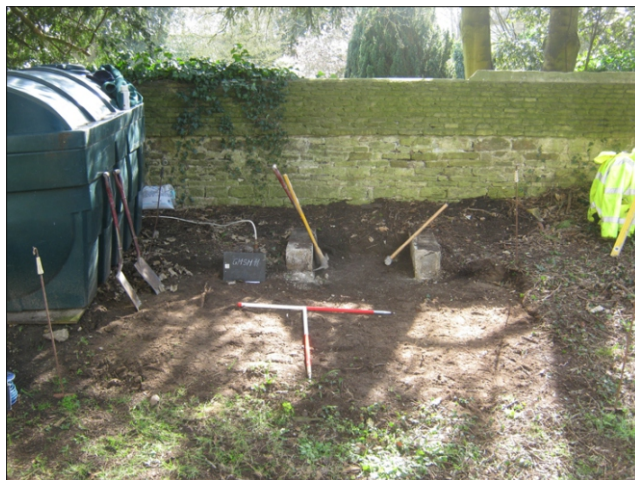
Plate 4. Excavated footing for concrete base, looking Northwest.

The footing of the concrete base for the new oil tank was excavated to a general depth 0.12m and covered an area of 3.10 x 2.10m (Plate 4). During hand excavation of footing was removed small amount of modern topsoil (100), seen as dark grey sandy silt.
