AN ARCHAEOLOGICAL WATCHING BRIEF

**CROSSING COTTAGE, TODENHAM ROAD,
MORETON-IN-MARSH,
GLOUCESTERSHIRE**

APRIL 2012

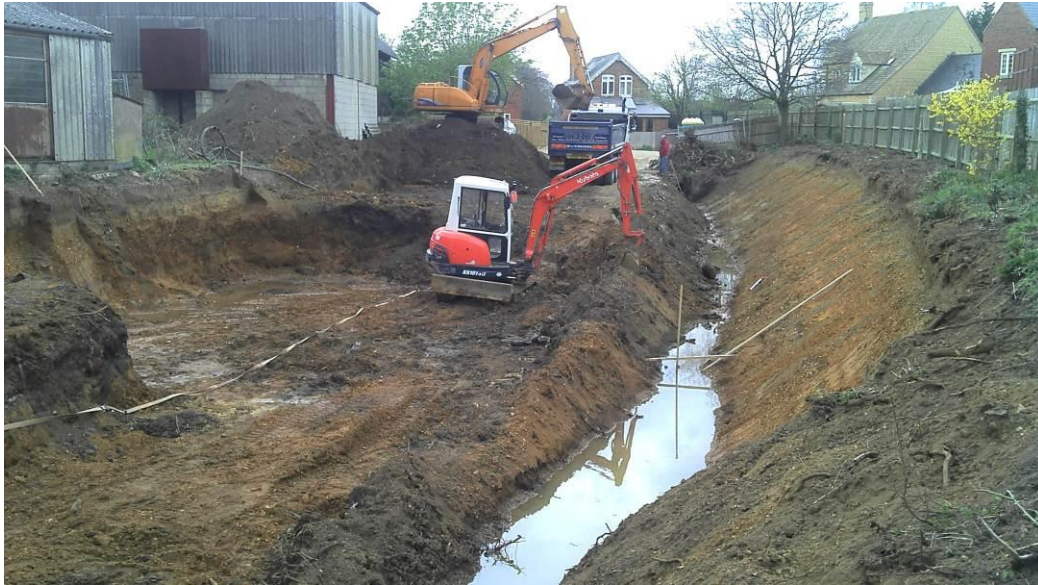
Unfortunately, the developer began ground-work on the Site without an archaeologist being present, and a visit by a JMHS staff member on the 3rd April 2012 found that the footprint of the southern building had already been excavated to a depth of over 1.5m deep into the natural subsoil (Fig. 2).

Figure 2. Photograph of the Site on the 3rd April 2012 looking north, showing the large quantity of material removed without monitoring at the southern extent of the development area, and the large open drainage ditch along the eastern boundary.

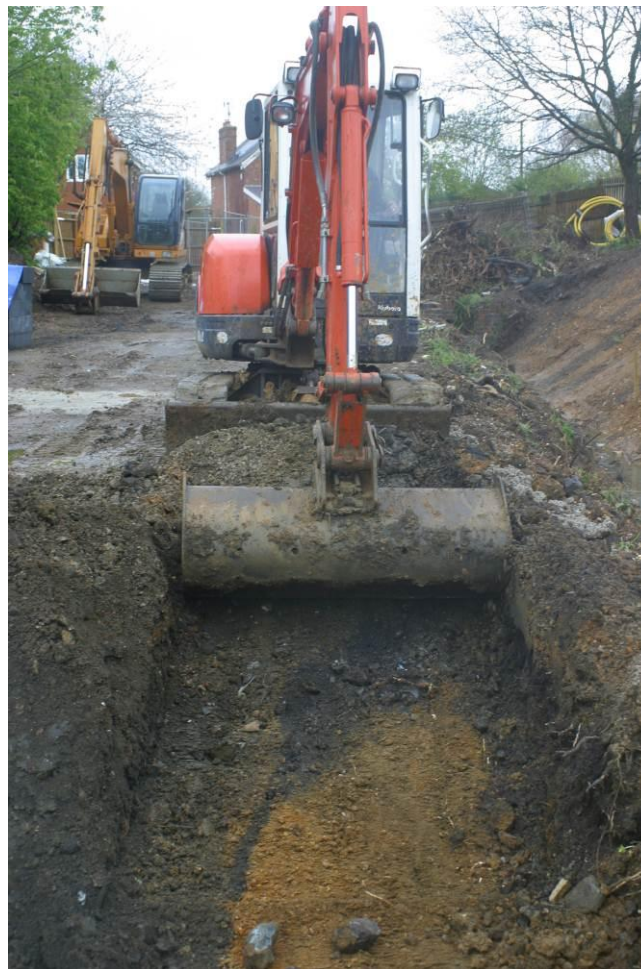
Figure 3. Machining on Site on the 18th April 2012 looking north-east, in the western trench alongside the existing drainage ditch. The line of the modern electricity cable cut is visible at the left side of the trench, and the earlier drainage cut at the right.

In addition to the cable trench, the sinuous line of a rectilinear feature on the eastern side of the eastern trench was identified, up to 0.30-0.40m wide as exposed in the bottom of the trench, and filled with dark grey-brown clayey silty loam and gravel (Fig. 3). Parallel to the extant drainage ditch, it was almost certainly an earlier cut of the drain that had silted up prior to the more recent recutting. It was planned but not excavated as modern brick and tile fragments, modern glass and porcelain fragments and several modern iron bolts and fittings were identified in its fill, and these finds were not retained.
